Annual Monitoring Report

Monitoring Year 6 of 7

Pee Dee Stream Restoration Project
NCDMS Contract No.: 004644
NCDMS Project No.: 95350
USACE Action ID: SAW-2012-01077
DWR #: 13-1140

Montgomery County, NC
Data Collected: November 2020
Date Submitted: January 2021

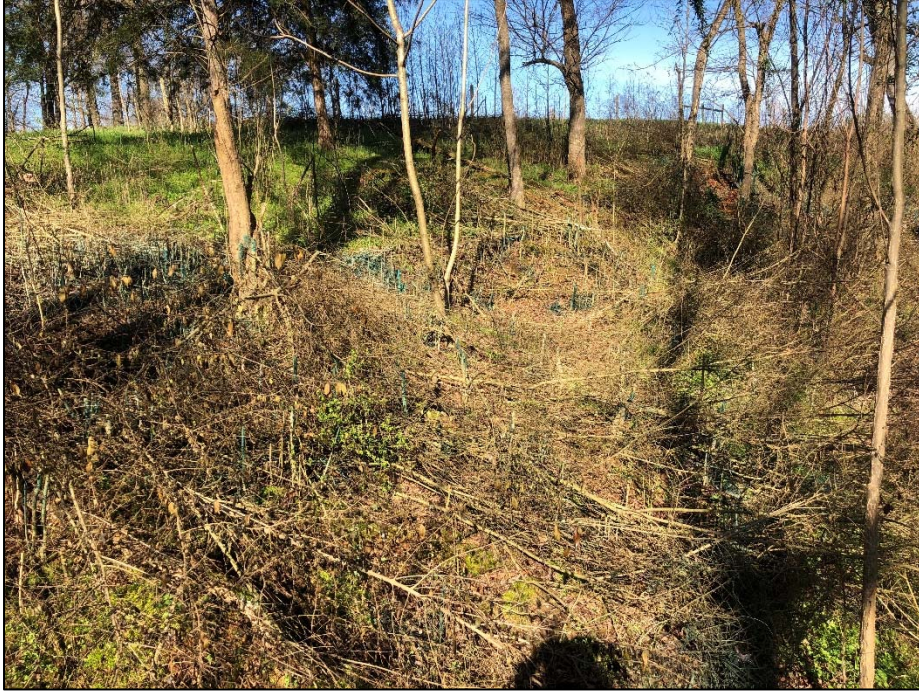
Method: Cut Stump Herbicide Treatment of Chinese Privet

- Overall, the privet treatment was extremely successful, and only a limited number of re-sprouts were observed. Some areas had cut privet left in the channel which will be removed, and follow-up privet treatments will be administered throughout the remainder of the monitoring period.

Treatment Area: >2.51 acres

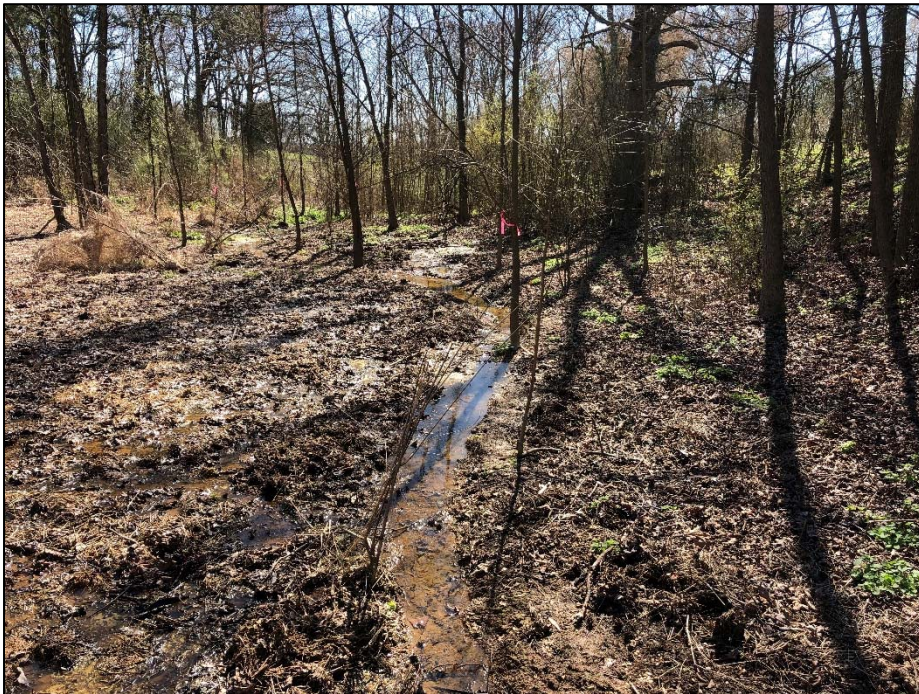
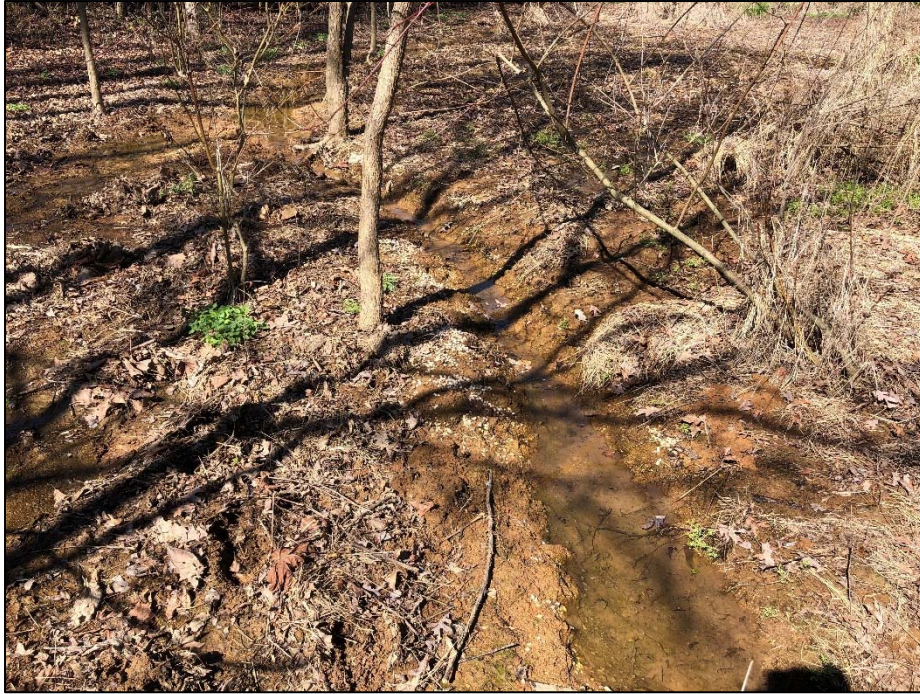
Flow Path Excavation

Date: January 2020

Method: Hand tools (shovels and rakes)

Treatment Length: +/- 150 feet (Dale 1)

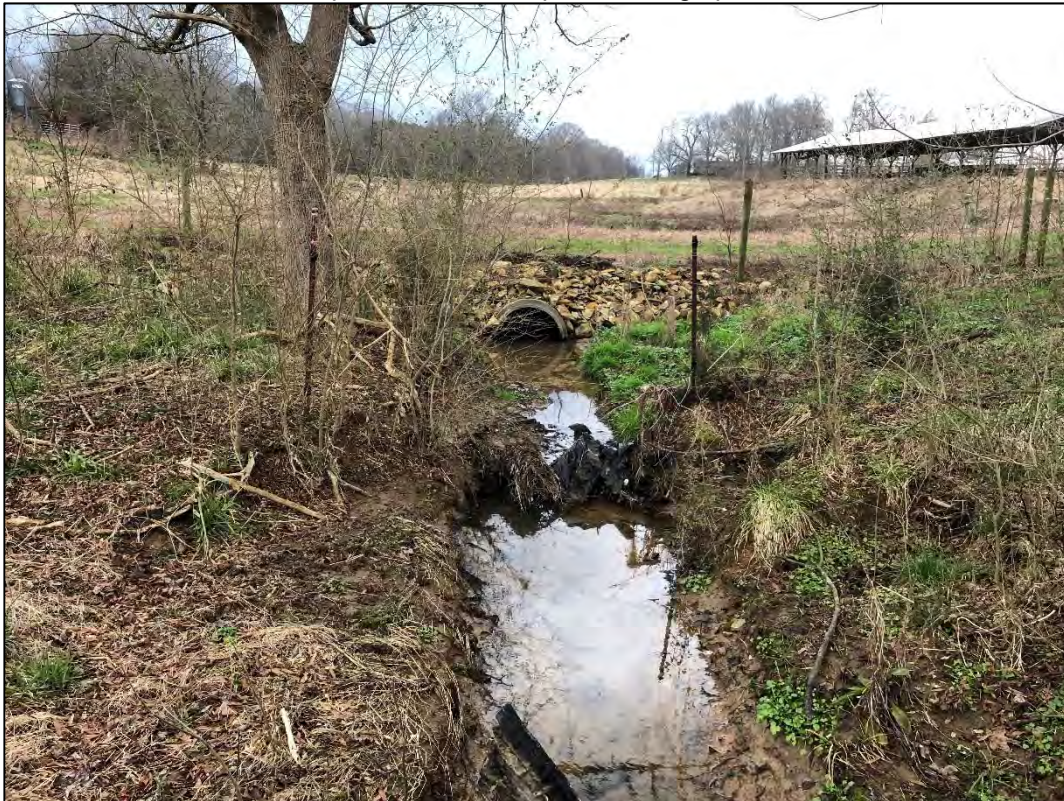
Thompson 1 above old pond looking upstream

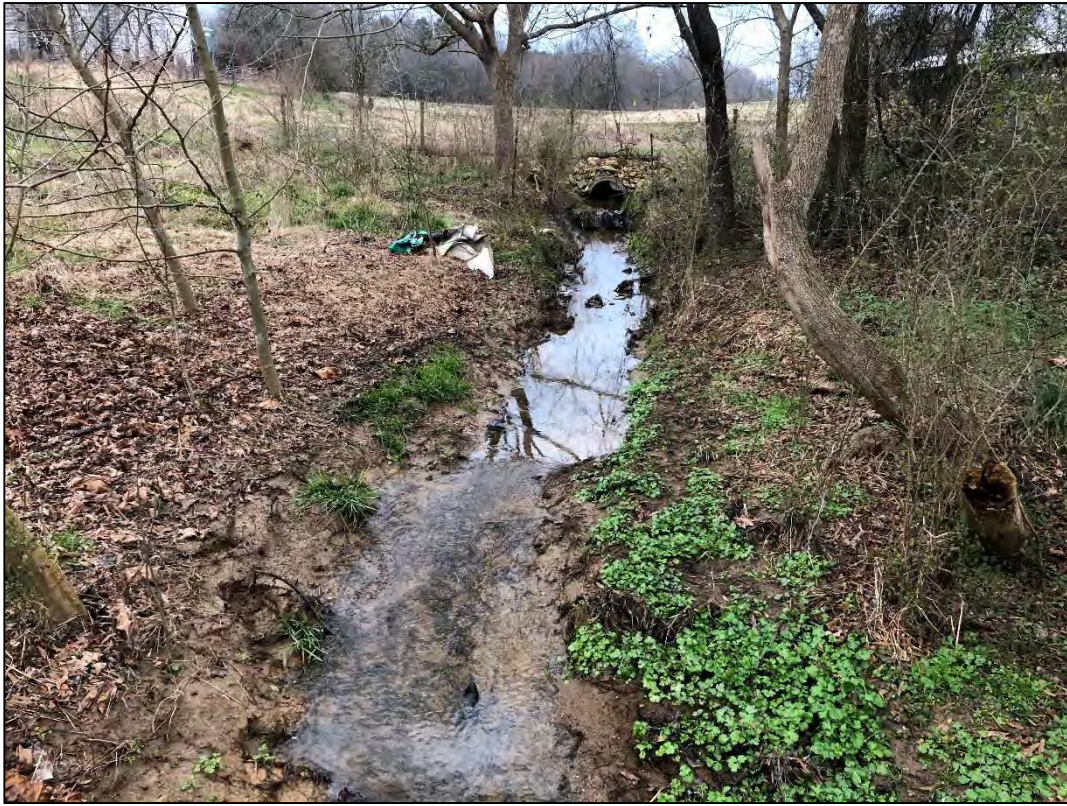
Thompson 1 above old pond looking upstream at new crossing

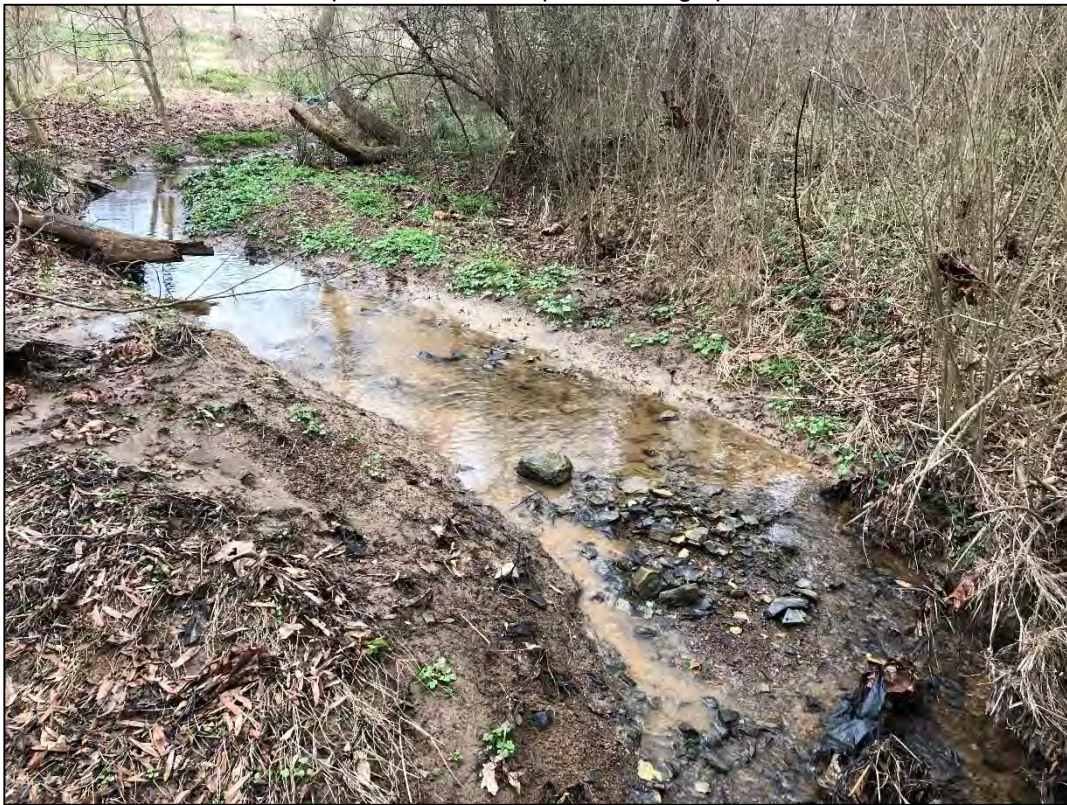
Thompson 1 above old pond looking upstream

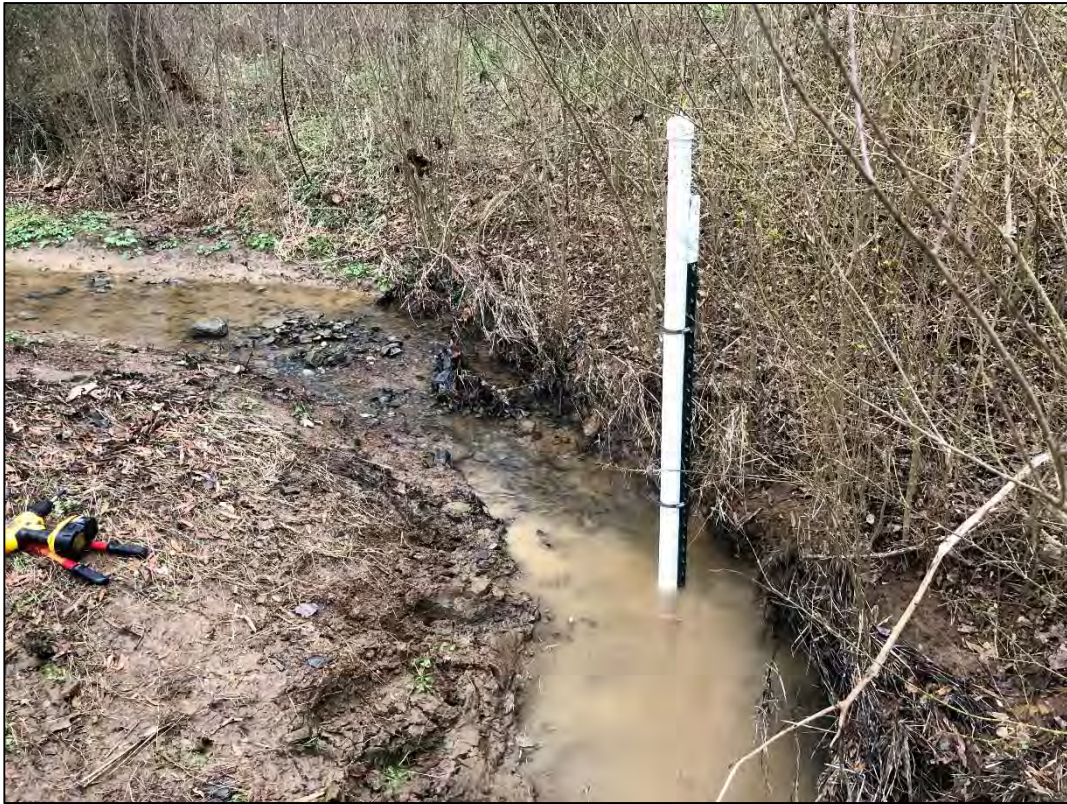
Thompson 1 above old pond looking upstream

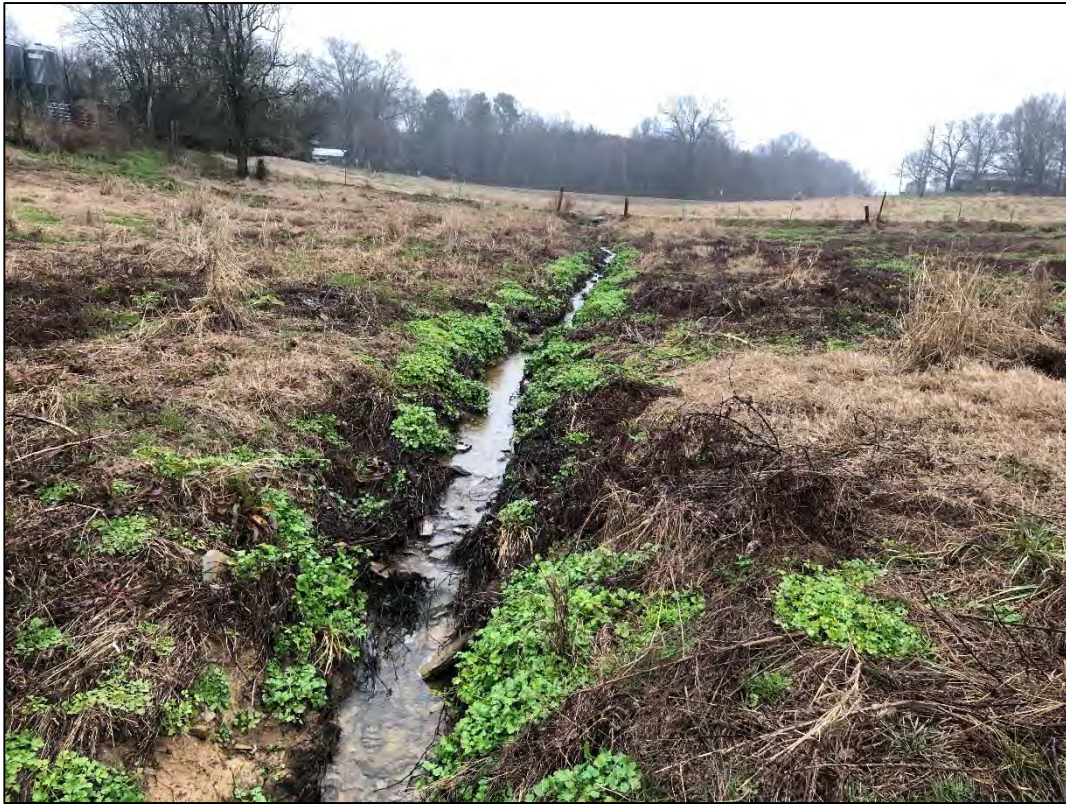
Following dam removal, the pond bottom cracked as it was drained. The cracks in the soil are up to a few feet deep. Any surface water that enters the pond bottom is lost into the cracks and a single-thread flow path is difficult to locate. Due to risk and budgetary constraints, RES does not plan on doing any work in this area.

Thompson 1 above old pond looking downstream into pond bottom

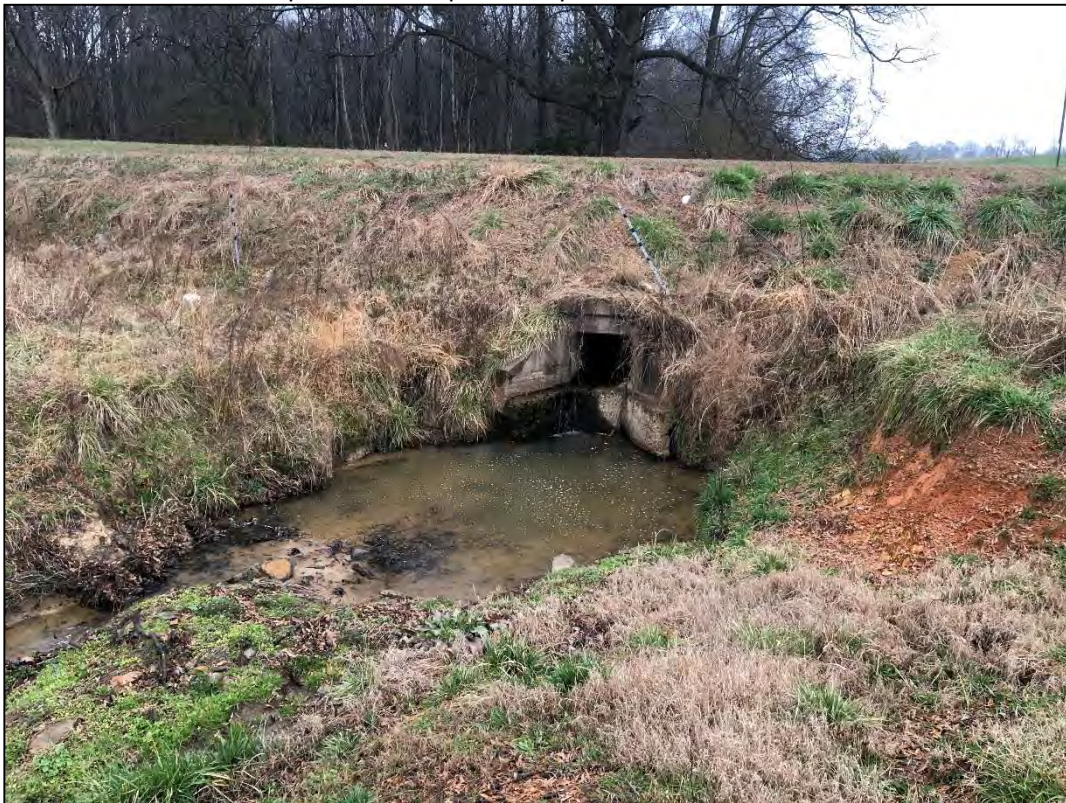
Thompson 1 in the pasture upstream of the easement
