**FINAL
MY2 (2023) MONITORING REPORT**

PHANTOM MILL

Alamance County, North Carolina

DMS Project No. 100057

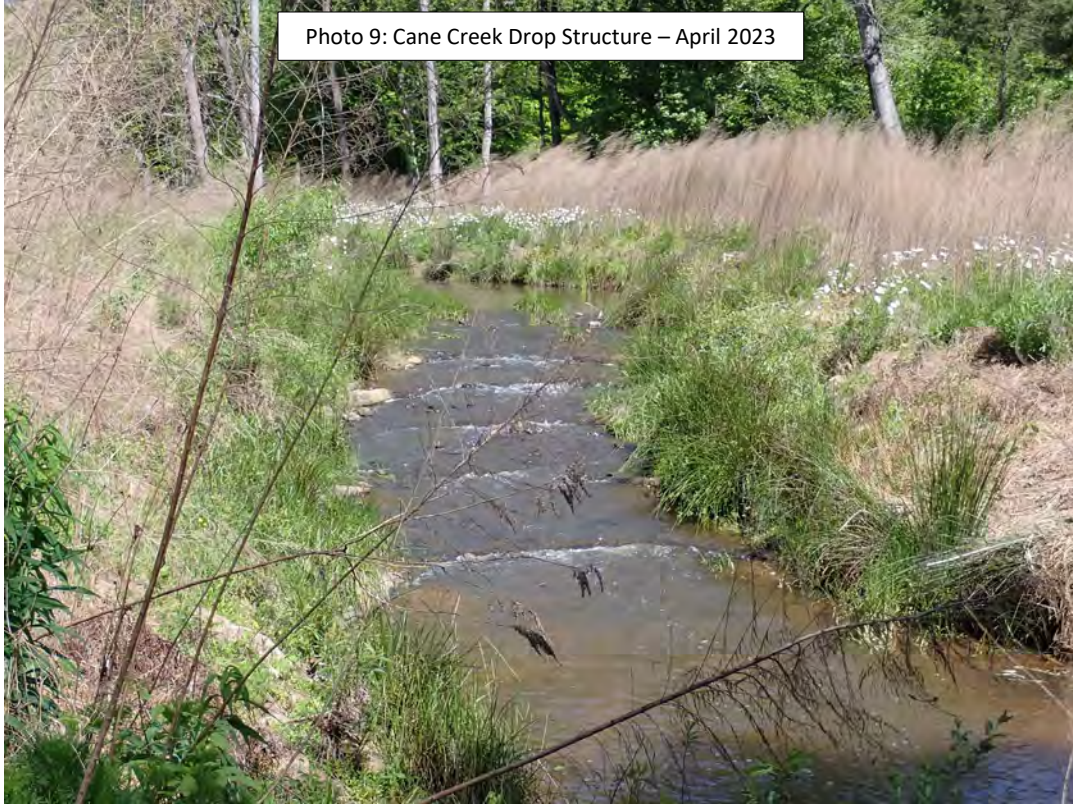
Photo 9: Cane Creek Drop Structure – April 2023

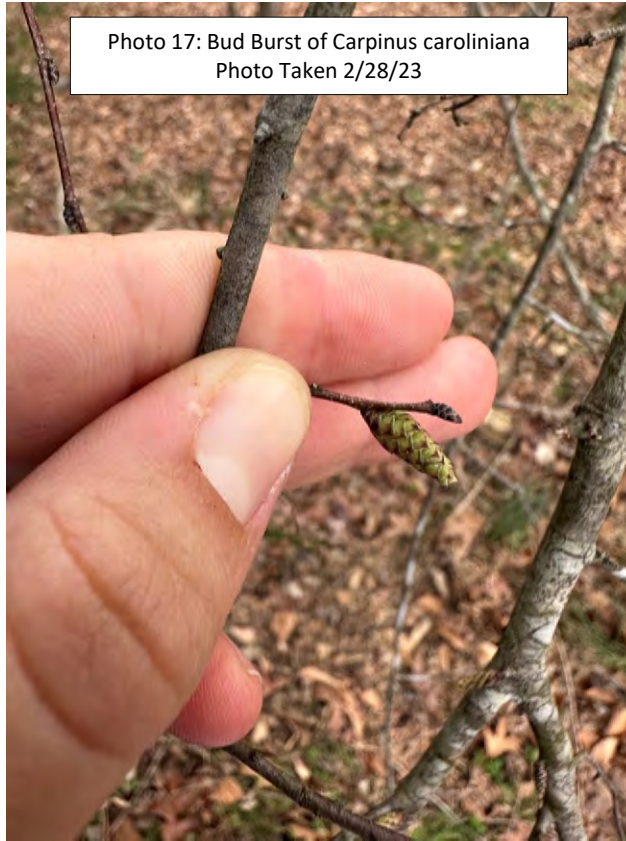
*Based on observed/documentated bud burst on the Site on February 28, 2023, and soil temperature of 49.16 °F documentated March 1, 2023.

Photo 17: Bud Burst of *Carpinus caroliniana*
Photo Taken 2/28/23

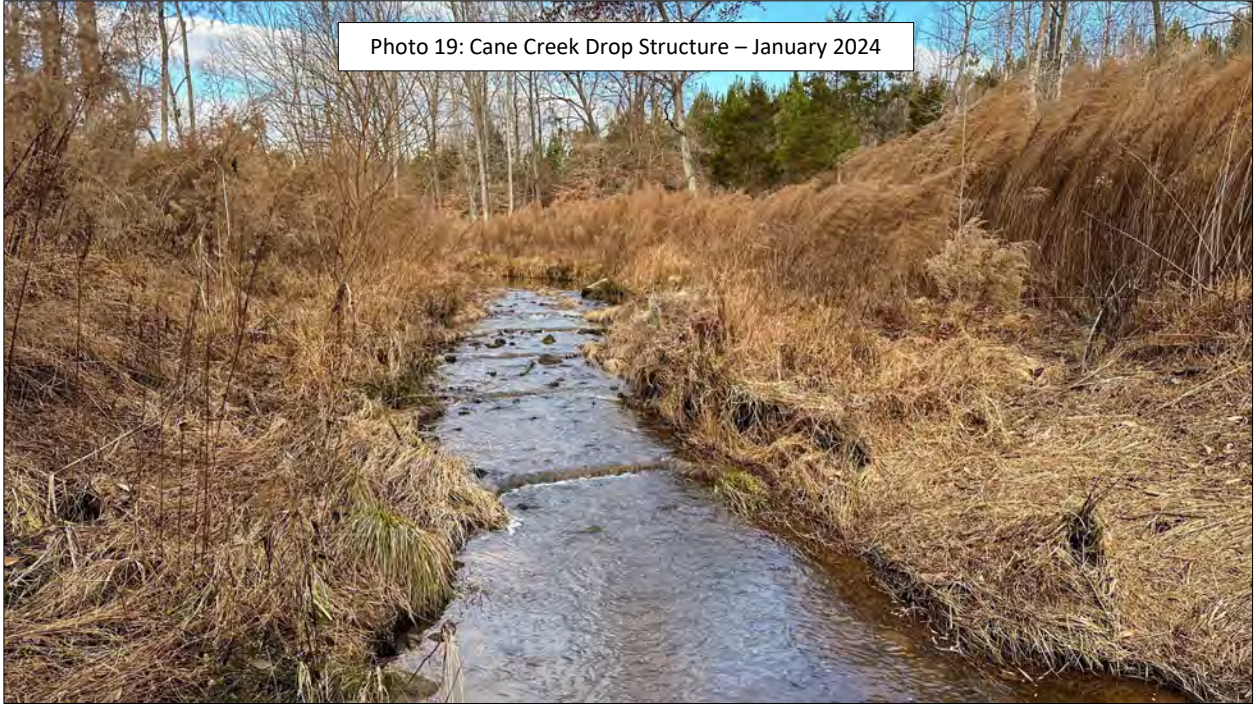
Photo 19: Cane Creek Drop Structure – January 2024

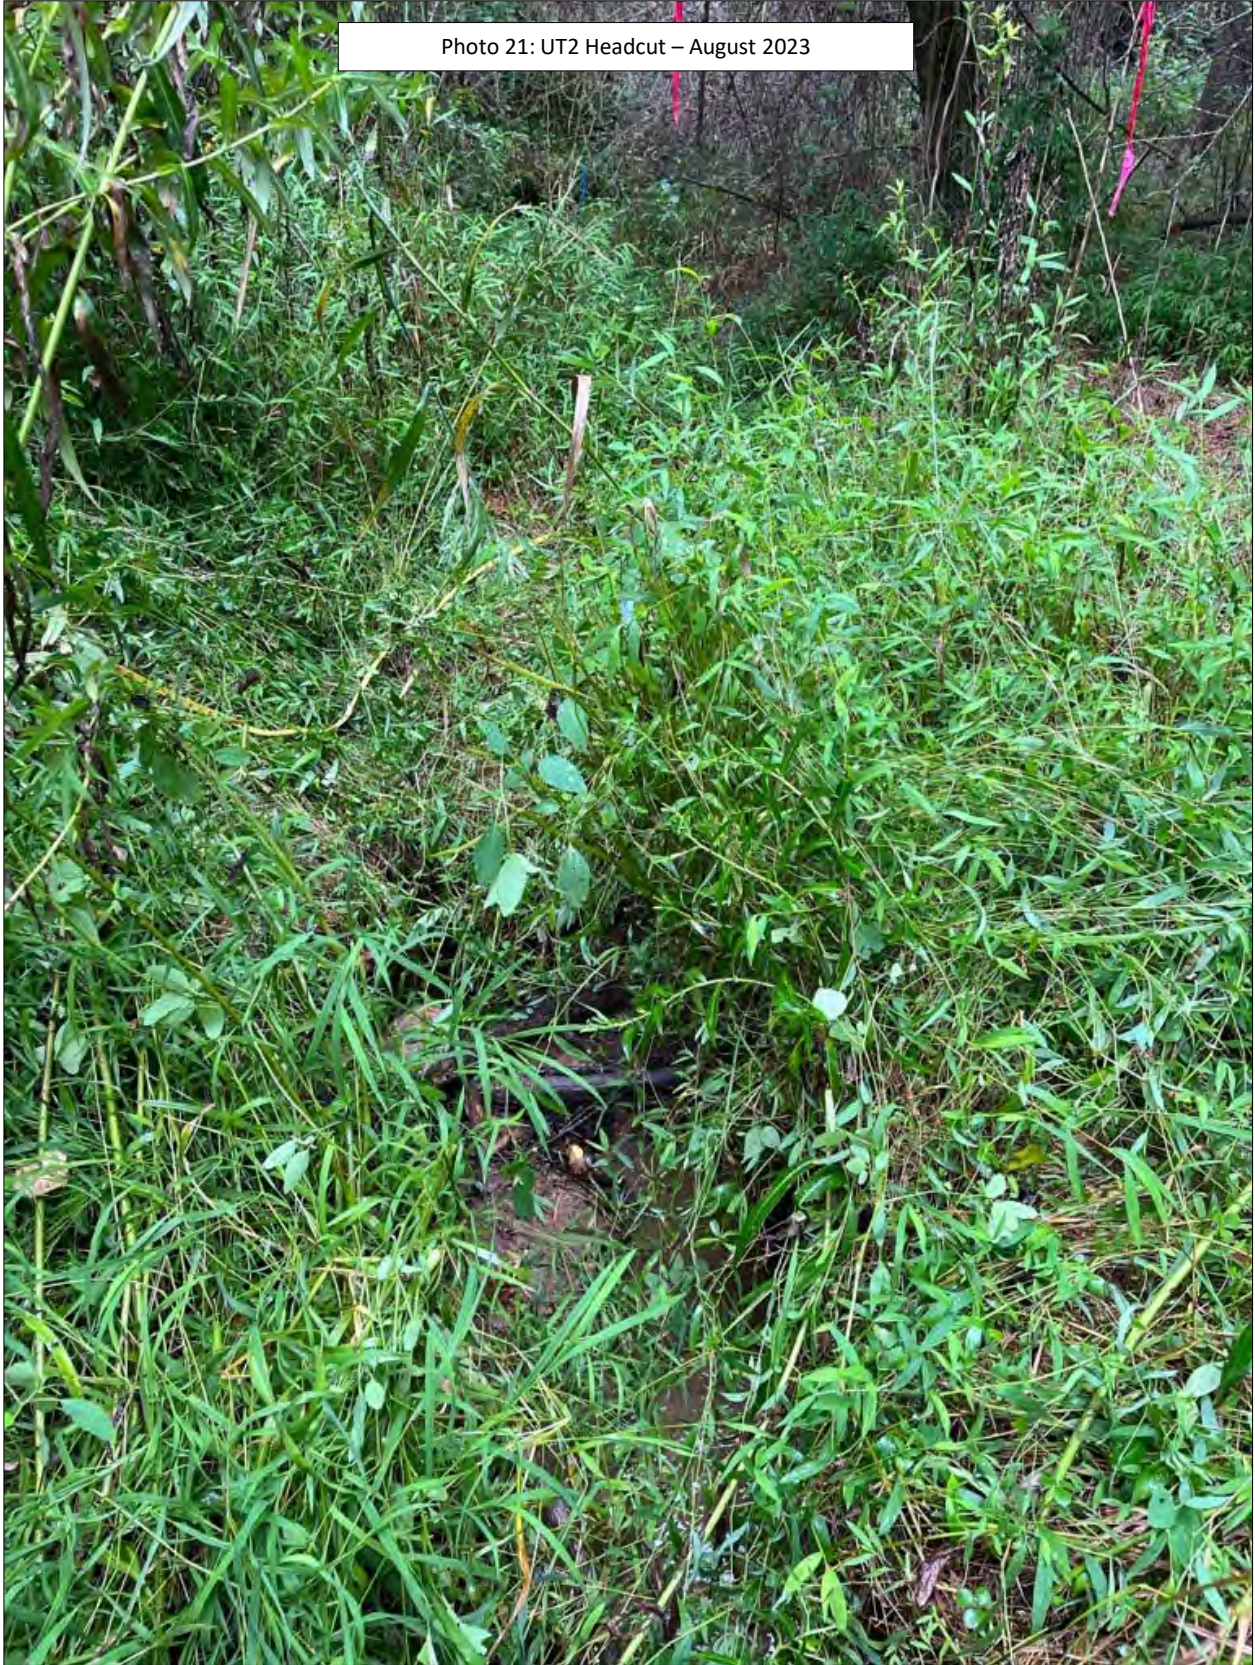
One stream area of concern was observed and repaired during Year 2 (2023) monitoring. At the bottom of the Enhancement II area of UT2, approximately 11 linear feet of the stream was found to be unstable due to piping (Figure 1, Appendix A). In an effort to arrest head cut formation, the area was stabilized with matting and rock found onsite piled outside the easement. The IRT was notified of the maintenance work, which was performed on October 24, 2023. Additionally, five 1- and 3-gallon containerized trees were planted within the footprint of the repair on December 22, 2023. Species included water oak, willow oak, sycamore, and river birch. Live staking of black willow and silky dogwood along the repaired reach is scheduled for mid to late February 2024. See Q4 2023/Q4 2024 Remedial Planting Plan in Vegetation Summary for details. Email correspondence and photos of the repair are in Appendix F. This area will continue to be monitored closely in years 3-7.

Photo 20: UT2 Repair

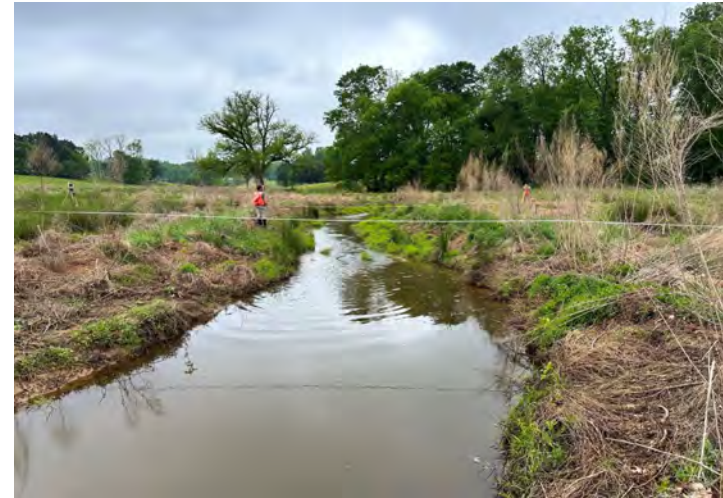
Site	Phantom Mill
Watershed:	Cape Fear River Basin, 03030002
XS ID	Cane Cr, XS -5, Pool
Feature	Pool
Date:	4/27/2023
Field Crew:	Perkinson, Lance, Adams, Smith

SUMMARY DATA	
Bankfull Elevation:	591.8
Bank Height Ratio:	0.97
Thalweg Elevation:	587.8
LTOB Elevation:	591.7
LTOB Max Depth:	3.9
LTOB Cross Sectional Area:	68.3

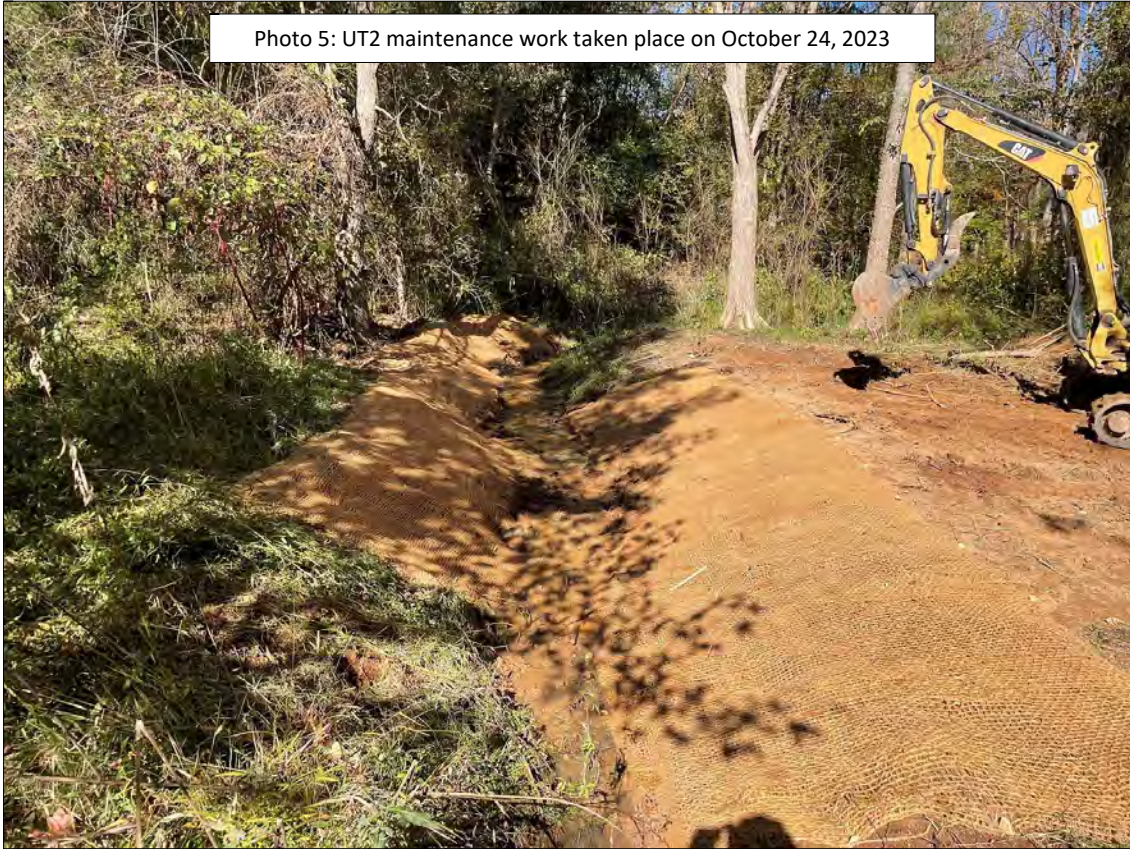
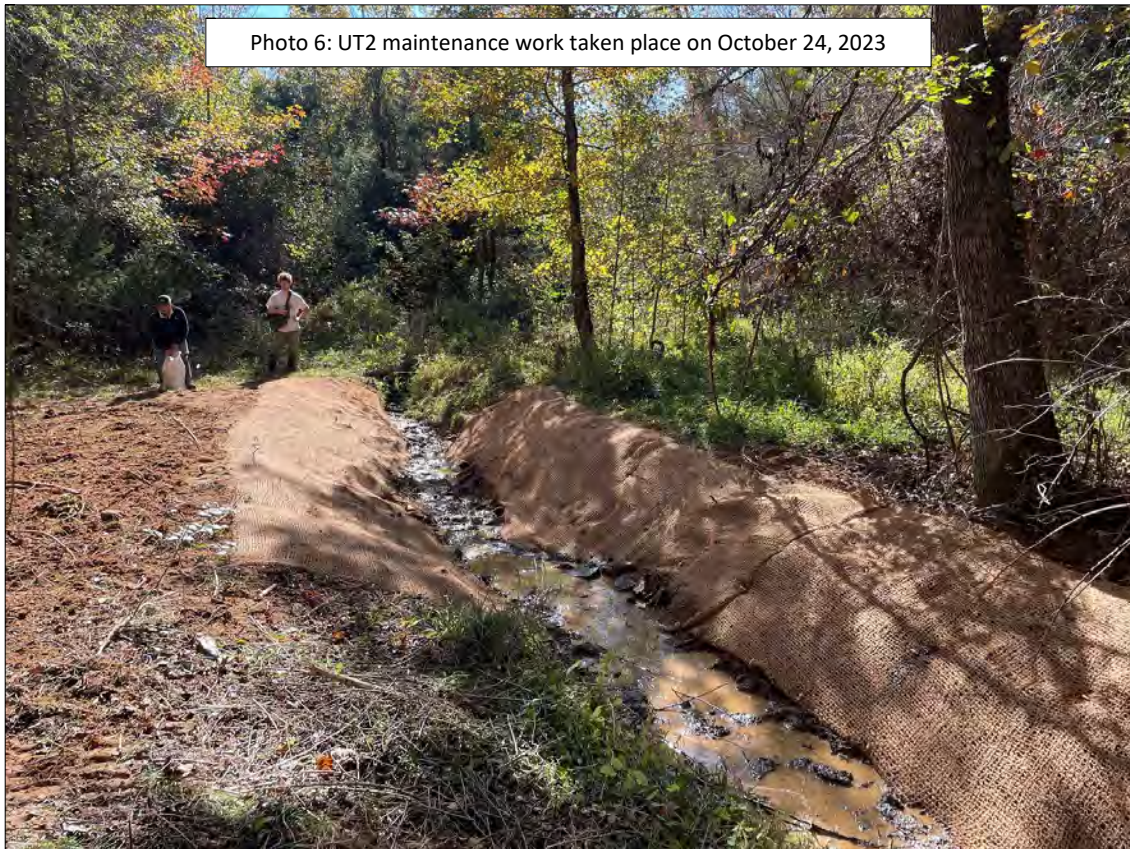
**Phantom Mill
MY-02 (2023) Maintenance Activity Photo Log**

We have a small area (about 11 linear feet) of piping at Phantom Mill near STA 8 on UT2. This is at the bottom of our enhancement II area. We are planning use some matting and onsite rock that is piled just outside the easement there to correct the issue while it is still minor and arrest the headcut that is forming. We expect to complete the repair in the next 60-90 days.
