MONITORING YEAR 3 REPORT

PHILLIPS–WILLIS SITE MIDDLE FORK CREEK

Madison County, North Carolina

EEP Project Number: 92703
Contract Number: D06082; Task Order: 07MON1-11

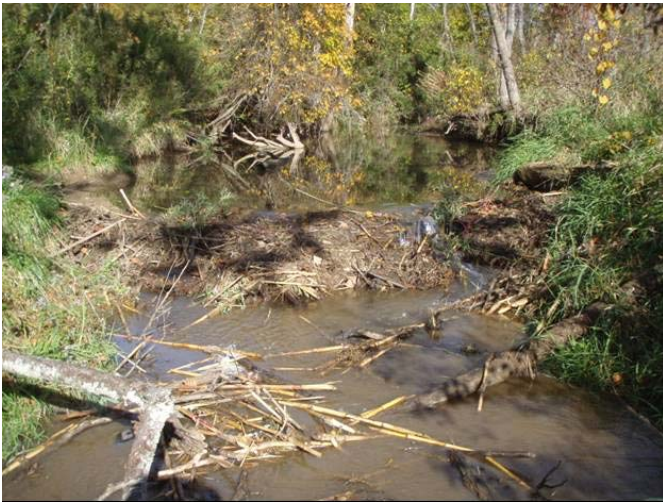
The few problem areas that were observed and photo documented were confined to the MFC channel (Appendix Table B.1.1). Problem areas such as bank sloughing or scour were typically <25 ft in length. Three locations with mid-channel bars were noted along the MFC reach. Bank sloughing, likely caused by a field drain, appears to have resulted in the formation of one mid-channel bar. The others appear to be the result of a combination of past beaver dam construction and heavy bed load being transported downstream from off-project areas. Beaver dam removal and animal eradication have occurred at the project site on three separate occasions; once the beaver dams were removed, the channel cut through the sediments deposited when the dams were ponding stream flows. Beaver dams also created two observed over-wide areas in the channel. These over-wide points along the channel have resulted in bank scour and bar formation problem areas. The most recent beaver dam was constructed on WB near its confluence with MFC. This channel obstruction was noted during the MY3 survey

Stream problem area 2, MFC beaver dam, 14 Oct 2008.

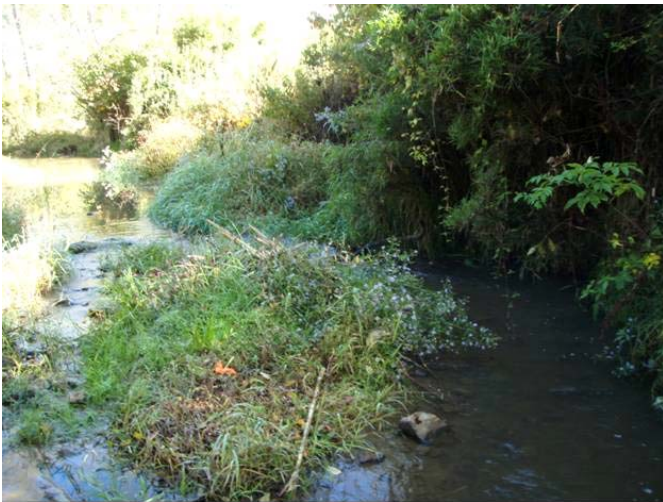
Stream problem area 3, MFC mid channel bar, 14 Oct 2008.

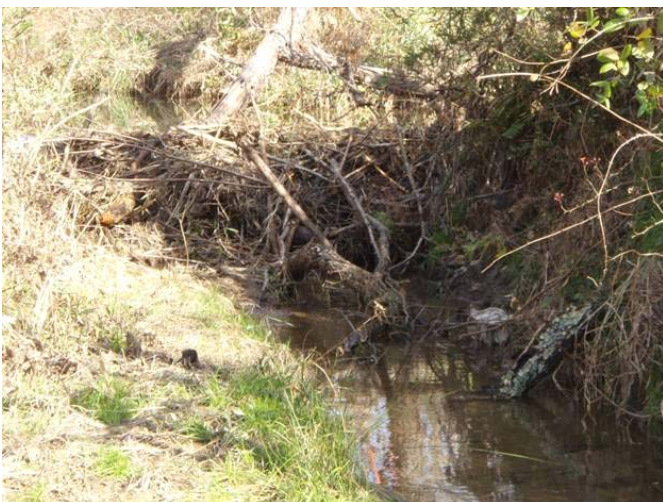
Stream problem area 4, WB beaver dam, 25 Nov 2009

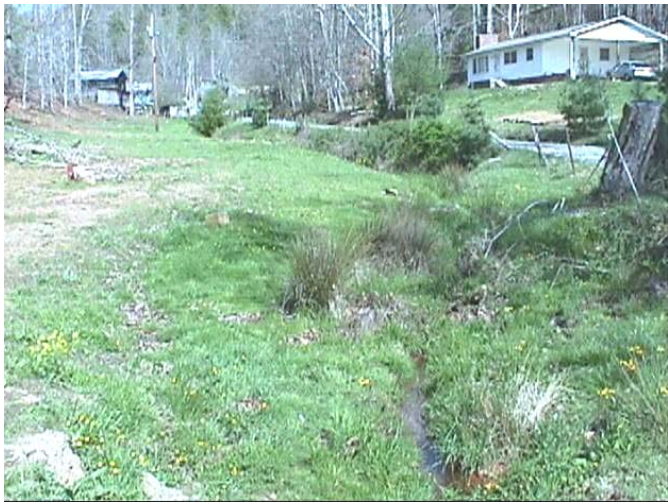
Photo point 9, pre-existing facing upstream, 15 April 2002.

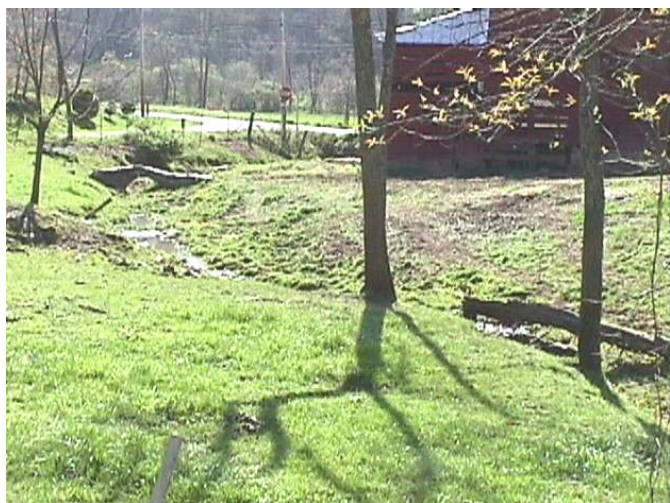
Photo point 10, pre-existing facing downstream, 15 April 2002.

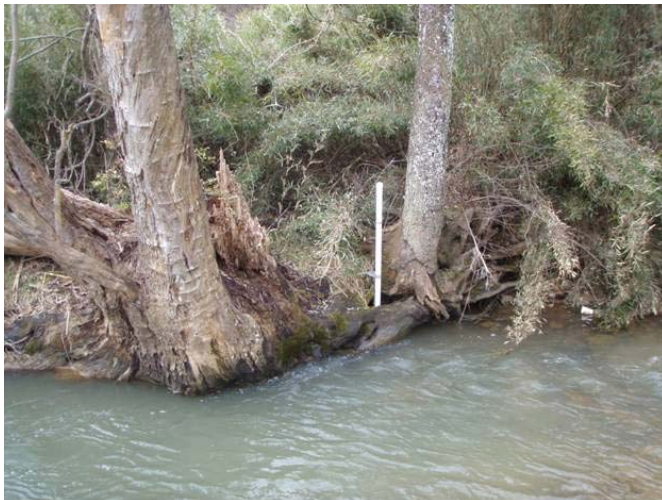
Crest gage location, MFC, established 14 Oct 08.

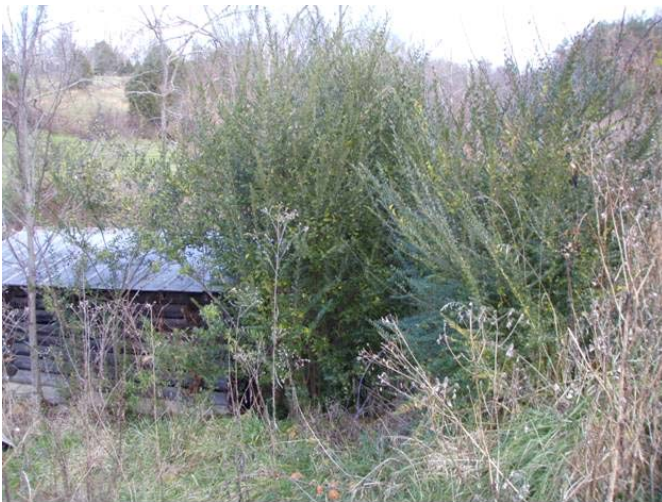
MY3 Vegetation Problem Areas			
Phillips-Willis Site (EEP project number 92703)			
Feature/Issue	Station Number/Range	Probable Cause	Photo Number
Chinese privet, multiflora rose present	MFC 17+50, left bank	Parent stock	1
Chinese privet present	MB 22+25, left bank	Parent stock	2

Veg problem area 2 MB, right bank, 25 Nov 2009.

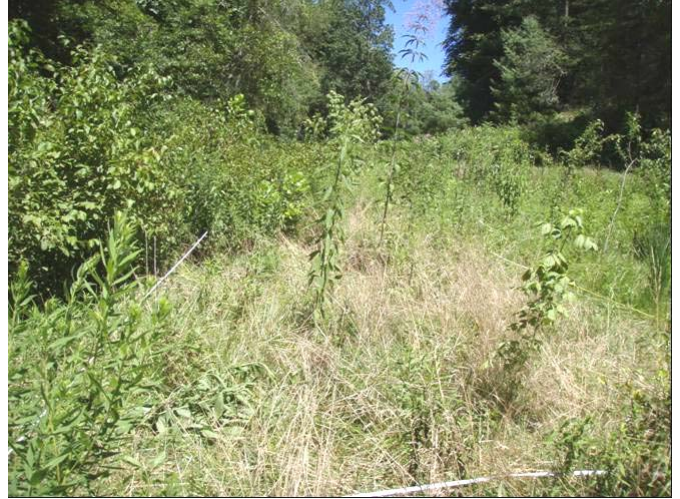
Vegetation plot 2 MB, facing upstream (0,3), 14 Aug 08.

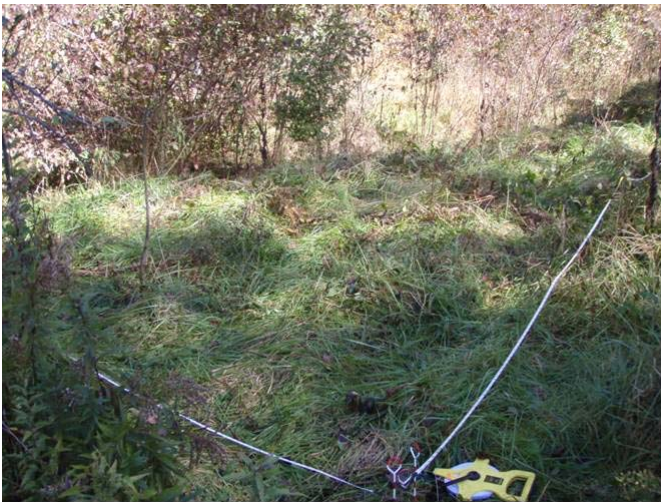
Vegetation plot 2 MB, facing upstream (0,3), 30 Oct 09.

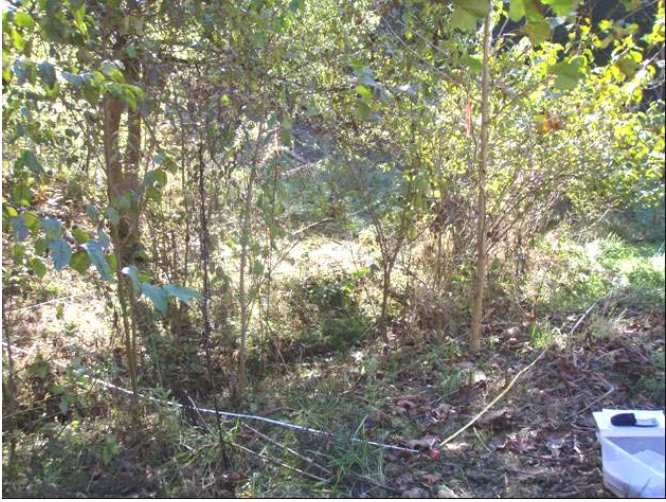
Vegetation plot 3 MB, facing downstream (0,0), 15 Oct 07.

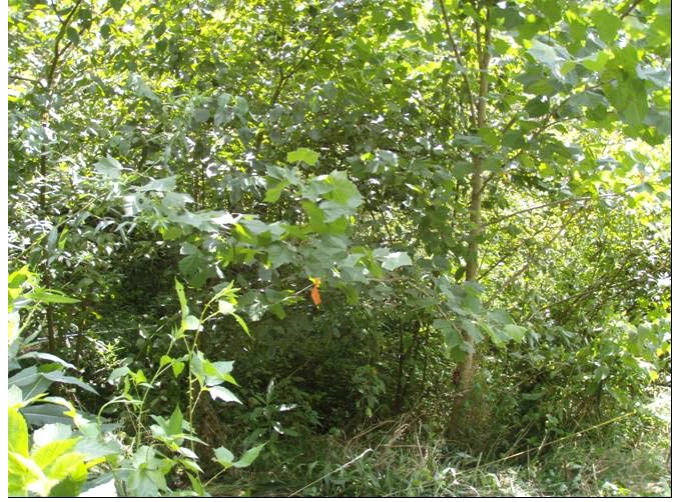
Vegetation plot 3 MB, facing downstream (0,0), 14 Aug 08.

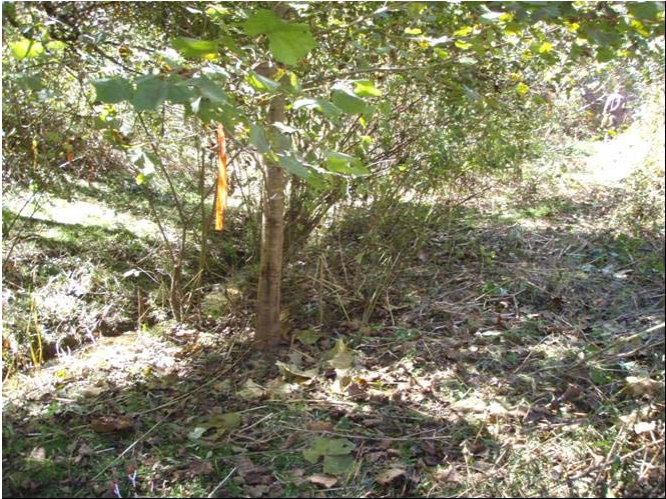
Vegetation plot 3 MB, facing downstream (0,0), 30 Oct 09.

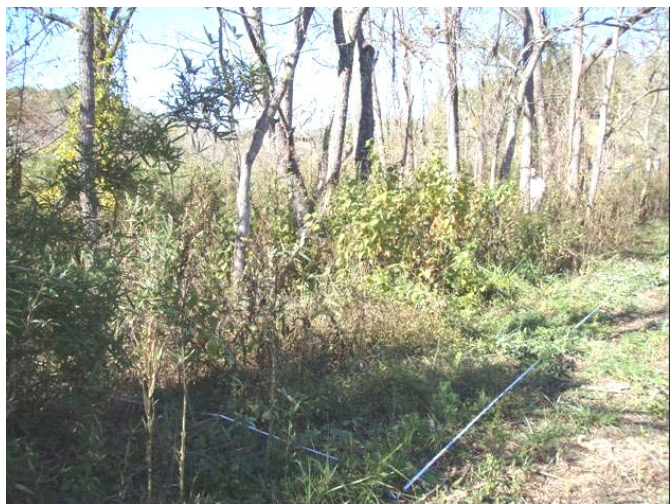
Vegetation plot 1 WB, facing upstream (0,0), 15 Oct 07.

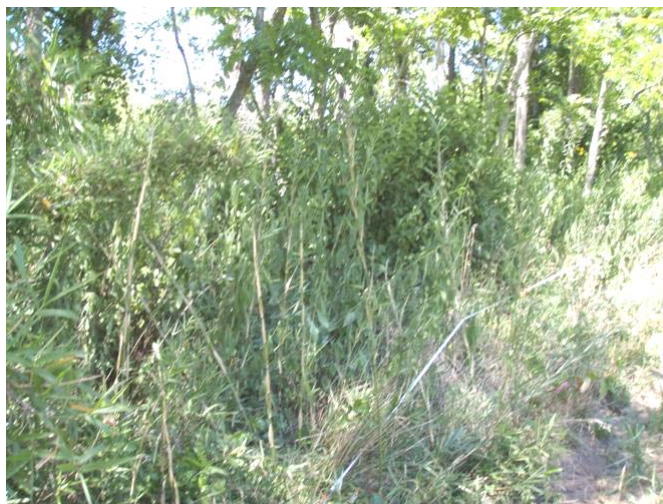
Vegetation plot 1 WB, facing upstream (0,0), 14 Aug 08.
