# PINCH GUT CREEK STREAM RESTORATION PROJECT

## ANNUAL MONITORING REPORT FOR 2010 (YEAR 3)

Contract Number D06043-A

**Prepared by:** Michael Baker Engineering, Inc.

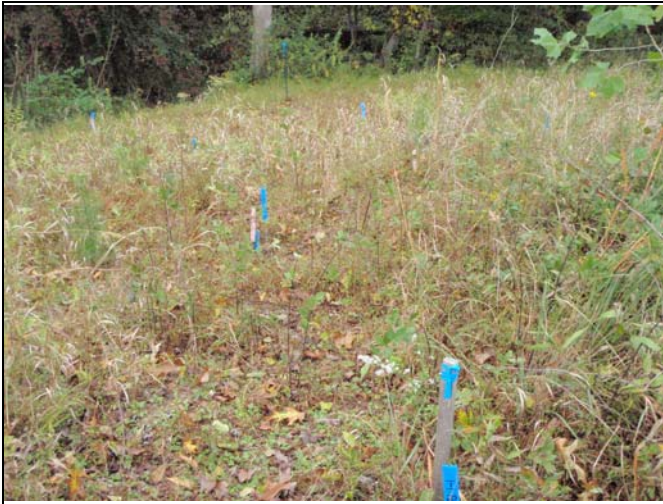
Vegetation Plot 1

It was noted during Year 3 monitoring that vegetation plots 1 and 2 demonstrated densities of 440 and 320 stems per acre, respectively. Although the density of plot 1 shows a density 440 stems per acre, the seven planted stems of spicebush *Lindera benzoin* in plot 1 are very weak and will not likely survive through Year 5. Plot 2 is also of concern due to low stems counts of very weak planted stems of black walnut (*Diospyros virginiana*). Therefore, additional trees will be planted in and around the vicinities of vegetations plots 1 and 2 in winter/spring of 2011.

During Year 3 monitoring, Multiflora rose (*Rosa multiflora*) was observed within vegetation plots 1, 2 and 6. Plots 1 and 2 will have additional stems added in 2011 and plot 6 will be closely observed during Year 4 monitoring. The *rosa multitiflora* observed in these areas will be treated in the summer/fall of 2011.

at this time. A significant presence of Blackberry (*Rubus spp.*) was noted within vegetation Plot 1.

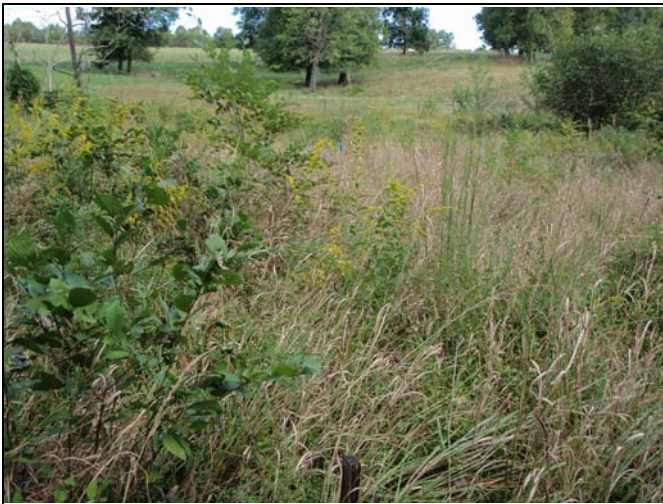
Vegetation Plot 2

Approximately six Tag alders (*Alnus serrulata*), 1 foot to 3 foot in size were observed in vegetation plot 2 following Year 3 monitoring. These volunteer species are native to the area and were also planted as part of the shrub layer for this project. The stems of *Alnus serrulata* did not seem to be posing a threat to the planted stems within the plot. No other significant volunteer woody species were observed in any other vegetation plots. The plots will continue to be assessed during Year 4 monitoring for volunteer species.

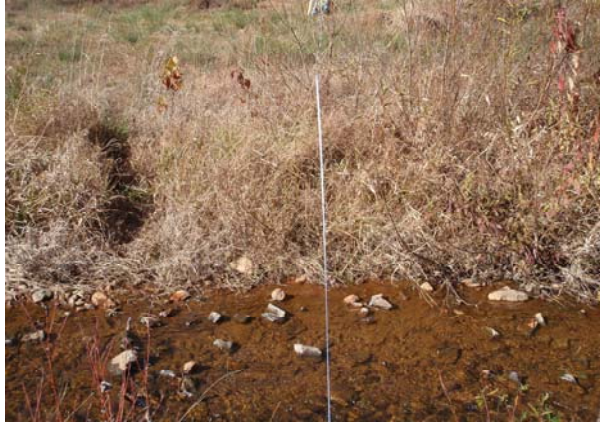
Looking at the Left Bank

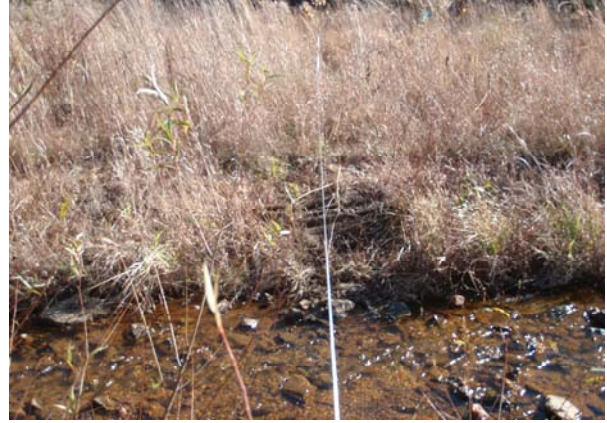
Looking at the Right Bank

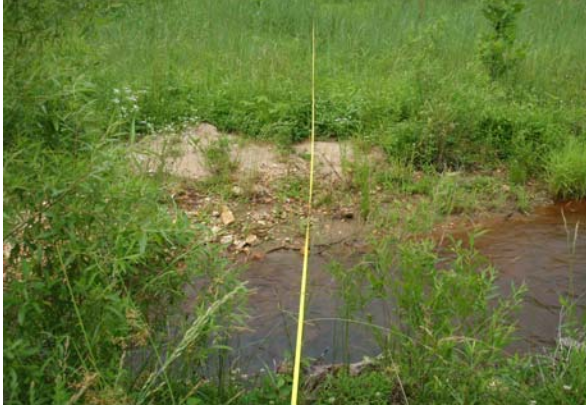
**Looking at the Left Bank**

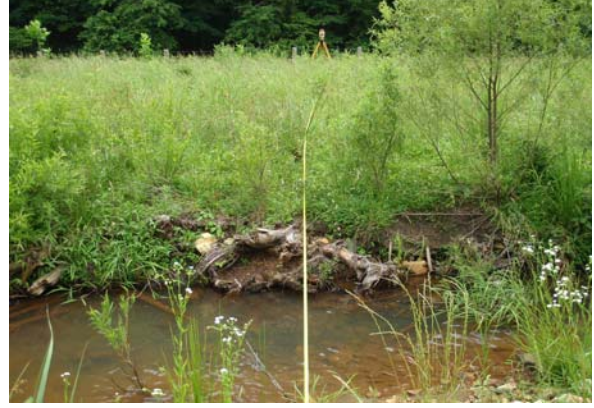
**Looking at the Right Bank**

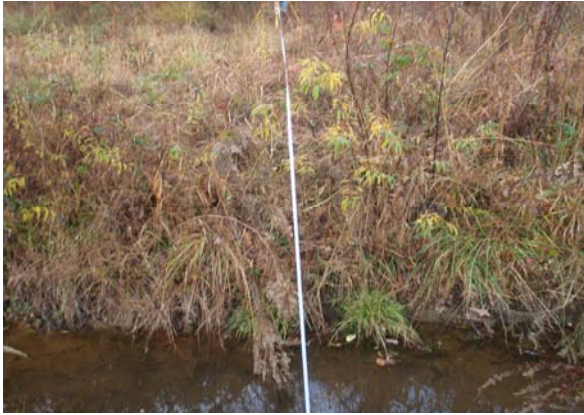
**Looking at the Left Bank**

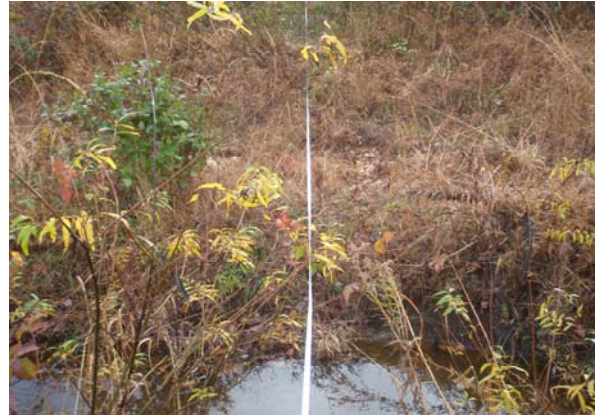
**Looking at the Right Bank**

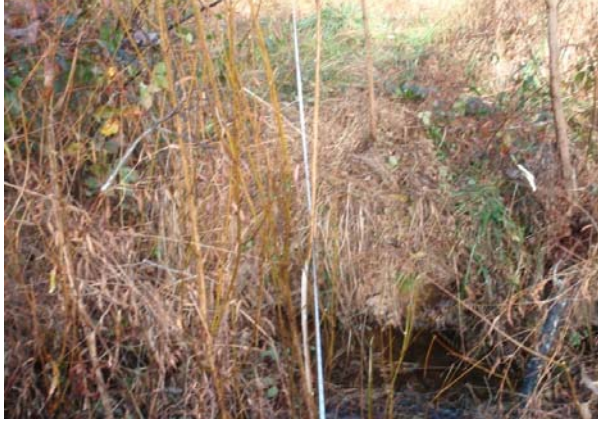
Looking at the Left Bank

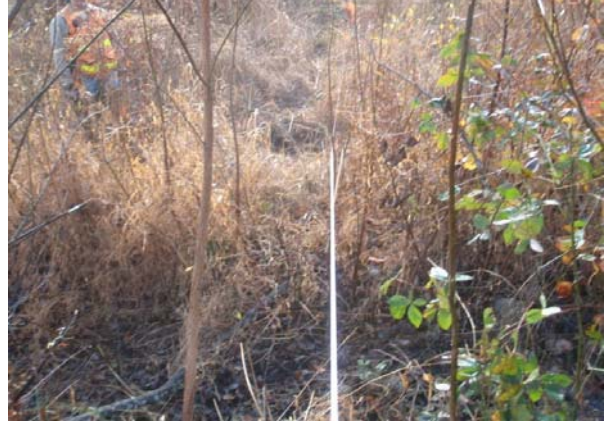
Looking at the Right Bank

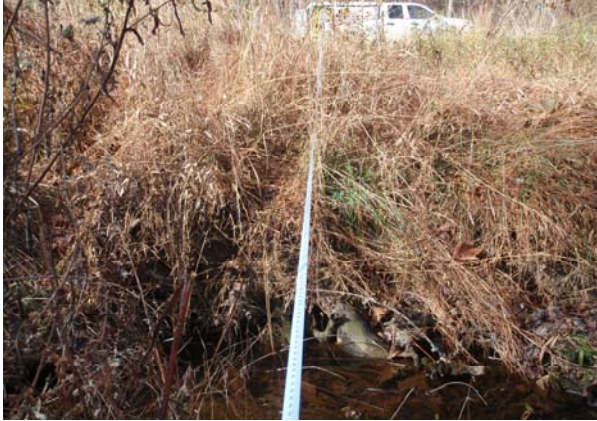
Looking at the Left Bank

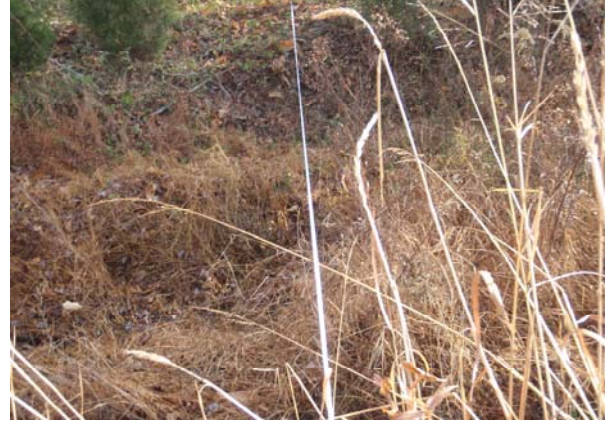
Looking at the Right Bank

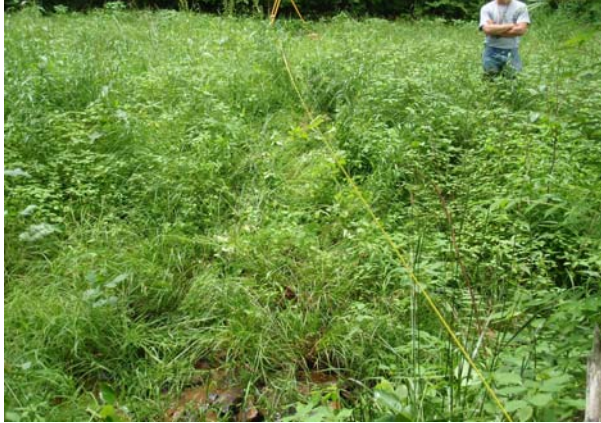
Looking at the Left Bank

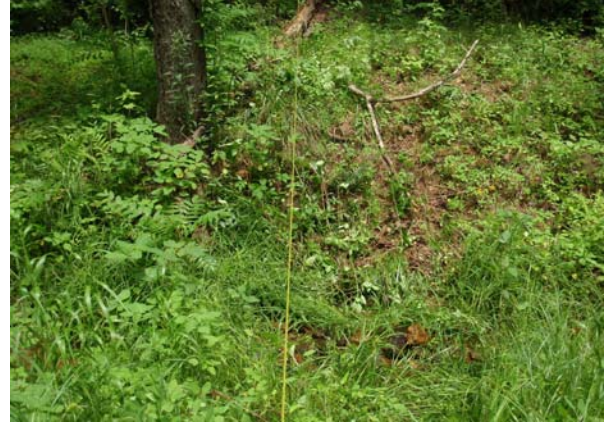
Looking at the Right Bank

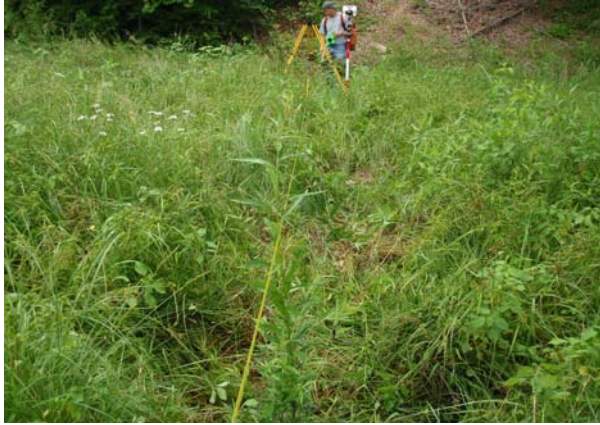
**Looking at the Left Bank**

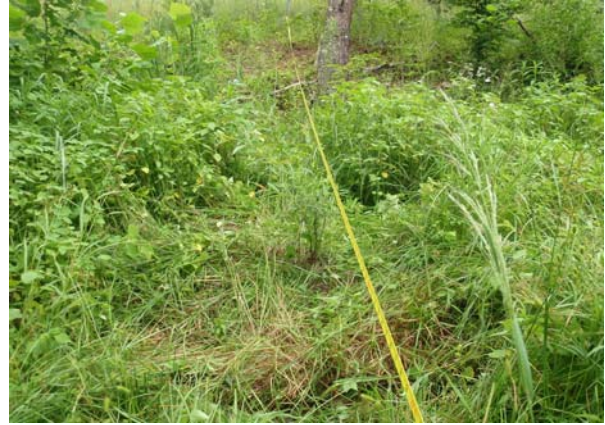
**Looking at the Right Bank**

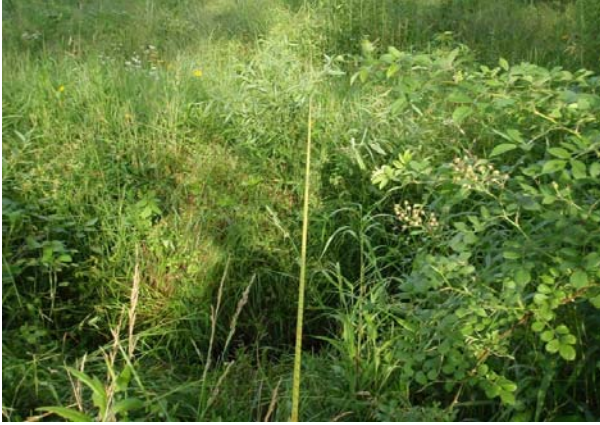
Looking at the Left Bank

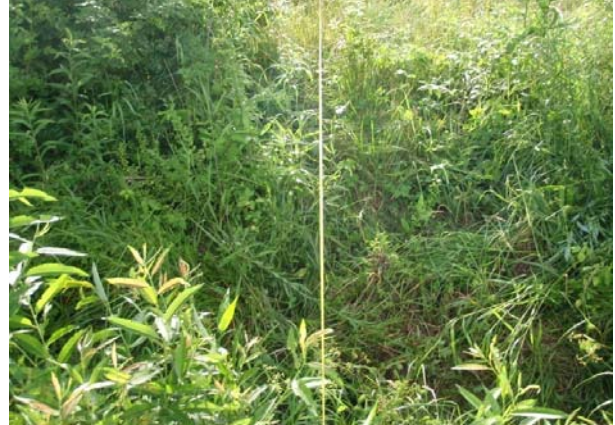
Looking at the Right Bank

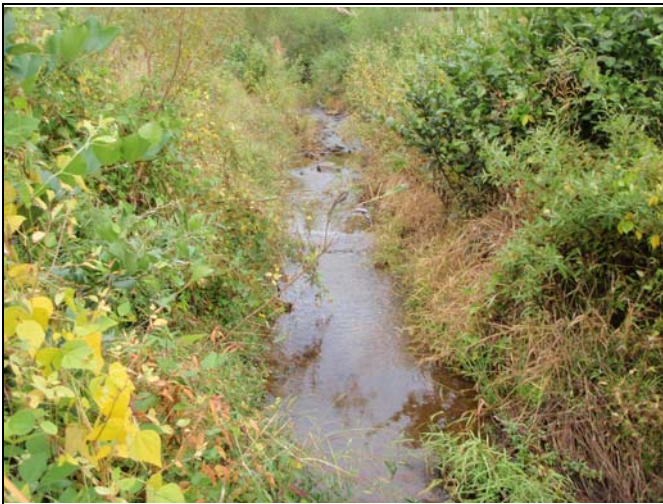
Photo Point 2 – J-Hook, UT1 Reach 4

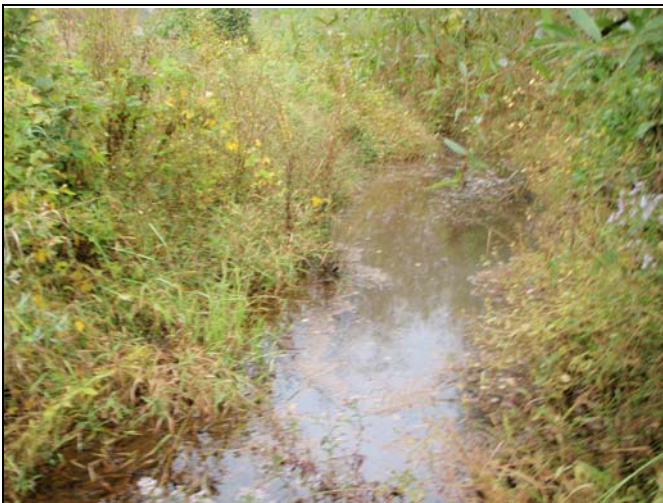
Photo Point 4 – J-Hook, UT1 Reach 4

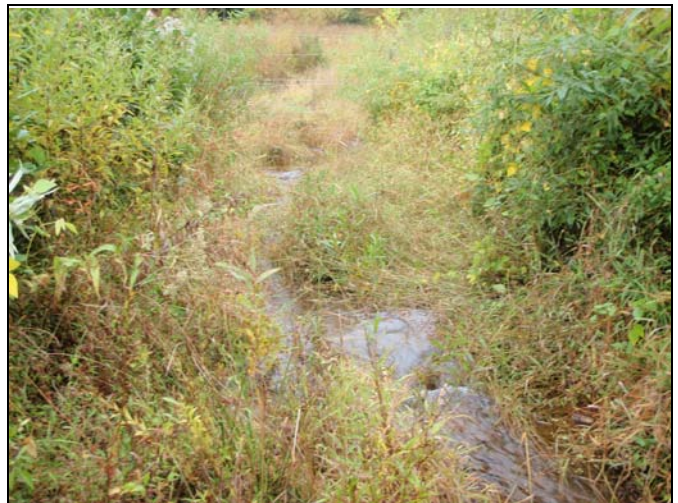
Photo Point 5 – Stream Crossing, UT1 Reach 4

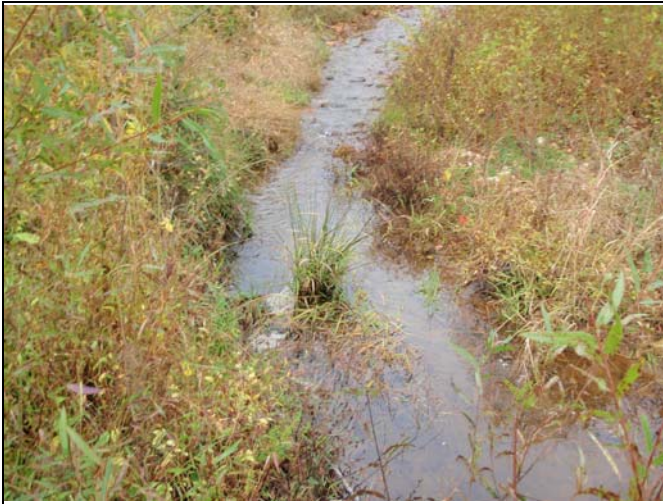
Photo Point 6 – J-Hook, UT1 Reach 4

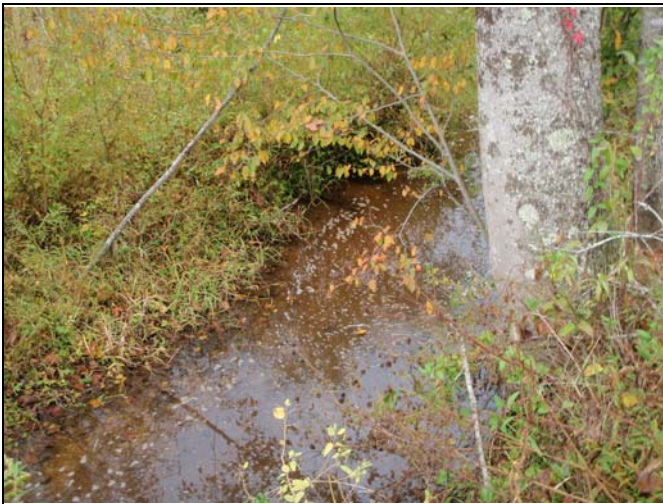
Photo Point 8 – J-Hook, UT1 Reach 4

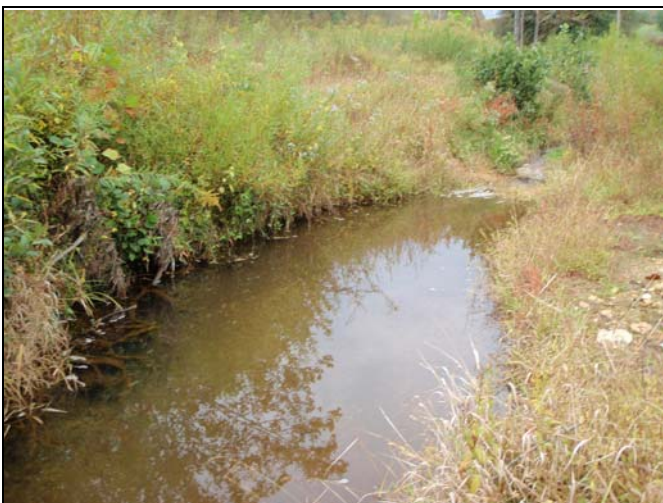
Photo Point 10 – J-Hook, UT1 Reach 4

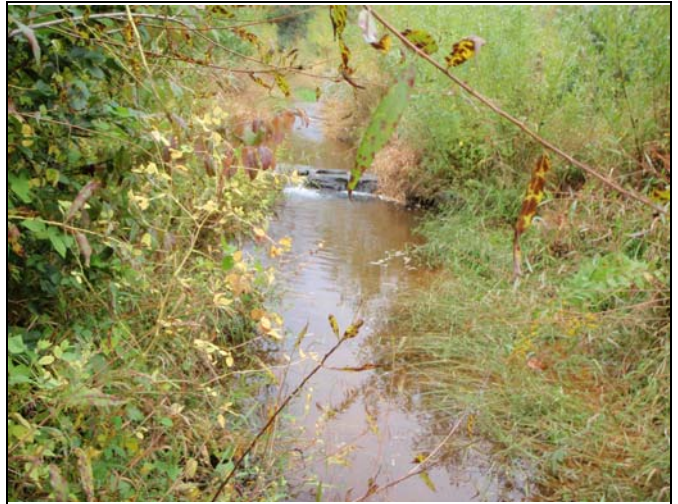
Photo Point 13 – Cross Vane, UT1 Reach 4

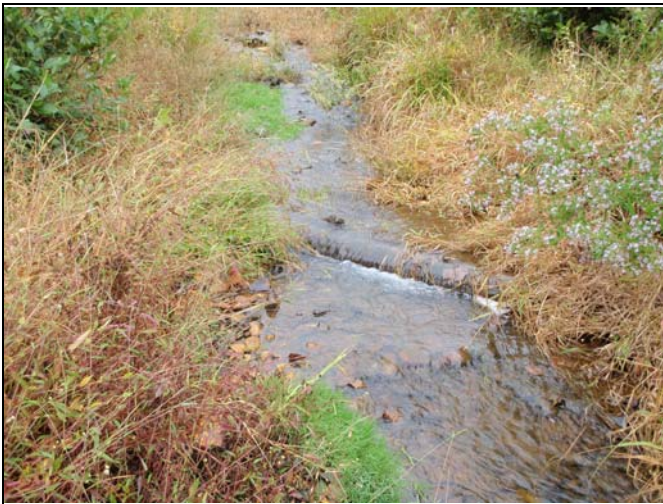
Photo Point 14 – Rock and Roll, UT1 Reach 4

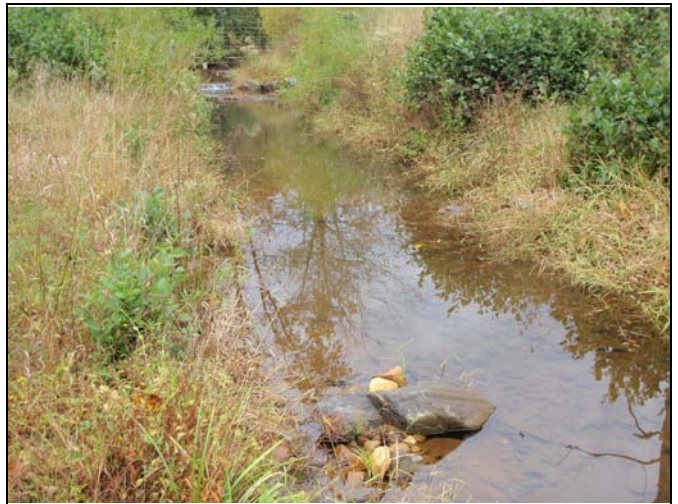
Photo Point 15 – Rock and Roll, UT1 Reach 4

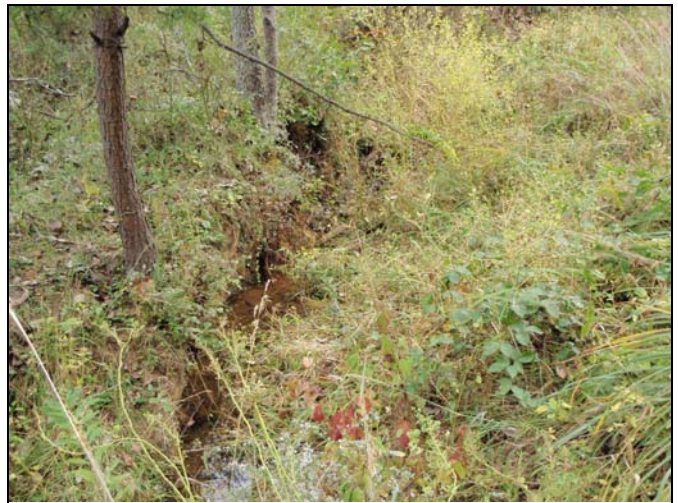
Photo Point 141 – Constructed Riffle, UT6

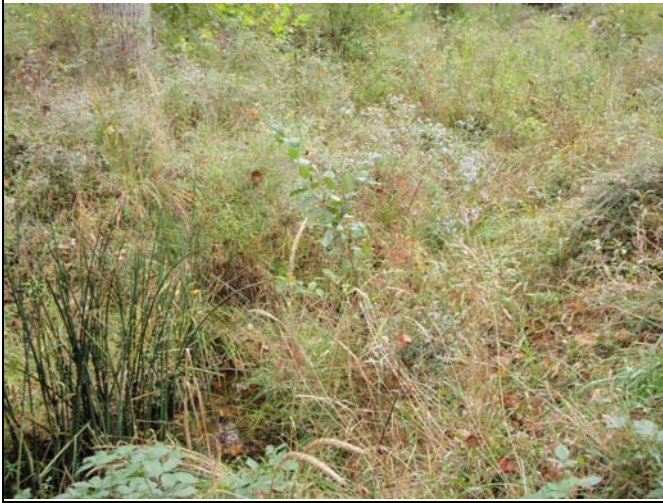
Photo Point 142 – Step Pool, UT6

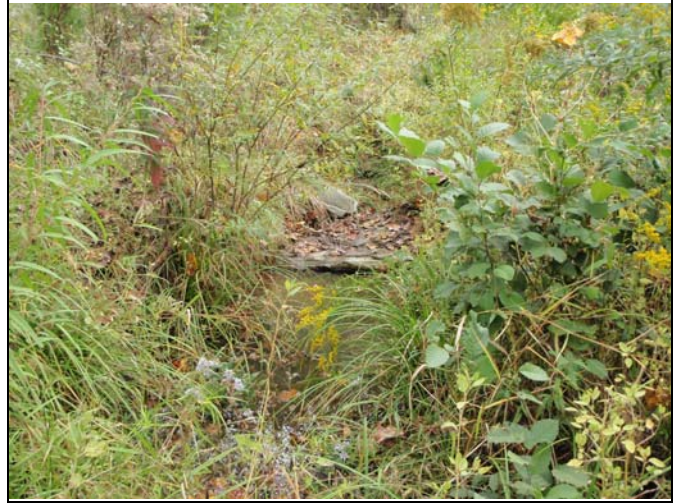
Photo Point 143 – Step Pool, UT6

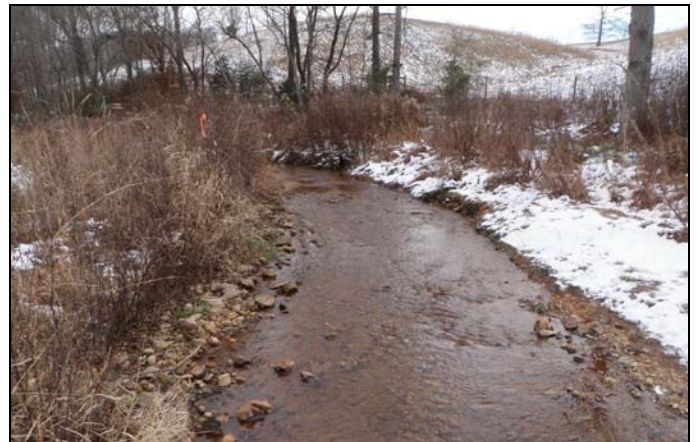
Looking at debris line on crest gauge at UT5\_R2 after January 2010 storm event
