MONITORING YEAR 3 AND YEAR 4 REPORT
PLEMMONS/KIRKPATRICK MITIGATION SITE
SPRING CREEK

Madison County, North Carolina

EEP Project Number: 92607
Contract Number: D06082; Task Order: 06FB05-1

Period Covered: January 2009 – December 2010

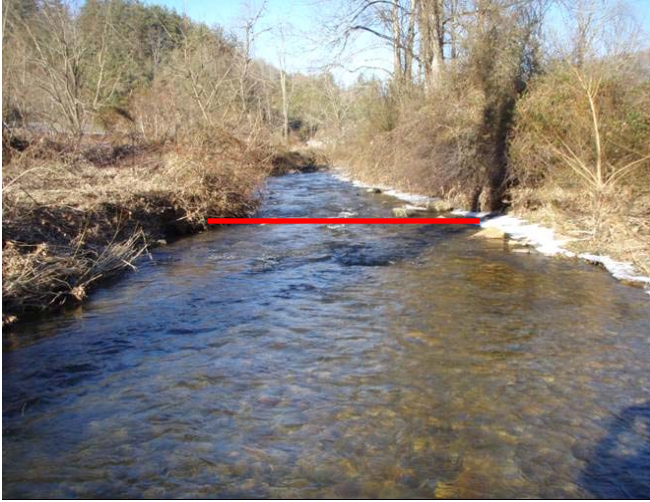
Cross-section 8, facing downstream, 9 Dec 2009, MY3

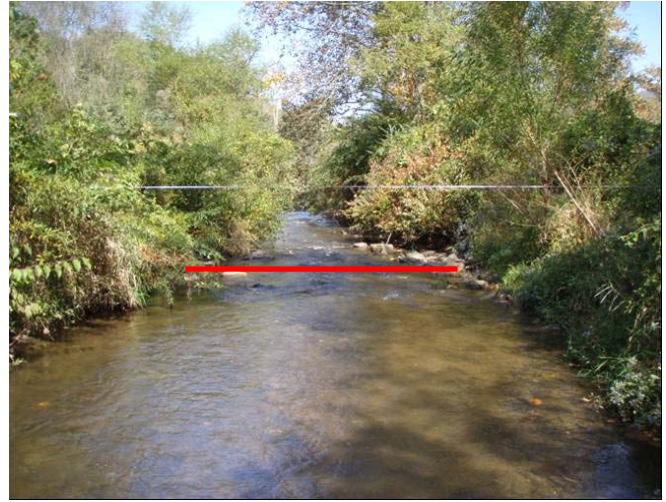
Cross-section 8, facing downstream, 13 Oct 2010, MY4.
