Annual Monitoring Report

Monitoring Year 7 of 7

Poplin Ridge Stream Restoration Project

NCDMS Project No.: 95359

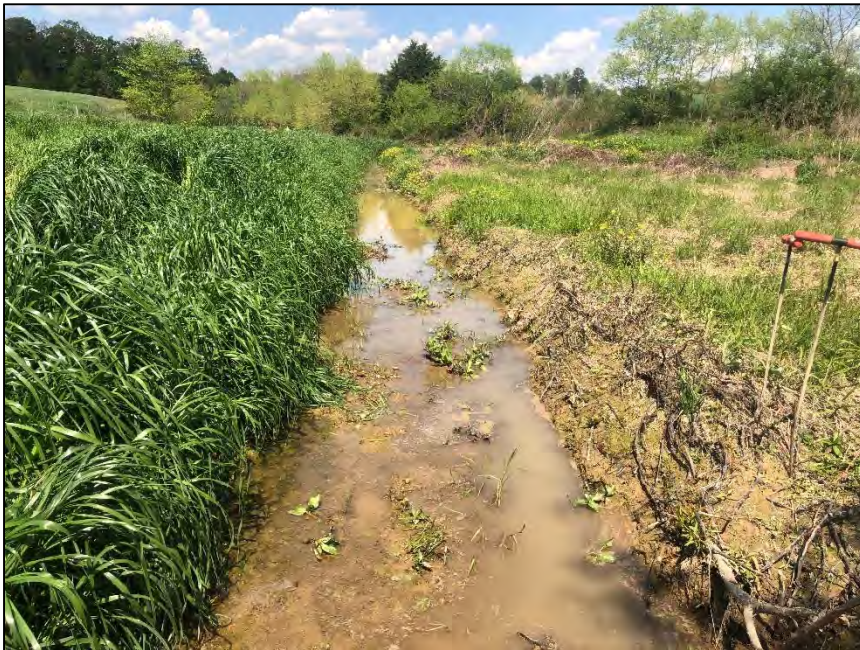
Livestakes on UT2-2 looking upstream

of Livestakes: 800

Species: Black willow, Buttonbush, and Cottonwood

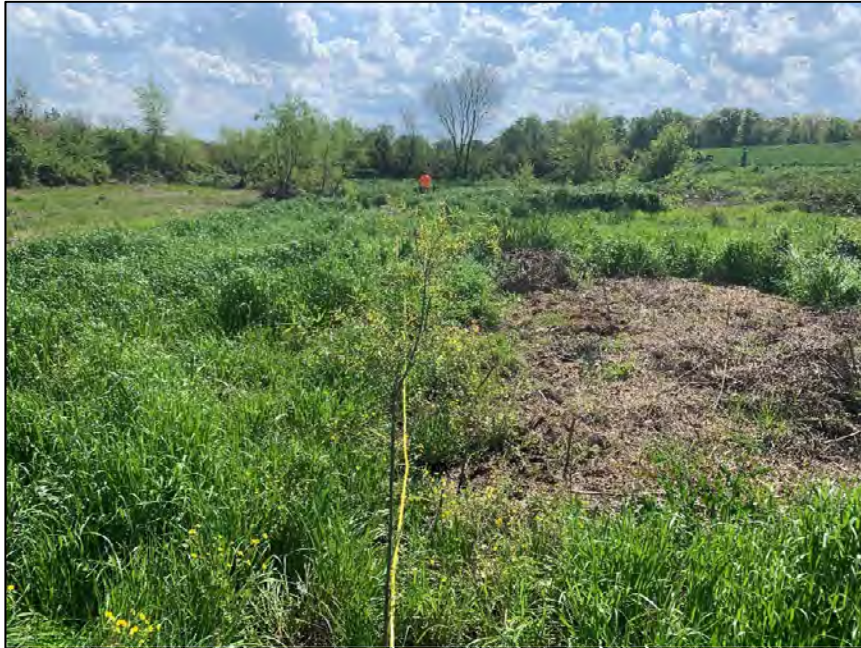
Random Vegetation Plot looking downstream

Low Stem Density Area Container Tree Planting in and around VP9 and VP10
