# **Annual Monitoring Report**

Monitoring Year 1 of 7

Poplin Ridge Stream Restoration Project

NCDMS Project No.: 95359

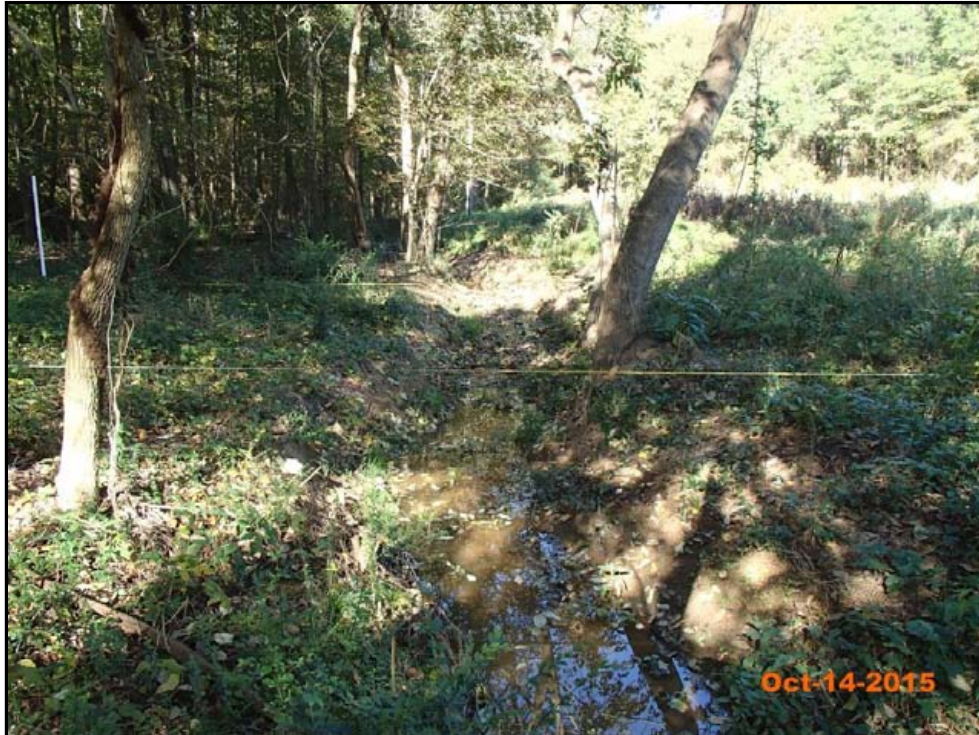
Project Reach UT1-1 – Permanent Photo Station 1  
Station 8+53 – Looking Upstream

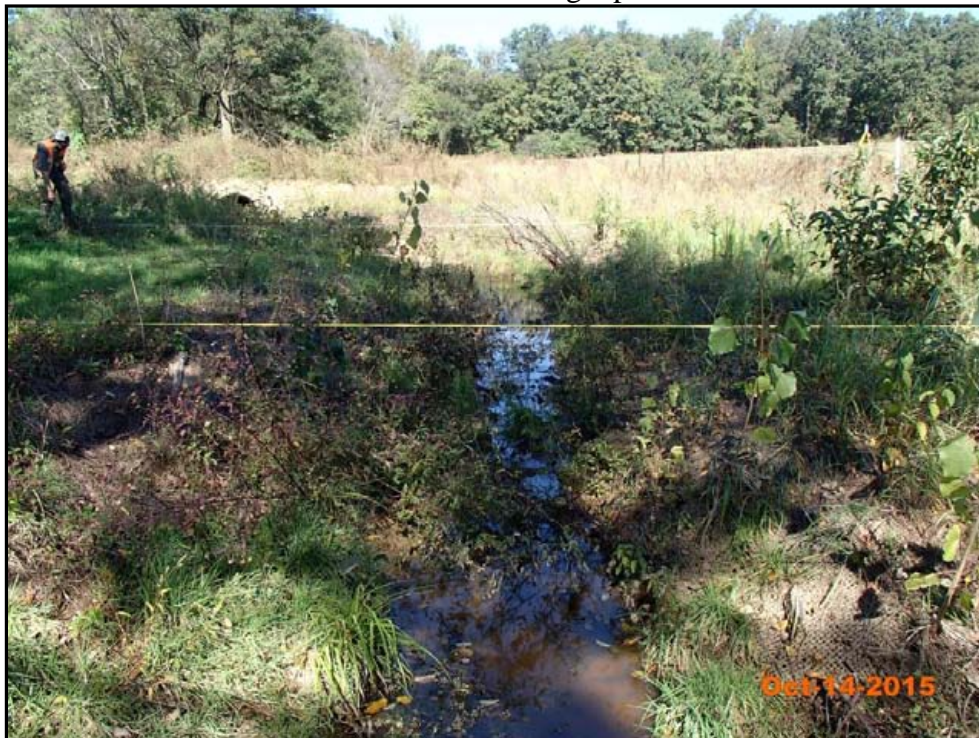
Project Reach UT1-2 – Permanent Photo Station 2  
Station 14+58 – Looking Upstream at Crossing

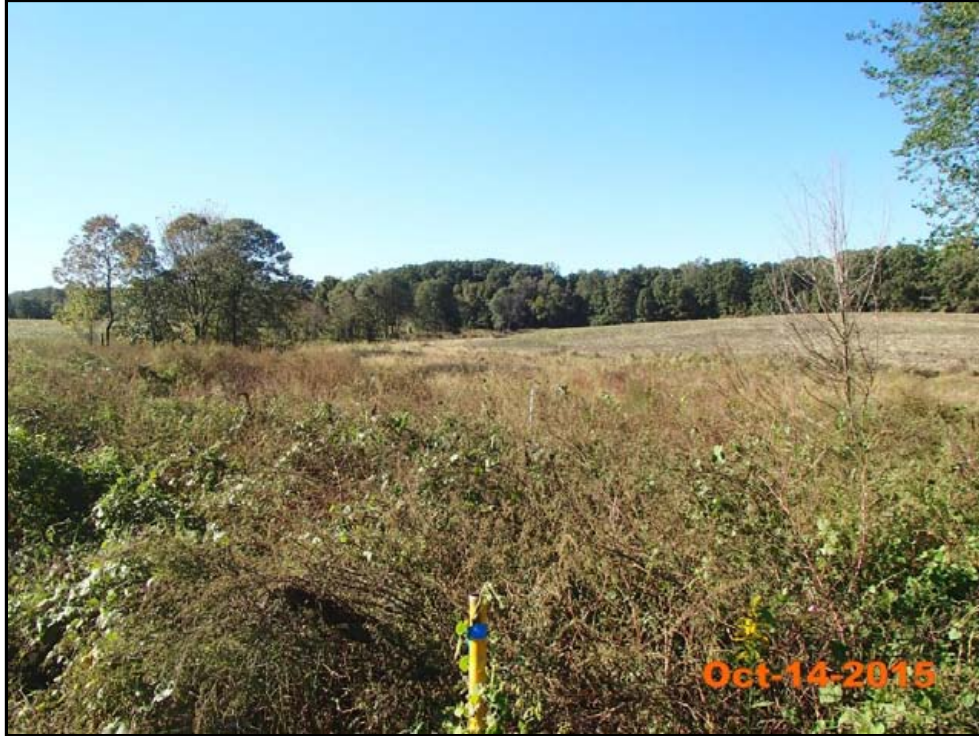
Project Reach UT1-2 – Permanent Photo Station 3  
Station 21+50 – Looking Upstream

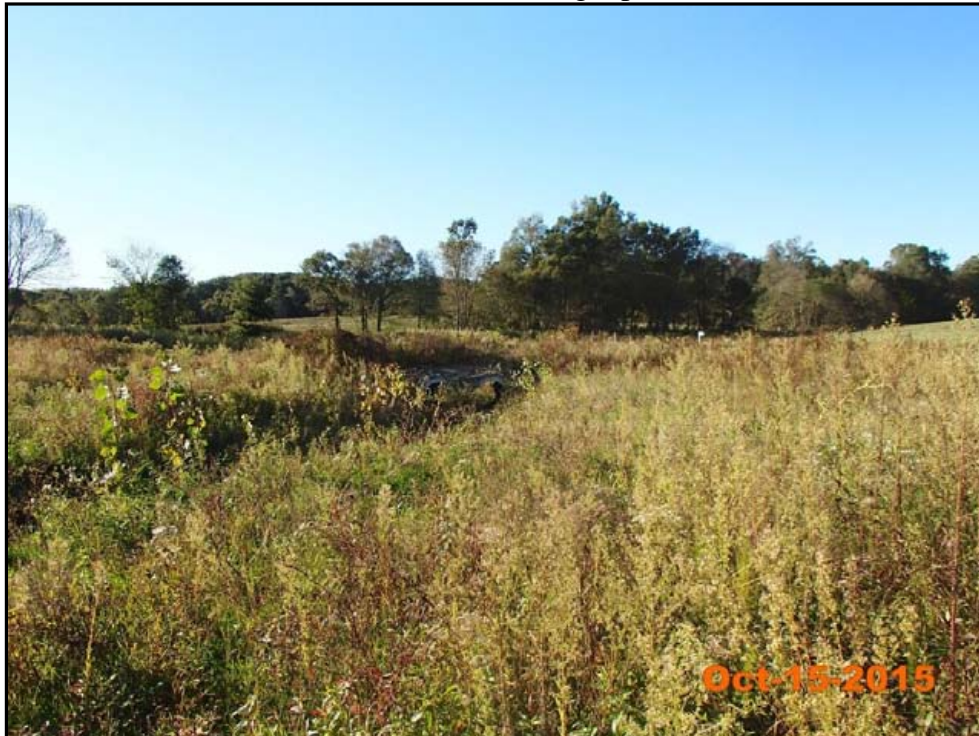
Project Reach UT1-3 – Permanent Photo Station 4  
Station 26+50 – Looking Upstream at Crossing

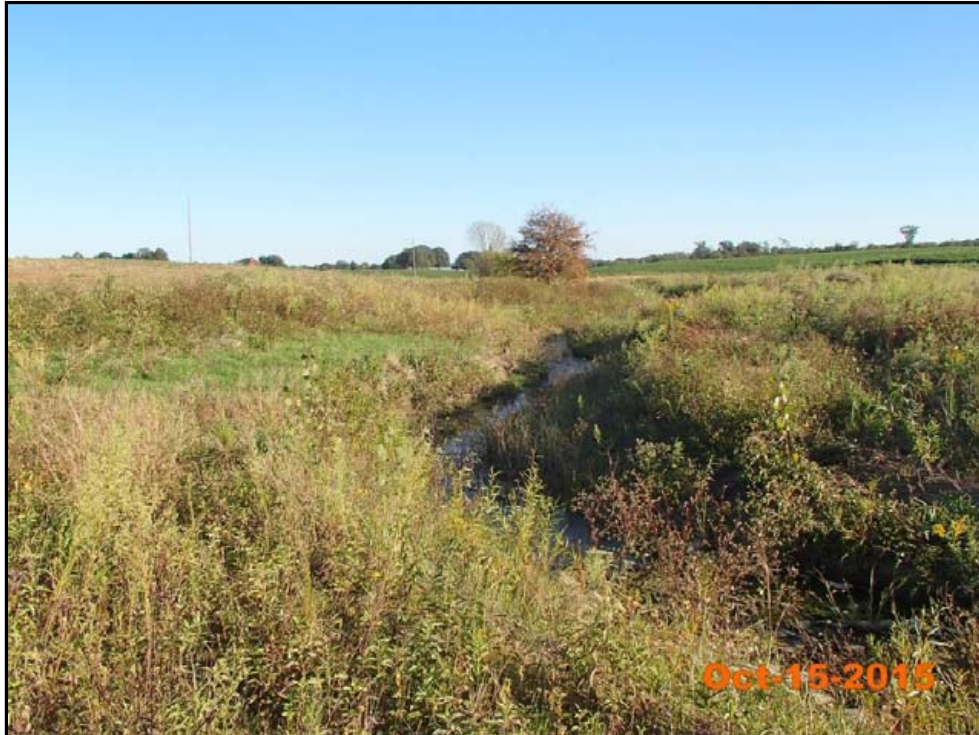
Project Reach UT1-3 – Permanent Photo Station 5  
Station 27+50 – Looking Downstream

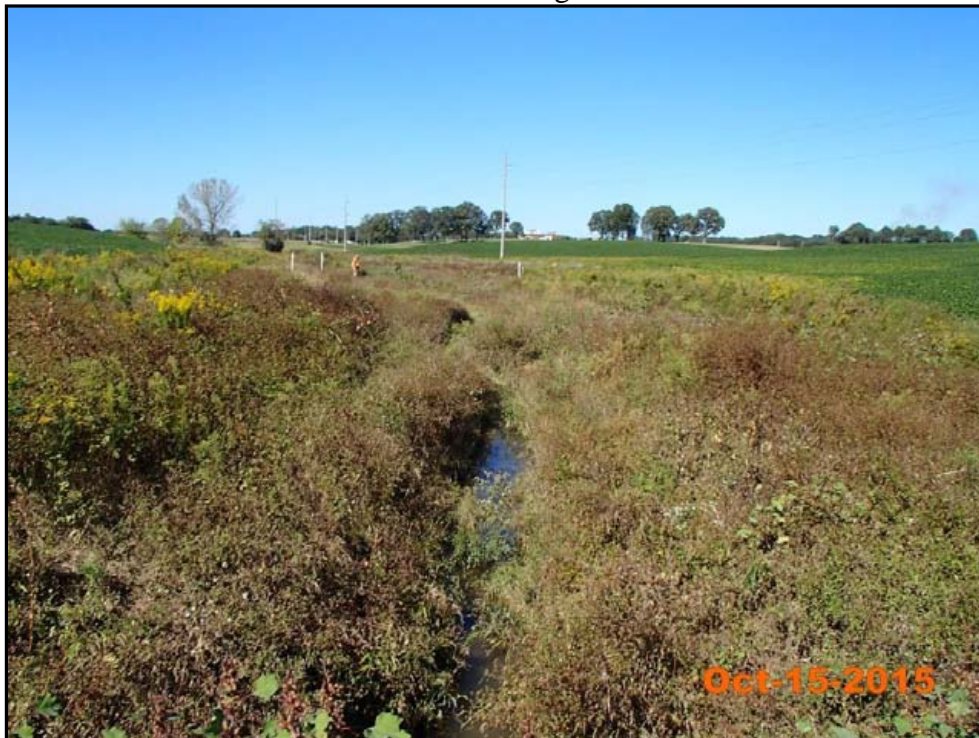
Project Reach UT1-4 – Permanent Photo Station 6  
Station 47+20 – Looking Upstream

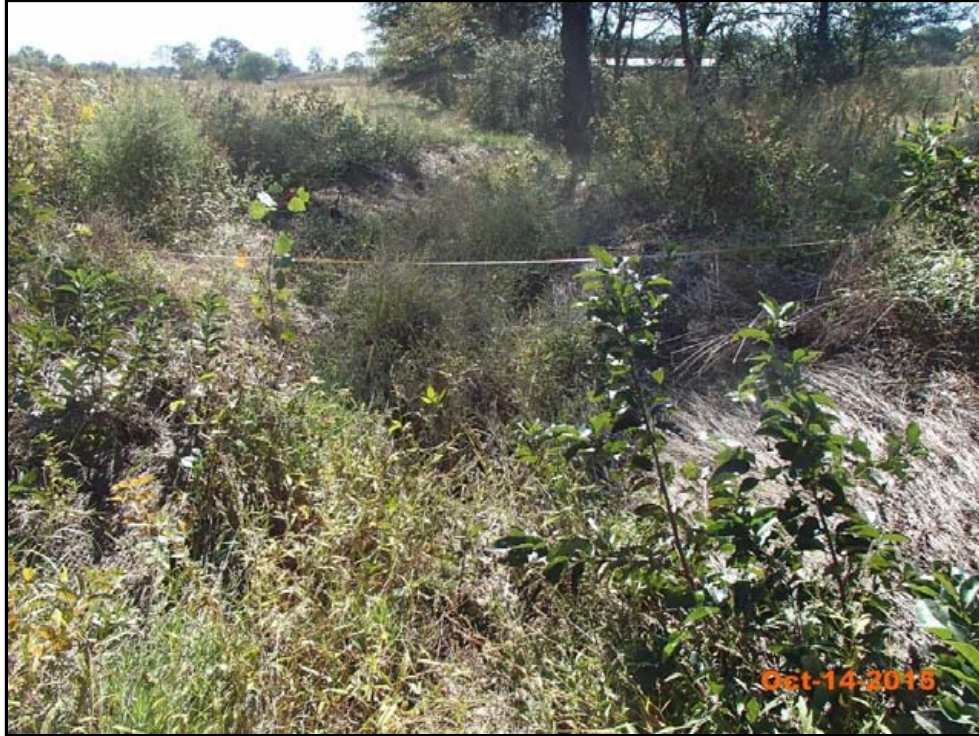
Project Reach UT1-A - Permanent Photo Station 7  
Station 2+00 – Looking Downstream

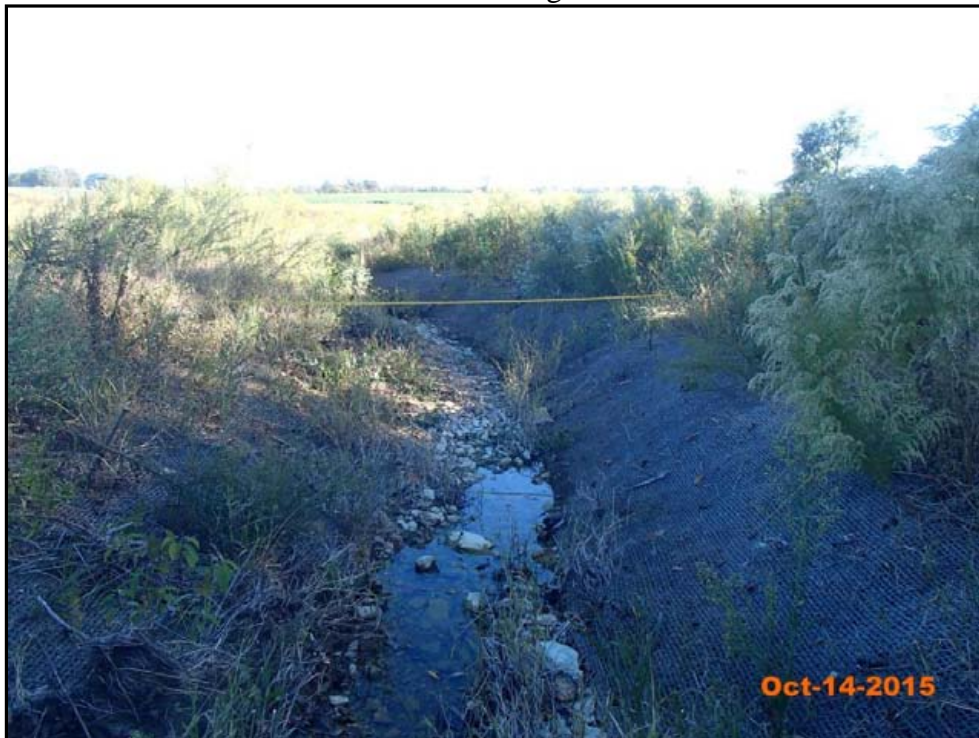
Project Reach UT1-B – Permanent Photo Station 8  
Station 9+86 – Looking Downstream

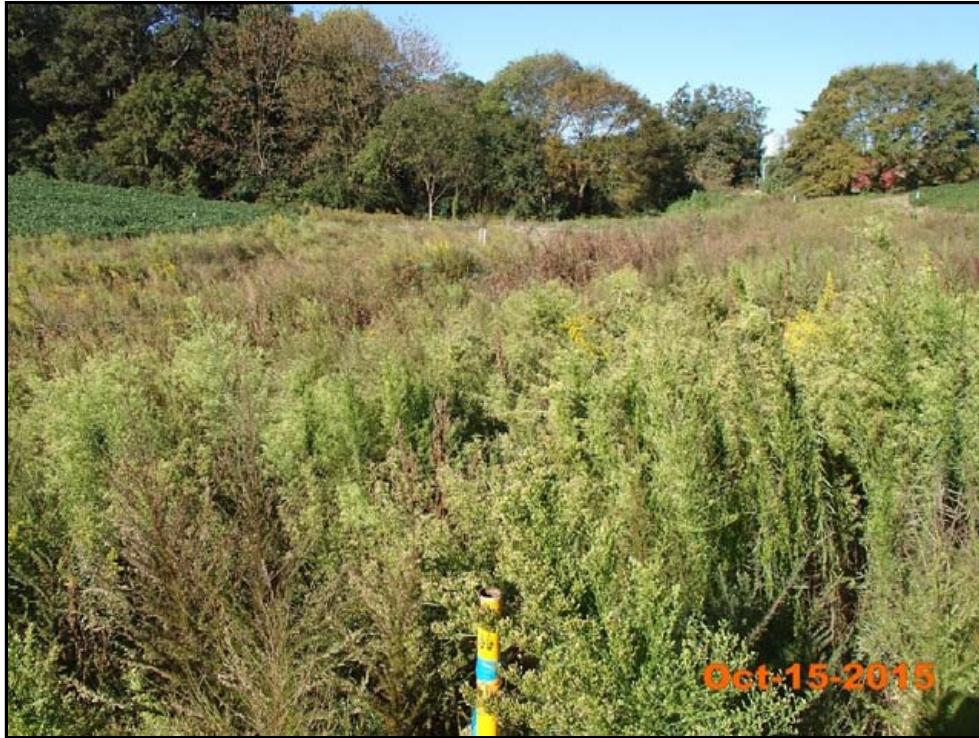
Project Reach UT1-C – Permanent Photo Station 9  
Station 2+50 – Looking Upstream

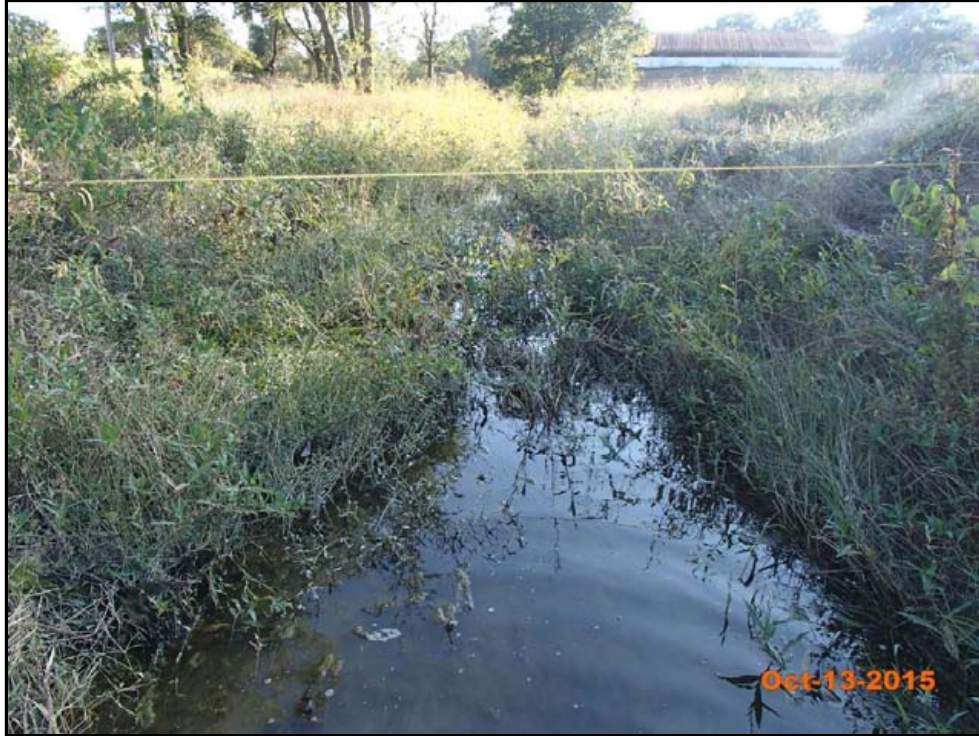
Project Reach UT2-4 – Permanent Photo Station 15  
Station 20+39 – Looking Downstream

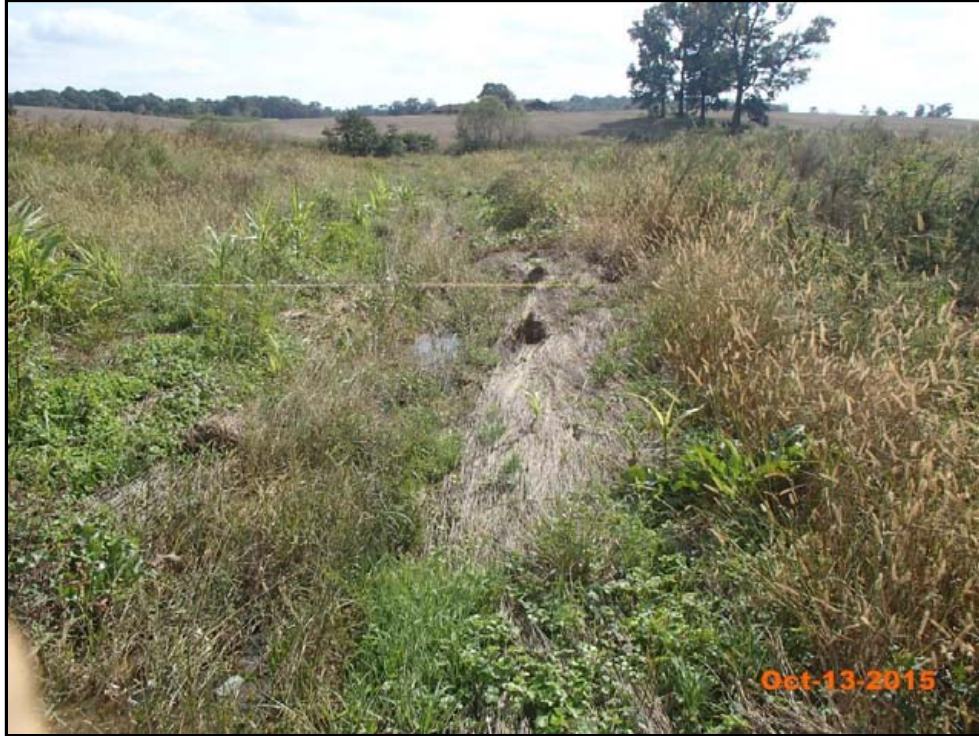
Project Reach UT2-A – Permanent Photo Station 17  
Station 2+62 – Looking Downstream
