Annual Monitoring Report

Monitoring Year 2 of 7

Poplin Ridge Stream Restoration Project

NCDMS Project No.: 95359

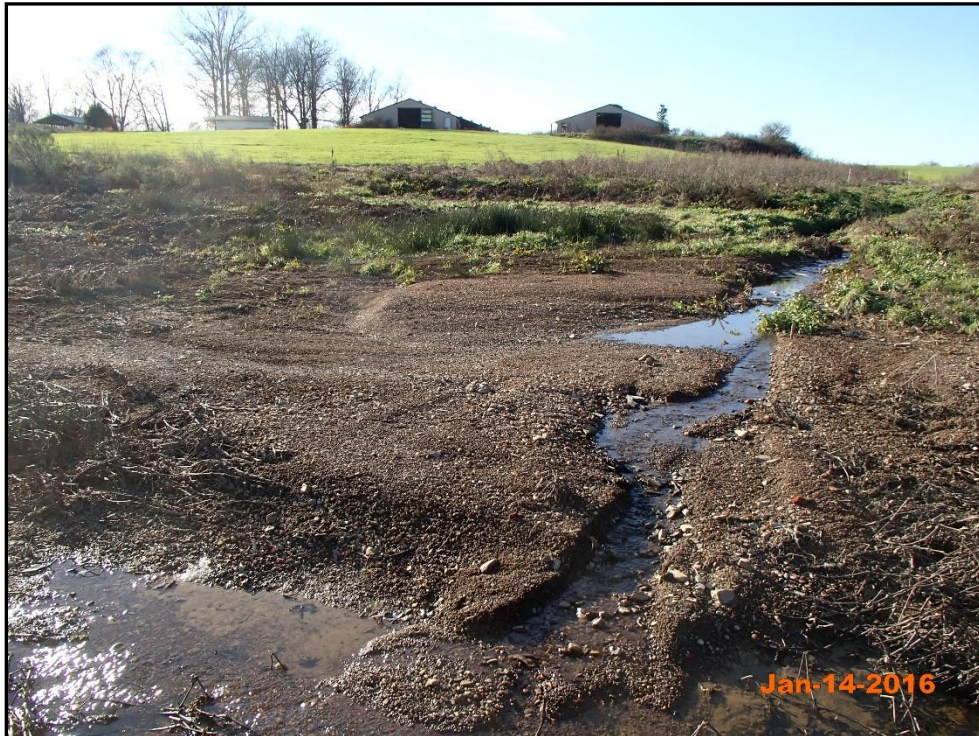
Project Reach UT2-A – Aggradation 4+50
