Price Park Stream Restoration

2003 Annual Monitoring Report

Prepared by: Biological & Agricultural Engineering
Water Resources Research Institute
North Carolina State University
Campus Box 7625
Raleigh, NC 27695

March, 2004

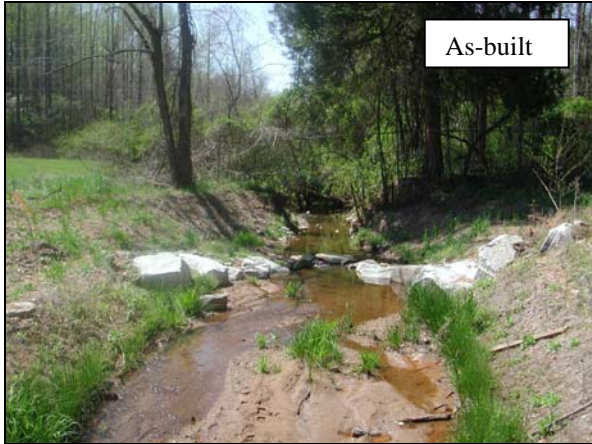
M1-US: Meander 1, looking in the upstream direction. Fenceline represents the beginning of the project and longitudinal profile. Note bar formation and vegetation establishment in this region.

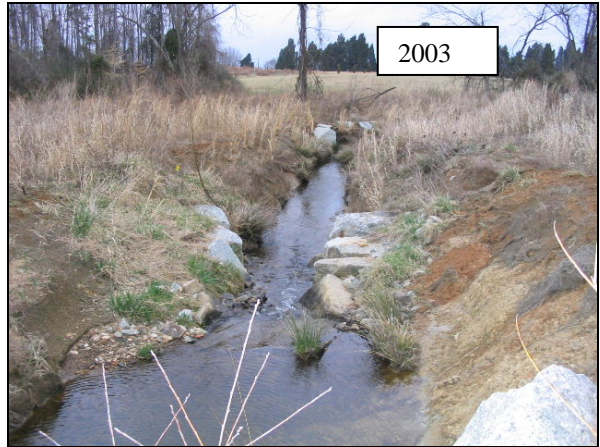
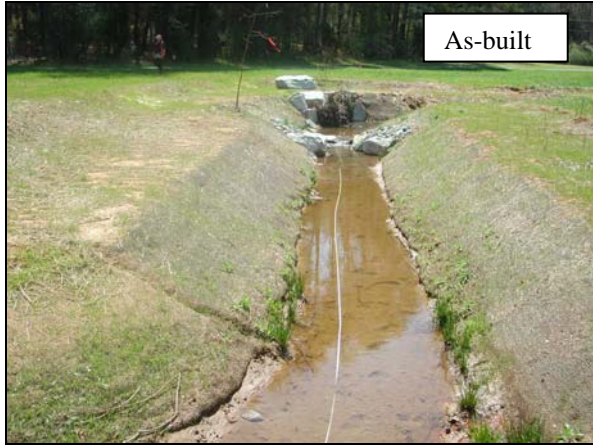
M4-DS: View from Meander 4 looking downstream towards Meander 5.

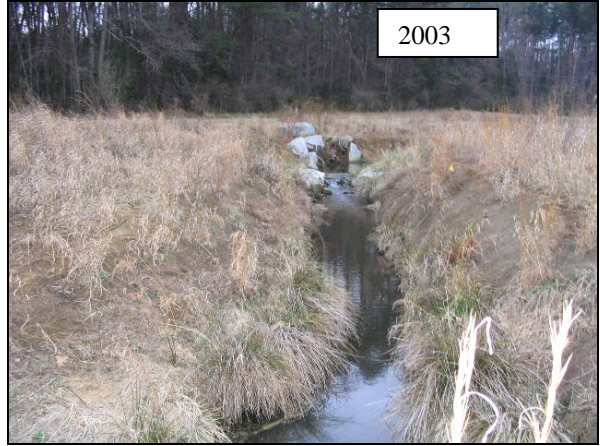
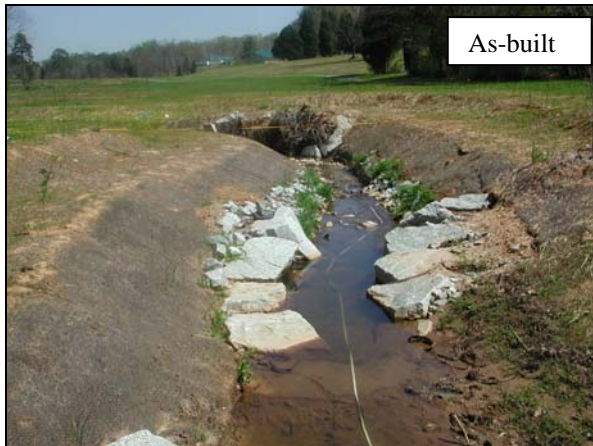
M5-US: View from Meander 5 looking upstream towards Meander 4.62

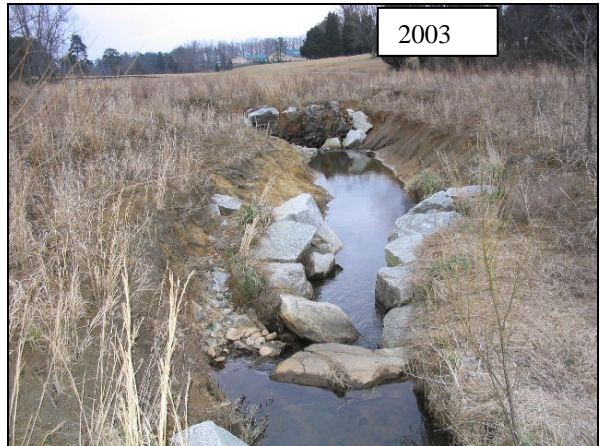
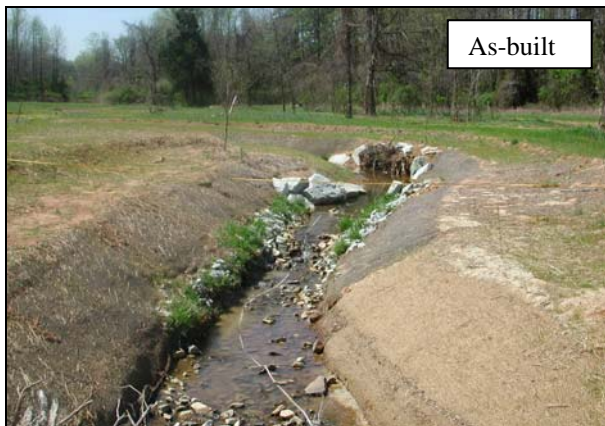
M5-DS: View from Meander 5 looking downstream towards Meander 6. 63

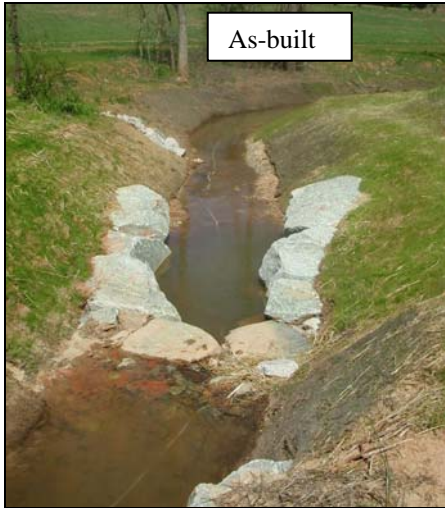
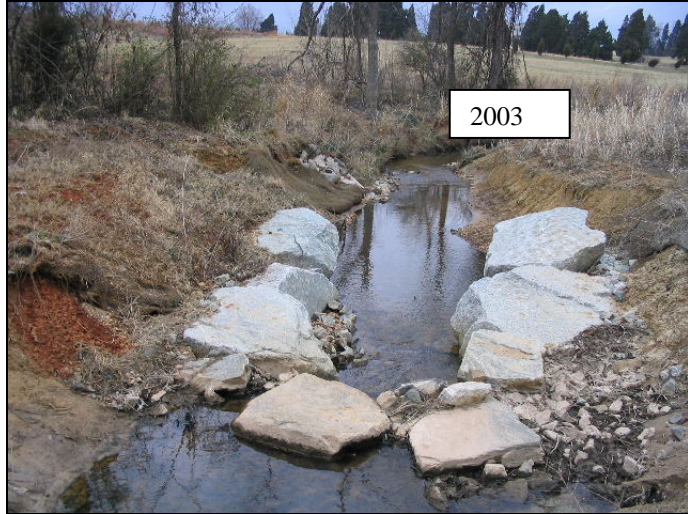
M6-DS: View from Meander 6 looking downstream. 65

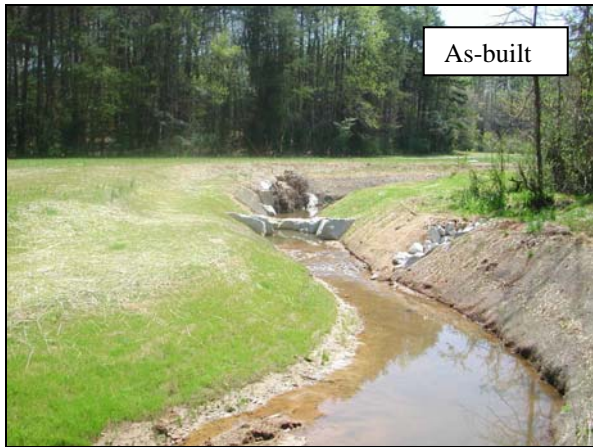
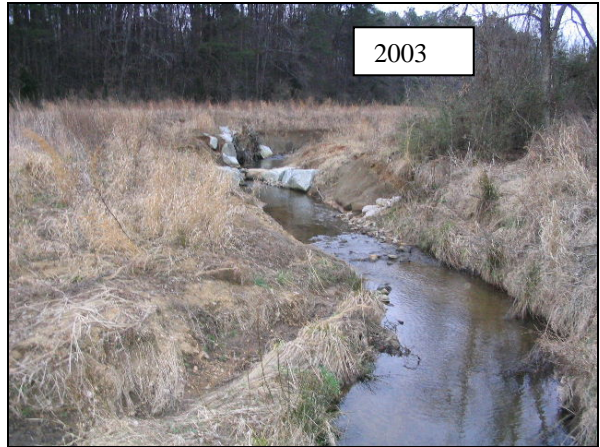
M7-US: View from Meander 7 looking upstream. 66

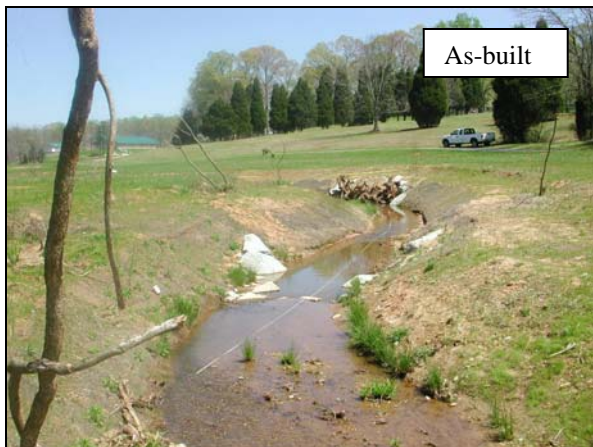
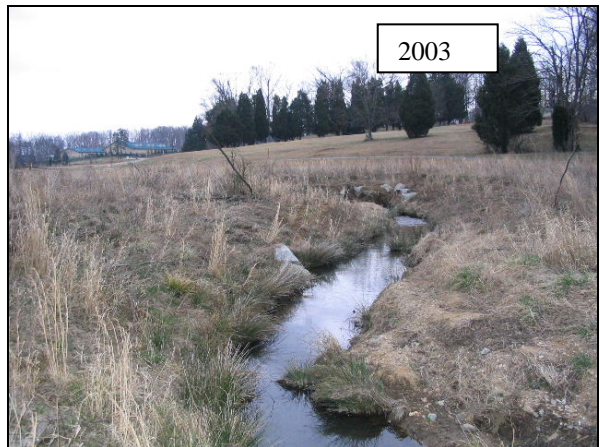
M7-DS: View from Meander 7 looking downstream. 67

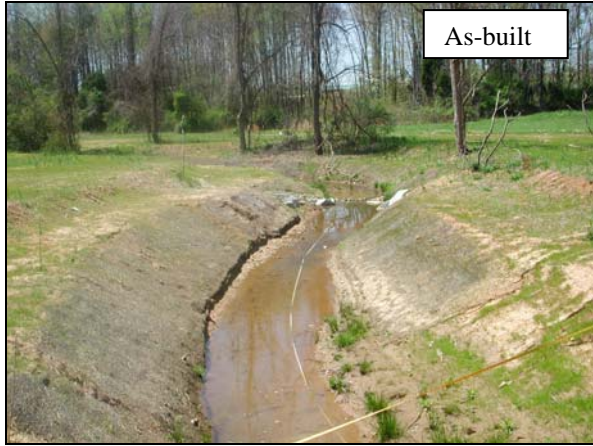
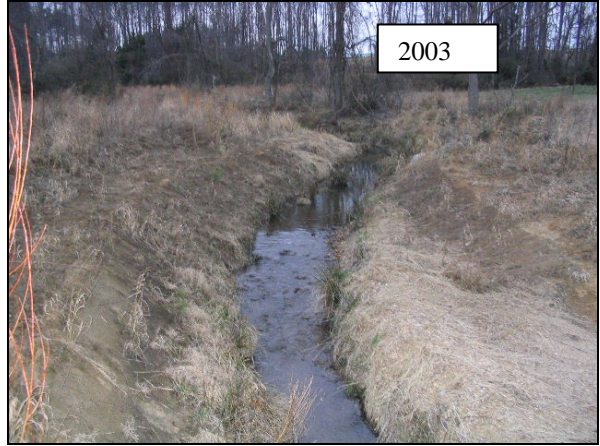
M8-US: View from Meander 8 looking upstream. 68

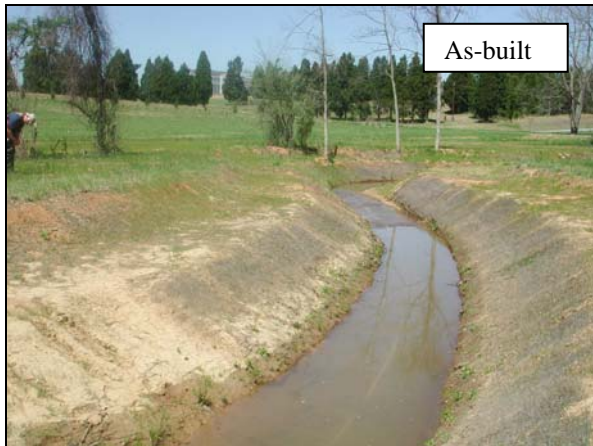
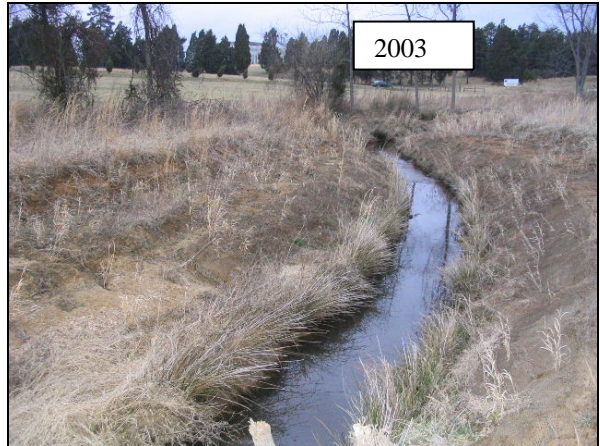
M8-DS: View from Meander 8 looking downstream towards Meander 9. 69

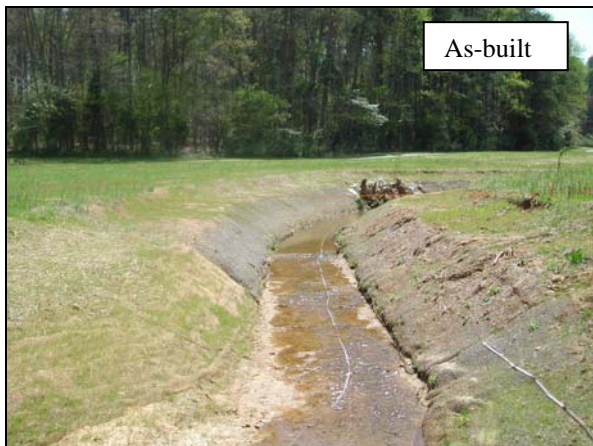
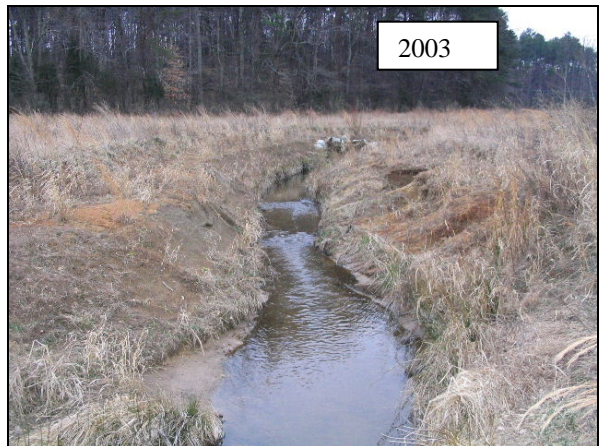
M9-US: View from Meander 9 looking upstream. 70

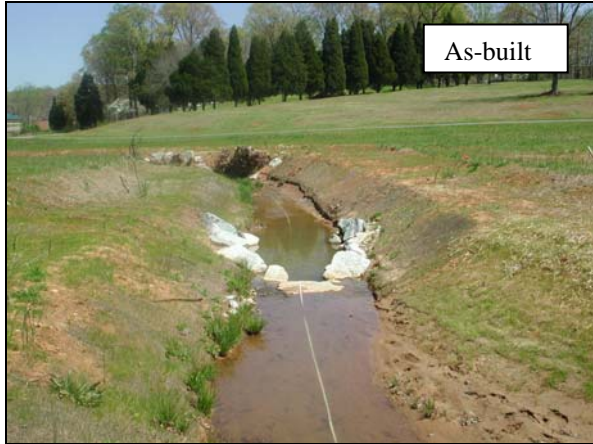
M9-DS: View from Meander 9 looking downstream. Note the point bar formation in the lower right corner of picture.71

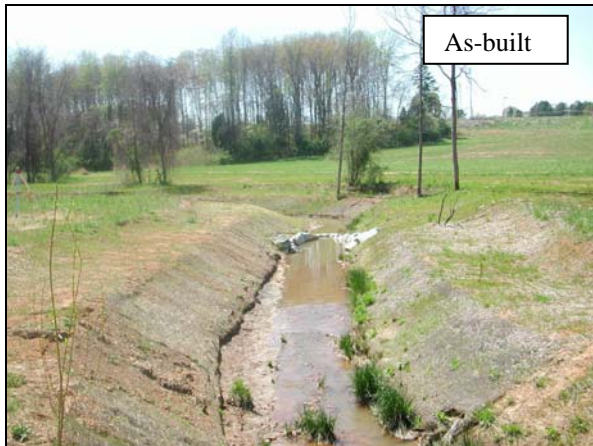
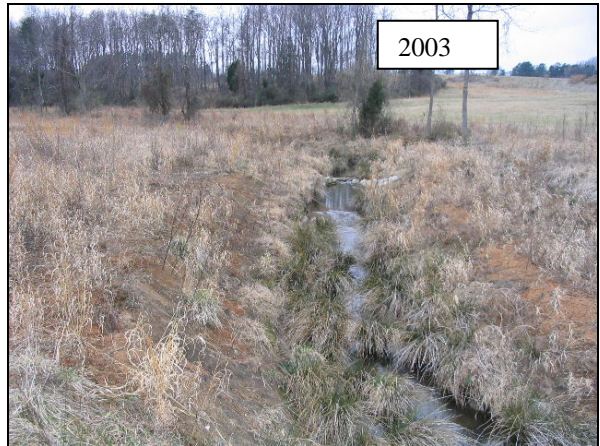
M10-US: View from Meander 10 looking upstream. 72

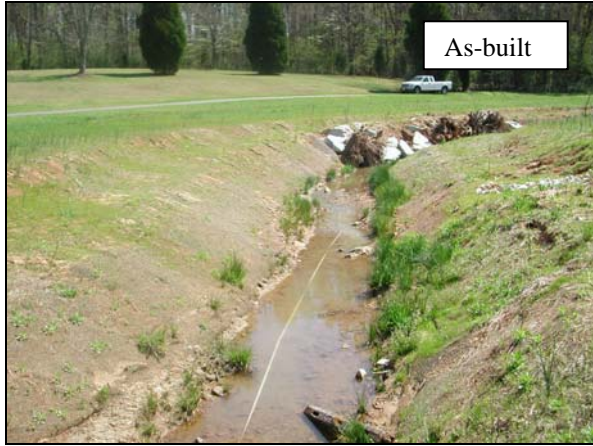
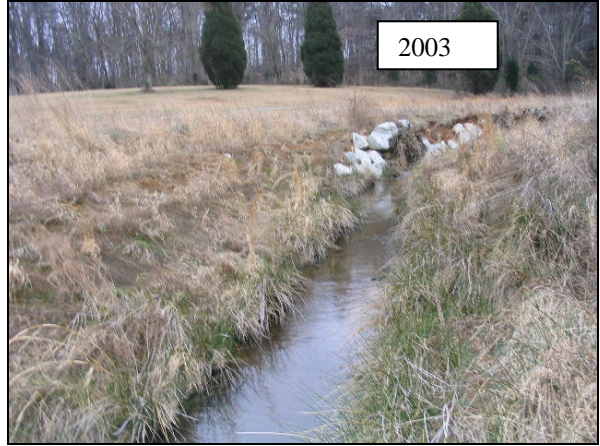
M11-US: View from Meander 11 looking upstream. 74

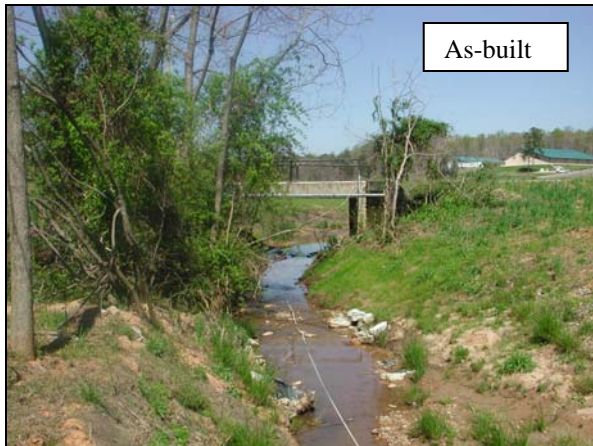
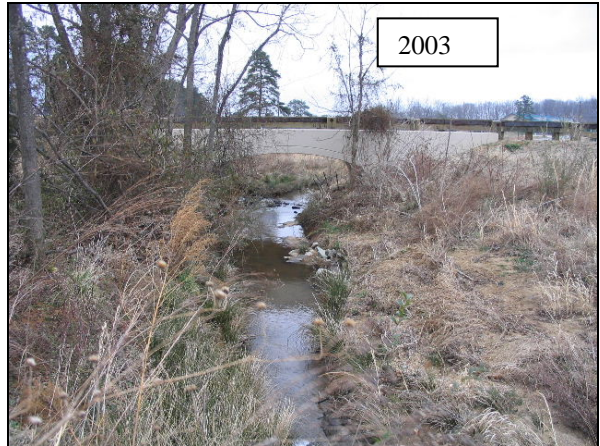
M11-DS: View from Meander 11 looking downstream. Jefferson Club Road crosses the stream via this 14' x 7.5 box culvert. 75

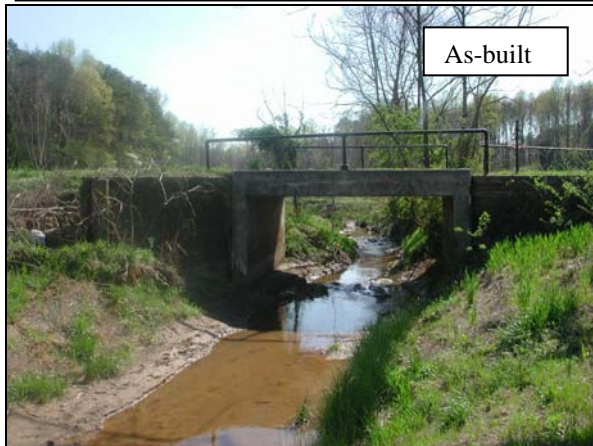
M12-US: View from Meander 12 looking upstream through the culvert. Note how the channel has narrowed and vegetated in the Year 1 photograph.76

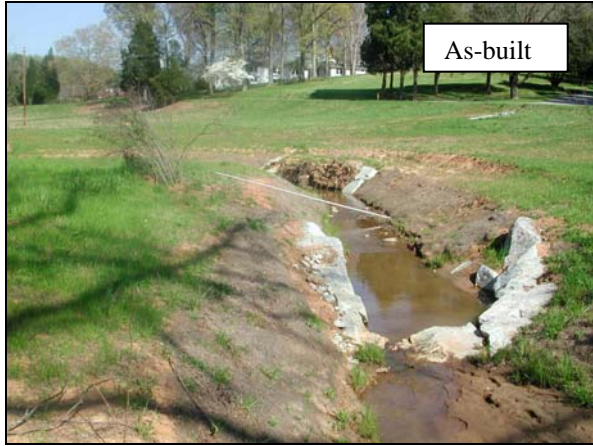
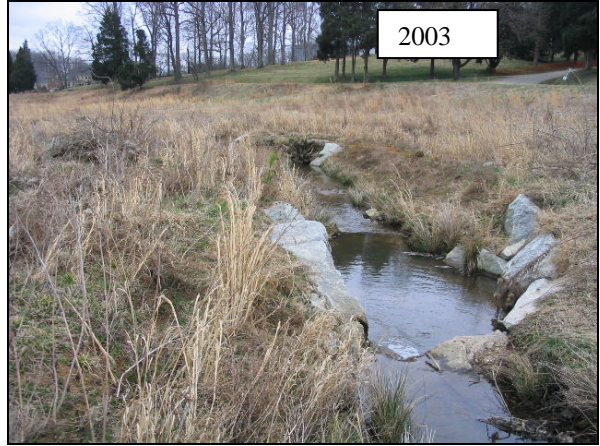
M12-DS: View from Meander 12 looking downstream. 77

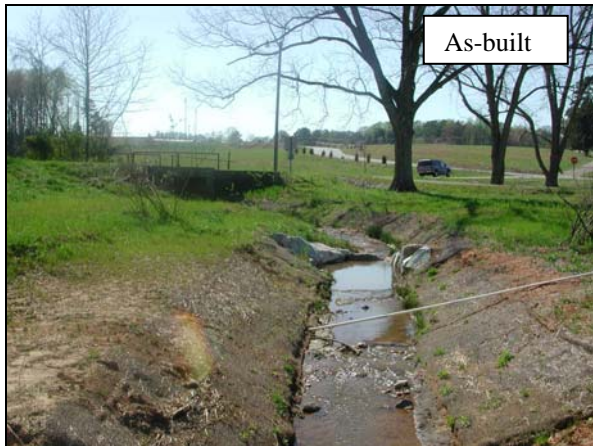
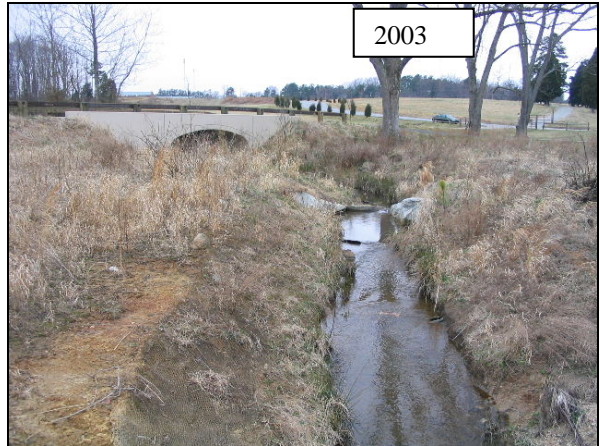
M13-US: View from Meander 13 looking upstream. 79

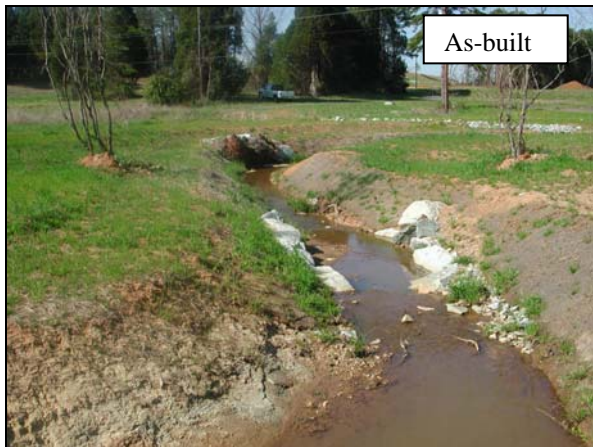
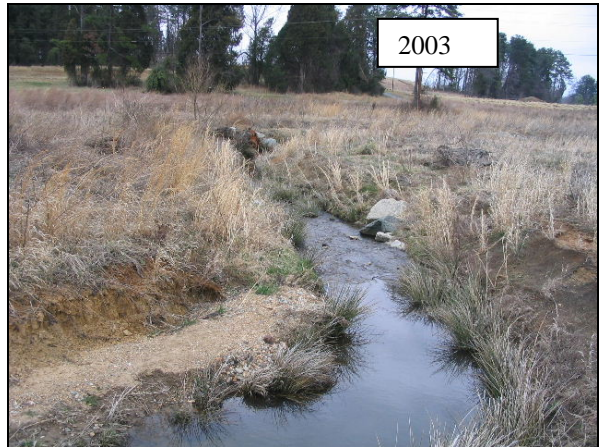
M13-DS: View from Meander 13 looking downstream. 80

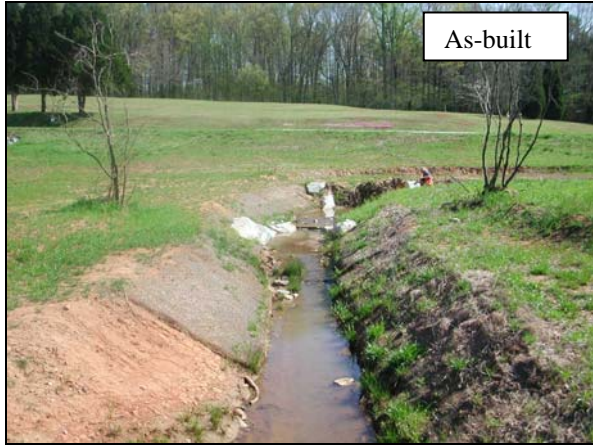
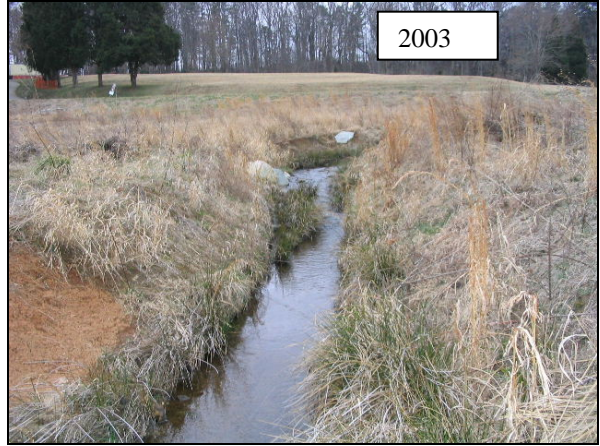
M14-US: View from Meander 14 looking upstream. 81

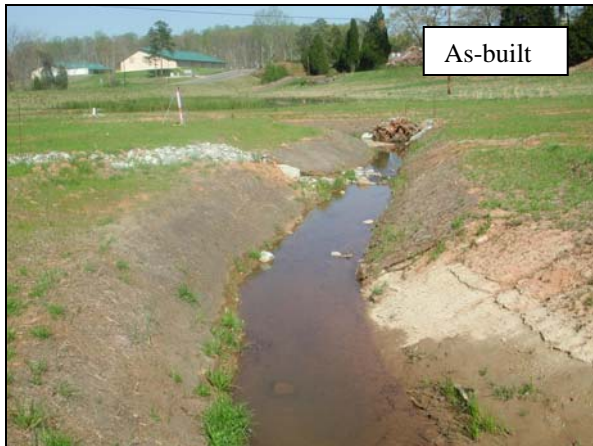
M14-DS: View from Meander 14 looking downstream. Note stone step-pool outfall to connecting roadway drainage to stream channel.82

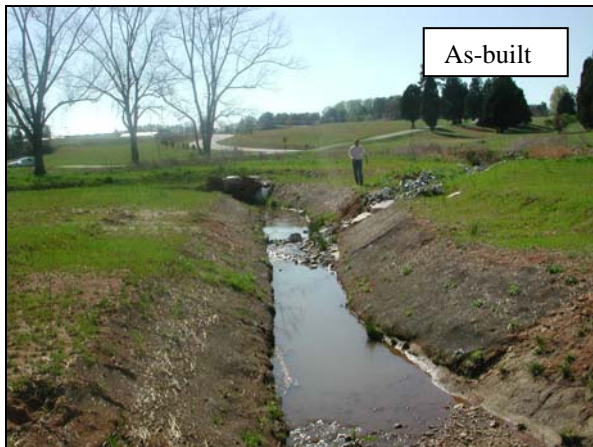
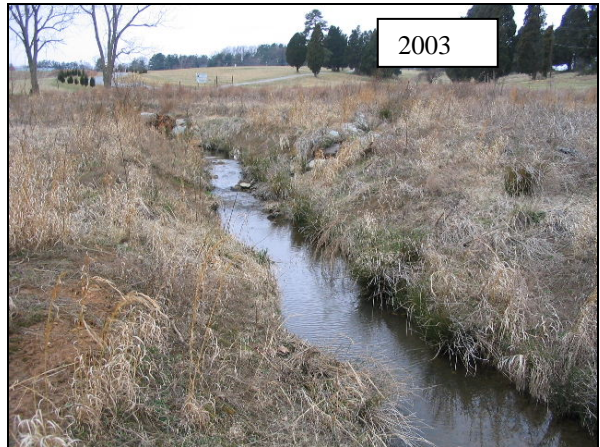
M15-US: View from Meander 15 looking upstream. 83

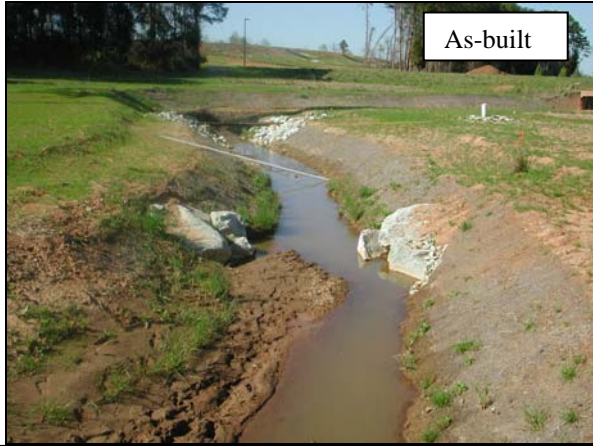
M15-DS: View from Meander 15 looking downstream. Note this cross-vane was moved upstream into the meander to avoid a gas line during construction. In effect, the upper portion of the cross vane has been covered up by the point bar.⁸⁴

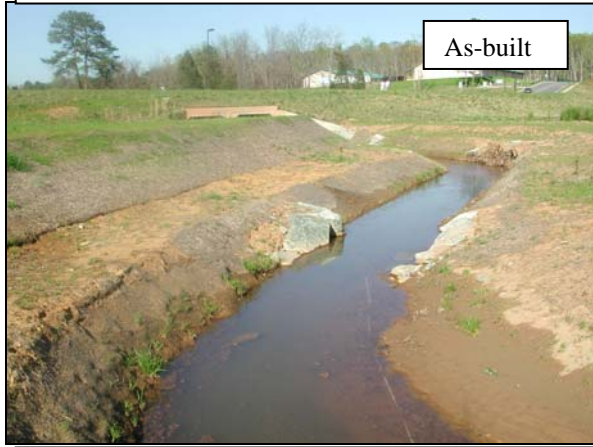
M16-US: View from Meander 16 looking upstream. The aerial sewer line was re-routed to make it perpendicular to the stream.⁸⁵

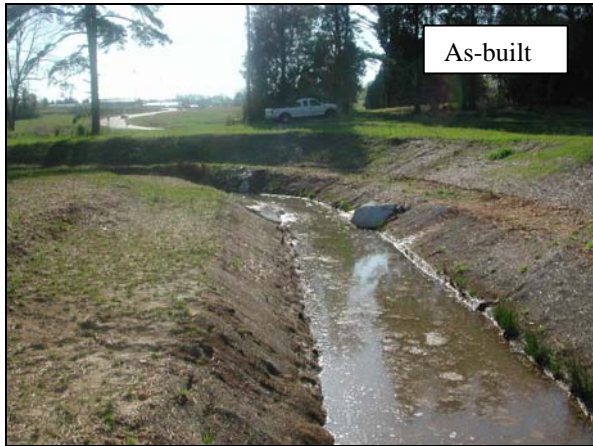
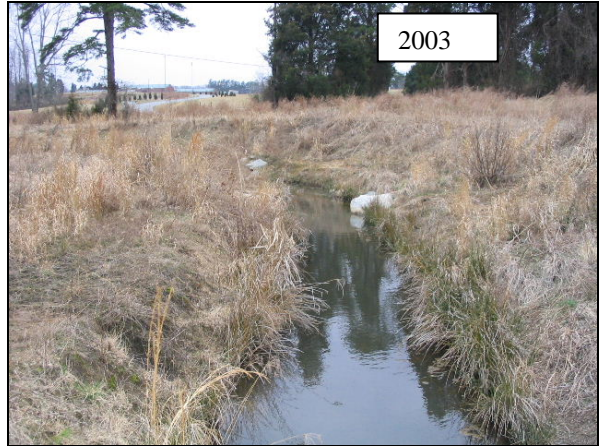
M16-DS: View from Meander 16 looking downstream. Cross-vane is drowned out due to backwater from the off-site lake downstream. ⁸⁶

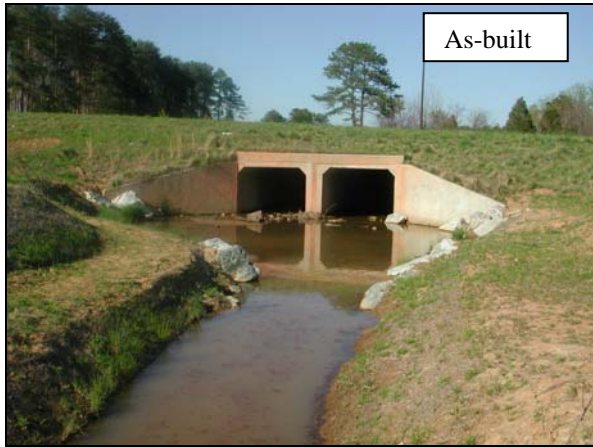
M17-US: View from Meander 17 looking upstream. 87
