Purlear Creek - Phase I Stream Restoration Annual Monitoring Report

Monitoring Year: 2005

NCEEP Project Number: 294

Prepared by: Biological & Agricultural Engineering, North Carolina State University
Campus Box 7625
Raleigh, NC 27695

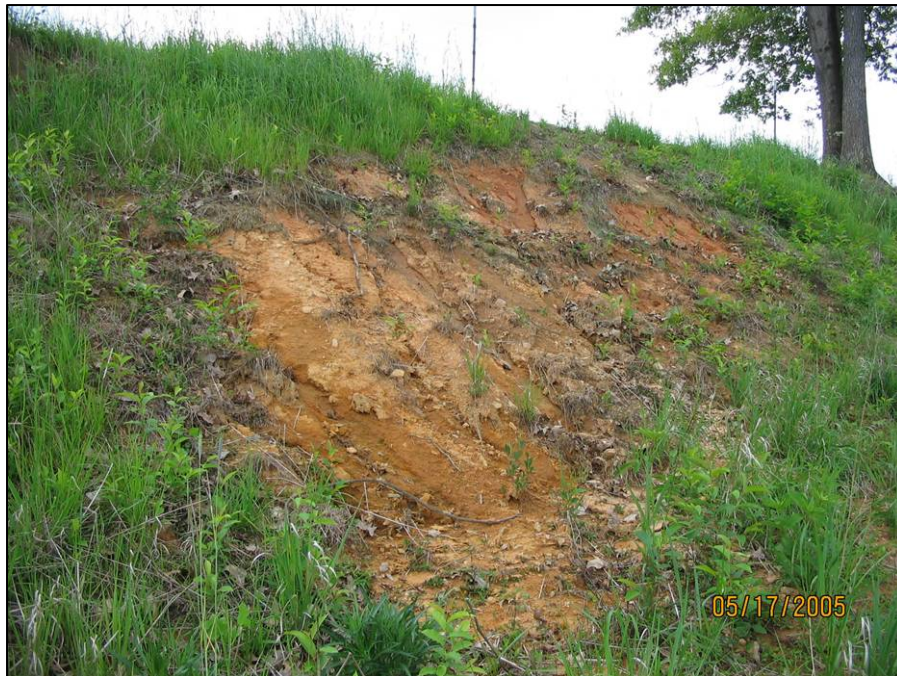
Vegetation Plot A 1. Bare Bank. Reach 6 Station (8+00)

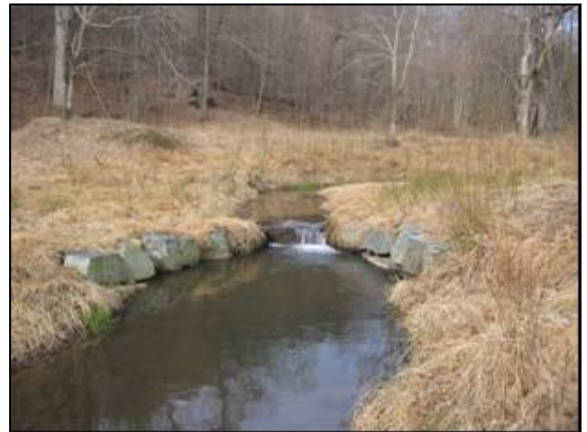
IP 4 Bed Elevation Drop (Station 0+30)

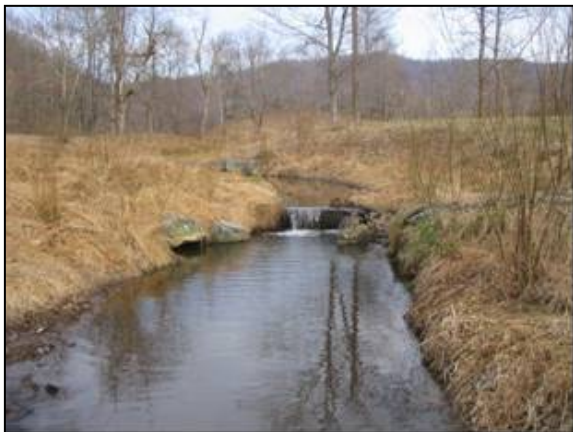
IP 5 Bed Elevation Drop (Station 0+89)

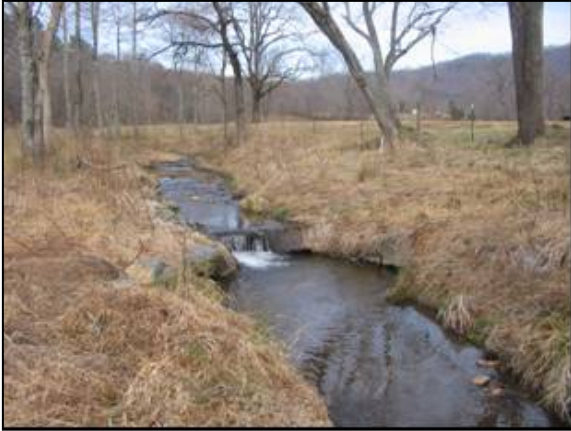
IP 7 Bed Elevation Drop (Station 5+50)

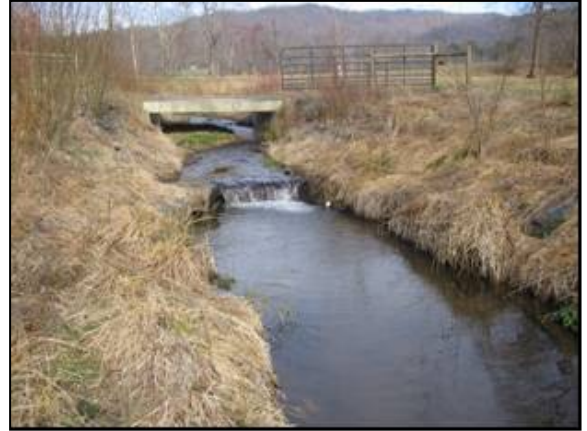
IP 8 Bed Elevation Drop Below Study Reach)

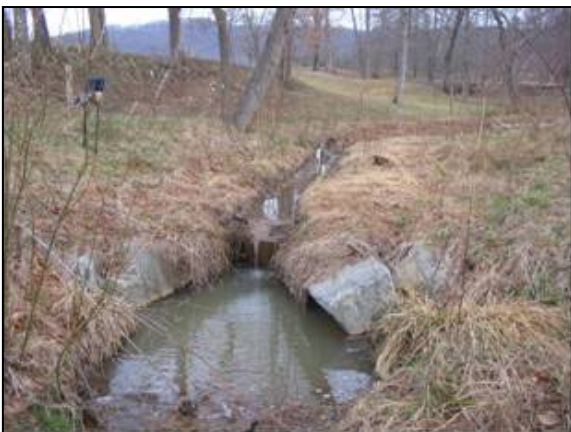
IP 11 Bed Elevation Drop (Station -1+30)

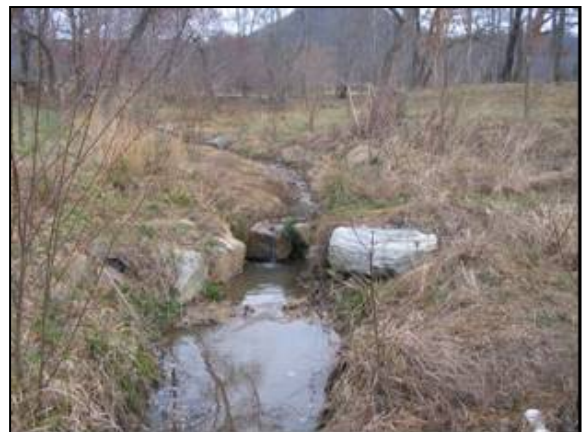
IP 12 Bed Elevation Drop (Station -0+65)

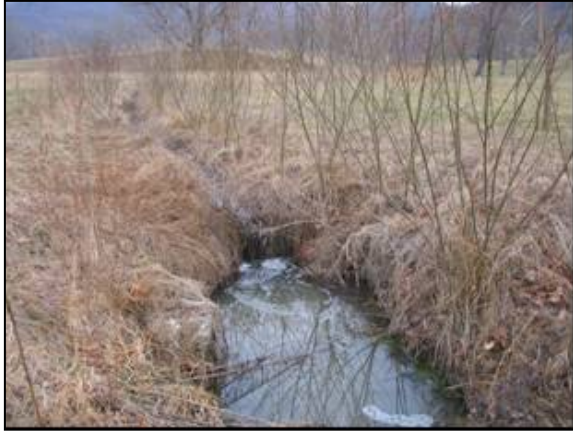
IP 13 Bed Elevation Drop (Station 0+74)

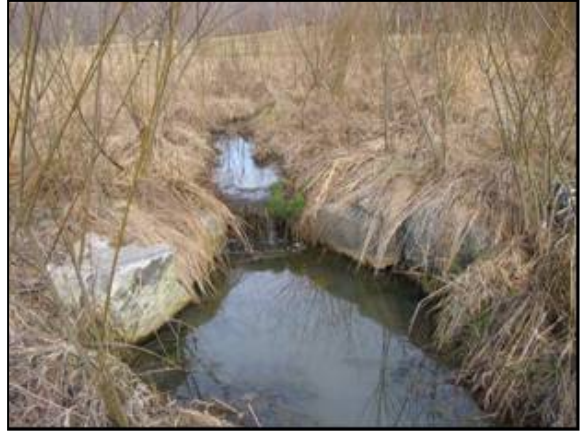
IP 14 Bed Elevation Drop (Station 1+75)

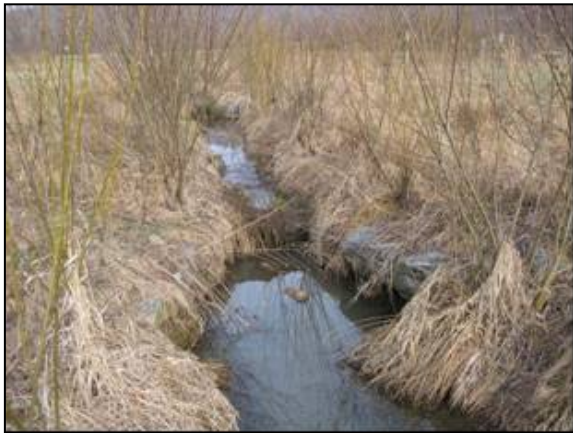
IP 15 Bed Elevation Drop (Below Study Reach)

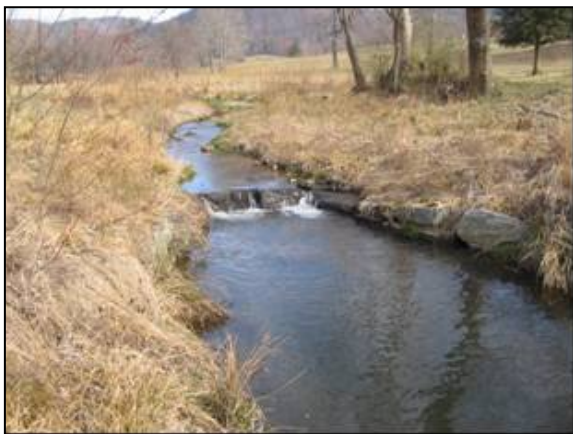
IP 16 Bed Elevation Drop (Above Study Reach)

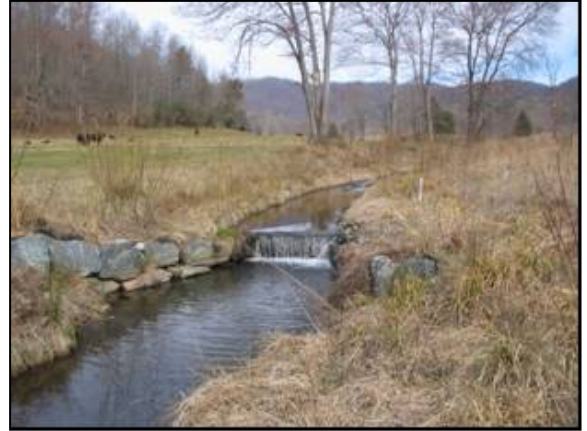
IP 19 Bed Elevation Drop (Station 2+77)

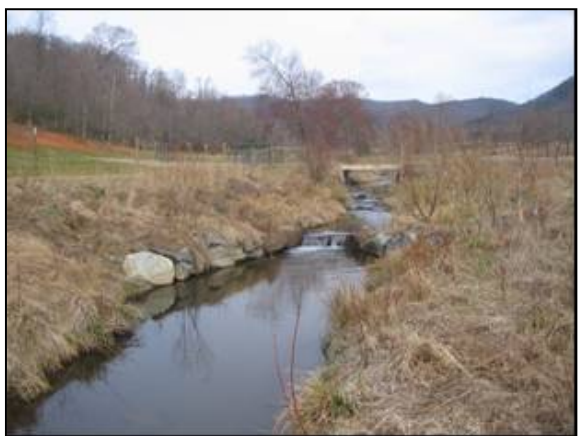
IP 21 Bed Elevation Drop (Below Study Reach)

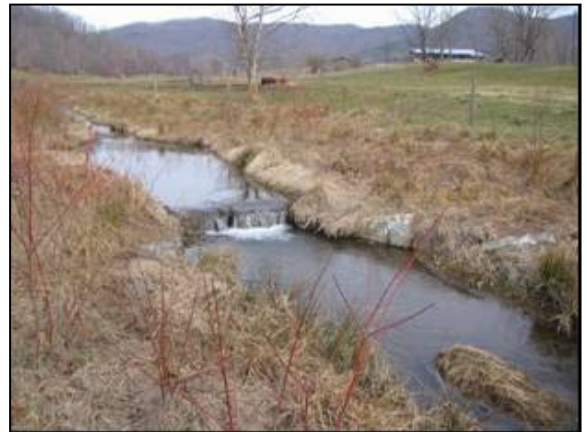
IP 23 Bed Elevation Drop (Below Study Reach)

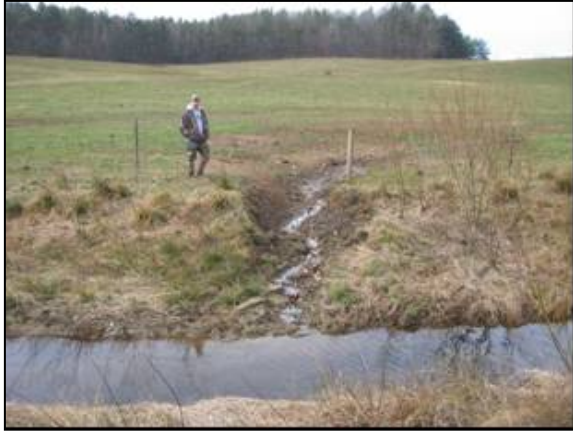
IP 24 Excess Nutrients through Buffer (Below Study Reach)

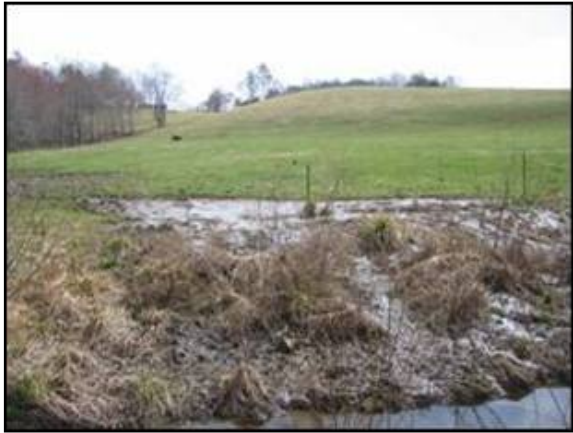
IP 25 Excess Nutrients through Buffer (Station 0+50)

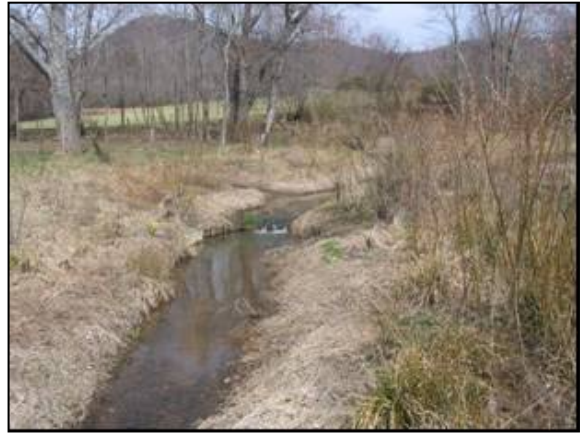
IP 26 Bed Elevation Drop (Station 1+84)

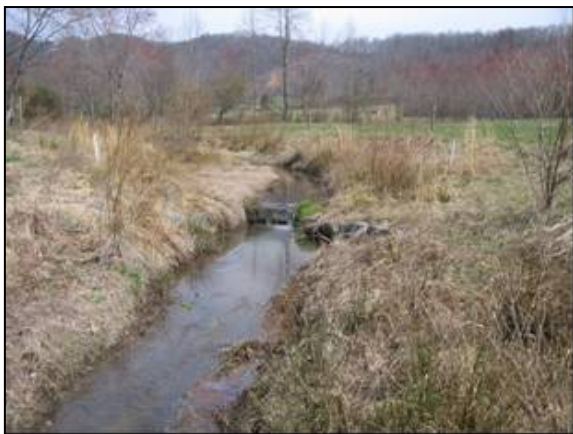
IP 27 Bed Elevation Drop (Station 3+15)

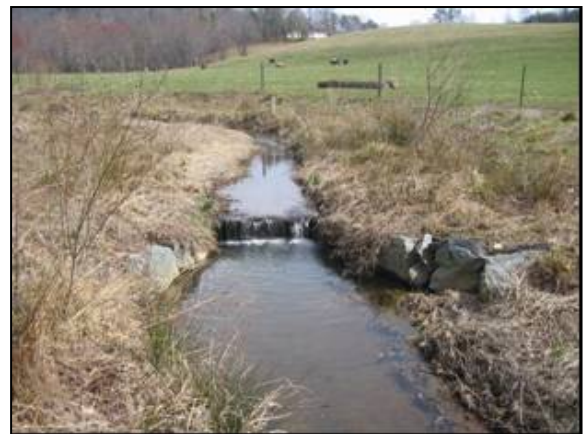
IP 28 Bed Elevation Drop (Station 5+00)

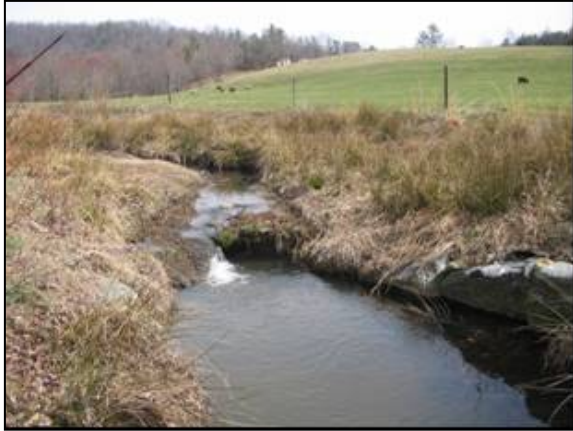
IP 29 Bed Elevation Drop (Station 6+50)

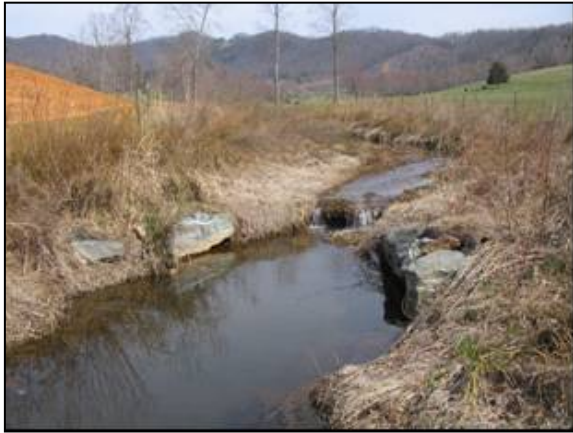
IP 30 Bed Elevation Drop (Above Study Reach)

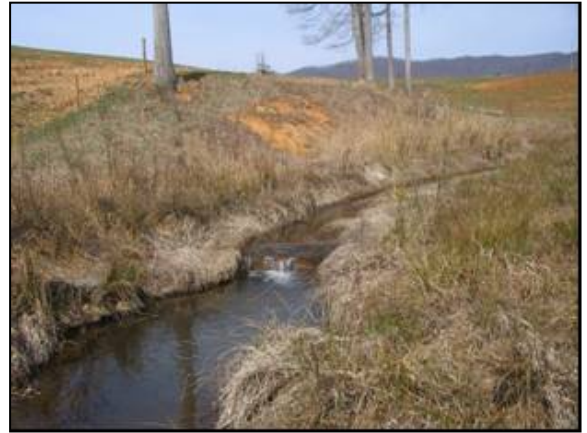
IP 31 Bed Elevation Drop (Above Study Reach)

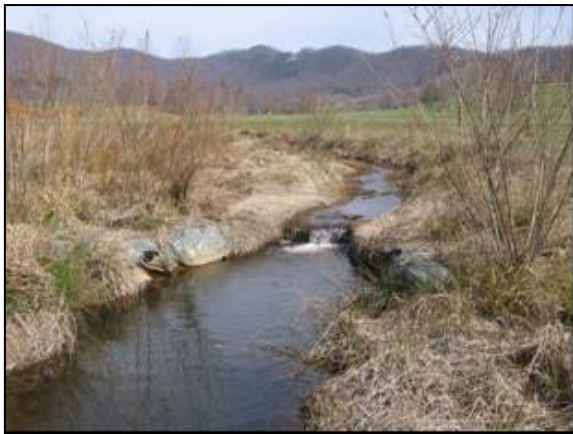
IP 32 Bed Elevation Drop (Above Study Reach)

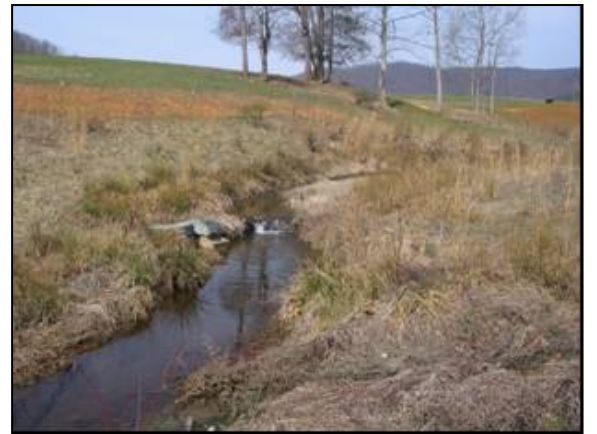
IP 33 Bed Elevation Drop (Above Study Reach)

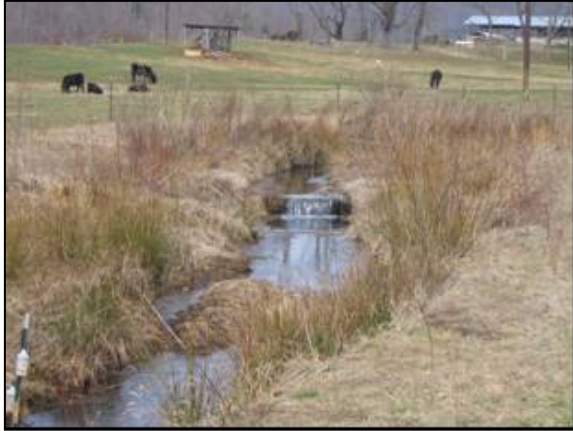
IP 34 Bed Elevation Drop (Below Study Reach)

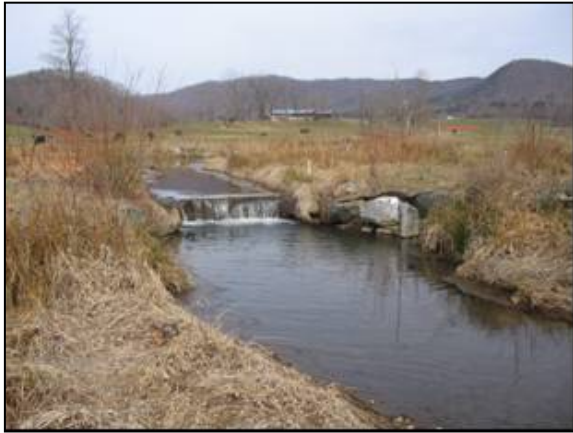
IP 35 Bed Elevation Drop (Above Study Reach)

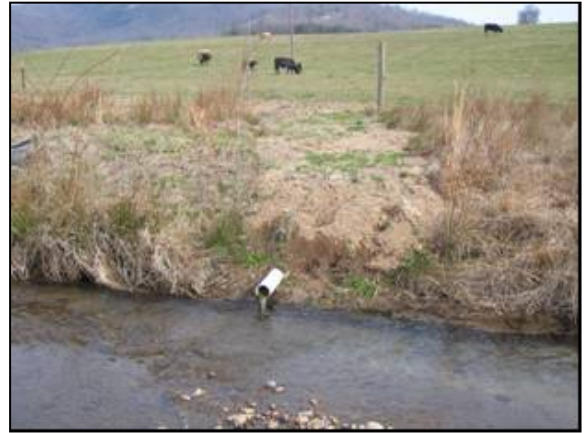
IP 36 Tile (Above Study Reach)

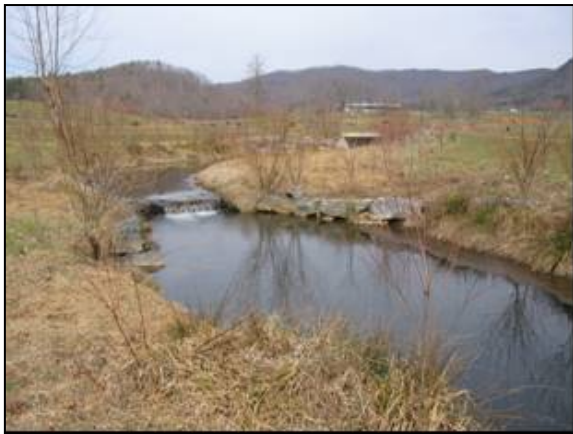
IP 37 Bed Elevation Drop (Station 1+00)

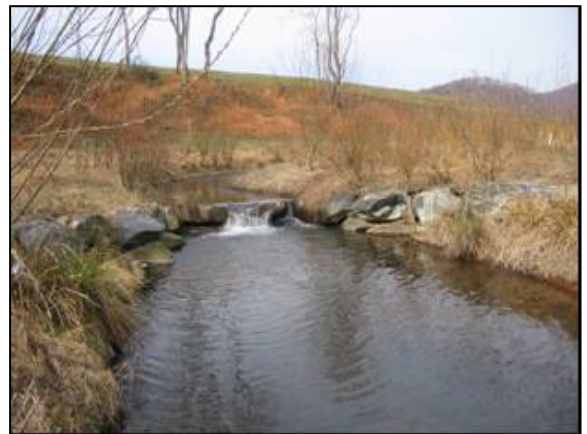
IP 42 Bed Elevation Drop (Station 4+70)

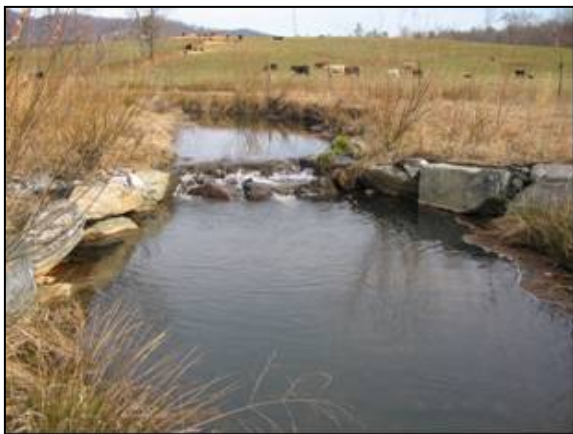
IP 43 Bed Elevation Drop (Station 6+00)

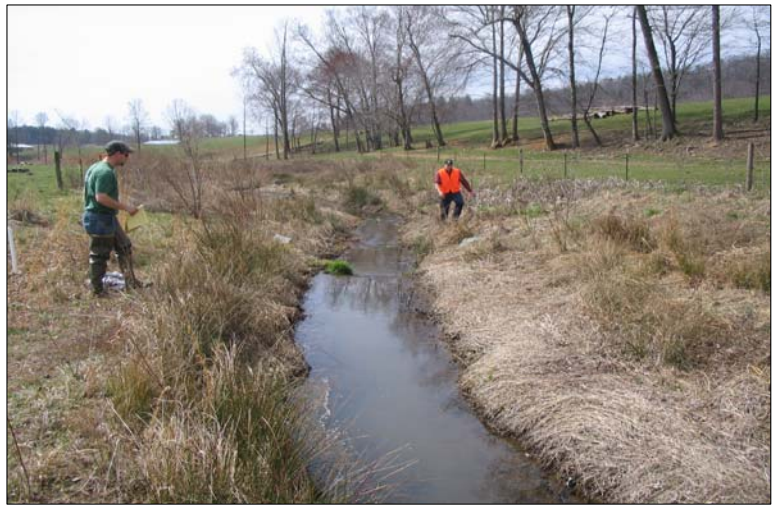
Photo of Area 4 Cross-Section #1 - Looking Downstream

As-Built	2005
Area	21.8	19.1
Width	25.1	25.1
Mean Depth	0.9	0.8
Max Depth	1.6	1.5
w/d ratio	28.9	32.9
FPW	50	50
ER (greater than)	2.0	2.0
Stream Type	C4	C4

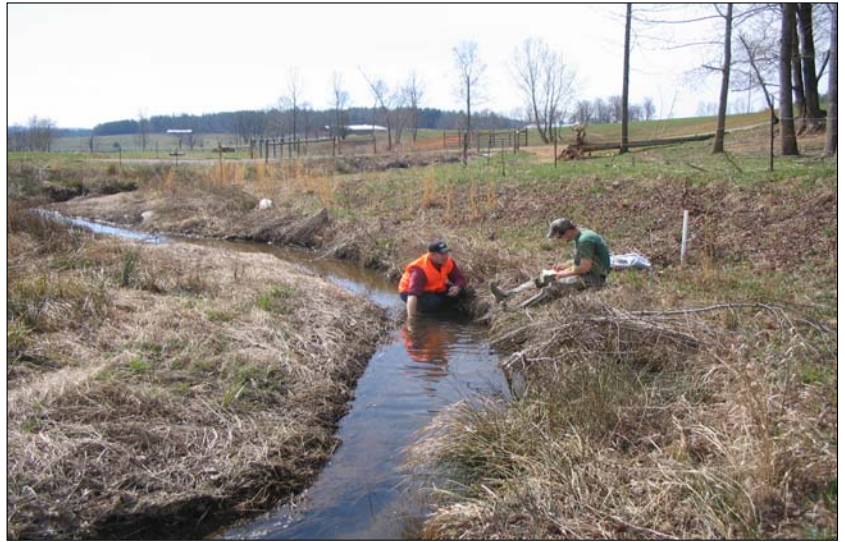
Photo of Area 4 Cross-Section #2 - Looking Downstream

As-Built	2005
Area	21.5	18.1
Width	22.6	21.2
Mean Depth	1.0	0.9
Max Depth	2.3	2.2

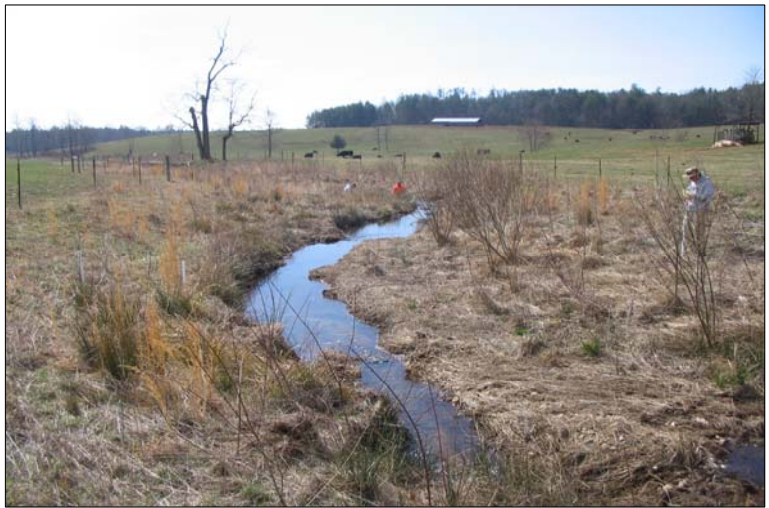
Photo of Area 5 Cross-Section #1 - Looking Downstream

Area	As-Built	2005
Width	26.8	29.4
Mean Depth	21.4	21.4
Max Depth	1.3	1.4
	2.5	3.3

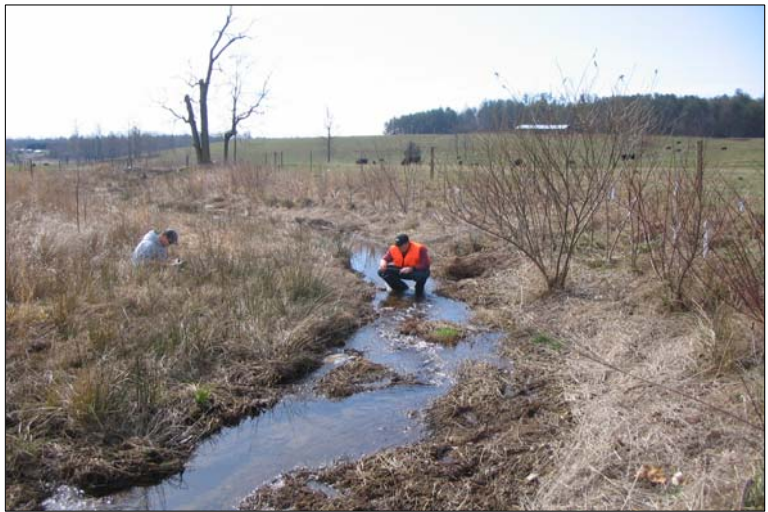
Photo of Area 5 Cross-Section #2 - Looking Downstream

As-Built	2005
Area	23.1	19.8
Width	26.3	25.0
Mean Depth	0.9	0.8
Max Depth	1.7	1.7
w/d ratio	30.0	31.7
FPW	60	60
ER (greater than)	2.3	2.4
Stream Type	C4	C4

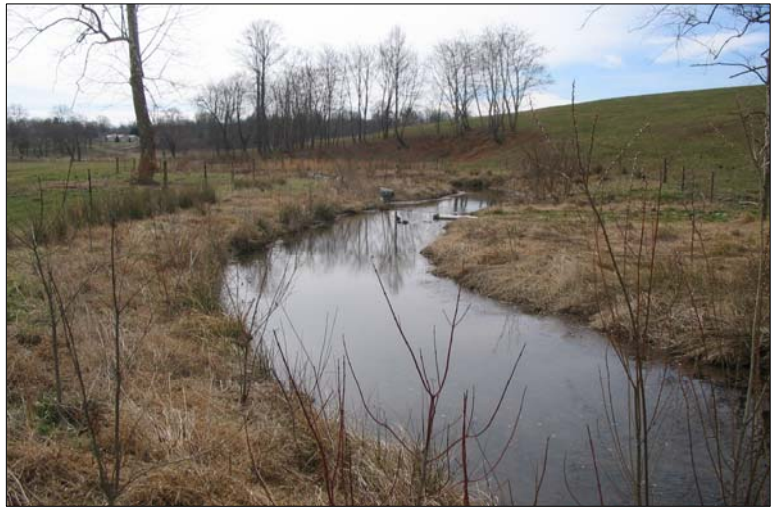
Photo of Area 6 Cross-Section #1 - Looking Downstream

As-Built	2005
Area	43.6	36.3
Width	18.9	19.2
Mean Depth	2.3	1.9
Max Depth	3.8	3.5

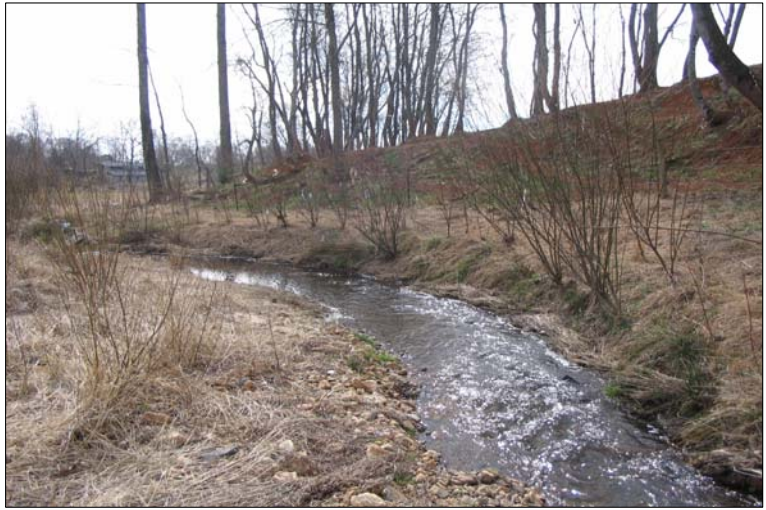
Photo of Area 6 Cross-Section #2 - Looking Downstream

As-Built	2005
Area	40.2	37.8
Width	27.1	26.9
Mean Depth	1.5	1.4
Max Depth	2.5	2.9
w/d ratio	18.3	19.2
FPW	60	60
ER (greater than)	2.2	2.2
Stream Type	C4	C4
