Purlear Creek - Phase I Stream Restoration Annual Monitoring Report

Monitoring Year: 2006

NCEEP Project Number: 294

PURLEAR CREEK - PHASE 1 STREAM RESTORATION 2006 MONITORING REPORT

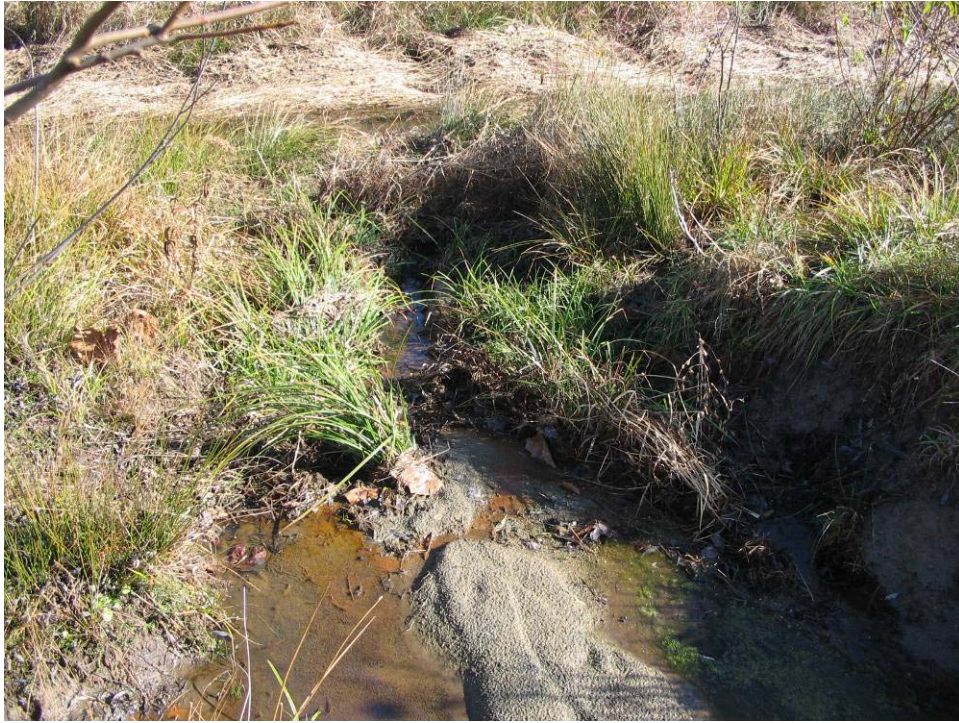
VPA-1, 27-Nov-06

Issue	UTM N	UTM E	Probable Cause	Photo #
Bare floodplain	4006028	473744	Head cut from pasture channel	VPA-1
Bare floodplain	4006168	473771	Head cut from pasture channel	VPA-2
Bare bank	4006343	473269	Constructed steep slope	VPA-3

No immediate action is recommended for problem areas.

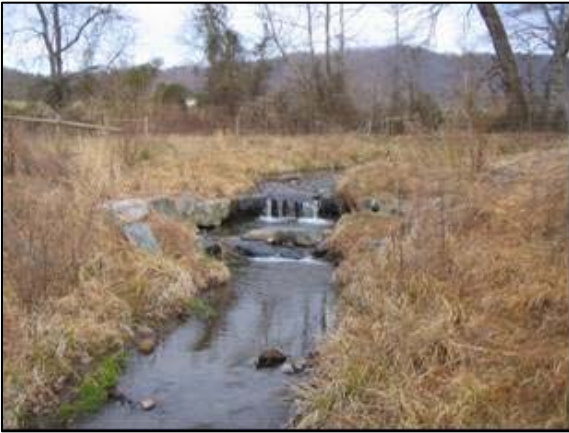
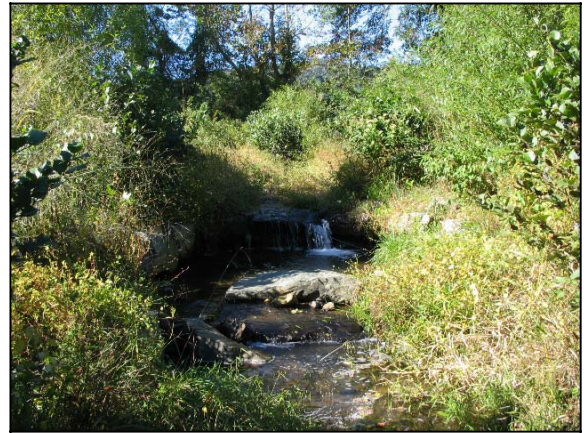
IP 1 Bed Elevation Drop (Upstream of Study Reach)

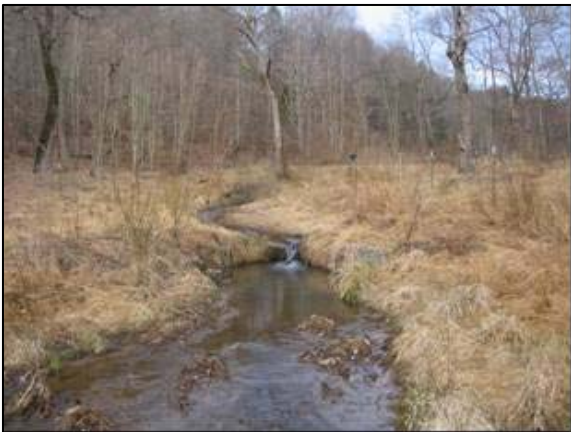
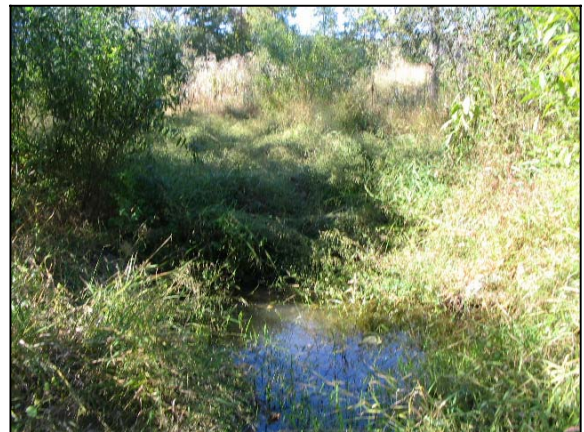
IP 2 Bed Elevation Drop (Upstream of Study Reach)

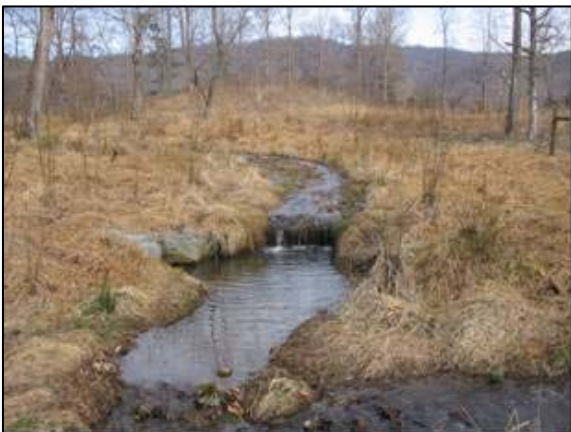
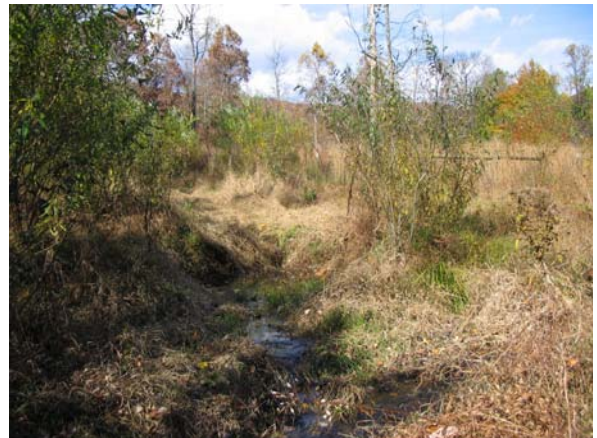
IP 3 Bed Elevation Drop (Upstream of Study Reach)

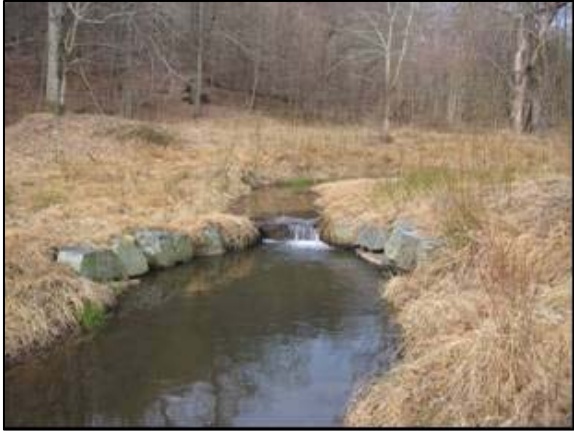
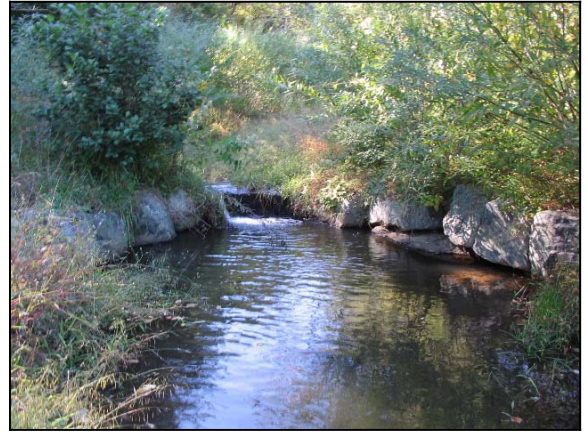
IP 4 Bed Elevation Drop (Station 0+30)

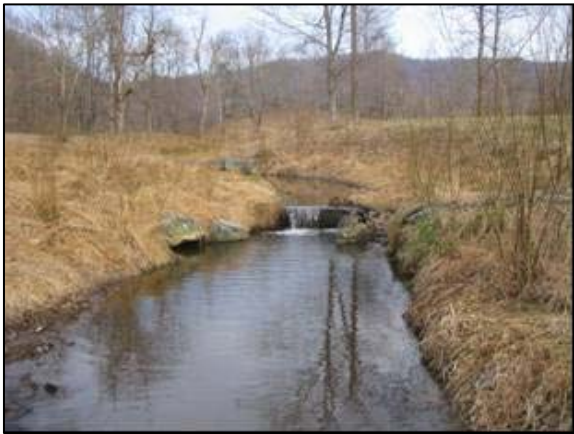
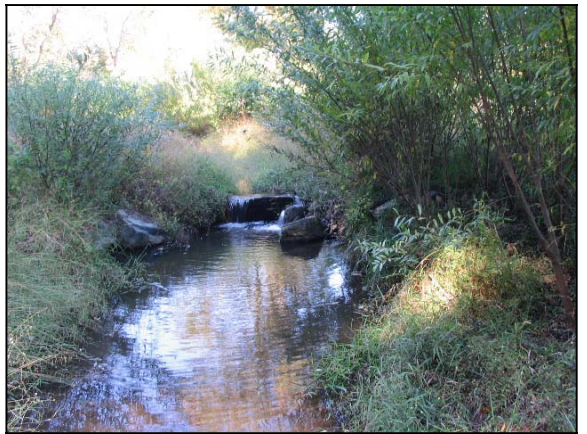
IP 5 Bed Elevation Drop (Station 0+89)

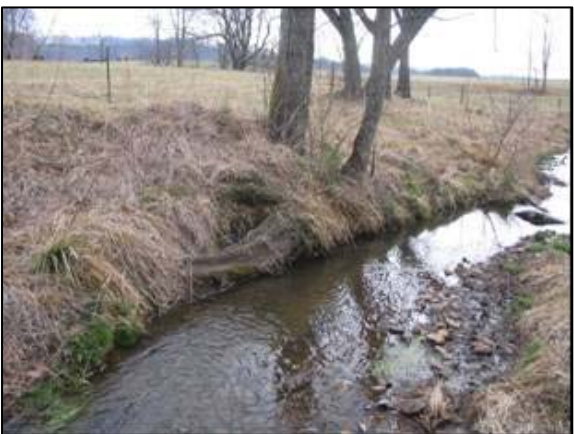
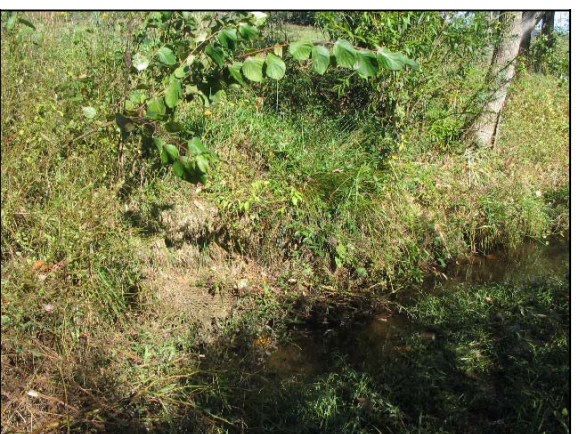
IP 6 Bank Erosion (Station 4+25)

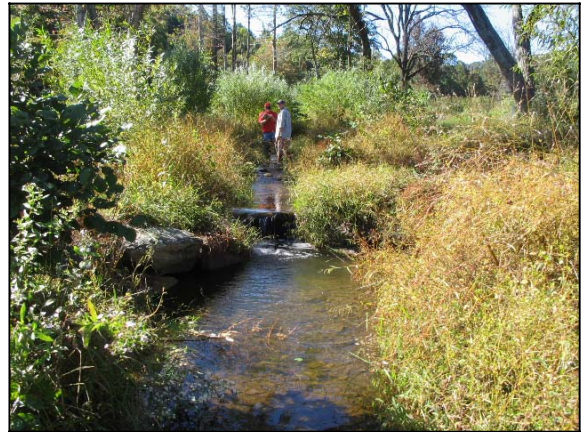
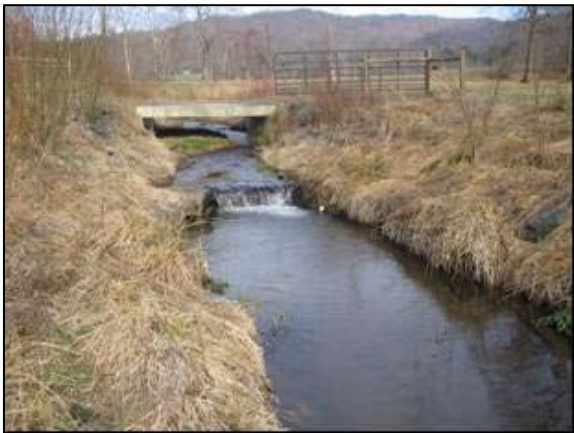
IP 7 Bed Elevation Drop (Station 5+50)

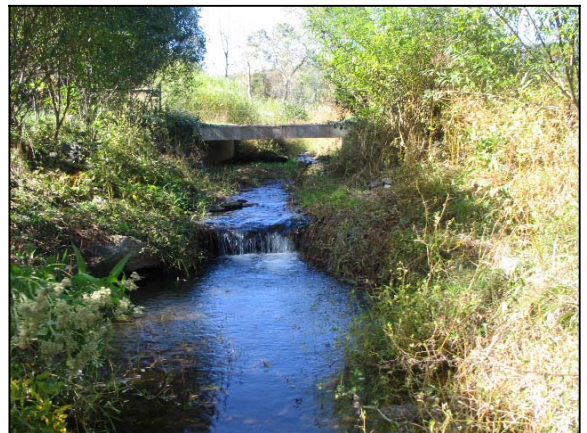
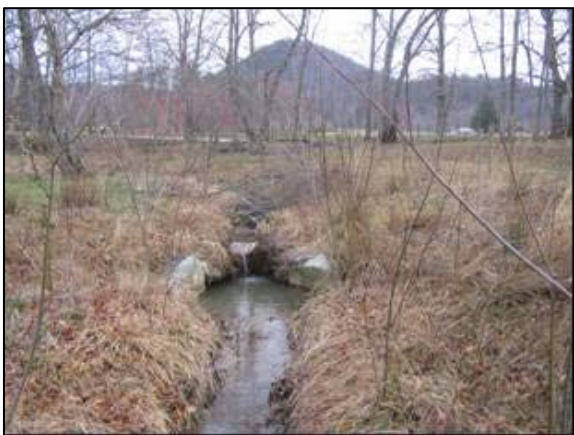
IP 8 Bed Elevation Drop Below Study Reach)

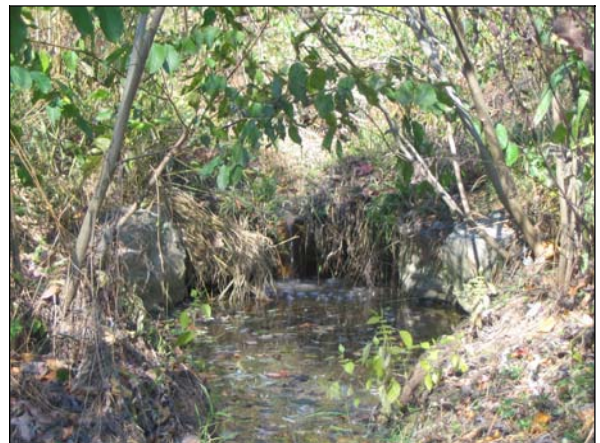
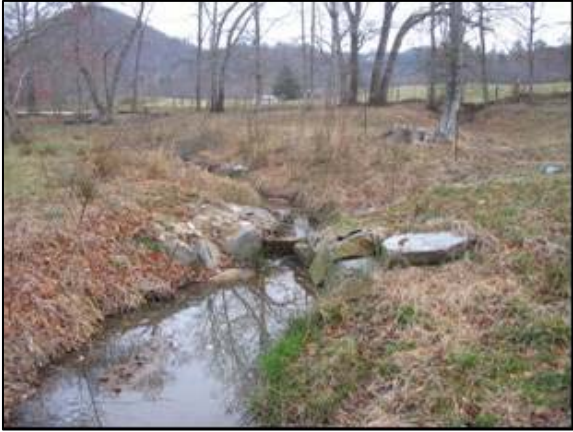
IP 9 Bed Elevation Drop (Upstream of Study Reach)

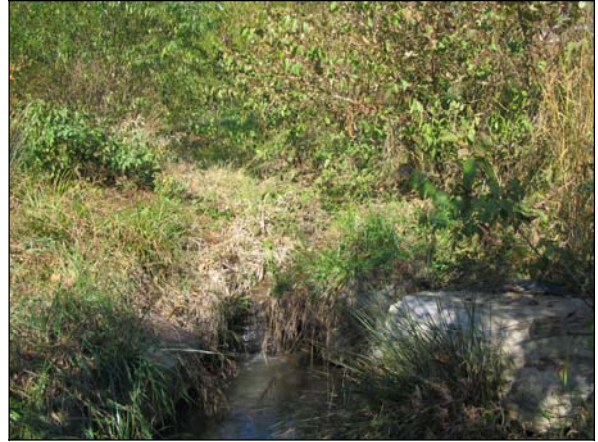
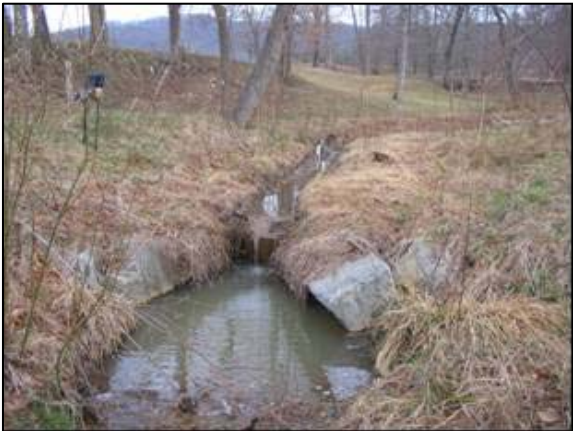
IP 10 Bed Elevation Drop (Upstream of Study Reach)

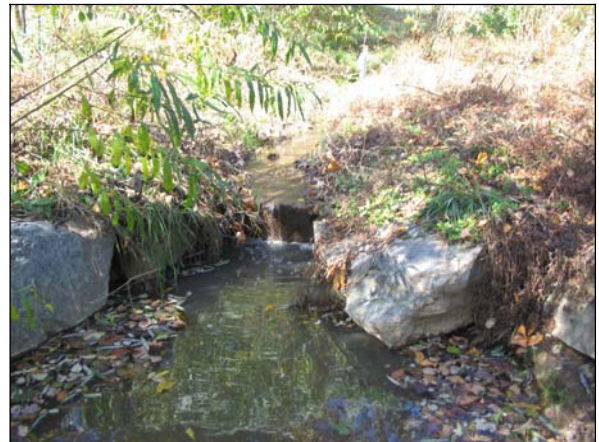
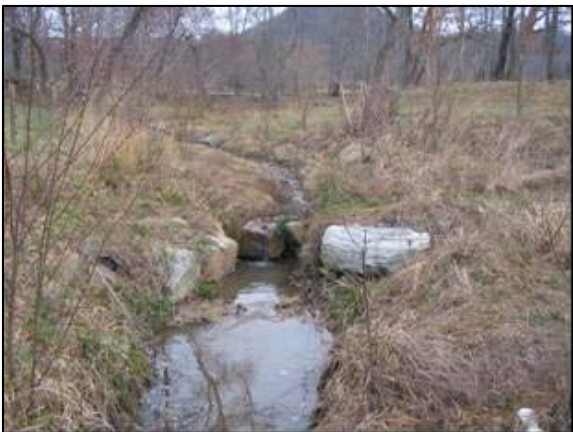
IP 11 Bed Elevation Drop (Station -1+30)

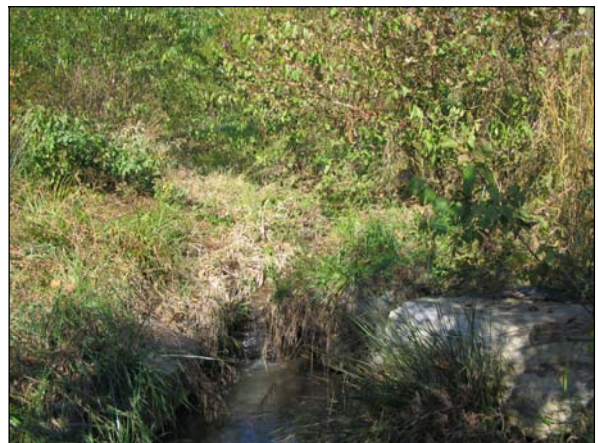
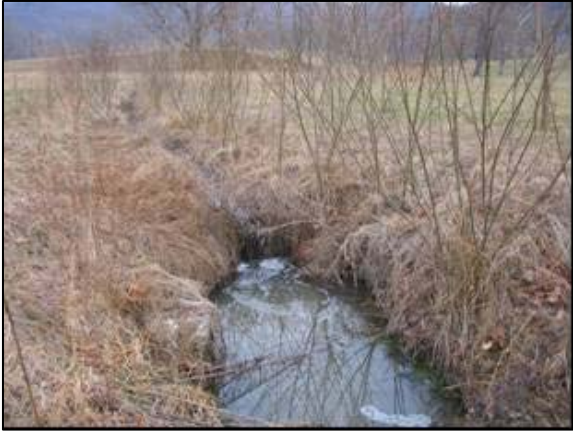
IP 12 Bed Elevation Drop (Station -0+65)

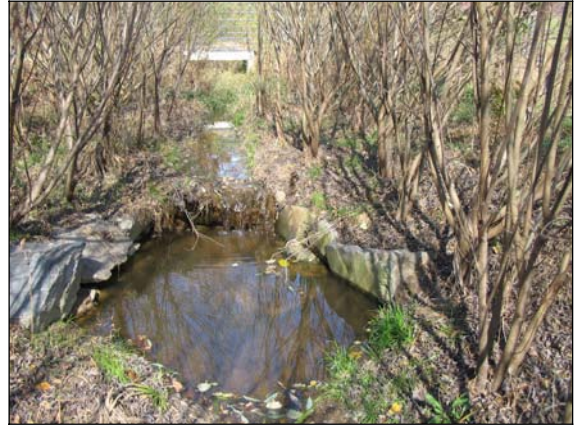
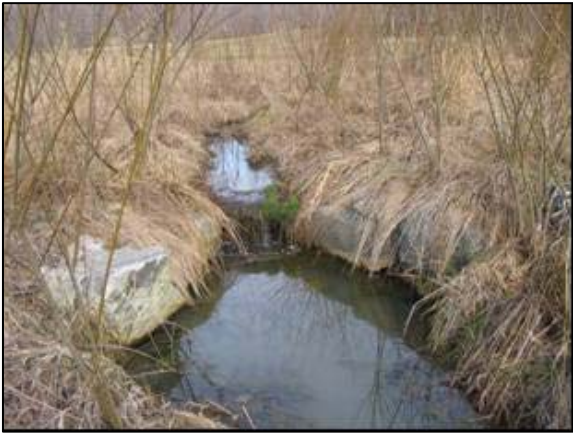
IP 13 Bed Elevation Drop (Station 0+74)

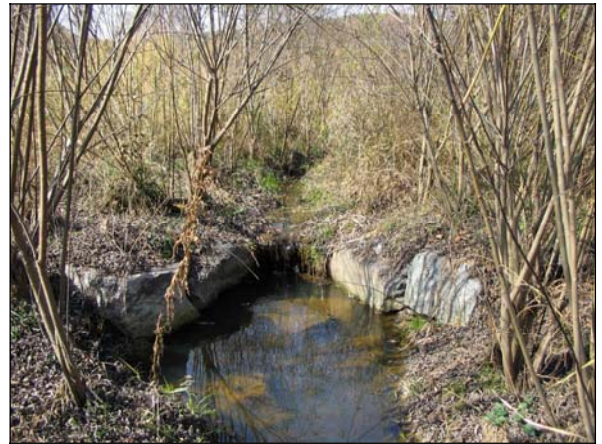
IP 14 Bed Elevation Drop (Station 1+75)

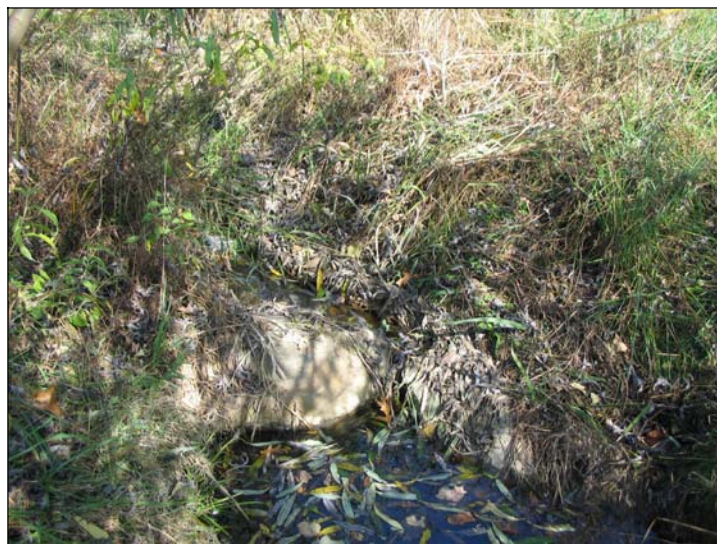
IP12a (new) Piping through cross vane (Station 2+20)

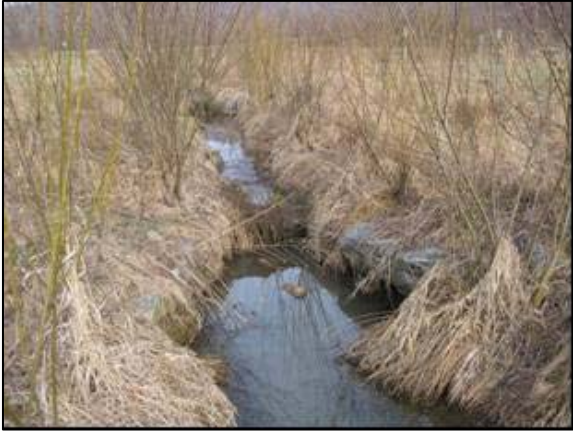
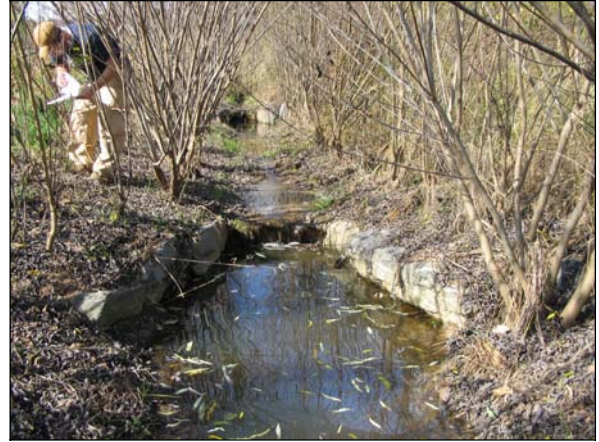
IP 15 Bed Elevation Drop (Below Study Reach)

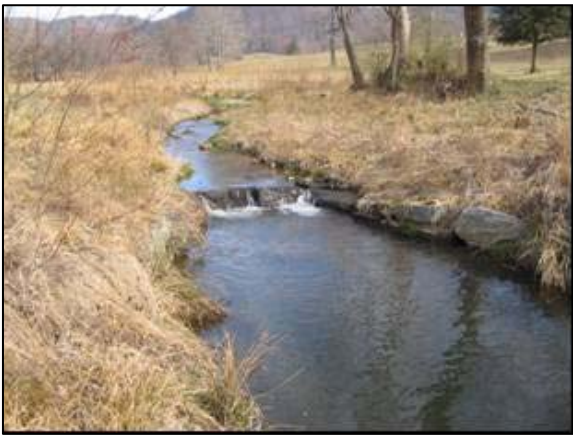
IP 16 Bed Elevation Drop (Above Study Reach)

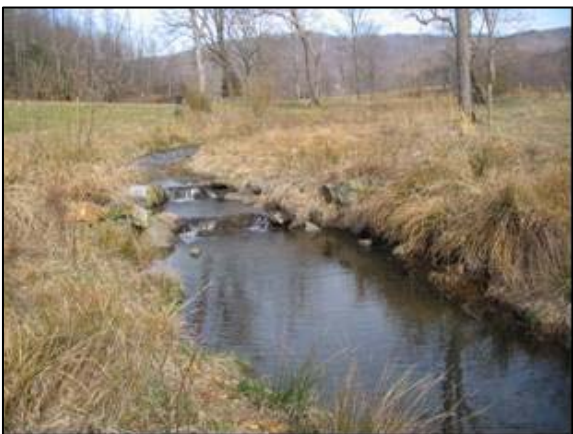
IP 17 Double Drop Vane w/ Erosion (Above Study Reach)

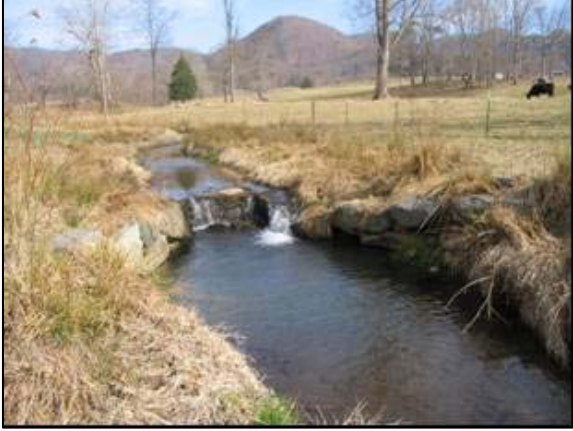
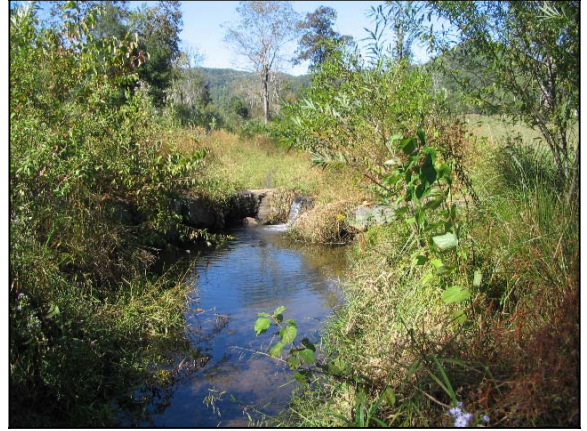
IP 18 Slump Arm (Station 0+00)

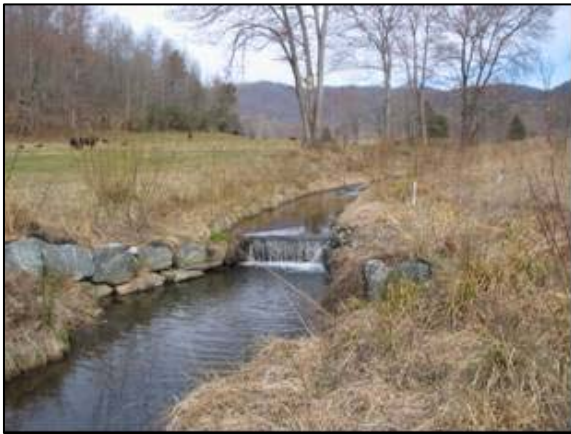
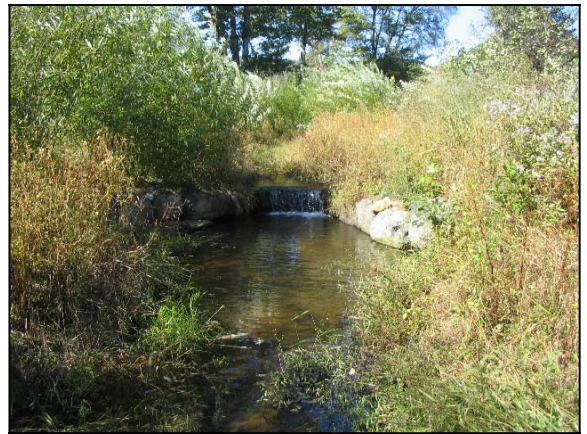
IP 19 Bed Elevation Drop (Station 2+77)

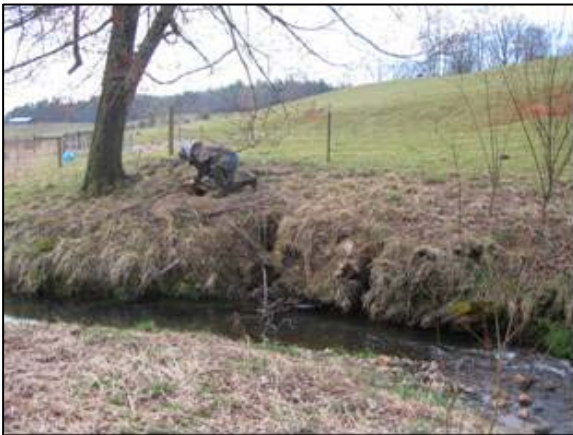
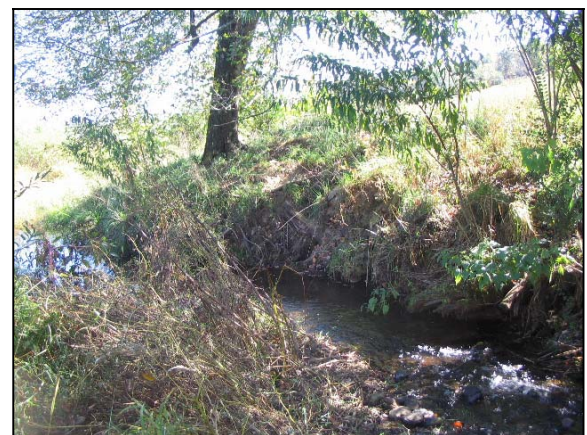
IP 20 Erosion Ground Hog Tunnels (Station 4+00)

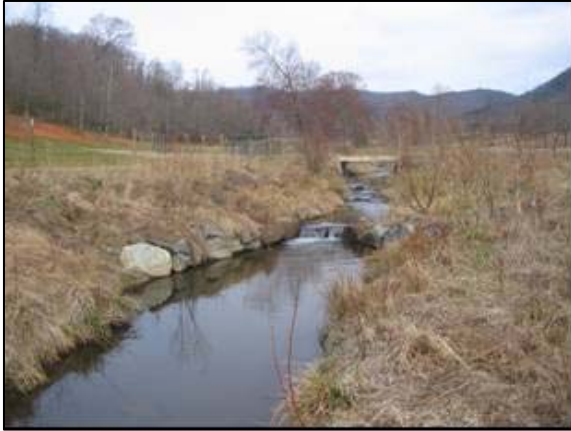
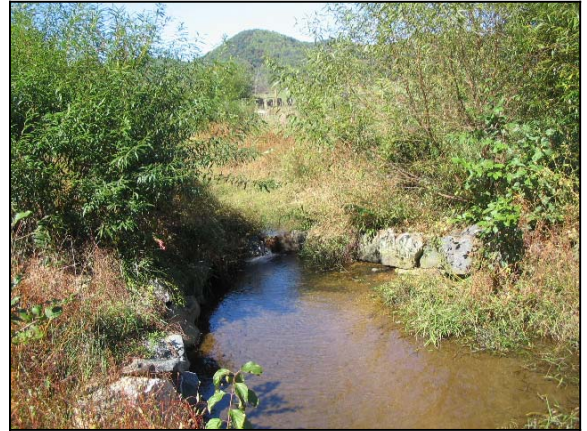
IP 21 Bed Elevation Drop (Below Study Reach)

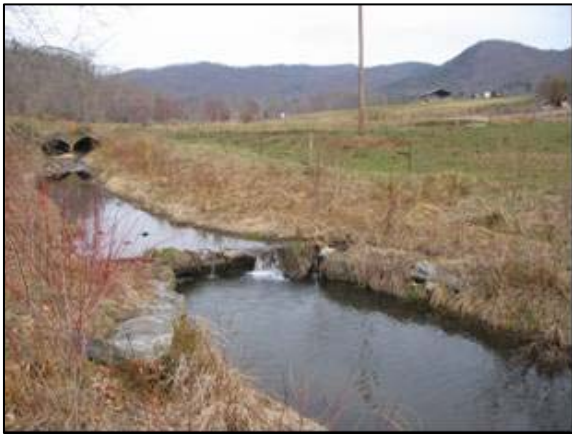
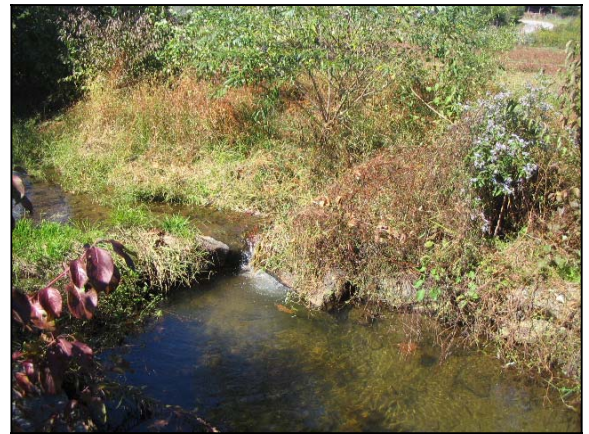
IP 22 Slump Arm and Piping (Below Study Reach)

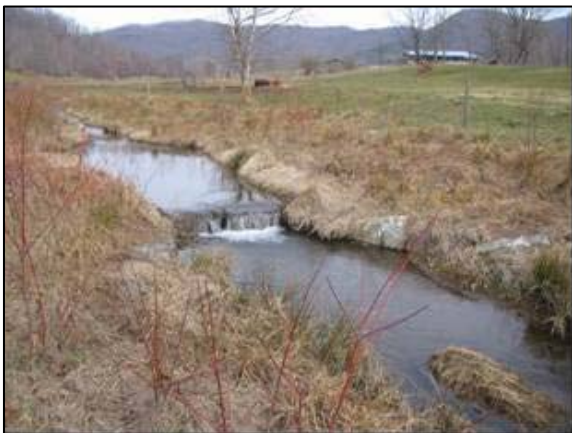
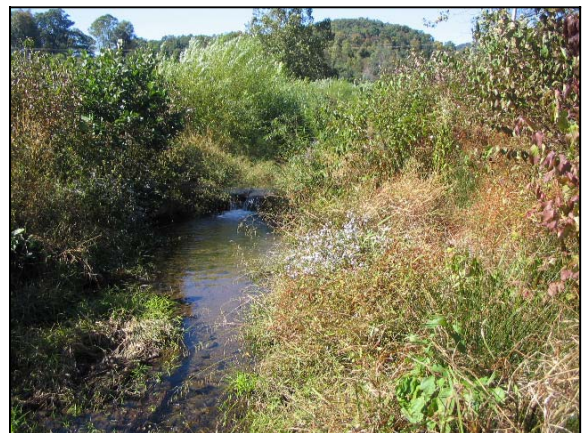
IP 23 Bed Elevation Drop (Below Study Reach)

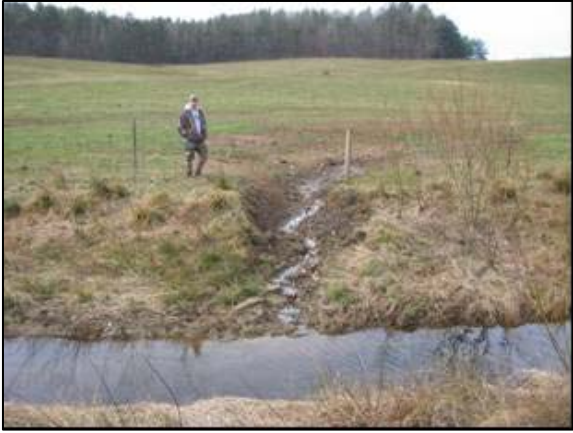
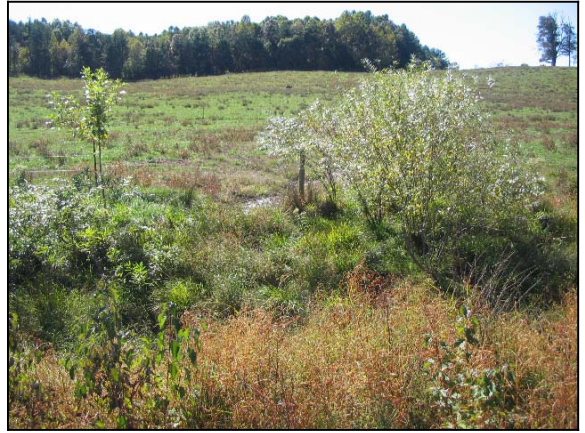
IP 24 Excess Nutrients through Buffer (Below Study Reach)

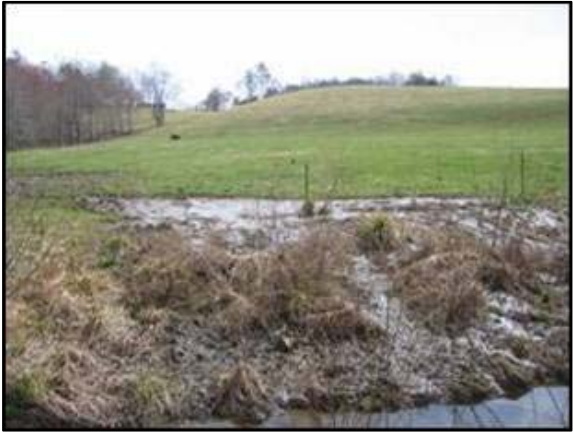
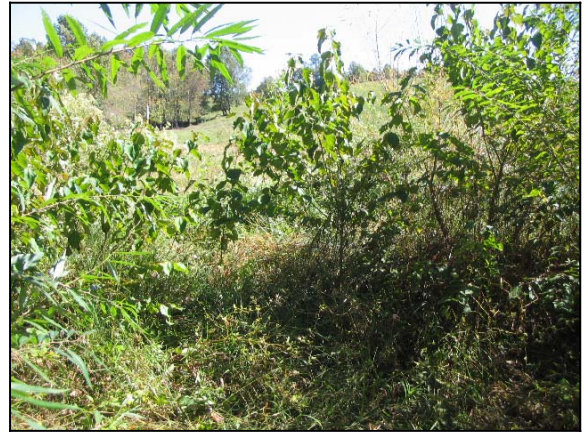
IP 25 Excess Nutrients through Buffer (Station 0+50)

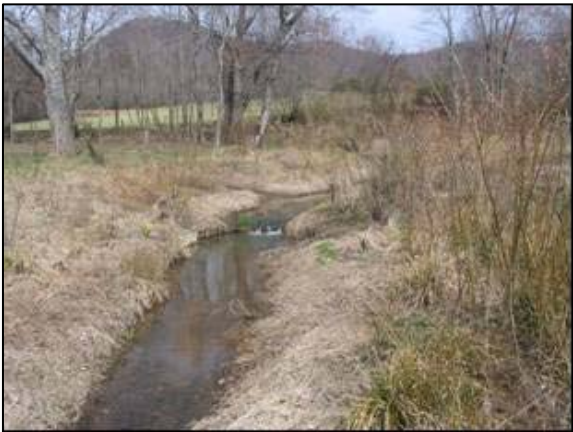
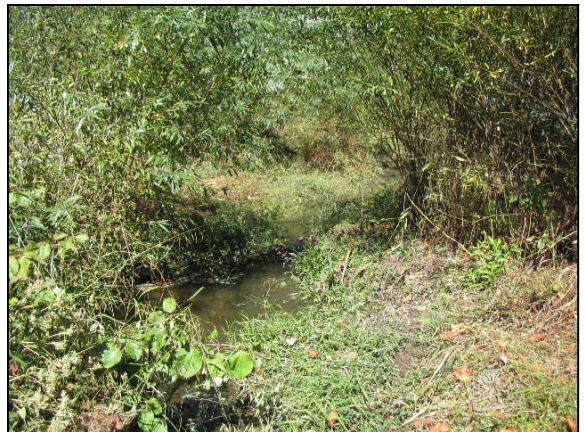
IP 26 Bed Elevation Drop (Station 1+84)

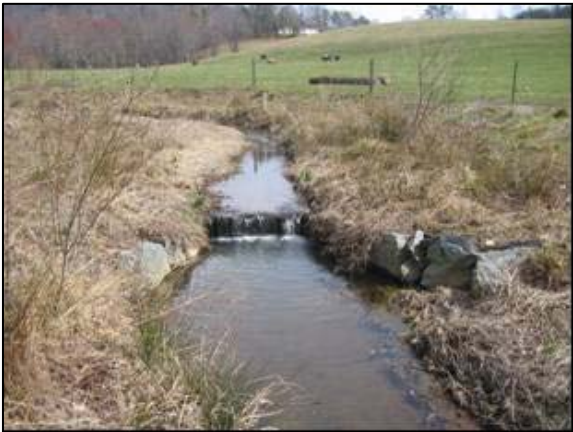
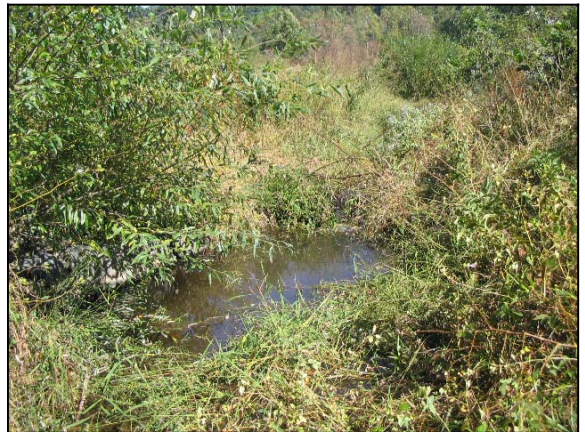
IP 27 Bed Elevation Drop (Station 3+15)

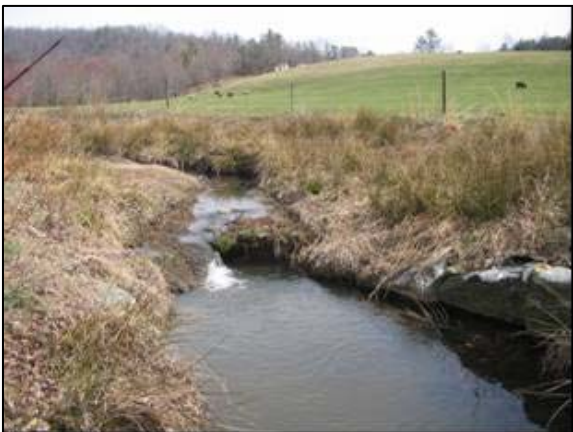
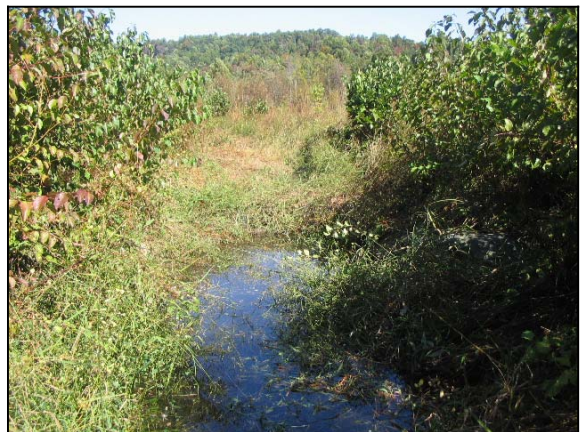
IP 28 Bed Elevation Drop (Station 5+00)

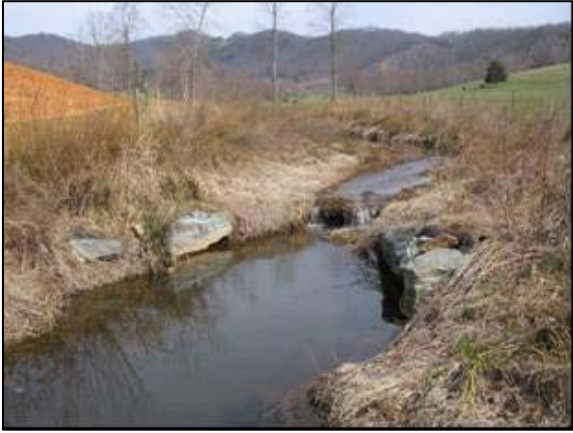
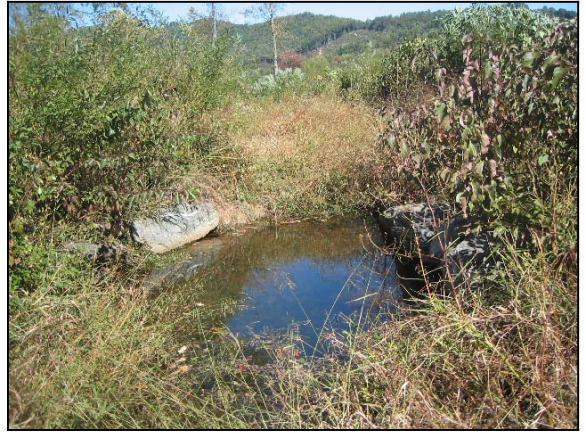
IP 29 Bed Elevation Drop (Station 6+50)

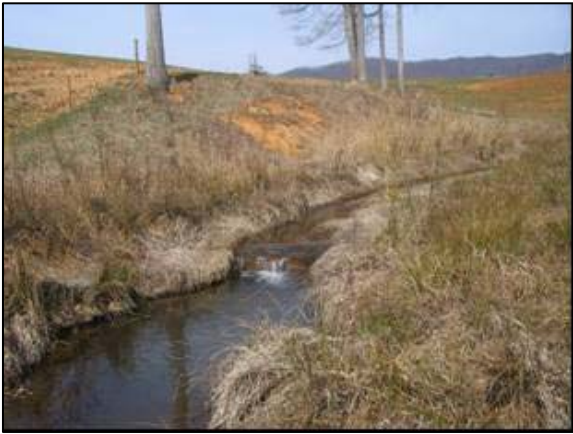
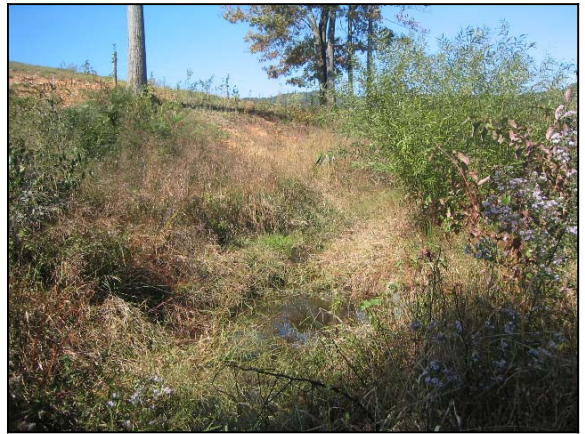
IP 30 Bed Elevation Drop (Above Study Reach)

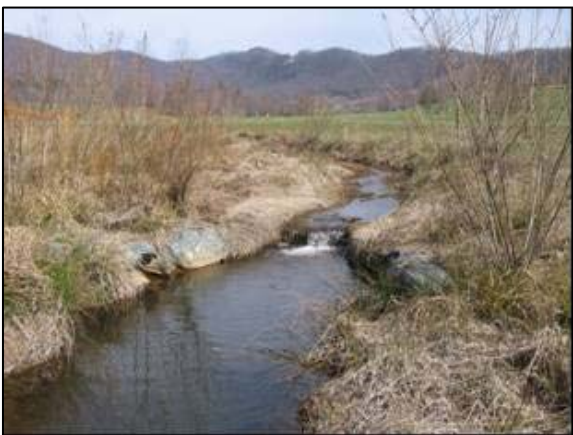
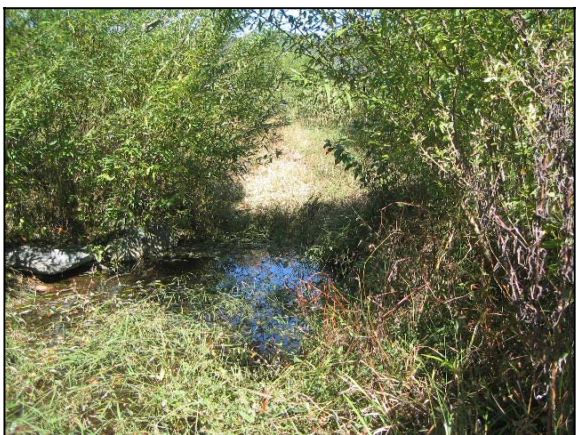
IP 31 Bed Elevation Drop (Above Study Reach)

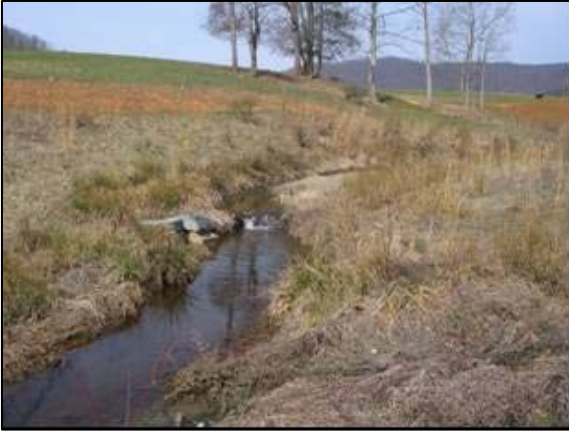
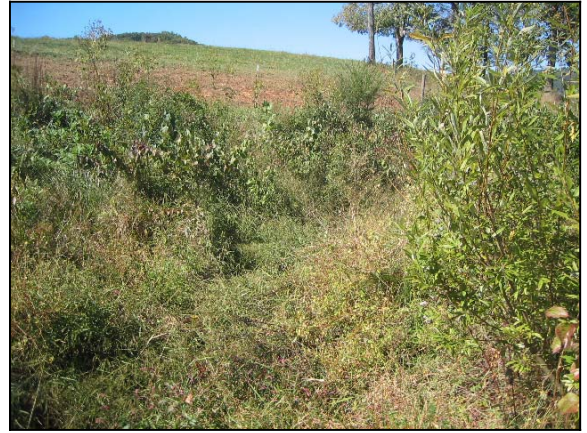
IP 32 Bed Elevation Drop (Above Study Reach)

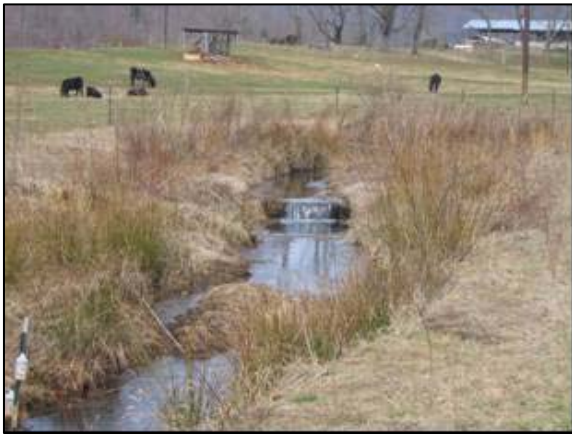
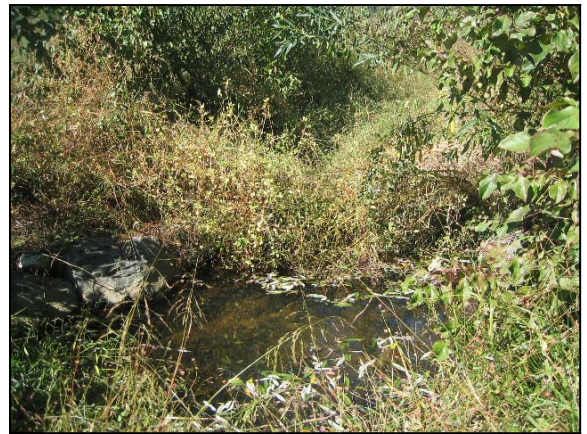
IP 33 Bed Elevation Drop (Above Study Reach)

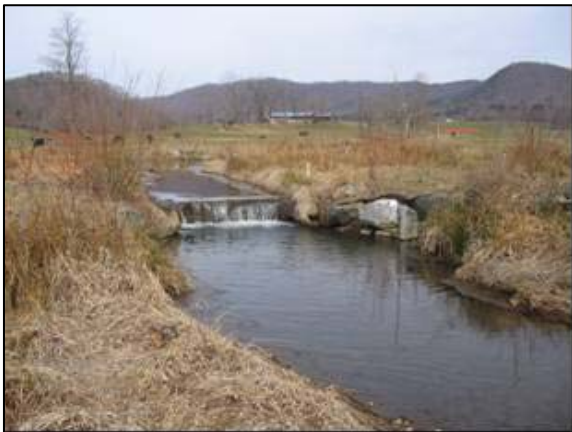
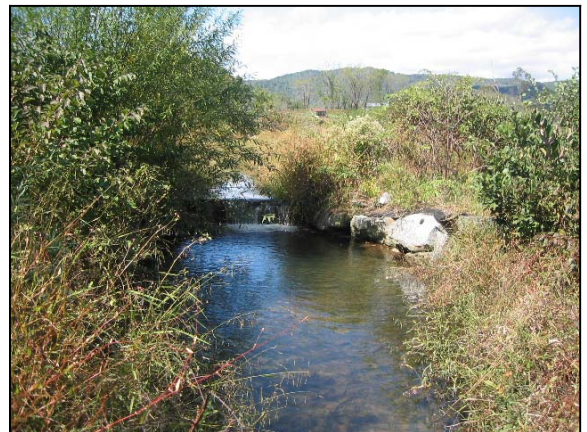
IP 34 Bed Elevation Drop (Below Study Reach)

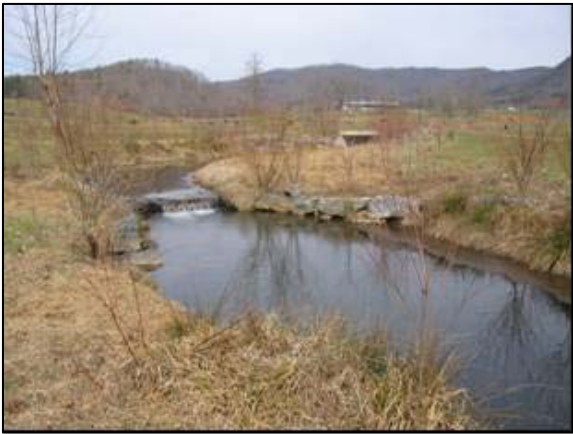
IP 36 Tile (Above Study Reach)

**Drain Tile could not be field located
Sept. 5, 2006**

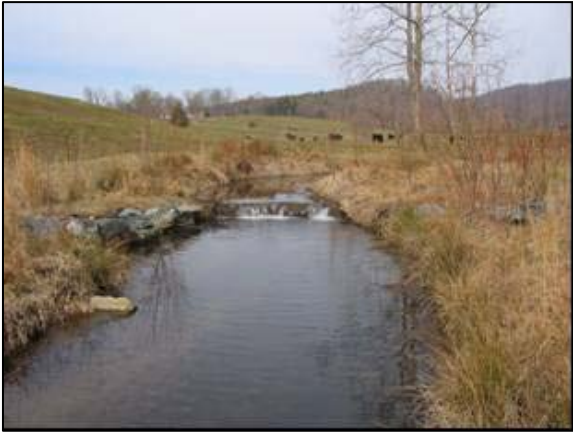
IP 39 Tile (Station 2+10)

**Drain Tile could not be field located
Sept. 5, 2006**

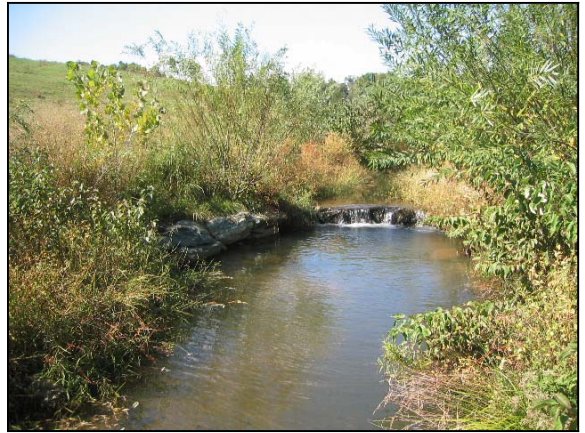
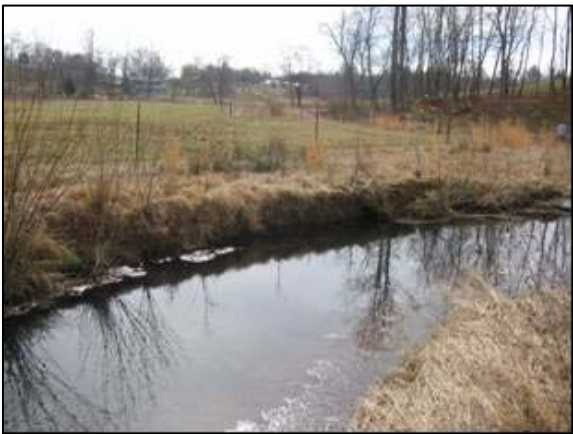
IP 40 Vane Undermine Rt. Arm (Station 3+50)

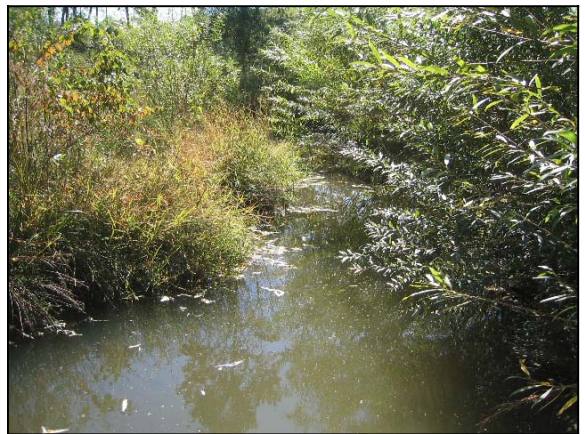
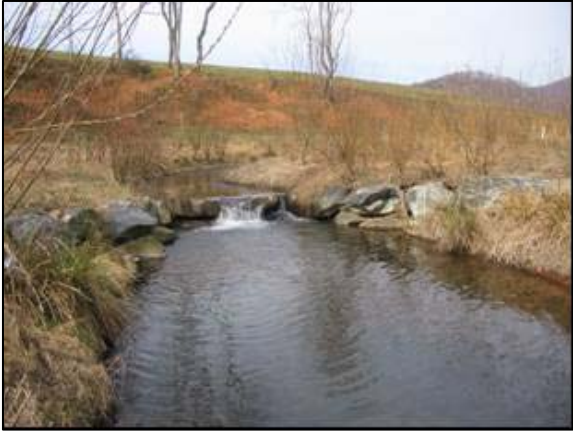
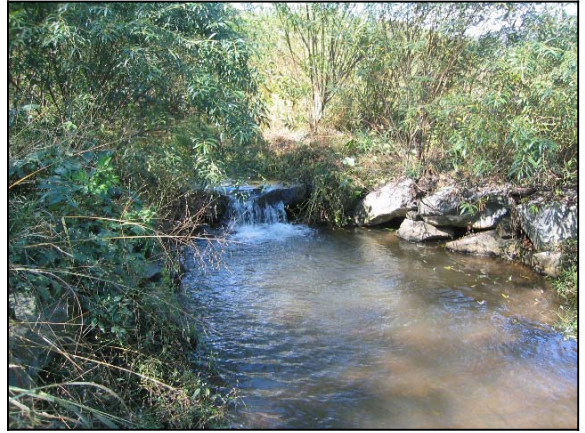
IP 41 Bank Erosion (Station 4+70)

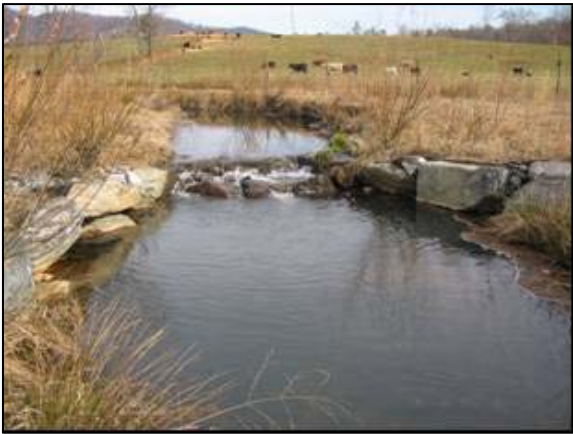
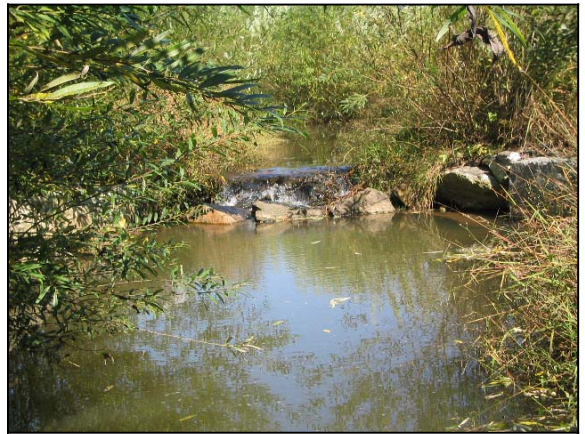
IP 42 Bed Elevation Drop (Station 4+70)

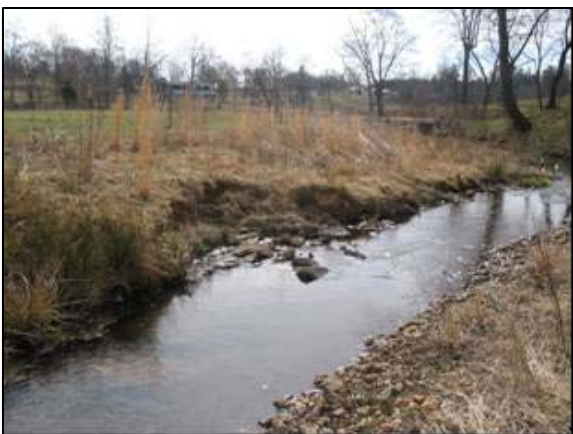
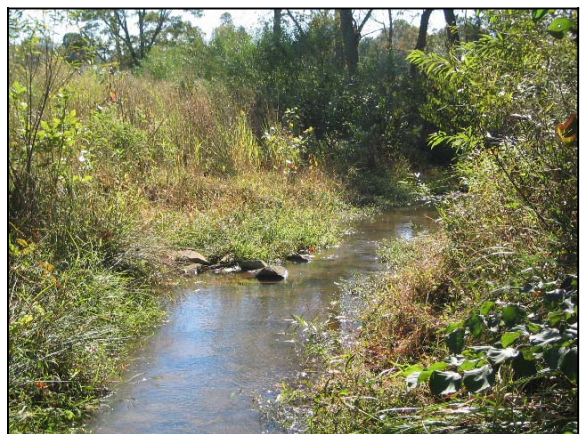
IP 43 Bed Elevation Drop (Station 6+00)
