Purlear Creek - Phase I Stream Restoration Annual Monitoring Report

Monitoring Year: 2008

NCEEP Project Number: 294

PURLEAR CREEK - PHASE I STREAM RESTORATION 2008 MONITORING REPORT

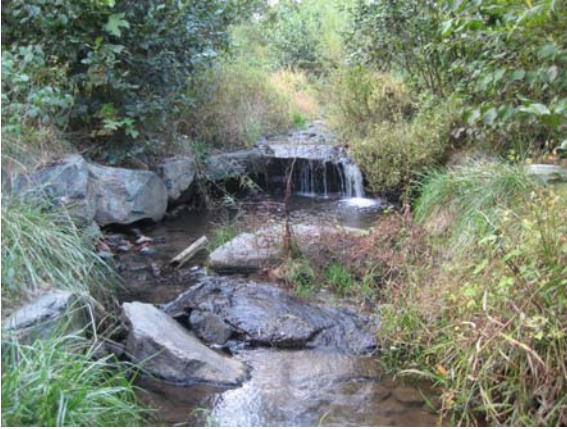
IP 1 Bed Elevation Drop and Loose Boulder (Upstream of Study Reach)

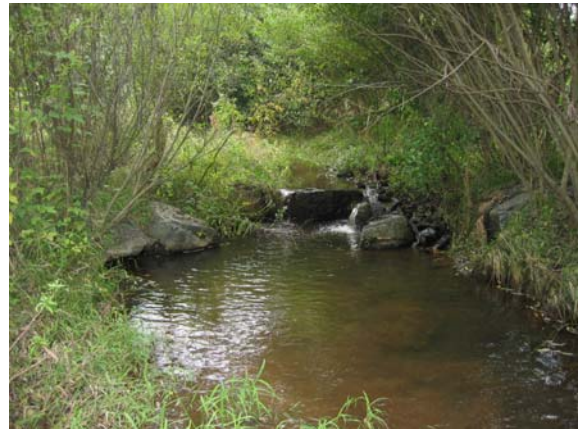
IP 5 Bed Elevation Drop and Piping at Left Arm (Station 0+89)

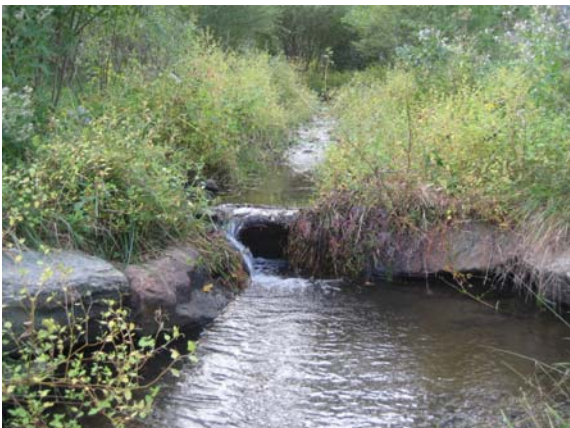
IP 7 Bed Elevation Drop (Station 5+50)

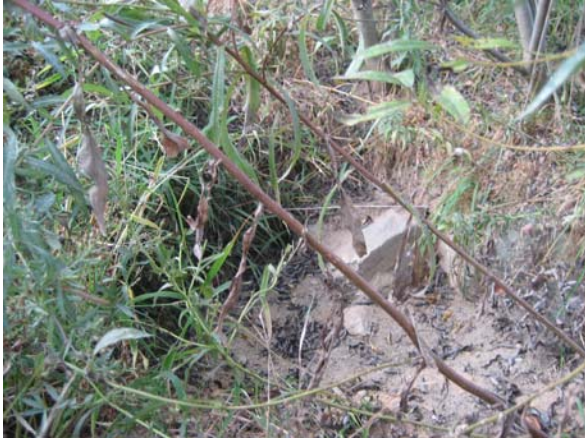
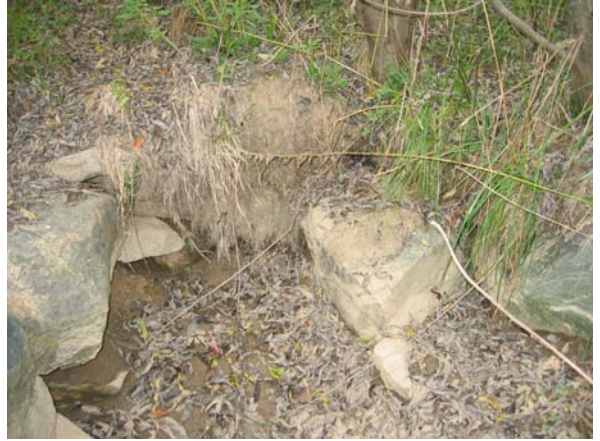
IP14a Piping through cross vane (Station 2+20) – Creek bed dry in 2007 and 2008

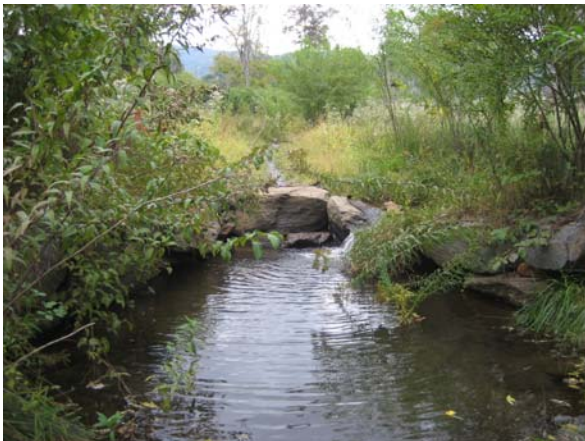
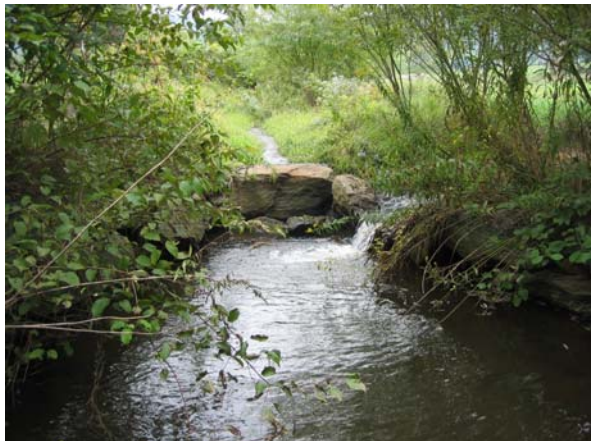
IP 18 Slump Arm (Station 0+00)

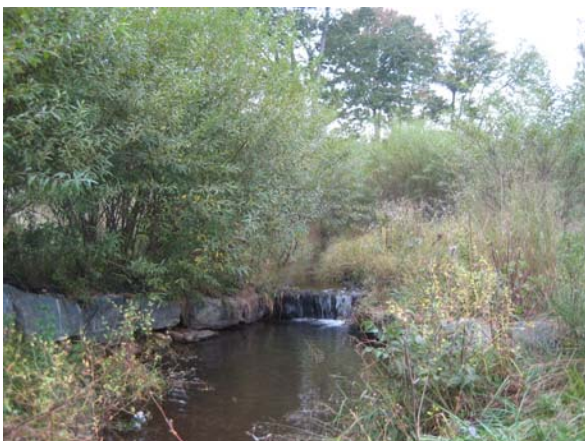
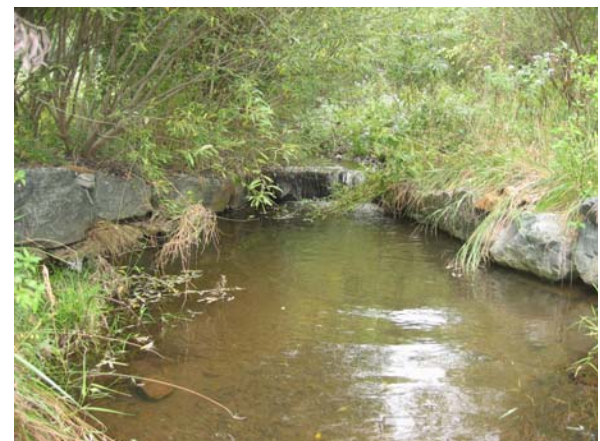
IP 19 Bed Elevation Drop (Station 2+77)

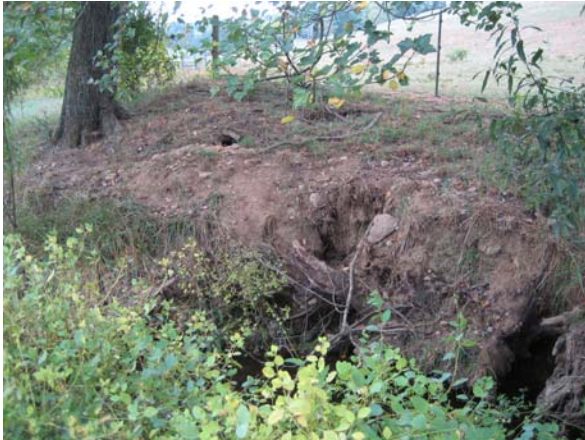
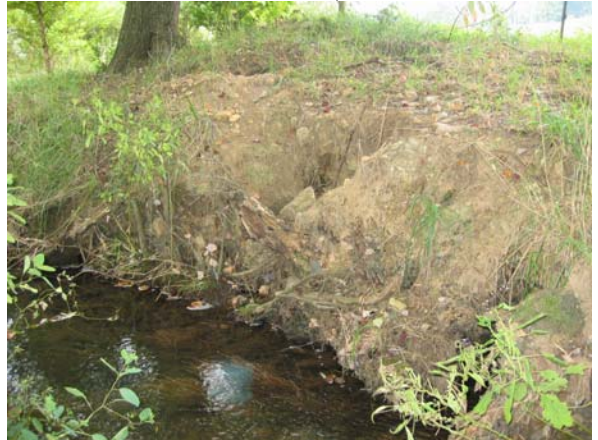
IP 20 Erosion Ground Hog Tunnels (Station 4+00)

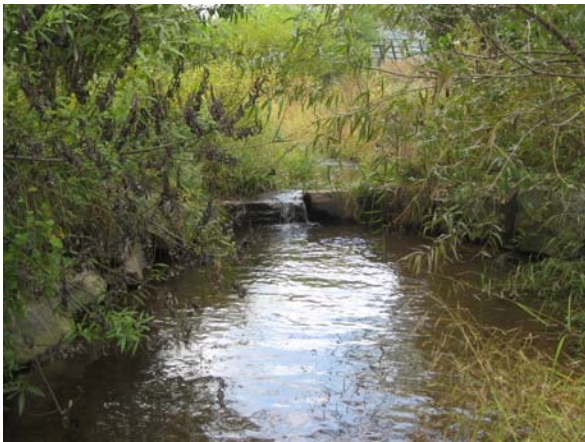
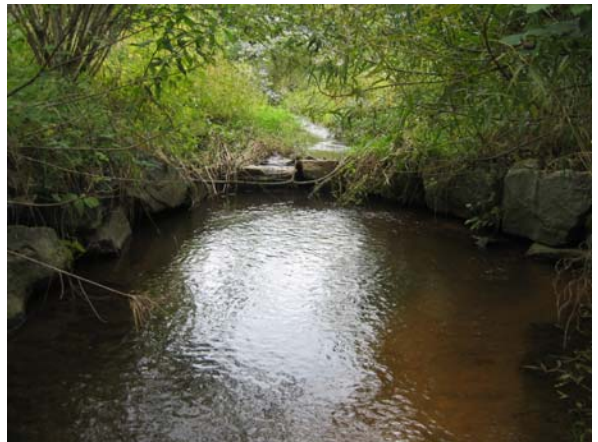
IP 21 Bed Elevation Drop and Piping Under Left Arm (Below Study Reach)

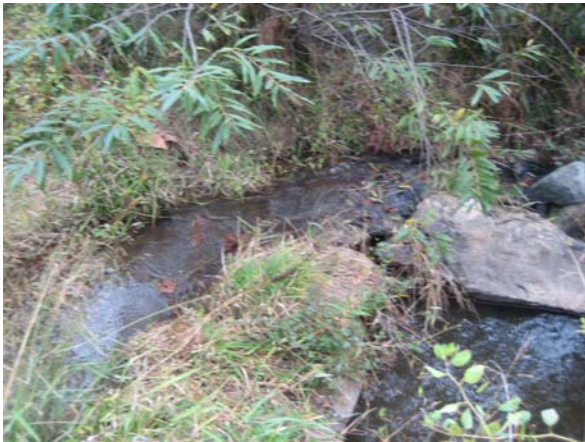
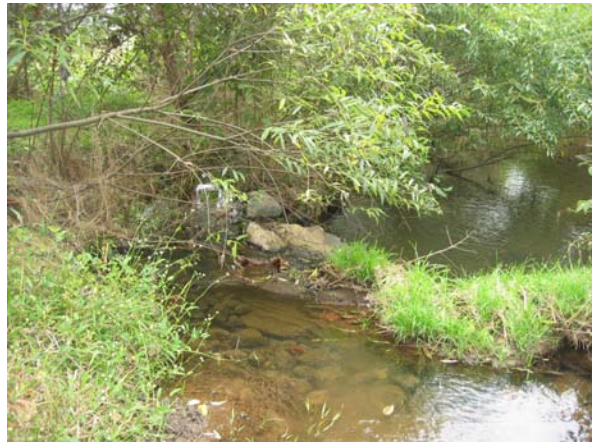
IP 22 Slump Arm and Piping (Below Study Reach)

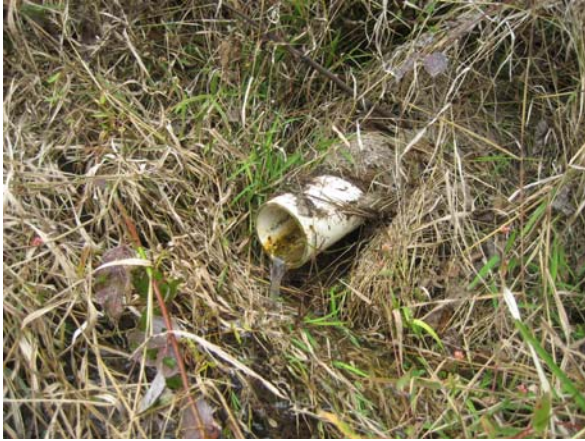
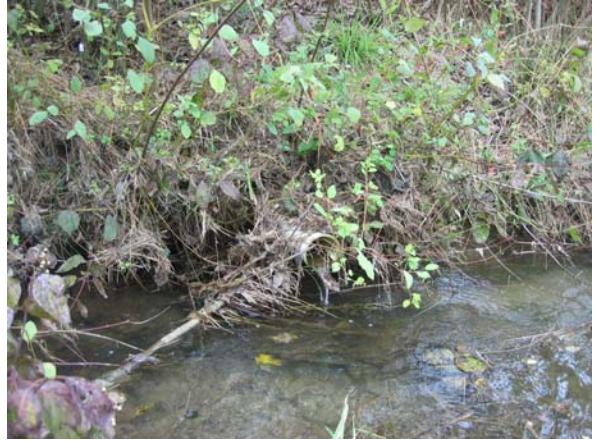
IP 36 Tile (Above Study Reach)

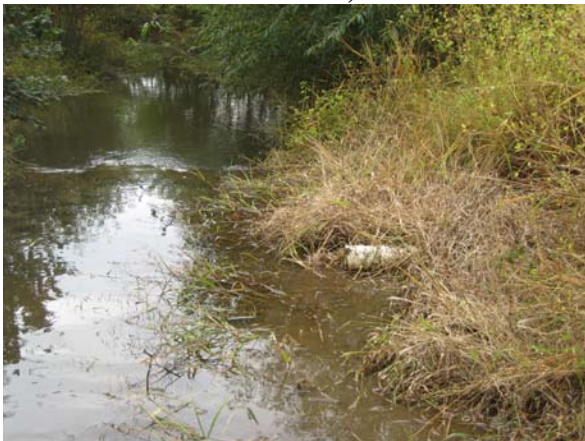
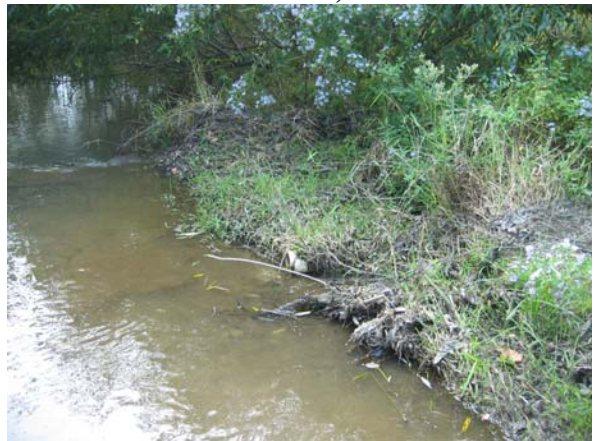
IP 39 Tile (Station 2+10)
