## **Russell Gap Stream Mitigation Project Year 3 (2022) Monitoring Report FINAL**

DMS Project ID No. 100003, DEQ Contract No. 6980 USACE Action ID No. SAW-2017-00826, DWR# 20150416 Alexander County, North Carolina, Catawba River Basin: 03050101-120010 MY3 Data Collection Period: January – October 2022

**INTERNATIONAL** Submission Date: February 2023

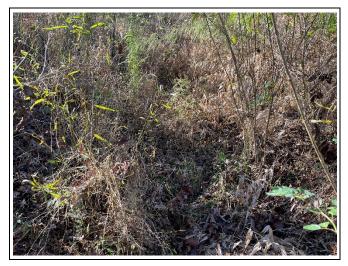
PP-1: Reach 13, view upstream Station 10+20. (November 8, 2022)

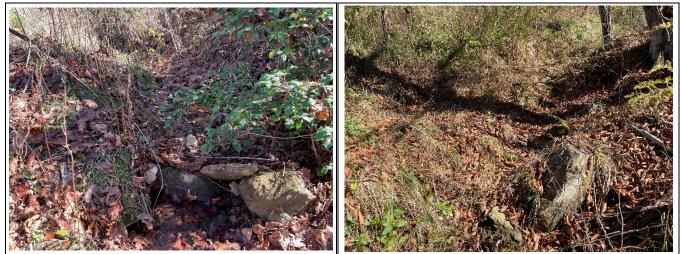
PP-55: Reach 25, view upstream at Station 11+20. (November 8, 2022)

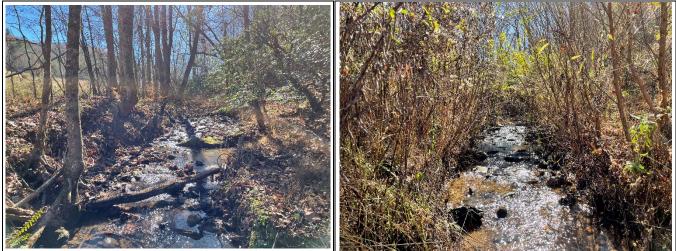
PP-61: Reach 8, view upstream at Station 38+00. (November 8, 2022)

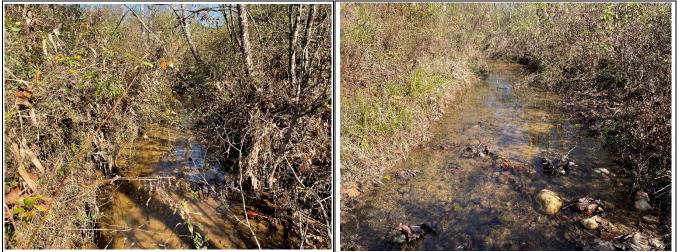
PP-67: Reach 4, view upstream at Station 11+10. (November 8, 2022)

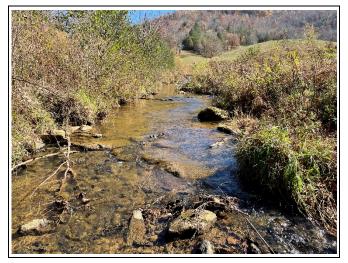
PP-81: Reach 3, view upstream at Station 36+40. (November 8, 2022)

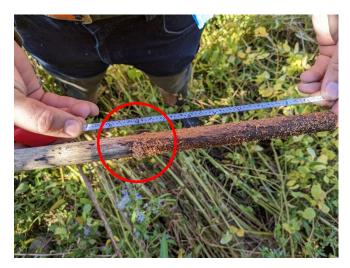
Crest Gauge 2 R9. BKF reading 8.25 inches (October 14, 2022)
