# **Russell Gap Stream Mitigation Project Year 1 (2020) Monitoring Report FINAL**

DMS Project ID No. 100003, DEQ Contract No. 6980

MY1 Data Collection Period: September – November 2020

Submission Date: December 2020

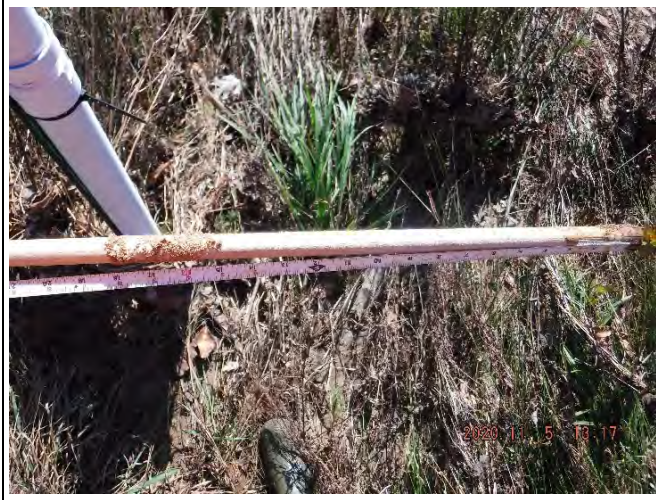
Crest Gauge 1 R1.

BKF reading 18". (November 5, 2020)

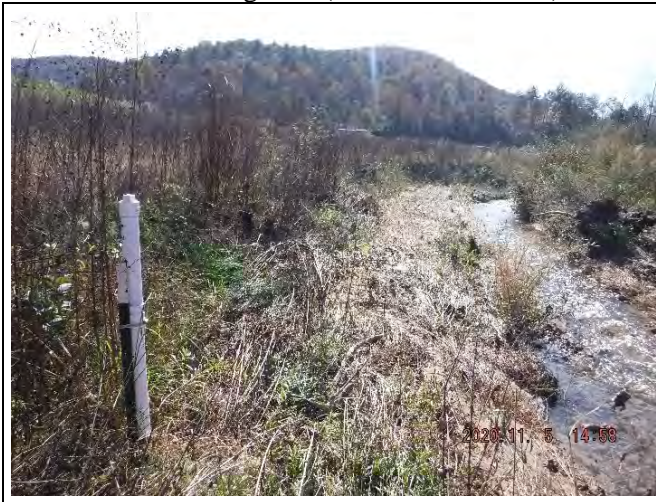
Crest Gauge 3 R4. Wrack lines. (November 5, 2020)

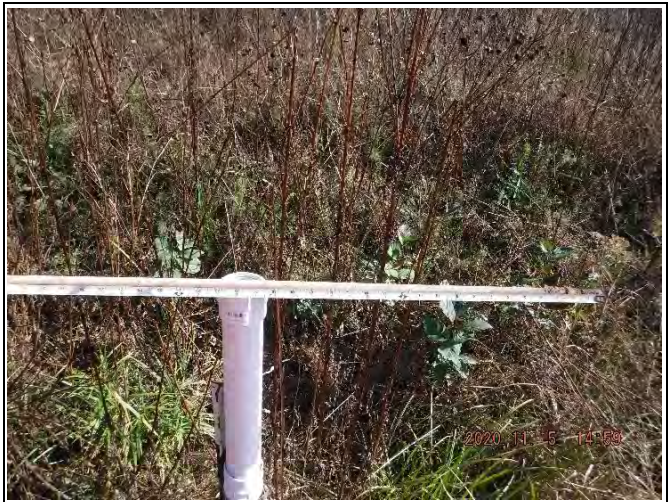
Crest Gauge 3 R4. BKF reading at 26" and 30." (November 5, 2020)
