Russell Gap Stream Mitigation Project Year 2 (2021) Monitoring Report FINAL

DMS Project ID No. 100003, DEQ Contract No. 6980

Alexander County, North Carolina, Catawba River Basin: 03050101-120010

MY2 Data Collection Period: January – October 2021

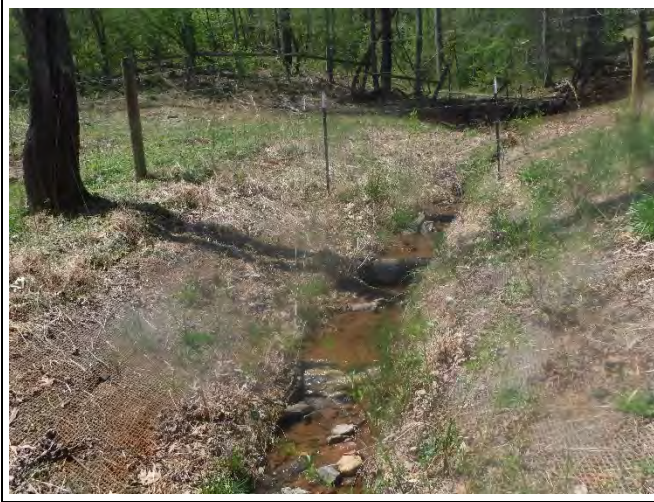
PP-1: Reach 13, view upstream Station 10+20.
(April 15, 2021)

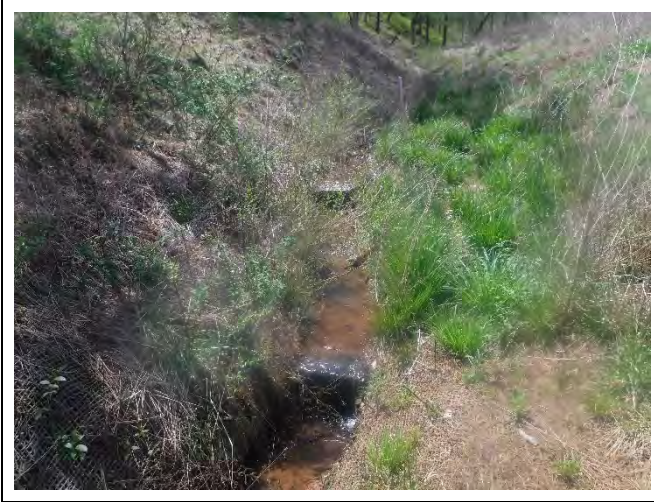
PP-3: Reach 14, view upstream Station 13+00.
(April 15, 2021)

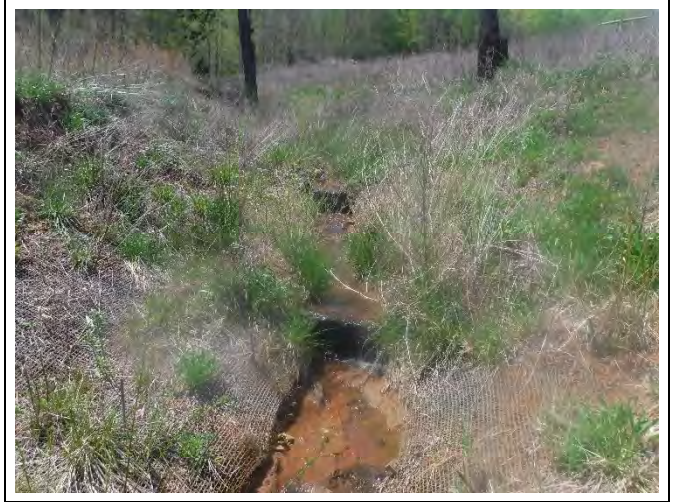
PP-4: Reach 14, view upstream Station 13+75.
(April 15, 2021)

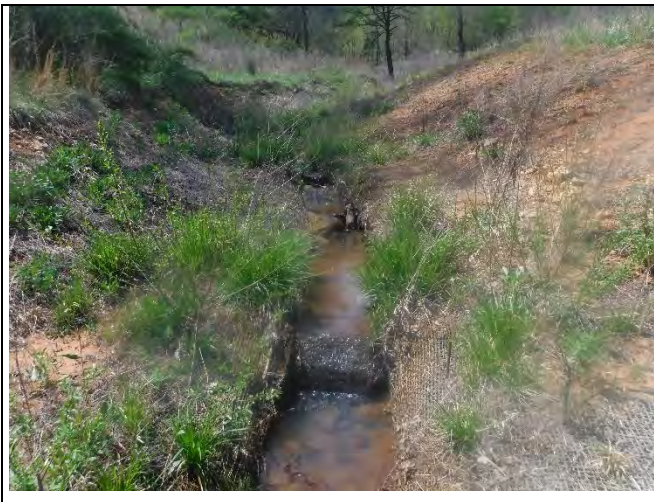
PP-5: Reach 14, view upstream Station 15+00.
(April 15, 2021)

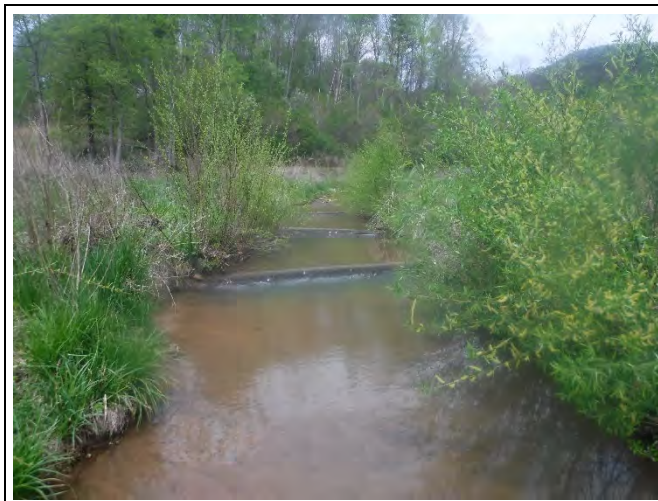
PP-8: Reach 1, view upstream Reach 1 at Station 13+00.
(April 15, 2021)

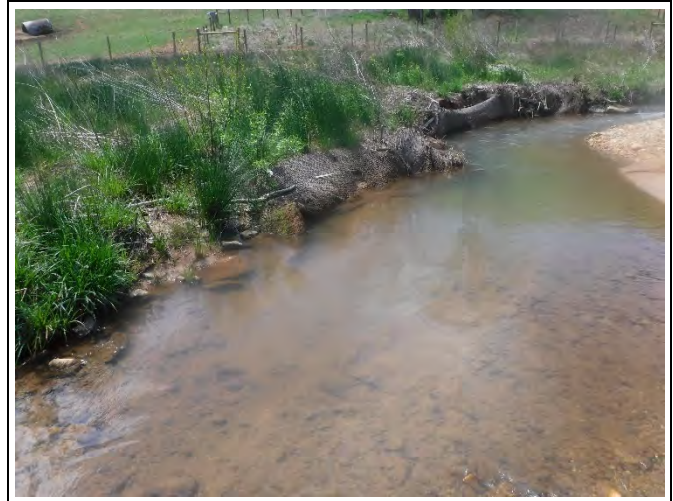
- The outer bend upstream of the R11 and R1 confluence had erosion and there were concerns of future alignment problems. Baker indicated that live staking and manual repairs would occur and be discussed in the MY2 report. Please update report with discussion on this issue. If erosion is still present, please update CCPV and Table 5.

PP-16: Reach 1, confluence of Reach 1 and Reach 11 at
Station 22+75. (April 15, 2021)

Response: Live stakes were installed on the right bank of R1 at SPA-1 (shown on CCPV) at the end of the 2021 growing season. Matting that had been displaced during flooding was repaired and re-staked. Live vegetation that had fallen into R11 was cut back to allow for flow in the design channel as to not undermine the right bank of R1 at SPA-1.

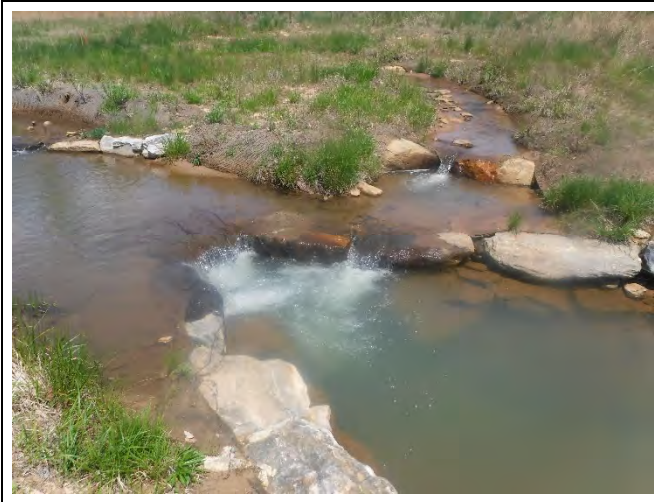
PP-19: Reach 1, view upstream Reach 12 at Station 29+10.
(April 15, 2021)

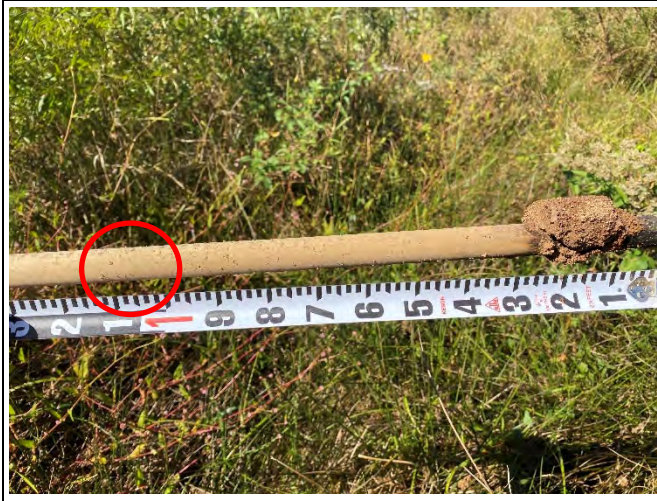
Crest Gauge 1 R1.

BKF reading 1.1 ft. (October 19, 2021)

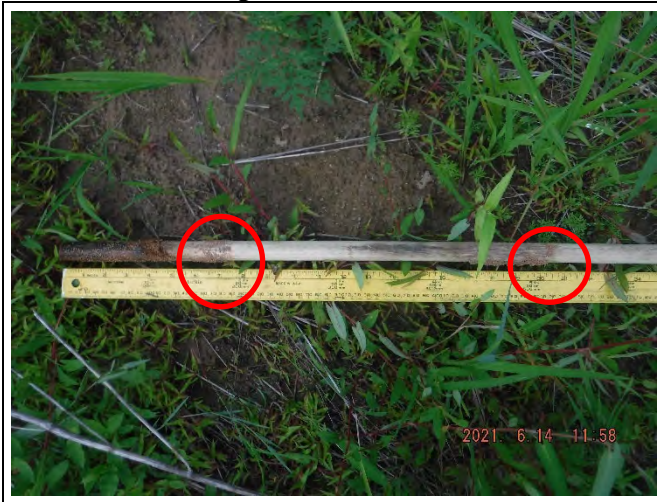
Crest Gauge 3 R4. BKF reading at 7.5 inches and 20.5 inches (June 14, 2021)
