CHARLES WILLIAMS STREAM, WETLAND, AND BUFFER SITE
DMS Project No. 80

MONITORING YEAR 4 (2016)
Construction Completed February 2013
Planting Completed February 2014

Randolph County, NC
State Construction Project No. 07-07125-01A

November 2016

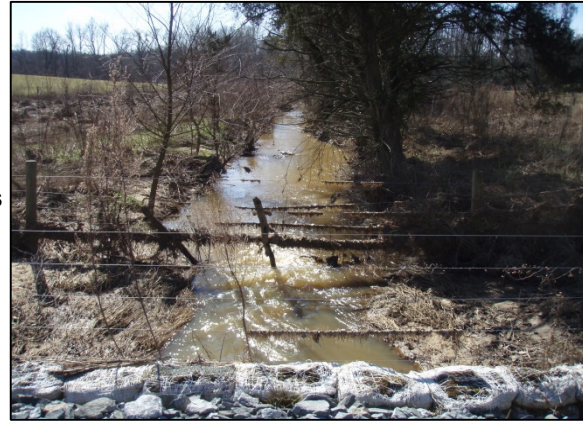
1. Wrack at High Elevation, Documented 18 Feb. 2016

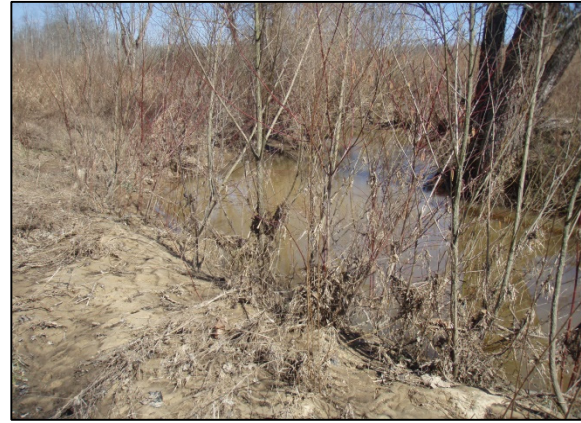
2. Overbank Wrack and Scour, Documented 18 Feb. 2016

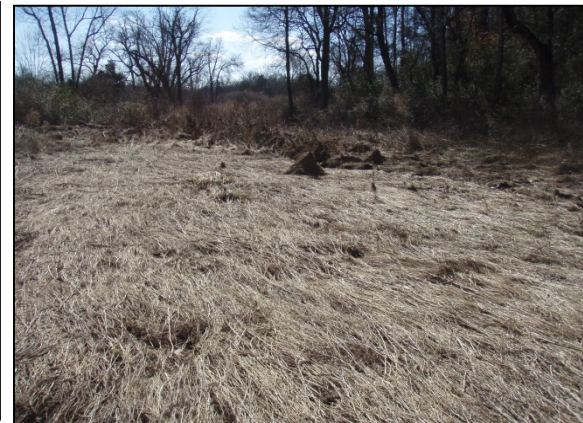
3. Flattened Vegetation Outside Channel, Documented 18 Feb. 2016

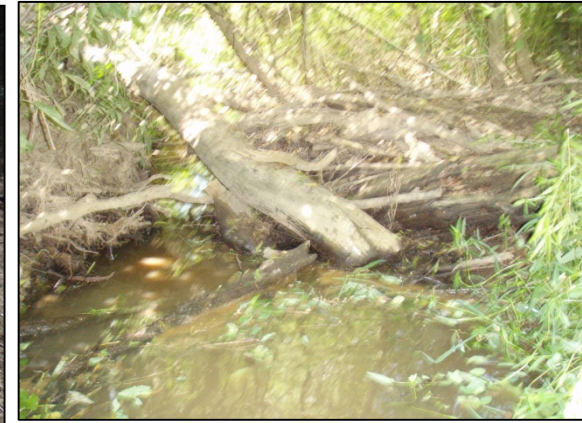
4. Log Jam Documented 20 July 2016

Table 12. Verification of Bankfull Events Charles Williams Stream, Wetland, and Buffer Site / 80 - UT to Sandy Creek: 1,850 linear feet			
Date of Data Collection	Date of Occurrence	Method	Photo # (if available)
11/6/2013	unknown	Crest Gauge	Not Available
3/6/2014	unknown	Visual On-site (wrack)	Not Available
9/16/2014	unknown	Crest Gauge	Not Available
4/17/2015	4/17/2015	Visual On-site (active overbank event)	Not Available
6/30/2015	unknown	Visual On-site (wrack, sediment staining, alluvial deposits)	Not Available
2/18/2016	unknown – likely caused by beaver dam breach	Visual On-site (wrack, sediment staining, alluvial deposits, flattened vegetation)	Overbank 1,2,3
7/20/2016	unknown	Visual On-site (log jam from previous high flow event)	Overbank 4

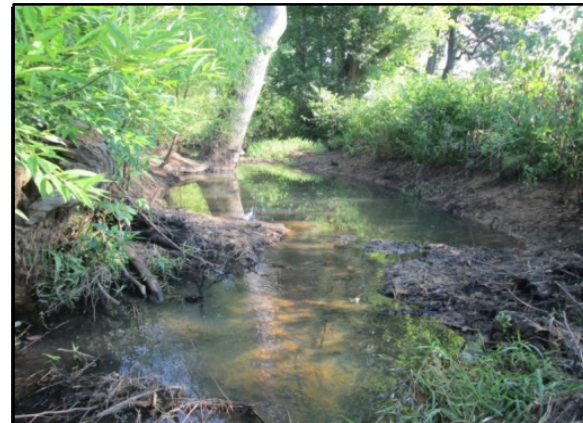
1. Breached Beaver Dam, 30 June 2015

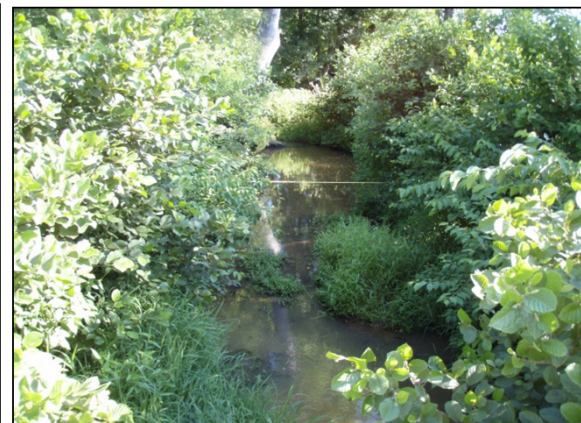
2. Site of Previous Beaverdam, Not Reconstructed as of 19 July 2016

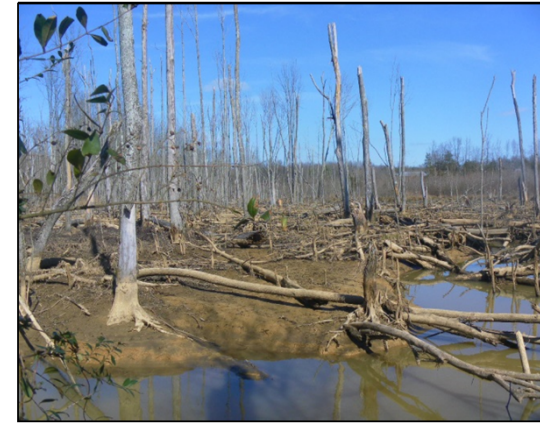
4. Breached Beaver Impoundment Upstream of Project, 18 Feb. 2016

Large beaver dam at upstream end of project was breached in late MY 3 or early MY 4, resulting in sediment deposition in pools downstream. No information whether cause was intentional/human or accidental/natural.
