**Shadrick Creek Restoration Project**  
**Annual Monitoring/Closeout Report**

Monitoring Year 5 of 5

Shadrick Creek Stream Restoration Project  
NCDMS Contract No. 7343  
NCDMS Project No. 92916  
DWR# 10-0465v2  
USACE Action ID: 2010-00764  
McDowell County, North Carolina  
Data Collected: April 2022 – November 2022  
Date Submitted: December 2022

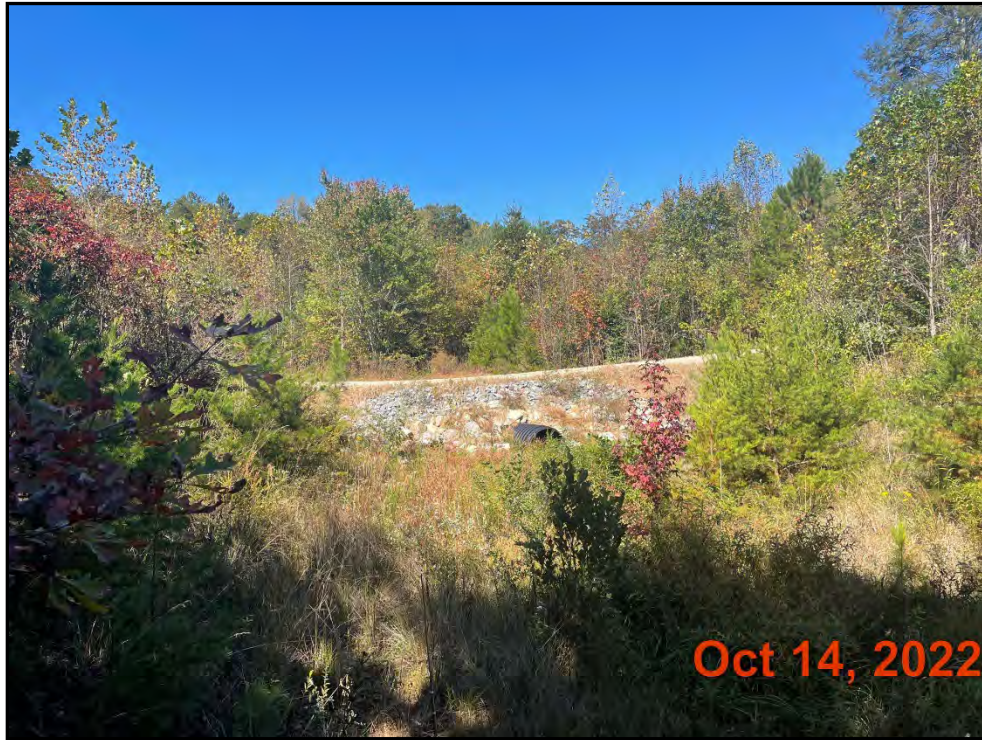
UT-1 – Permanent Photo Station 1  
Looking Upstream

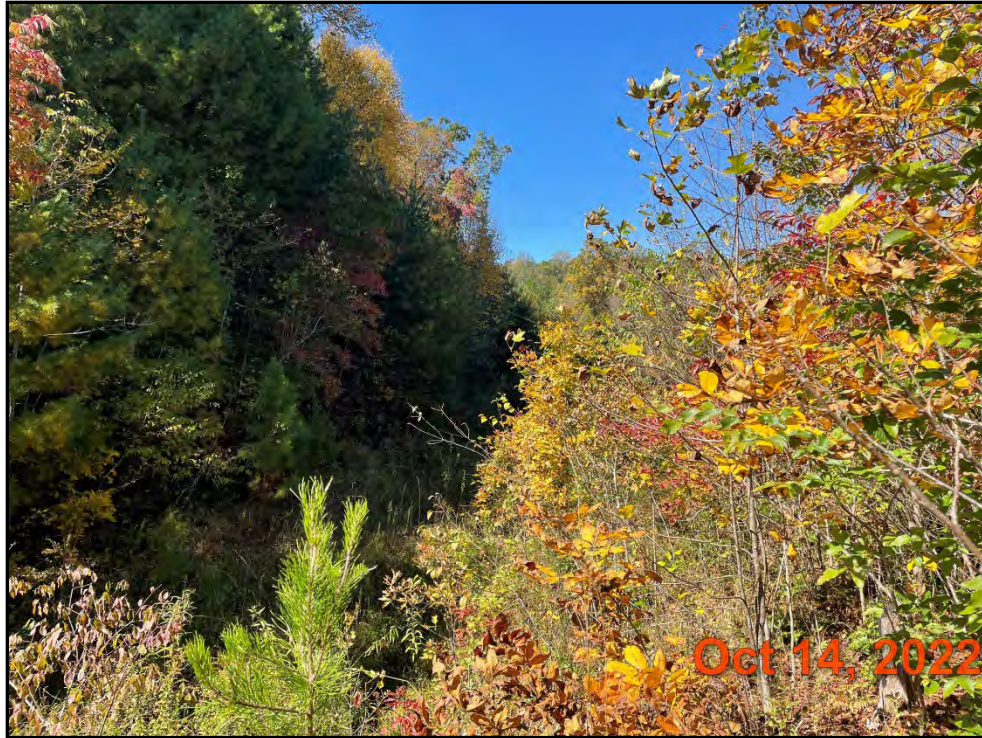
UT-1 – Permanent Photo Station 2  
Looking Upstream

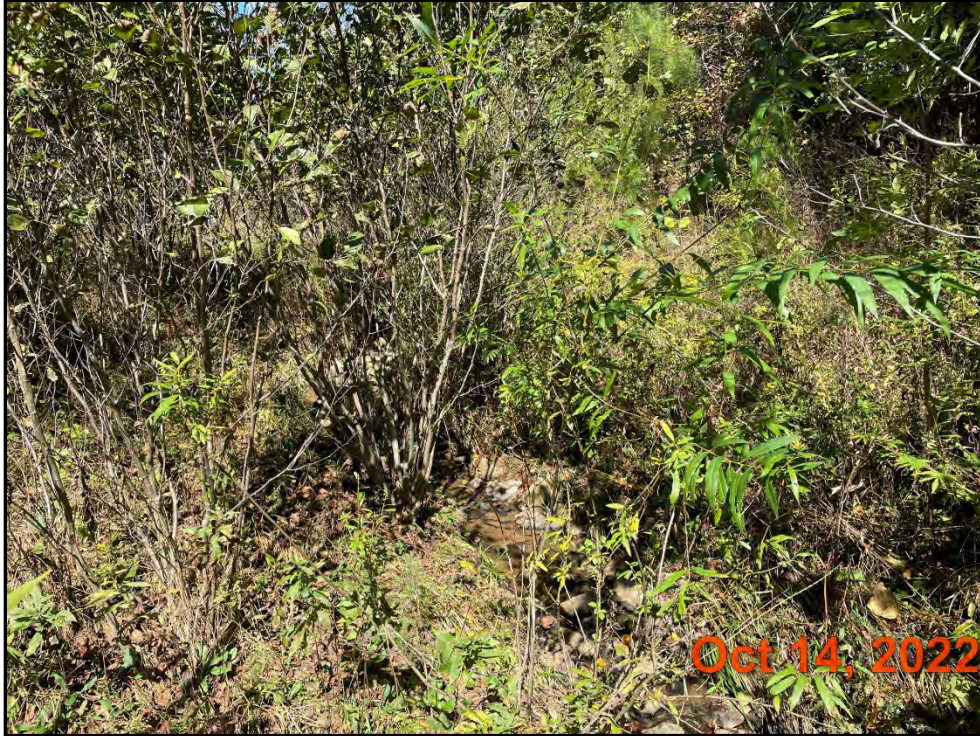
UT-1 – Permanent Photo Station 3  
Looking Upstream

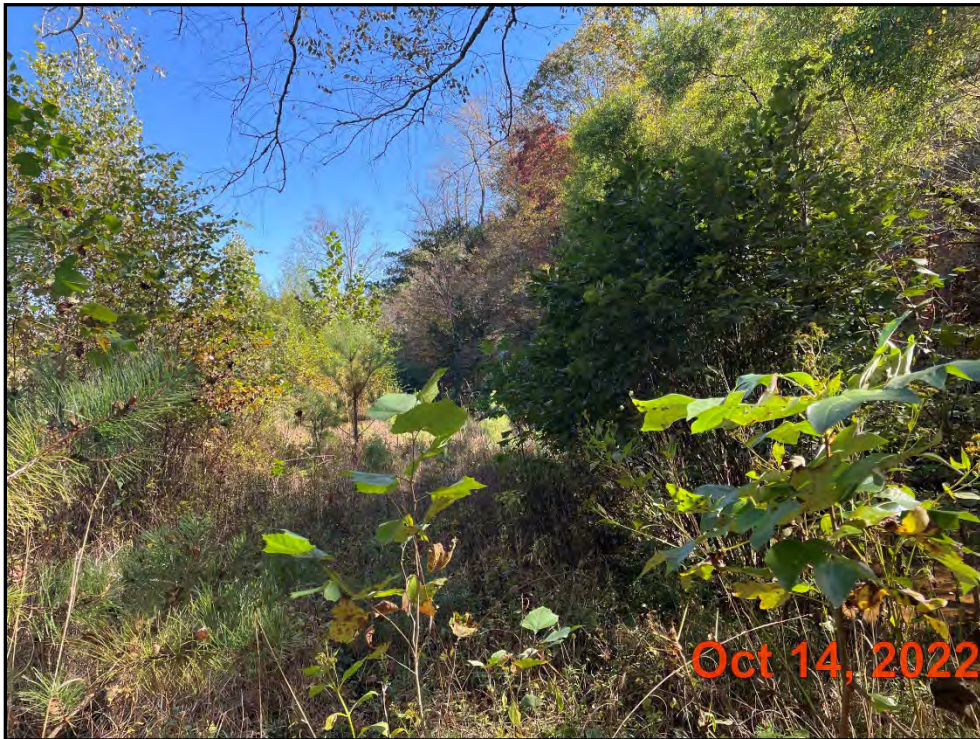
Shadrick Creek Reach 1 – Permanent Photo Station 4  
Looking Downstream

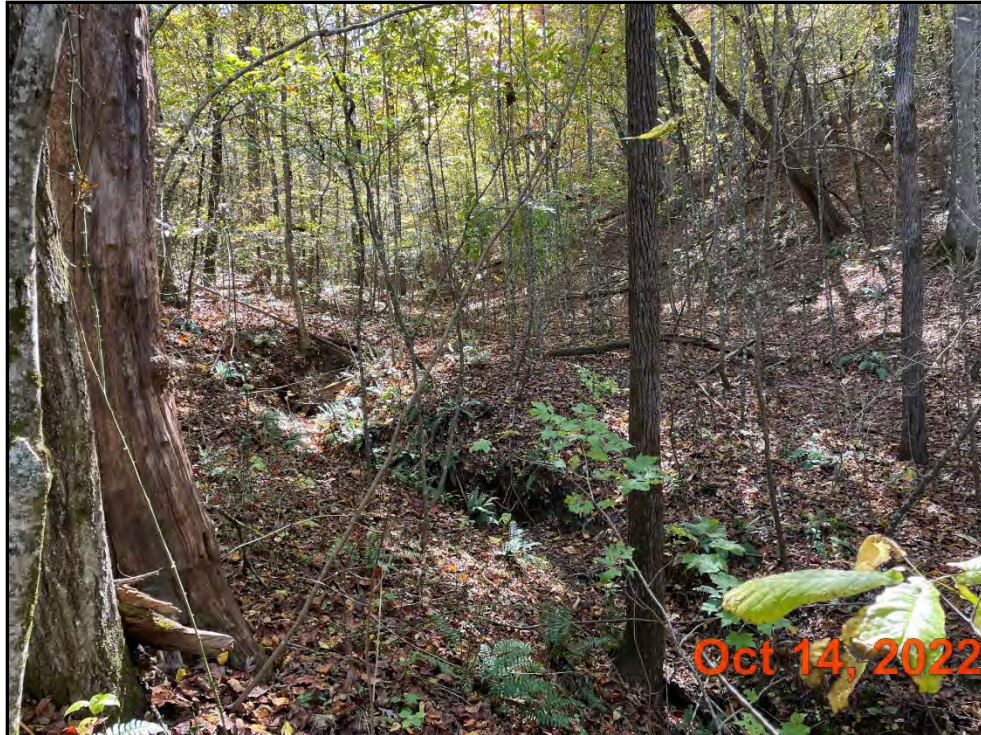
UT-6 – Permanent Photo Station 5  
Looking Upstream

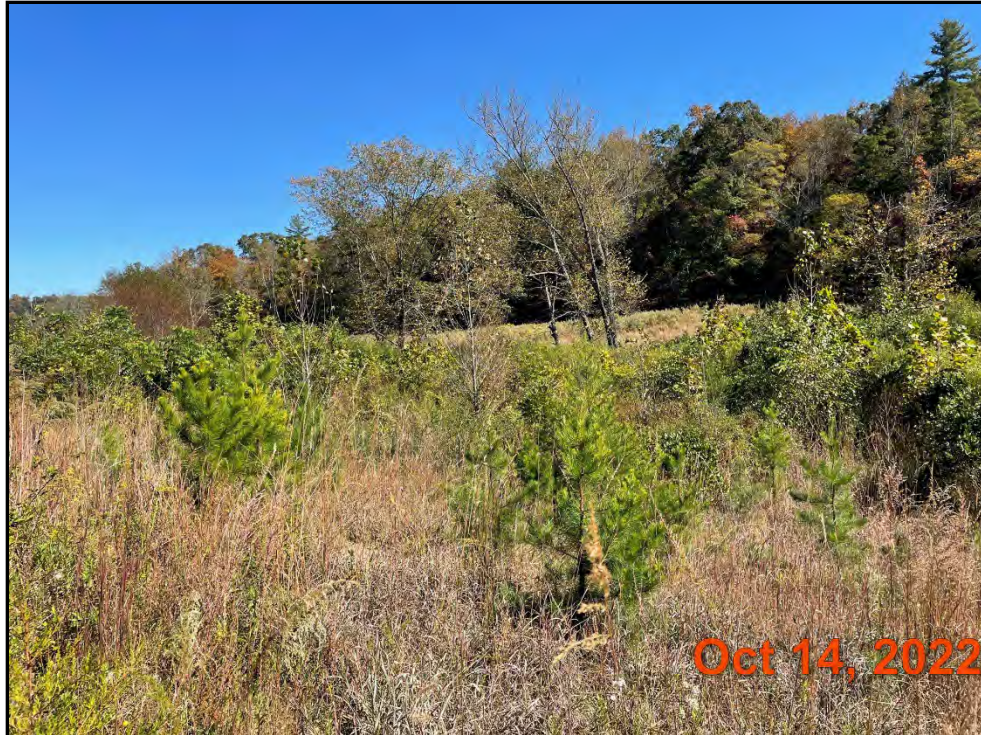
Shadrick Creek Reach 1 – Permanent Photo Station 6  
Looking Downstream

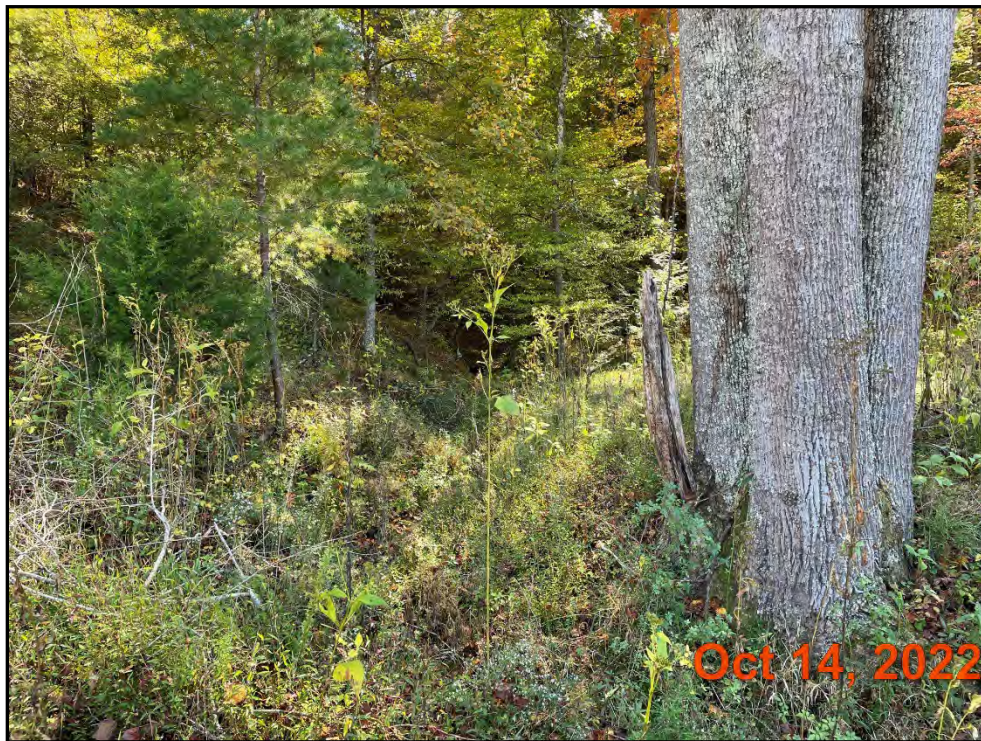
UT-5 – Permanent Photo Station 7  
Looking Upstream from Crossing

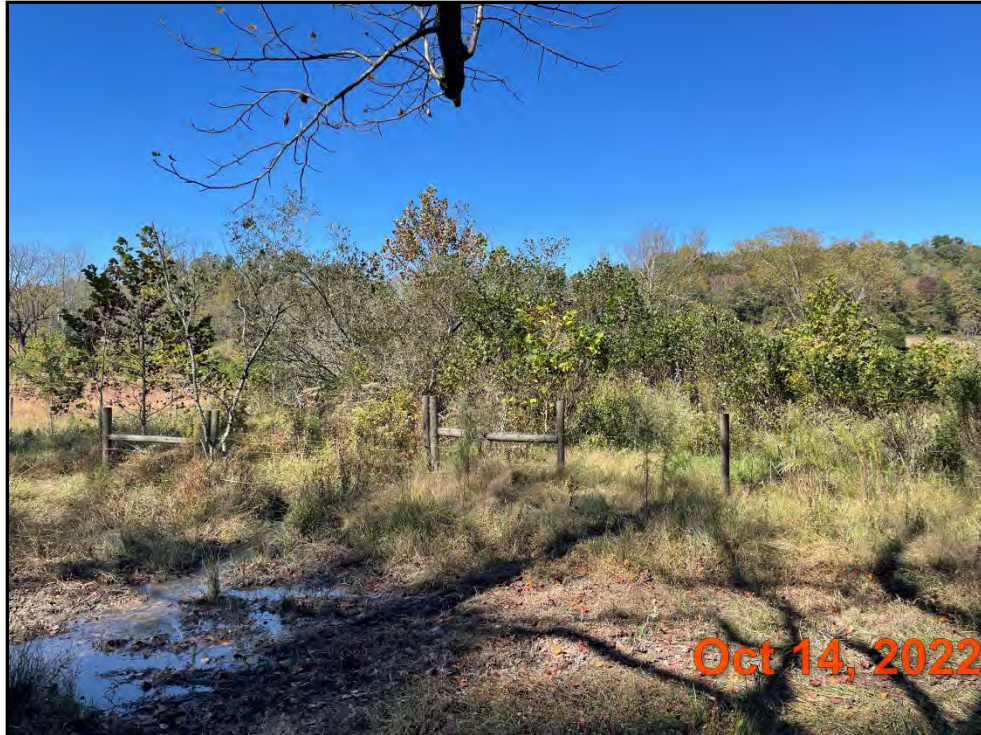
UT-5 – Permanent Photo Station 7  
Looking Downstream from Crossing

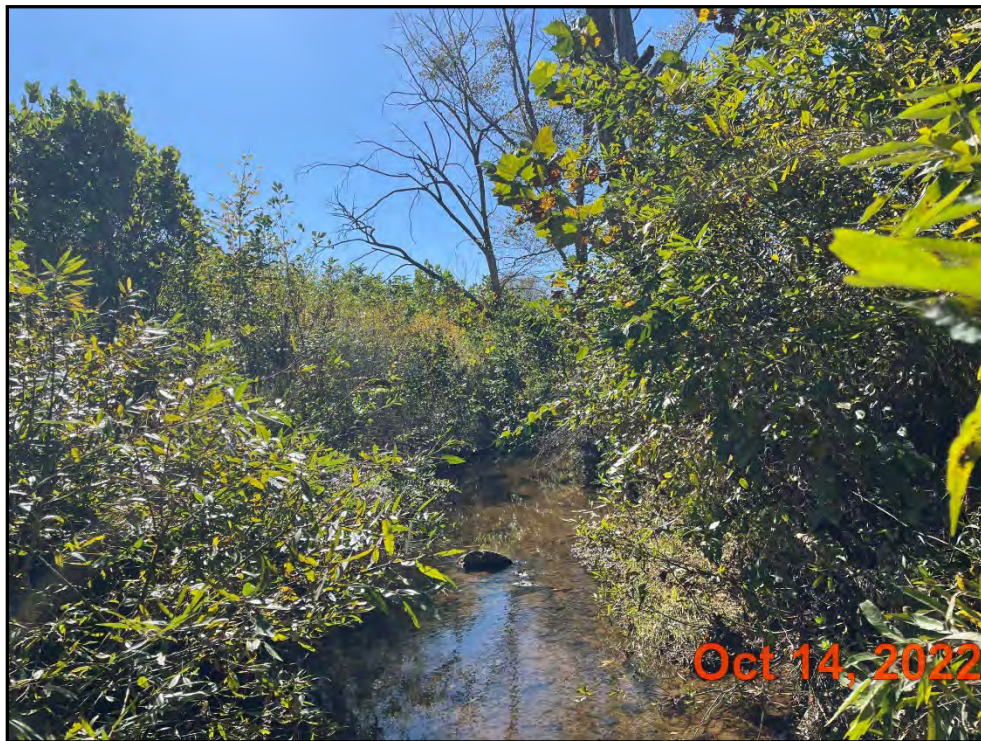
Shadrick Creek Reach 1 – Permanent Photo Station 8  
Looking Upstream from Cross-Section 4

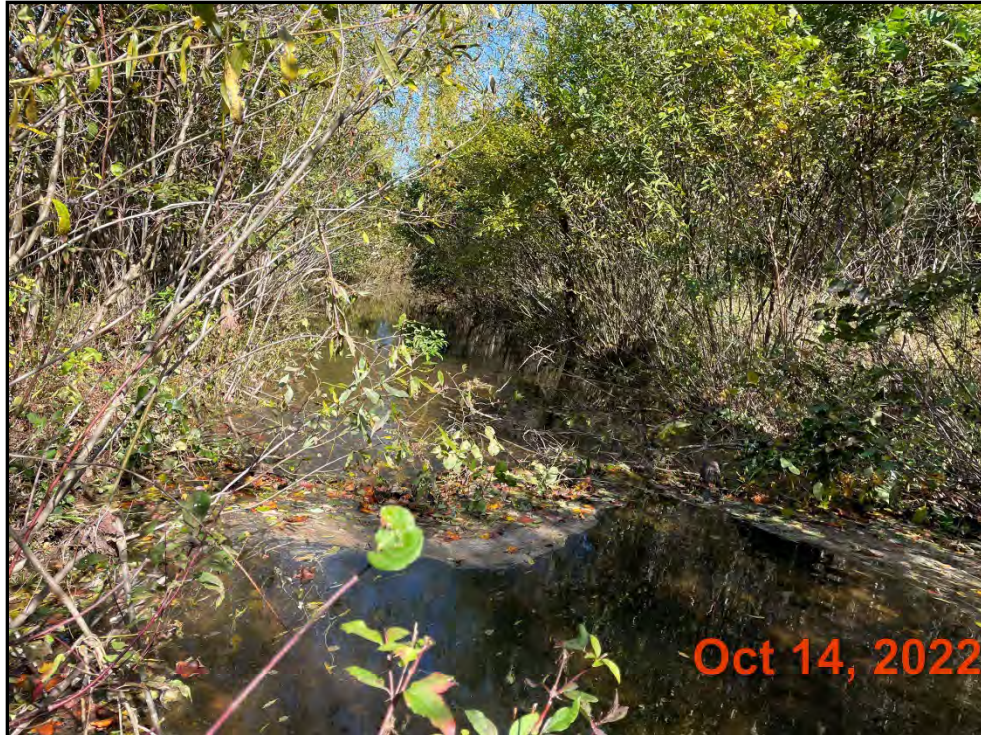
Shadrick Creek Reach 1 – Permanent Photo Station 8  
Looking Downstream from Cross-Section 4

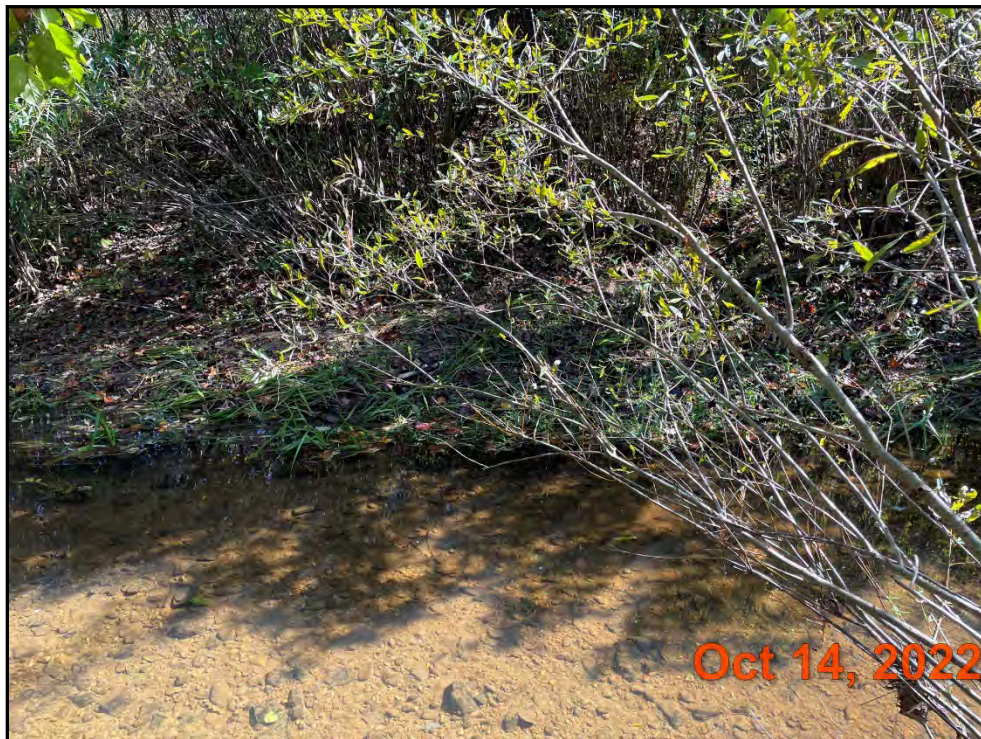
Shadrick Creek Reach 1 – Permanent Photo Station 9  
Looking Upstream at UT-2

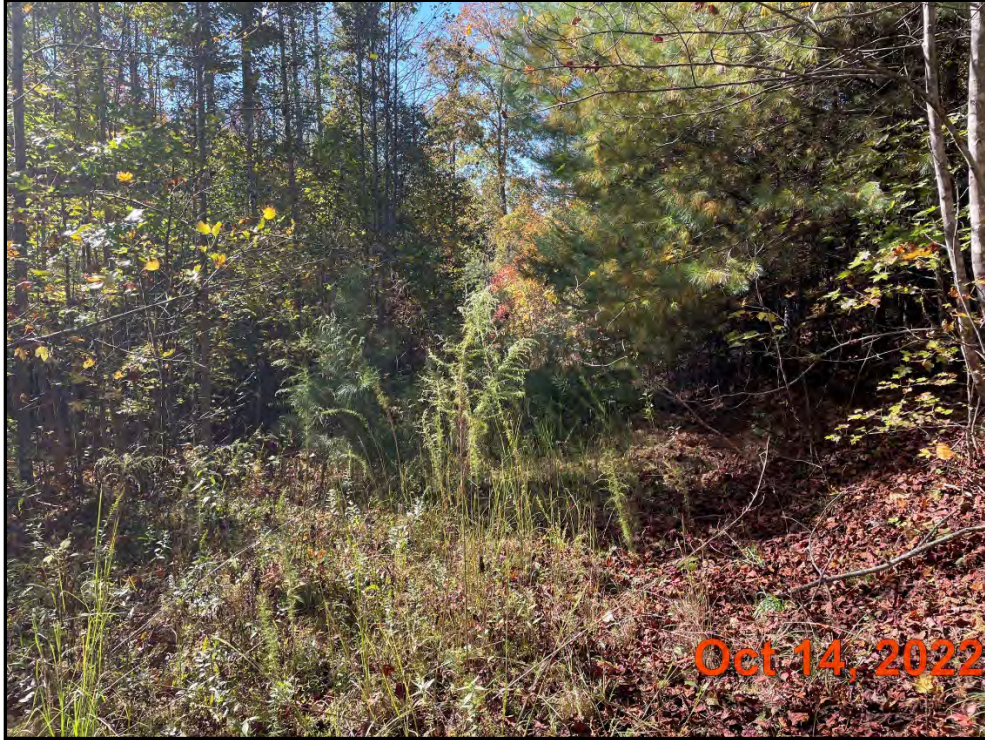
UT-2 - Permanent Photo Station 10  
Looking Downstream at Easement

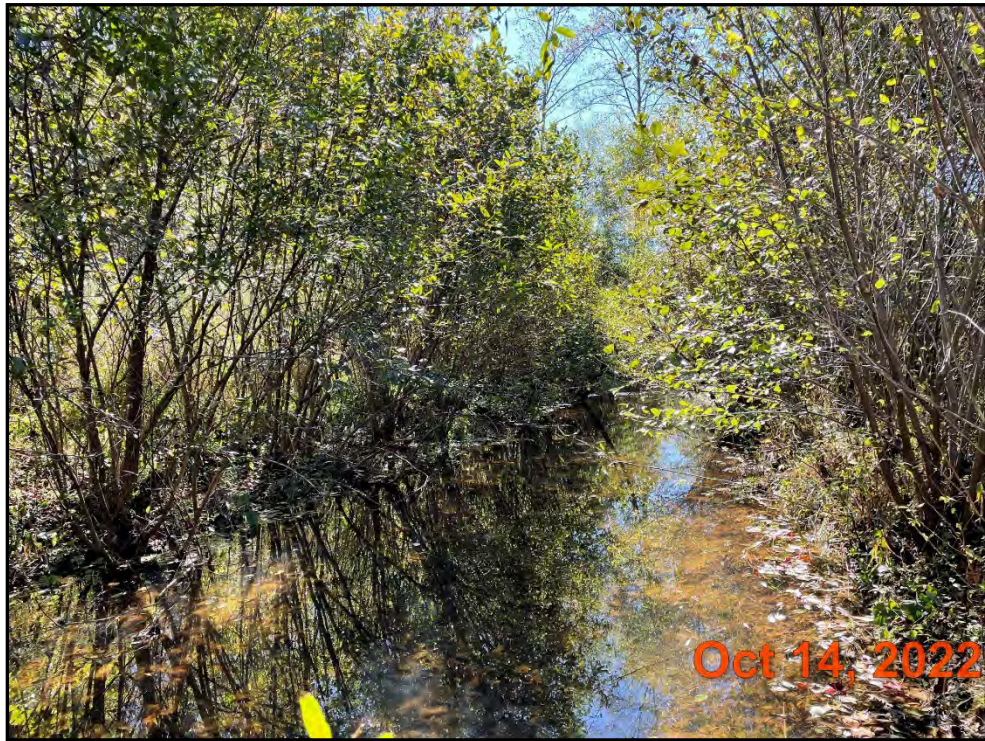
Shadrick Creek Reach 1 – Permanent Photo Station 11  
Looking Upstream from Cross-Section 6

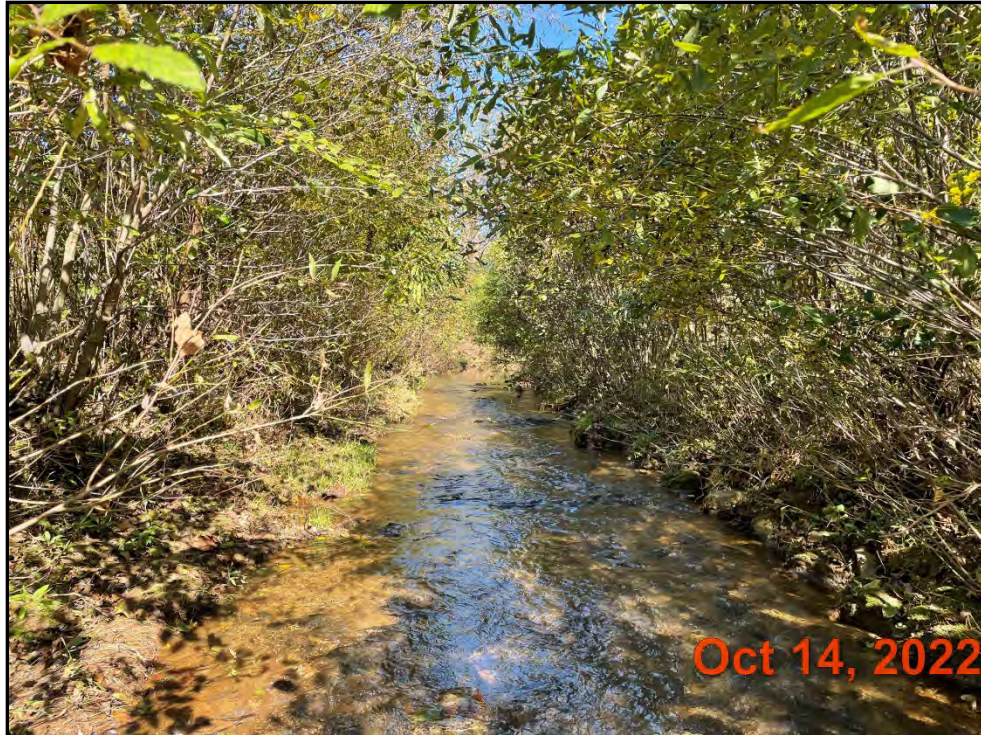
Shadrick Creek Reach 1 – Permanent Photo Station 11  
Looking Downstream from Cross-Section 6

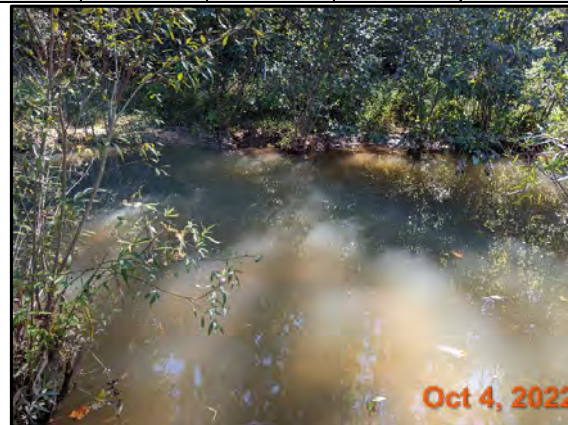
**XS Number:** 7  
**XS Type:** Riffle

**\* Cross section not surveyed due to beaver impoundment**

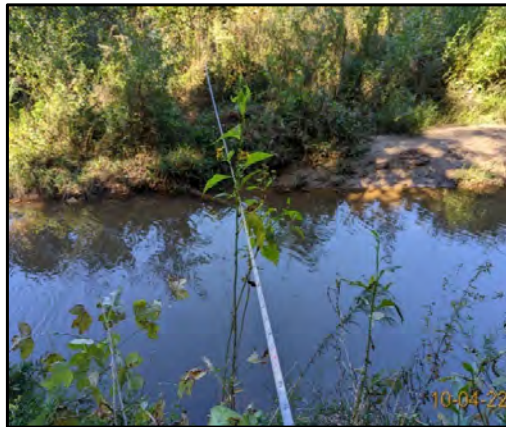
XS Number: 8  
 XS Type: Pool

\* Cross section not surveyed due to beaver impoundment

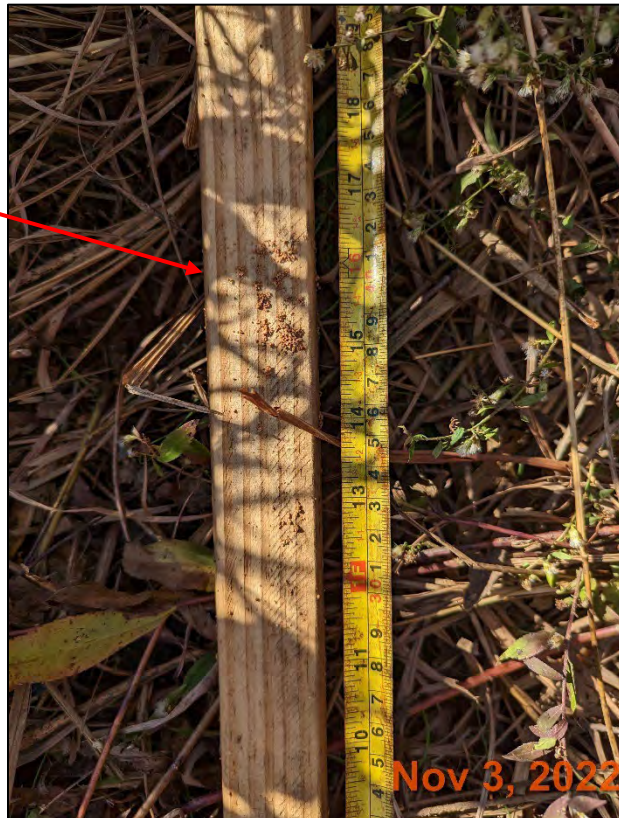
Photo #2 – Shadrick Creek Reach 3 Crest Gauge at 1.3 feet (Recorded ~bankfull)
