Shadrick Creek Restoration Project

Annual Monitoring Report

Monitoring Year 2 of 5

Shadrick Creek Stream Restoration Project

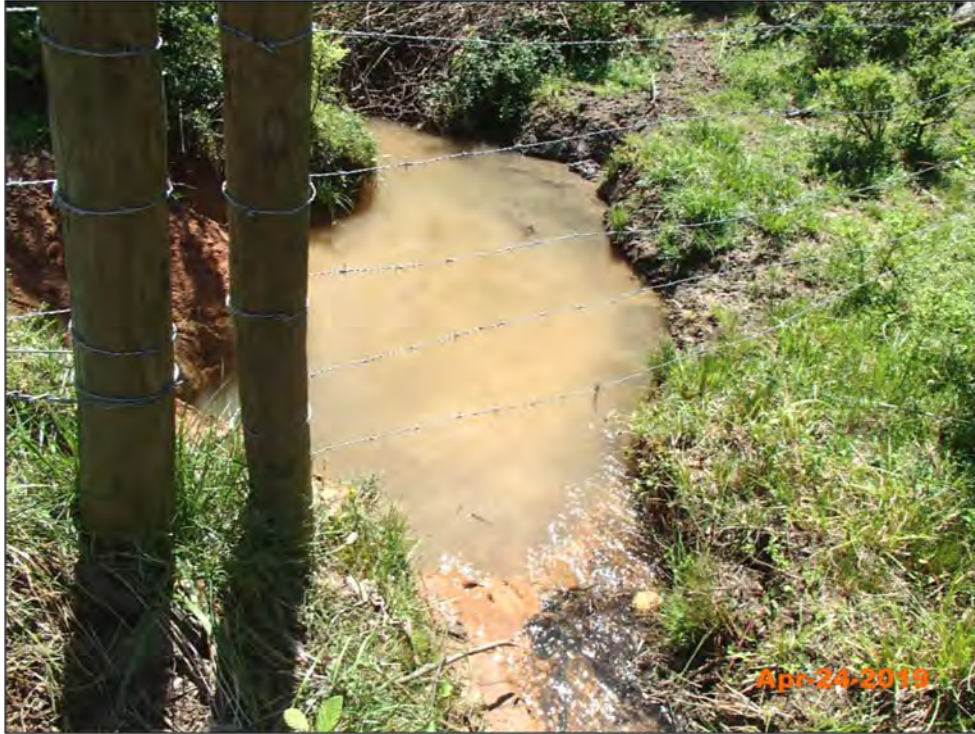
UT1– Bank Erosion Station 29+50

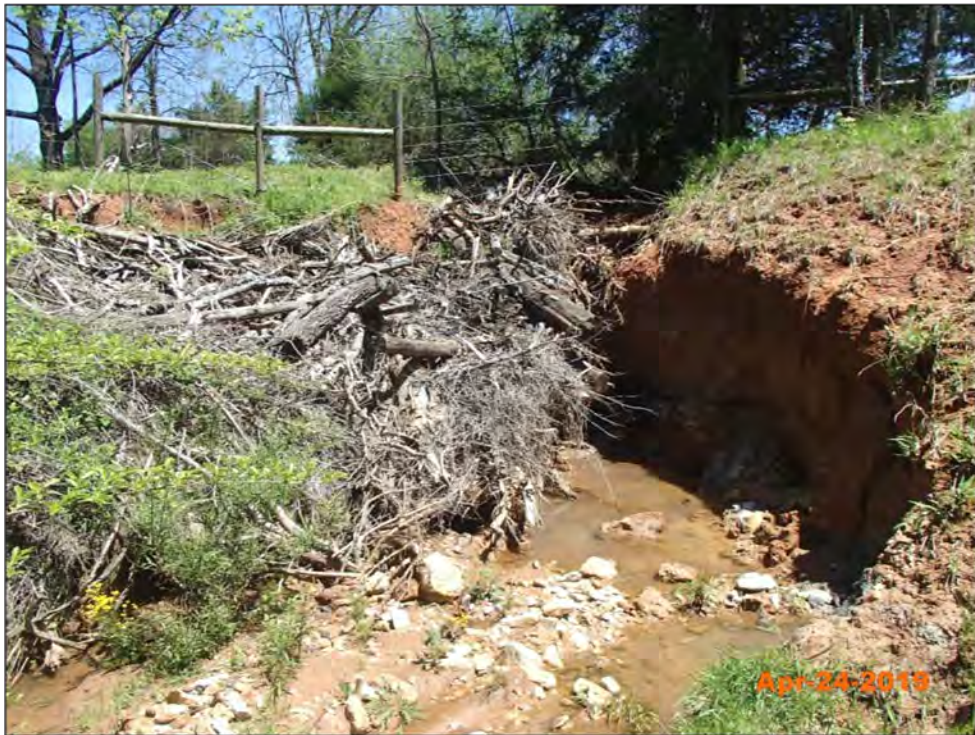
UT 9 – Evidence of cattle bypass
