Shadrick Creek Restoration Project

Annual Monitoring Report

Monitoring Year 3 of 5

McDowell County, North Carolina

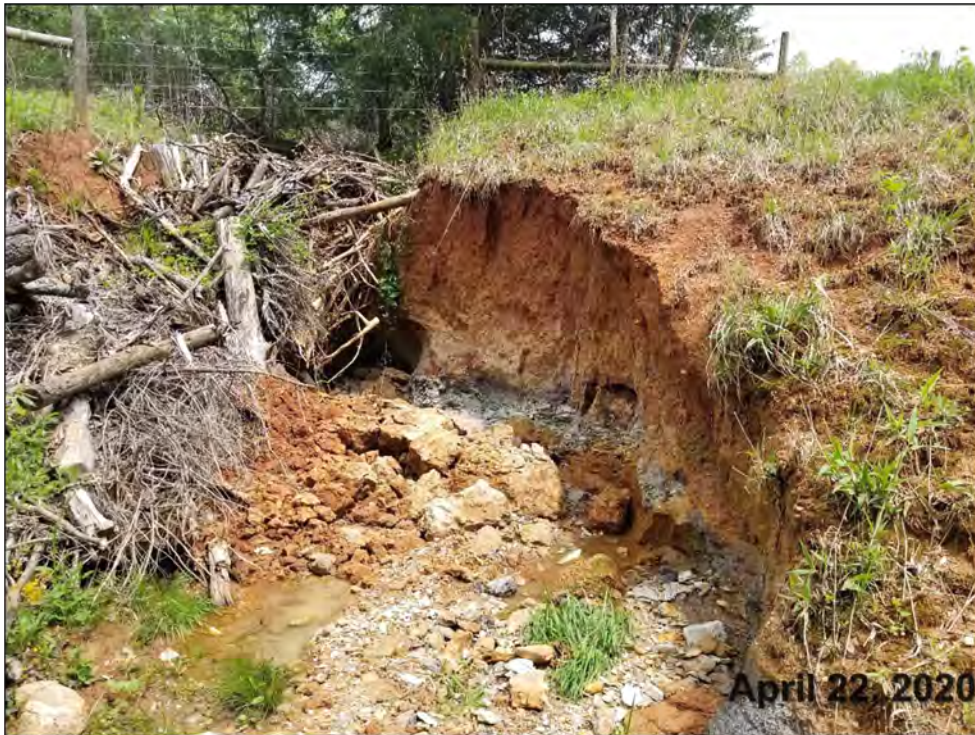
An approximately 10ft long headcut was documented as mass wasting at the farthest upstream extent of UT10 (Table 5, Figure 2 CPPV). This headcut is migrating towards the easement boundary. DMS has contracted with an engineer to develop a repair plan to be implemented in the Winter of 2021. This repair will be documented in the MY4 report and photos.

UT 10 – Headcut

- For UT10, please add discussion that DMS has contracted with an engineer to develop a repair plan for the UT10 headcut. This repair will occur in winter 2021. The repair will be documented in the MY4 report and photos. **Text and discussion of headcut added.**
