# MONITORING YEAR 3 ANNUAL REPORT

## SHAKE RAG MITIGATION SITE

Madison County, NC

DMS Project No. 100018

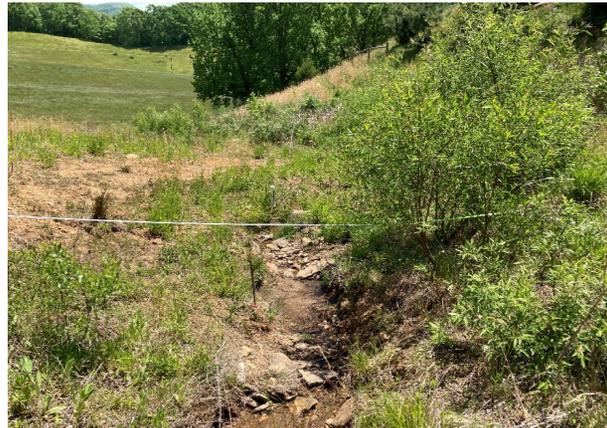
#### Cross-Section 3-UT3 Reach 2

Note: Survey captures MY3 repairs with current low top of bank
