MONITORING YEAR 4 ANNUAL REPORT

SHAKE RAG MITIGATION SITE

Madison County, NC
DEQ Contract No. 7190
DMS Project No. 100018
USACE Action ID No. SAW-2017-01570
DWR Certification No. 17-1157
RFP# 16-006991 (September 16, 2016)

Data Collection Period: January – October 2023
Draft Submission Date: November 30, 2023
Final Submission Date: January 4, 2024

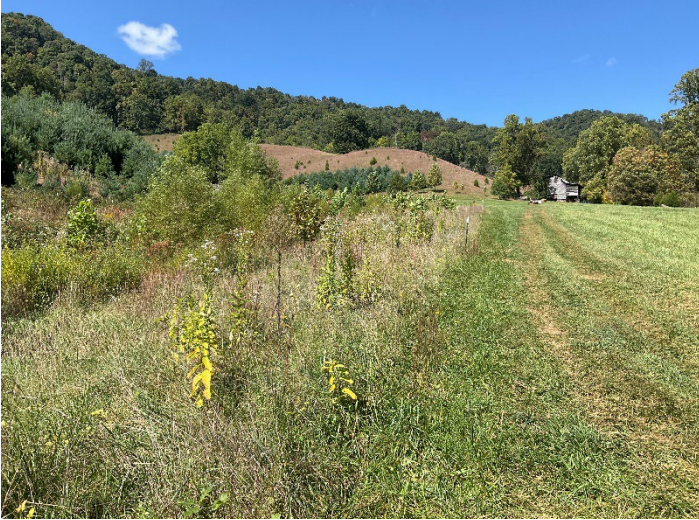
Posts added along CE Boundary – UT4, view up-valley (10/02/2023)

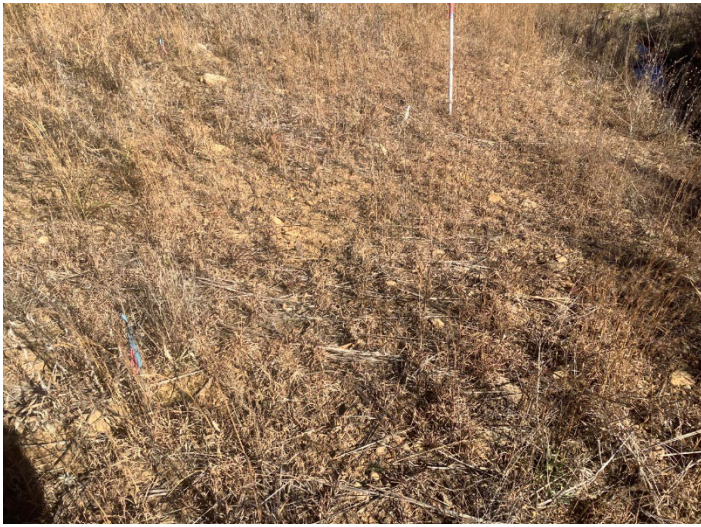
Poor herbaceous cover – UT3 Reach 2 near VP2 (12/03/2021)

7. Continuing up UT3, improvements in herbaceous coverage were observed near VP2. Joe described stewardship efforts which consisted of reseeding with a cover crop mixes for the last three seasons and spraying the area with compost tea beginning this year.
