FINAL
MY3 (2023) MONITORING REPORT

SHAW'S RUN MITIGATION SITE
Columbus County, North Carolina
Lumber River Basin
Cataloging Unit 03040203

DMS Project No. 100055
Full Delivery Contract No. 7515
DMS RFP No. 16-007337
USACE Action ID No. SAW-2018-01169
DWR Project No. 2018-0866

Data Collection: January – November 2023
Submission: January 2024

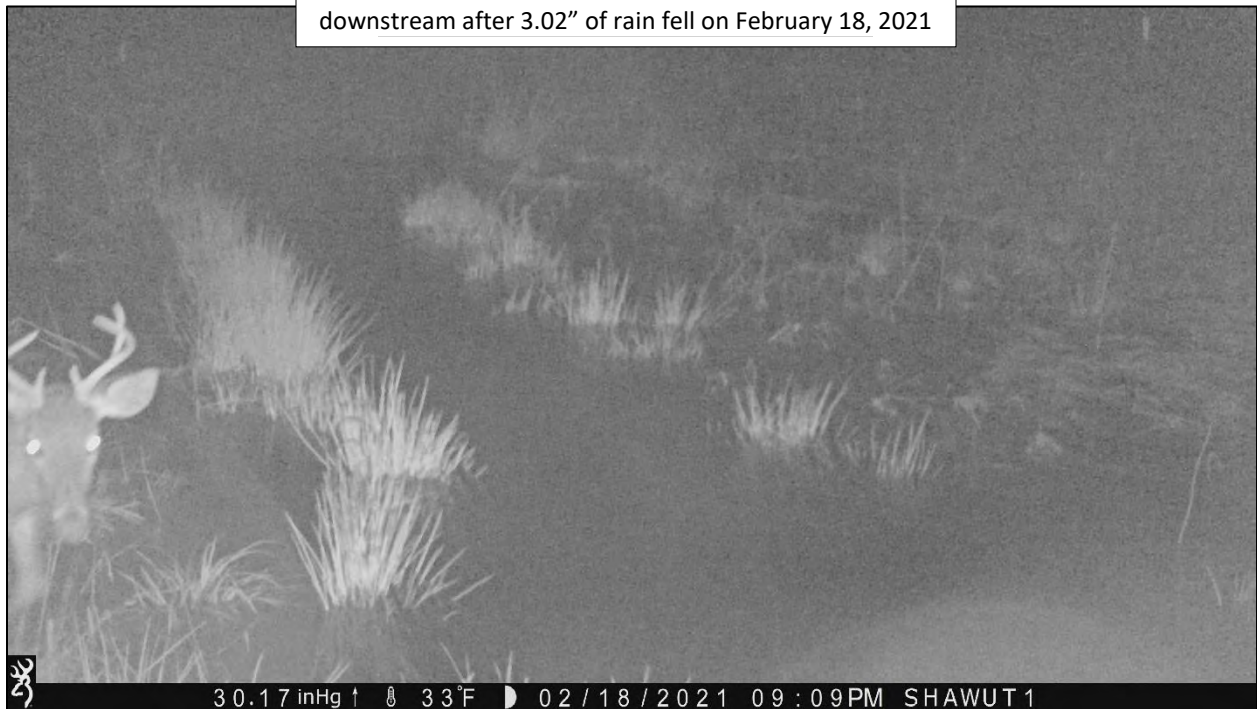
Photo 1: Bankfull event documented on UT 1 downstream after 3.02" of rain fell on February 18, 2021

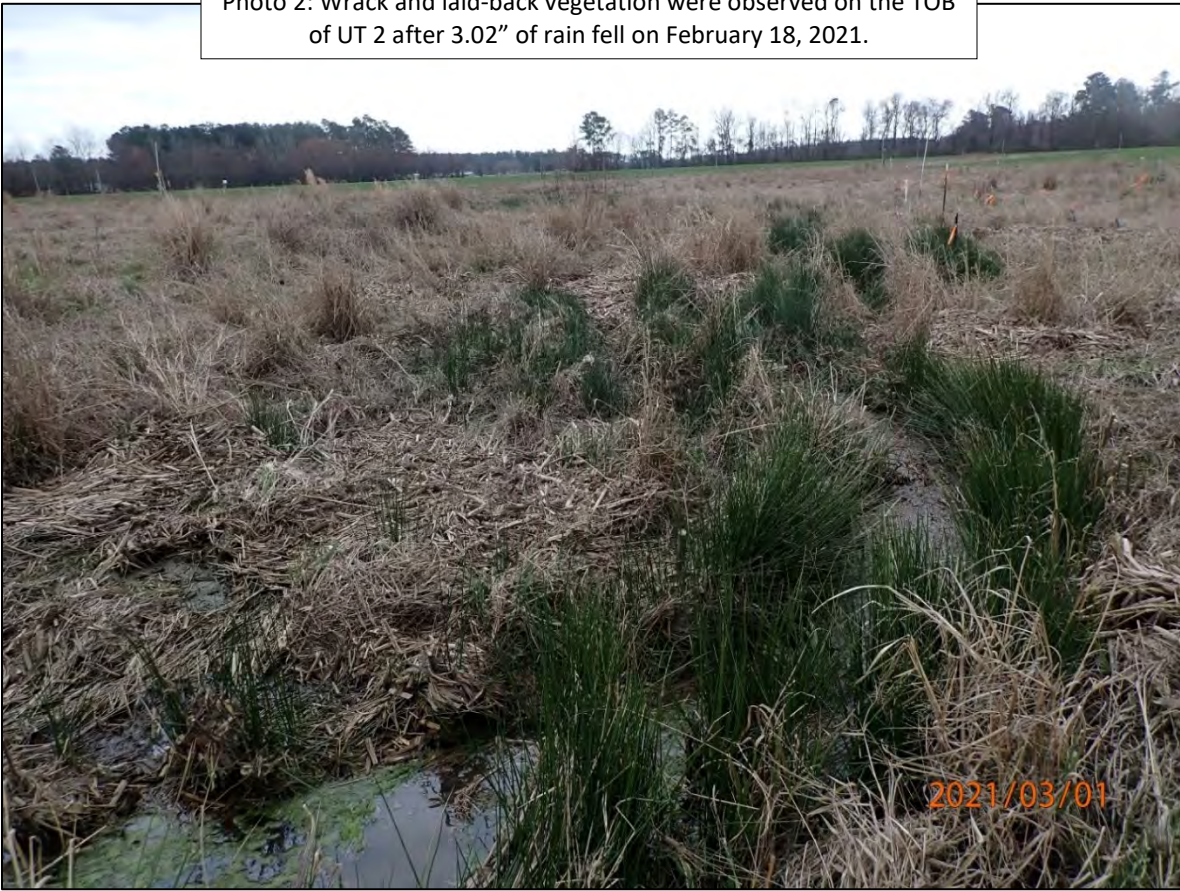
Photo 2: Wrack and laid-back vegetation were observed on the TOB of UT 2 after 3.02" of rain fell on February 18, 2021.

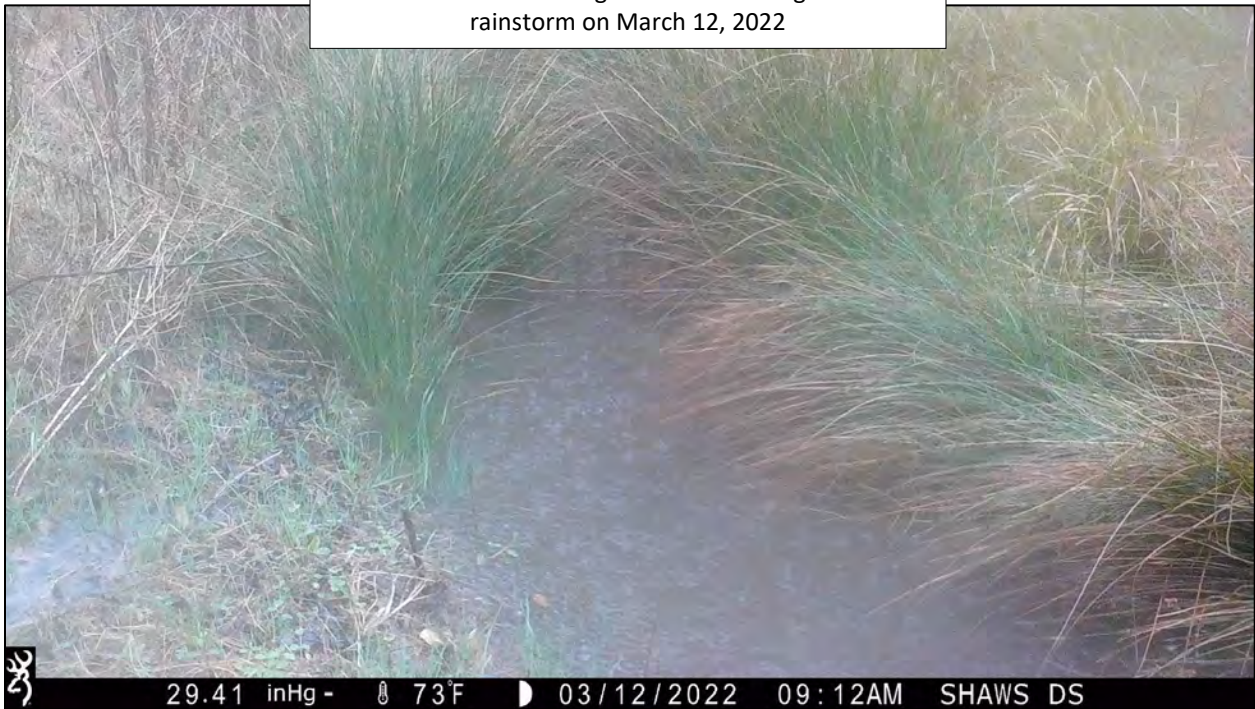
Photo 3: UT 1 swelling to bankfull during a 1.20" rainstorm on March 12, 2022

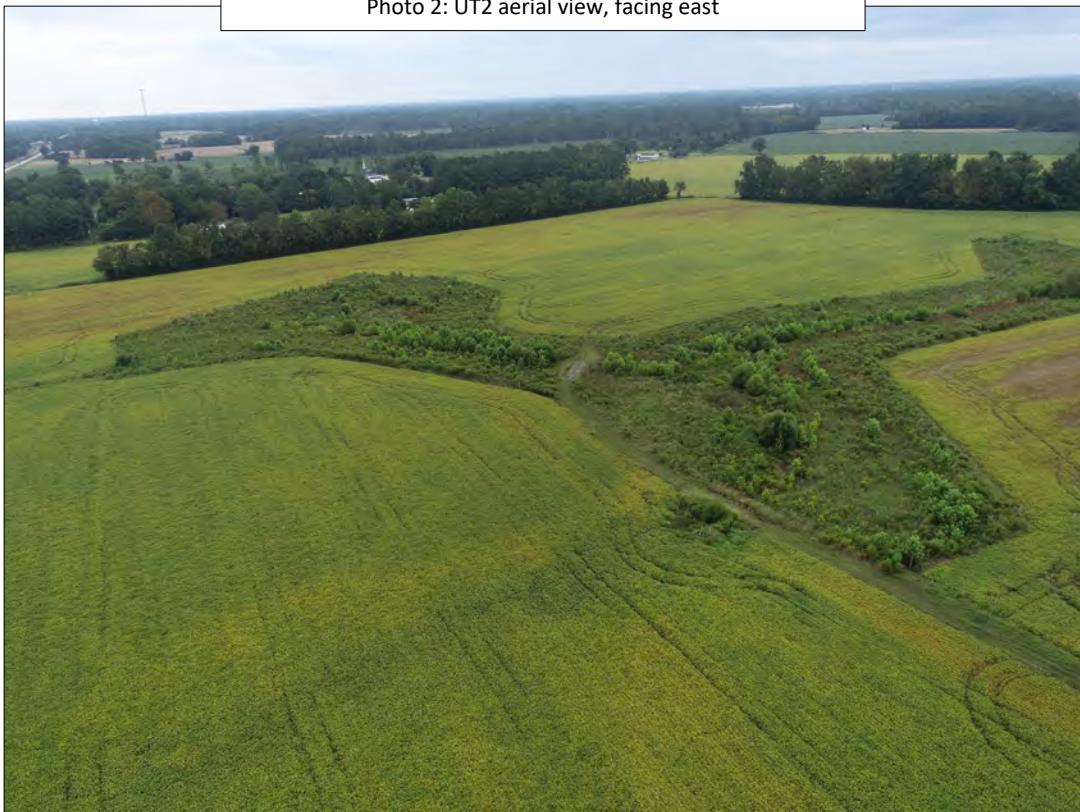
Photo 2: UT2 aerial view, facing east

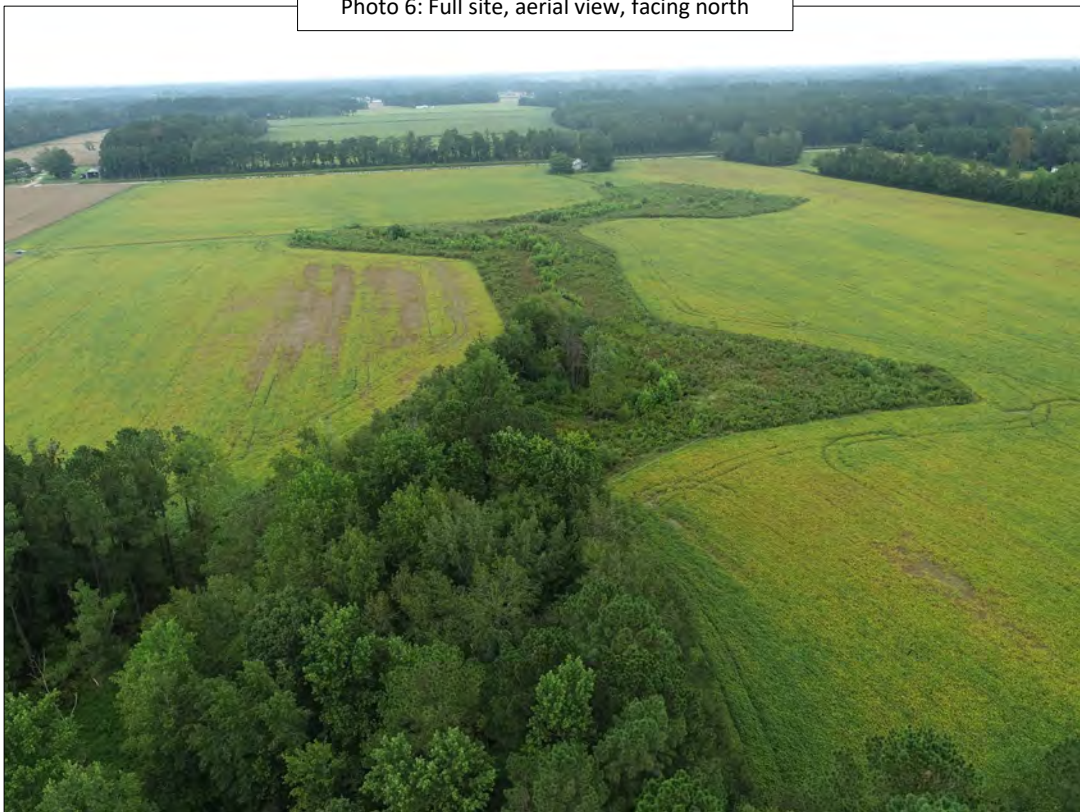
Photo 6: Full site, aerial view, facing north

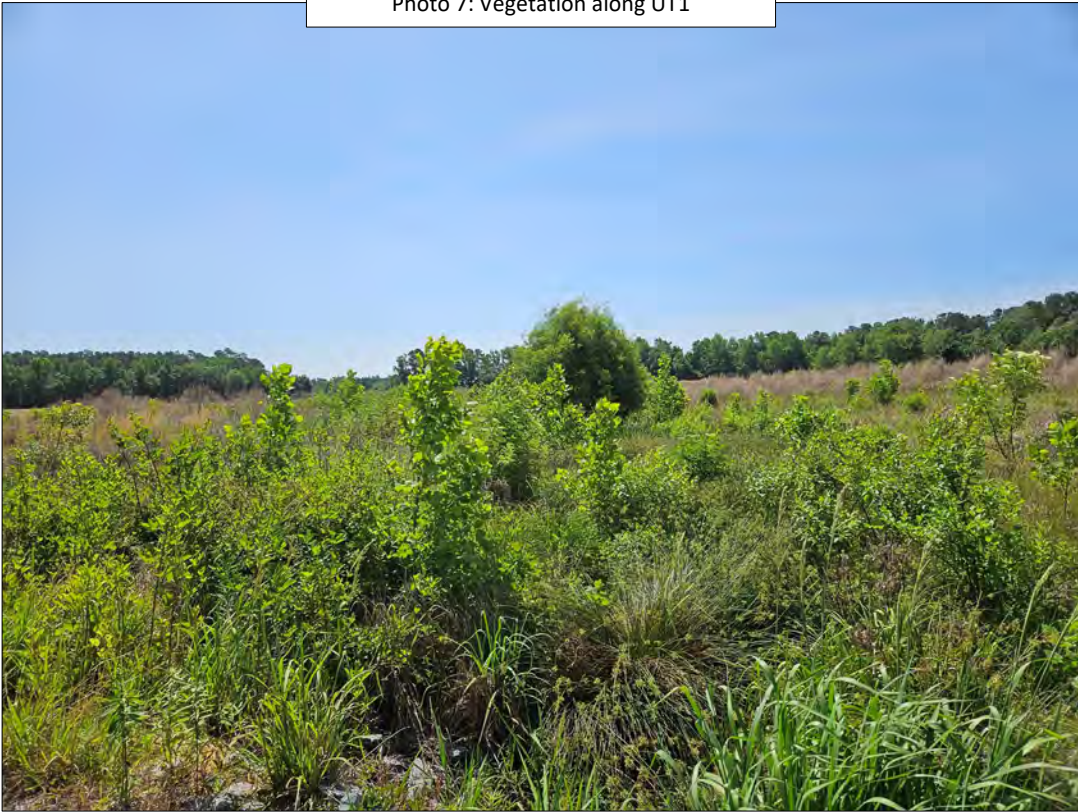
Photo 7: Vegetation along UT1

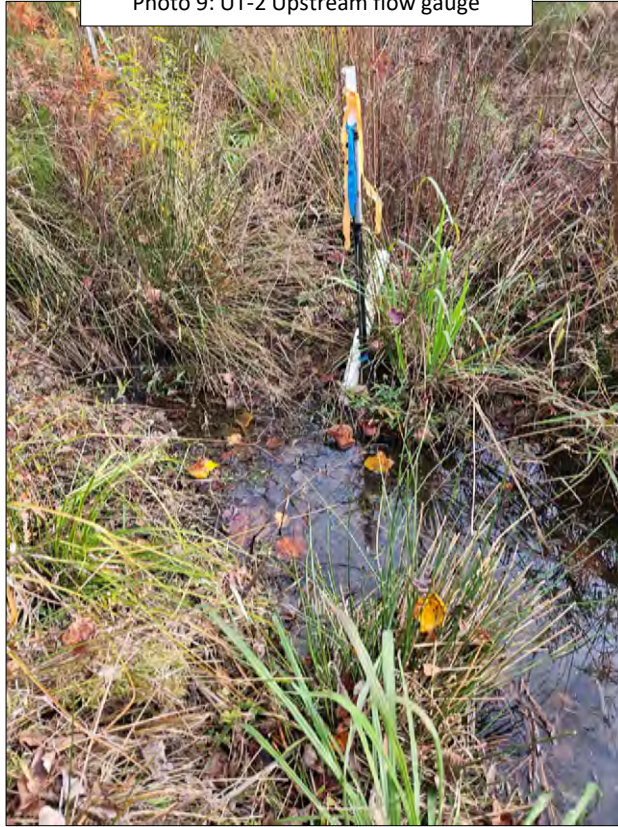
Photo 9: UT-2 Upstream flow gauge

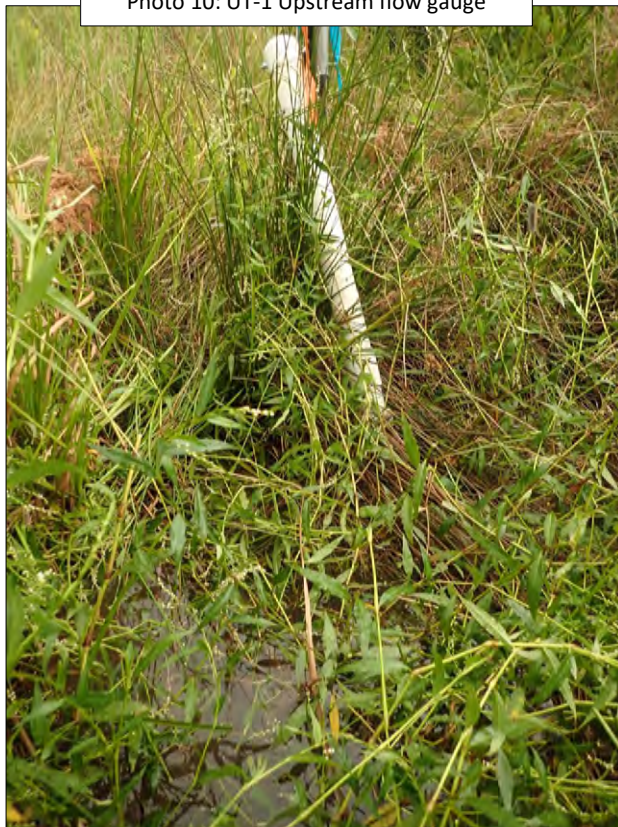
Photo 10: UT-1 Upstream flow gauge

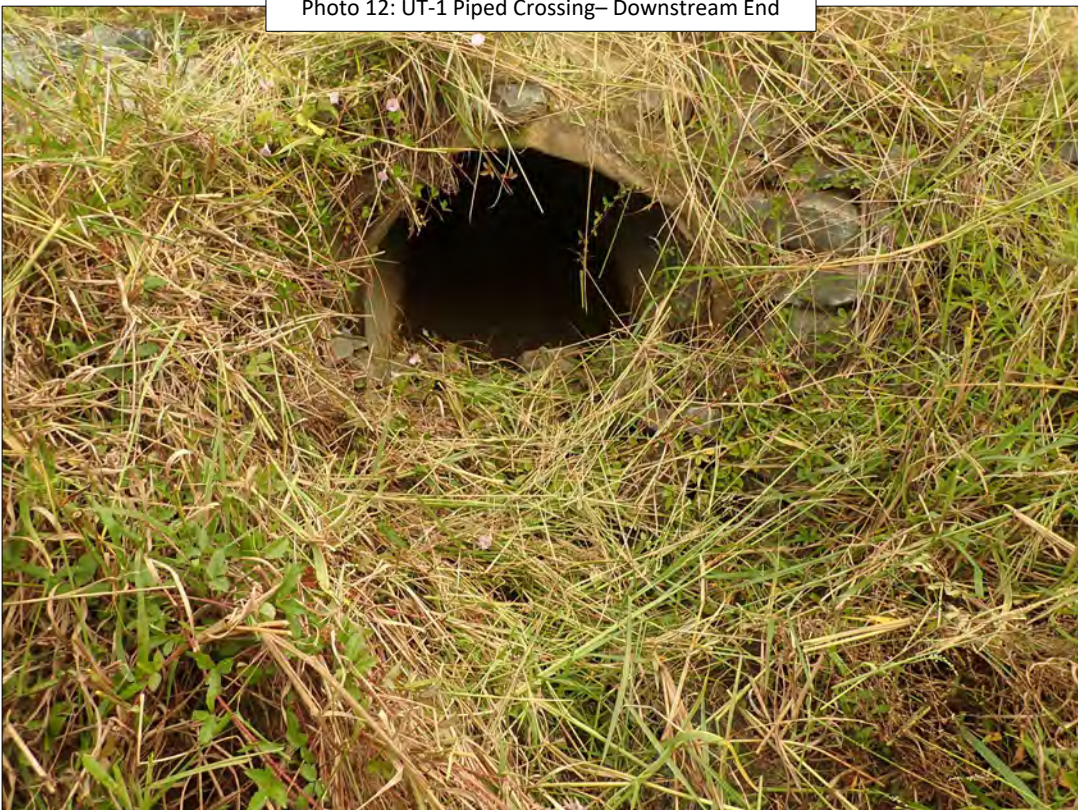
Photo 12: UT-1 Piped Crossing– Downstream End

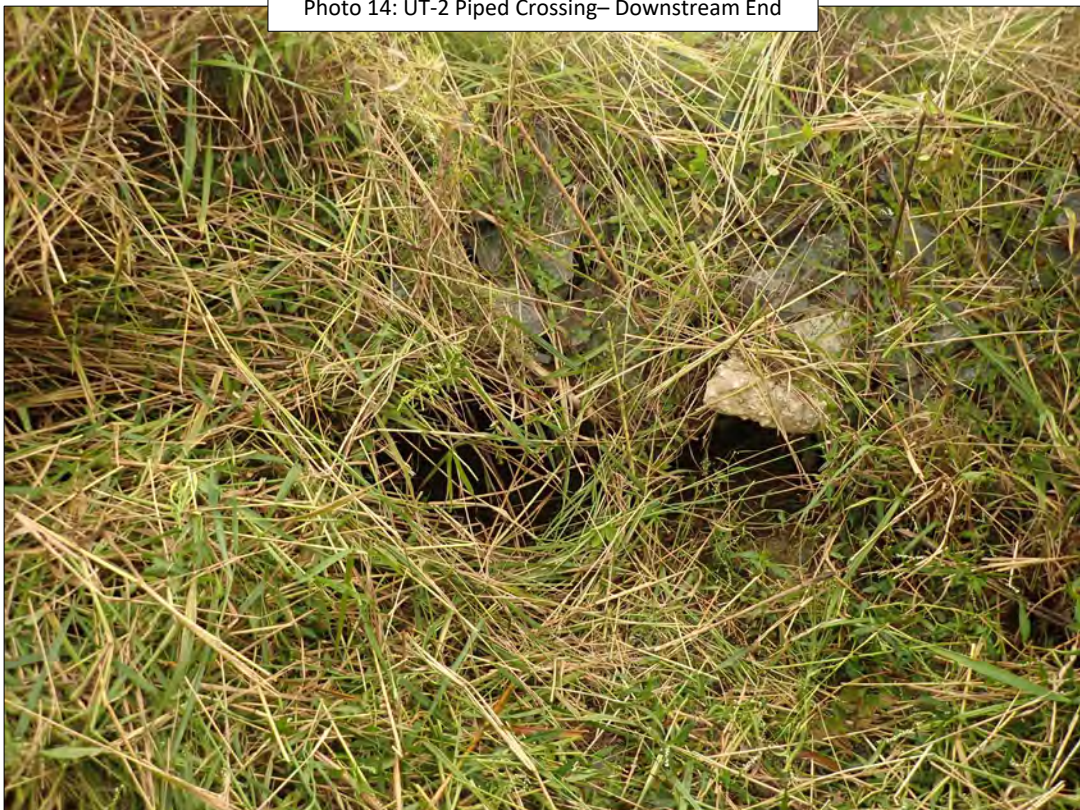
Photo 14: UT-2 Piped Crossing– Downstream End

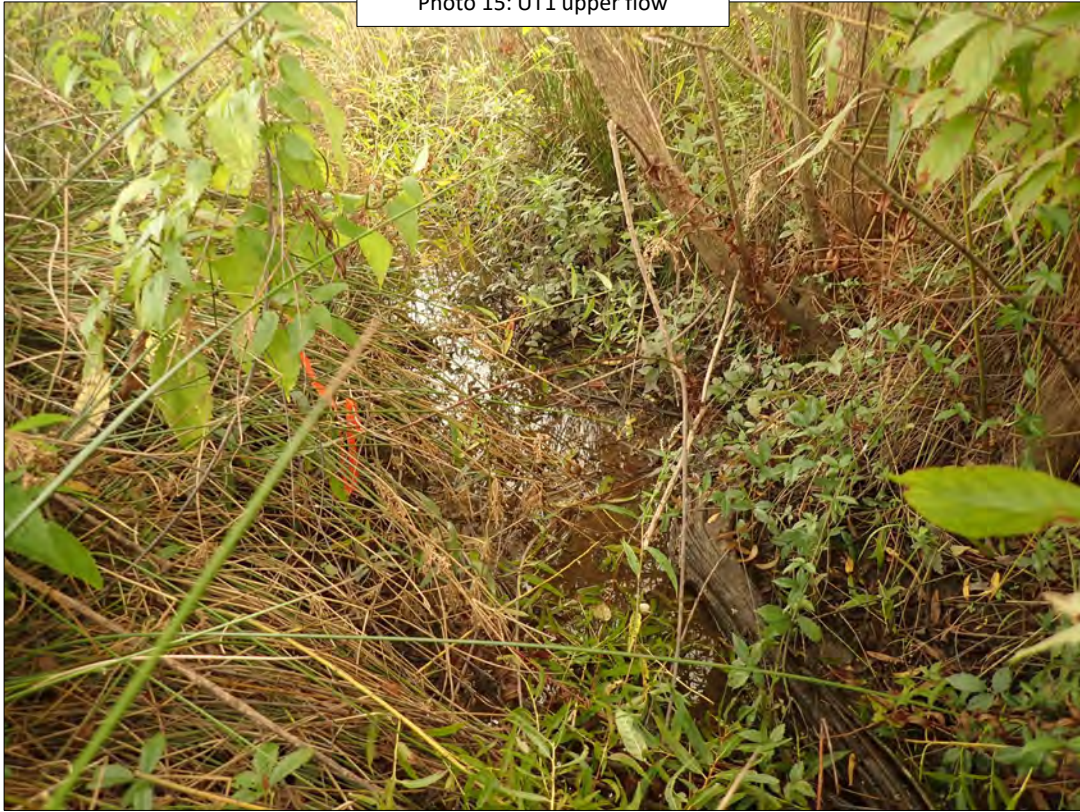
Photo 15: UT1 upper flow

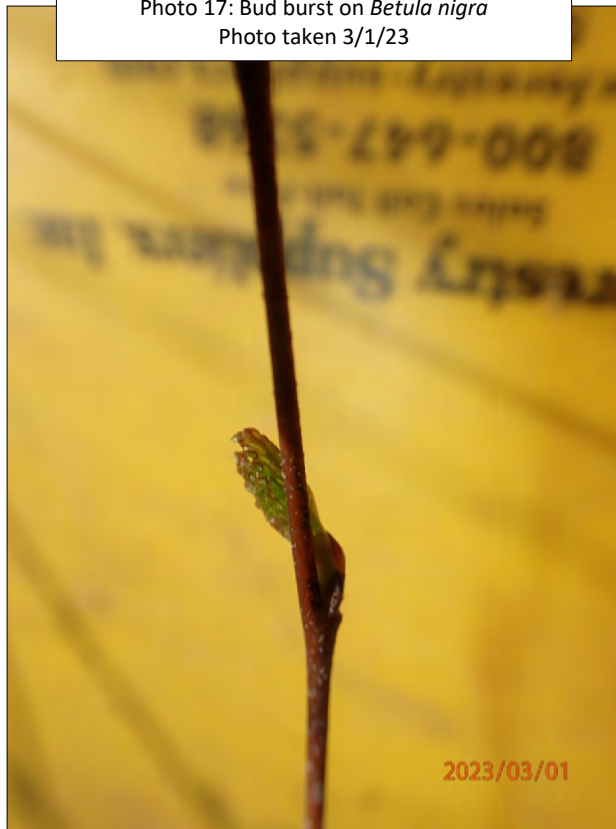
Photo 17: Bud burst on *Betula nigra*
Photo taken 3/1/23

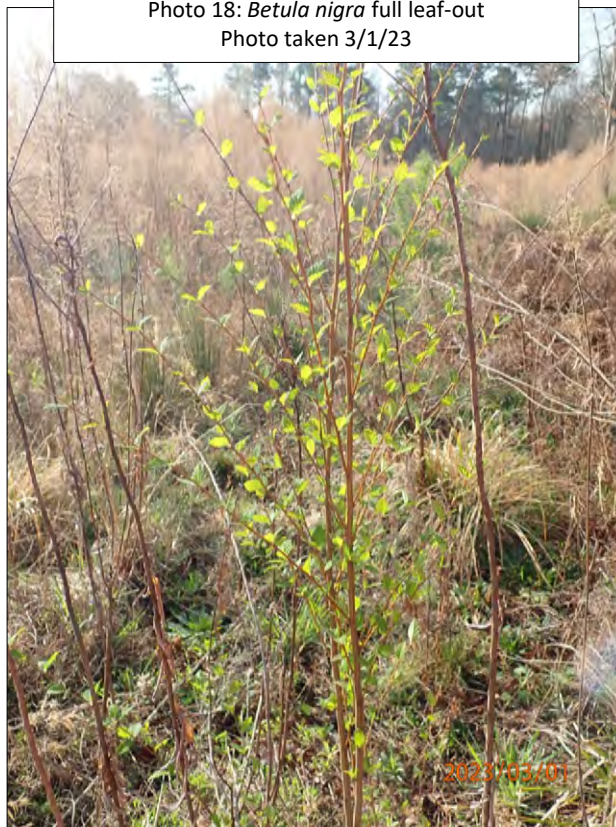
Photo 18: *Betula nigra* full leaf-out
Photo taken 3/1/23

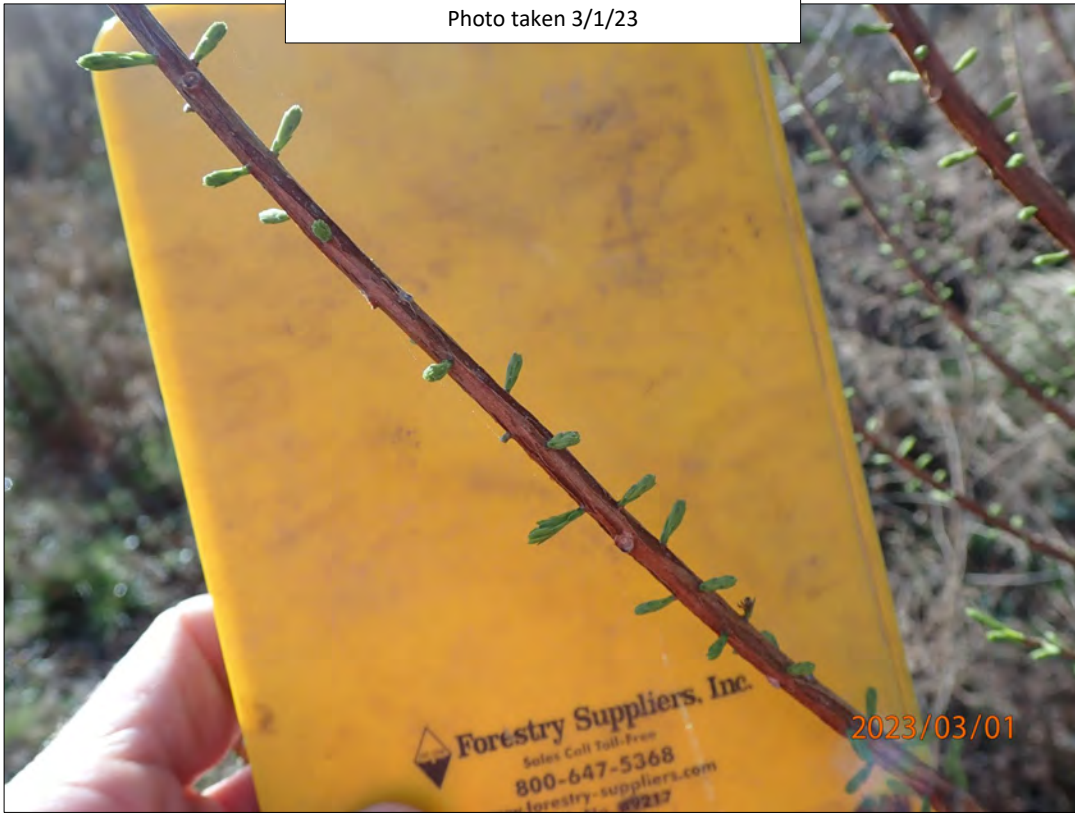
Photo 19: Bud burst on *Taxodium distichum*
Photo taken 3/1/23
