Shepherds Tree Stream and Wetland Restoration

EEP Project No. 333

2010 Monitoring Report: Year 6

Jordan, Jones and Goulding
309 East Morehead Street, Suite 110
Charlotte, NC 28202

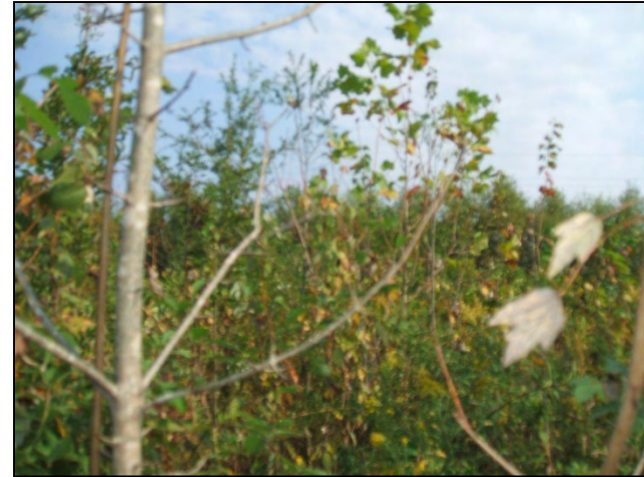
Vegetation Plot 2
(10/2010)

The 2010 vegetation monitoring results indicated that the Site is meeting vegetative success criteria. Although, not all the plots meet the success criteria individually (Plots 2, 5, and 10), the average site density is approximately 436 planted stems per acre, which exceeds the year 5 goal of 260 planted stems per acre. There is an average of 42 live planted stems per plot. A review of the natural recruits monitored indicated an increase in the average site density to approximately 1,321 stems per acre with an average of 99 recruitment stems per plot. The total number of native woody species per plot ranged from 8-15, indicating good diversity as well. Plots 2, 5, and 10 also meet the success criteria with the addition of natural recruits; 289, 232, and 232 planted stems per acre, respectively. Some loss of streambank vegetation was evident in previous monitoring years due to beaver activity; however, the overall growth of the streambank vegetation is good and appears to have improved over the past few years. This is most likely due to the resprouting of suspected dead saplings and new volunteer species.

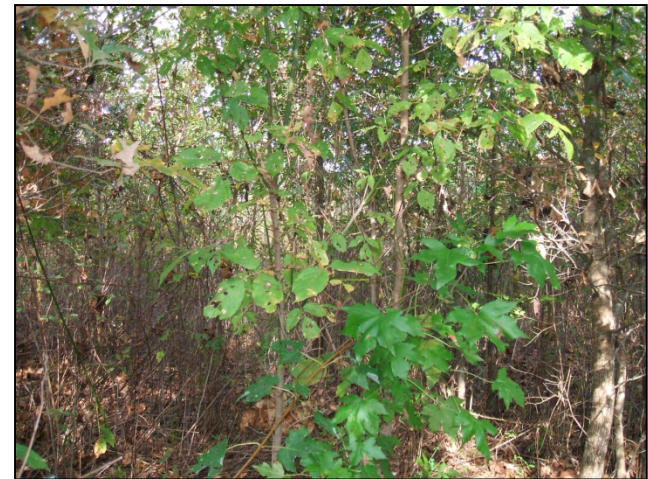
Vegetation Plot 8
(10/2010)

Throughout the Site and along the easement fencing, Kudzu (*Pueraria lobata*) encroachment has remained an issue. Near and within vegetation Plot 8, Kudzu has dominated the vegetation along the stream channel and is strangling planted woody species. During the 2010 monitoring year, NCEEP initiated active exotic invasive vegetation treatments to control the Kudzu. An additional follow up treatment will be conducted in 2011 as well. Please refer to Appendix 1.2

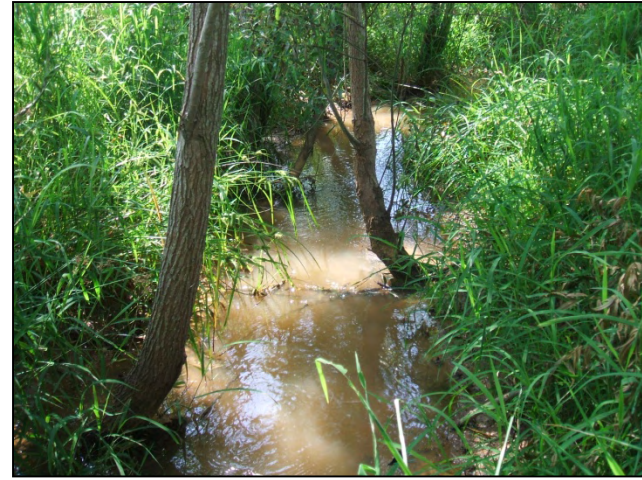
Photo Point 9-View Downstream
Main Channel (7/2010)

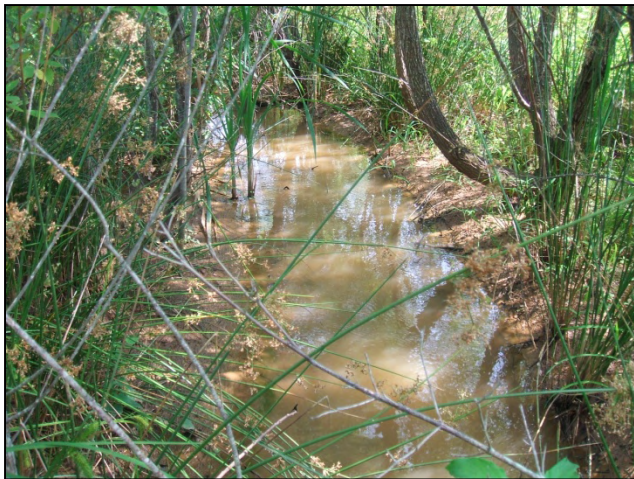
Photo Point 10-View Upstream
Main Channel (7/2010)

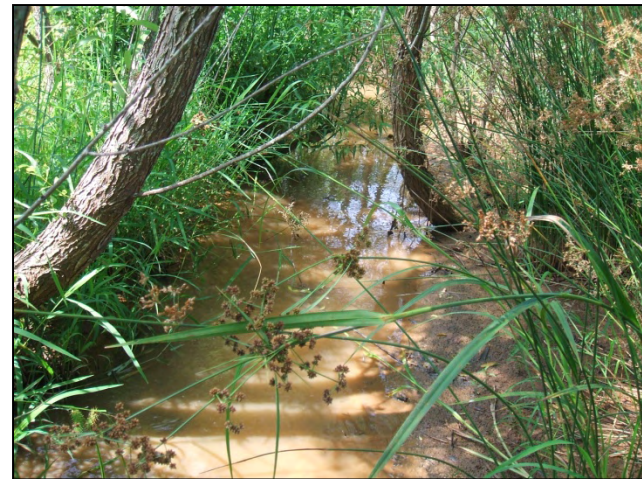
Photo Point 10-View Downstream
Main Channel (7/2010)

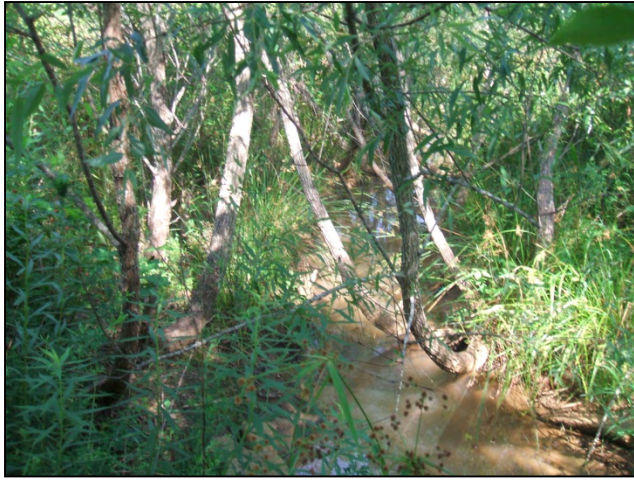
Photo Point 11-View Upstream
Main Channel (7/2010)

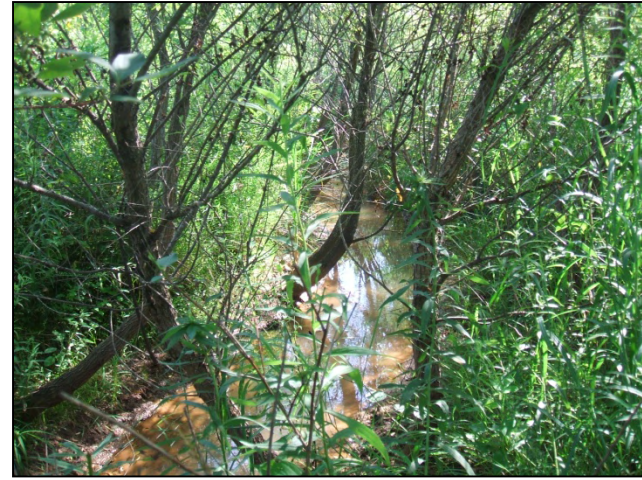
Photo Point 11-View Downstream
Main Channel (7/2010)

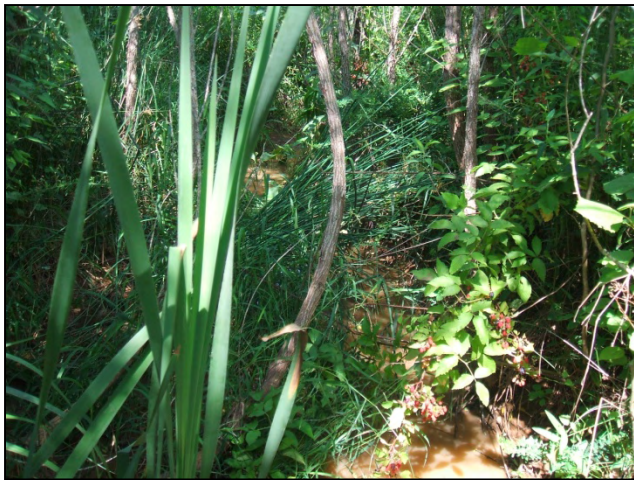
Photo Point 13-View Upstream
Main Channel (7/2010)

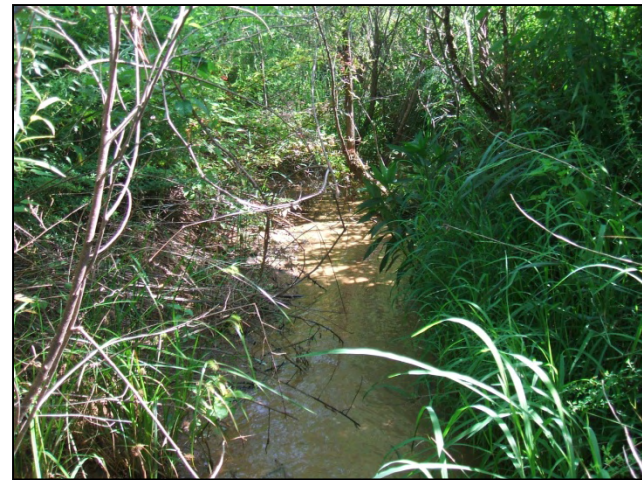
Photo Point 13-View Downstream
Main Channel (7/2010)

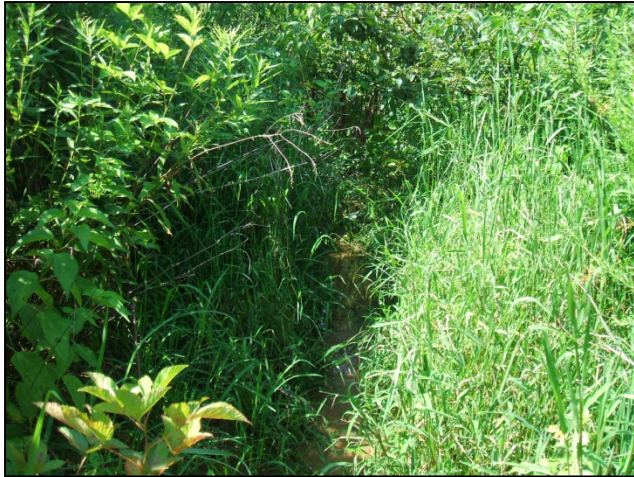
Photo Point 14-View Upstream
Main Channel (7/2010)

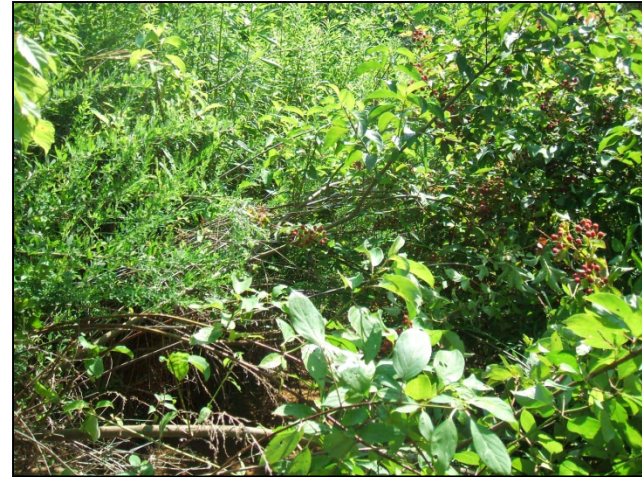
Photo Point 14-View Downstream
Main Channel (7/2010)

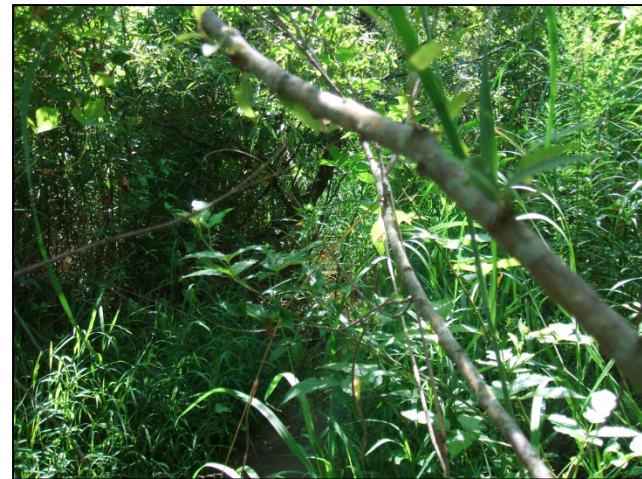
Photo Point 15-View Downstream
Main Channel (7/2010)

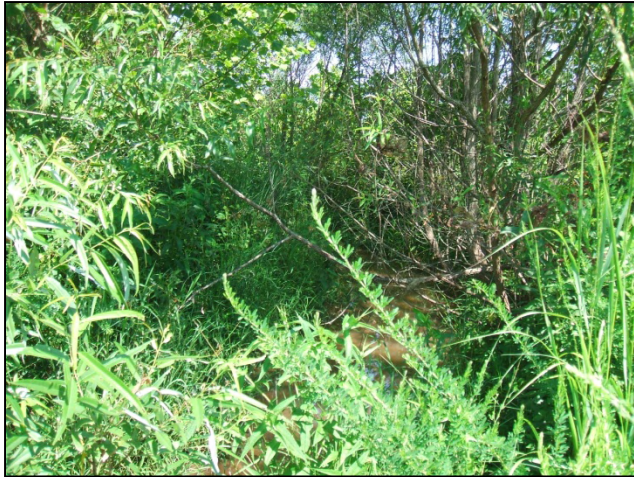
Photo Point 16-View Upstream
Main Channel (7/2010)

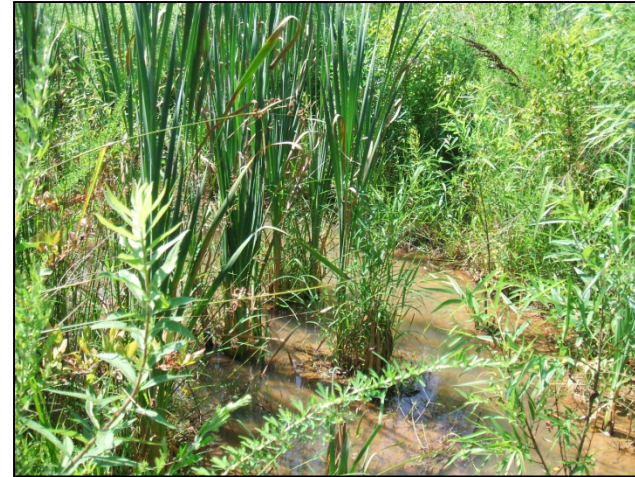
Photo Point 16-View Downstream
Main Channel (7/2010)

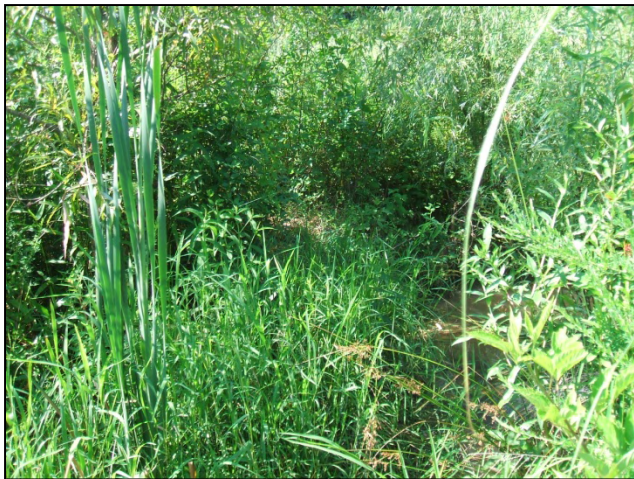
Photo Point 17-View Upstream
Main Channel (7/2010)

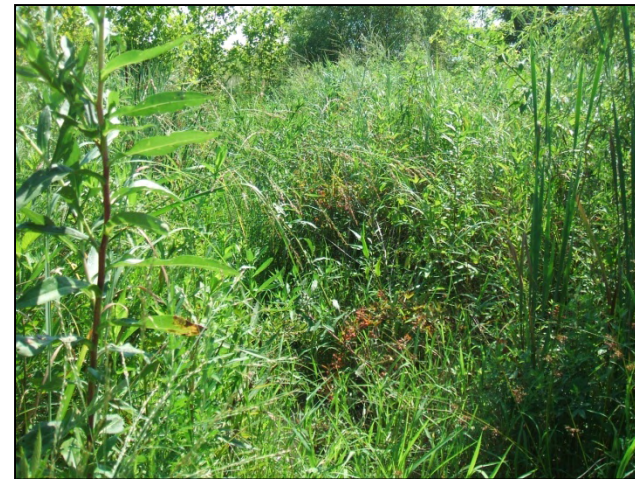
Photo Point 17-View Downstream
Main Channel (7/2010)

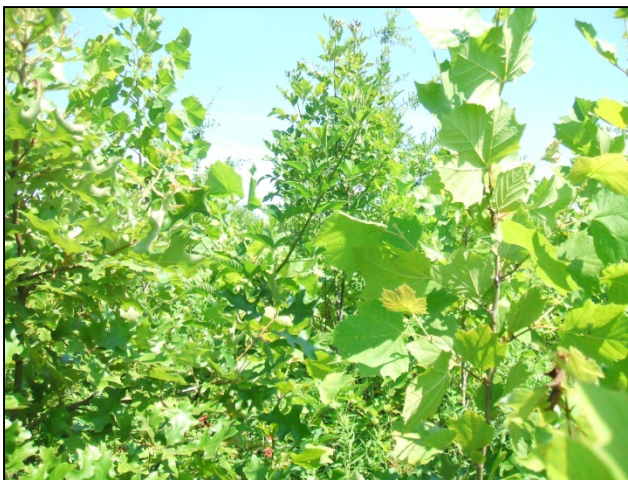
Photo Point 18-Vegetation Plot (7/2010)

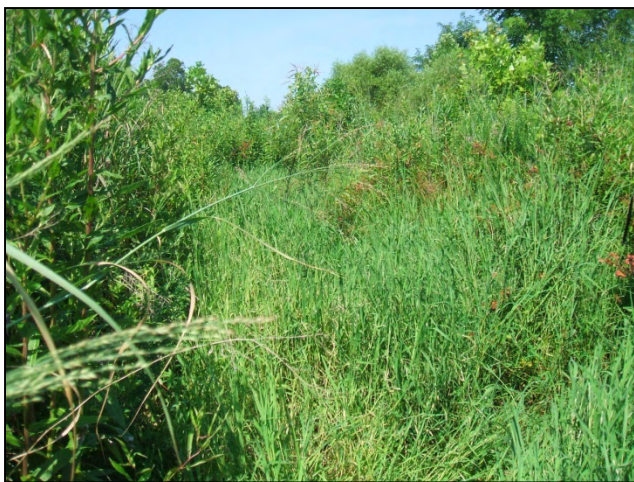
Photo Point 19-View Upstream
Main Channel (7/2010)

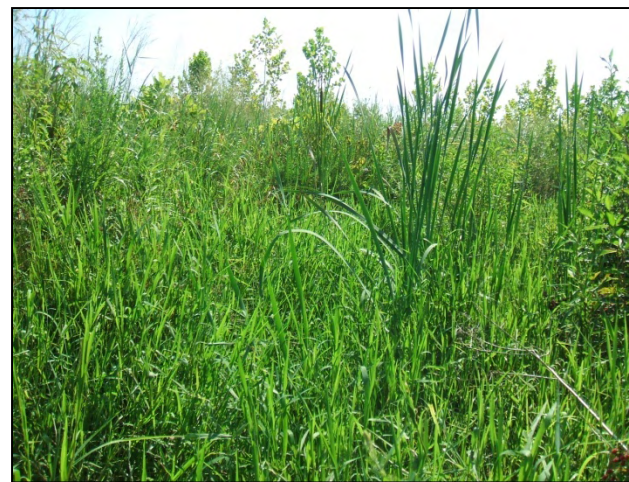
Photo Point 19-View Downstream
Main Channel (7/2010)

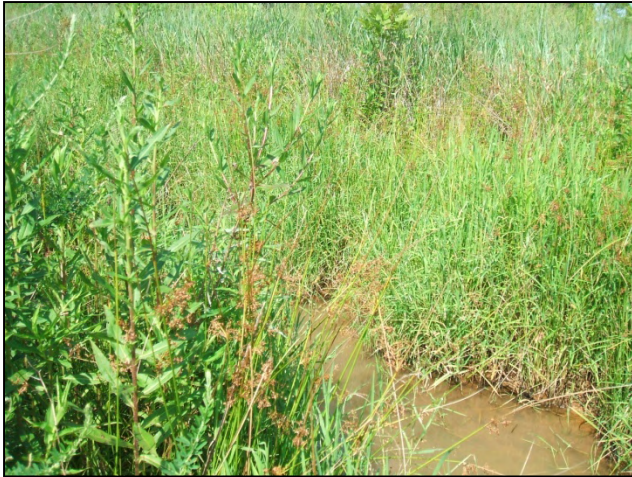
Photo Point 20-View Upstream
Main Channel (7/2010)

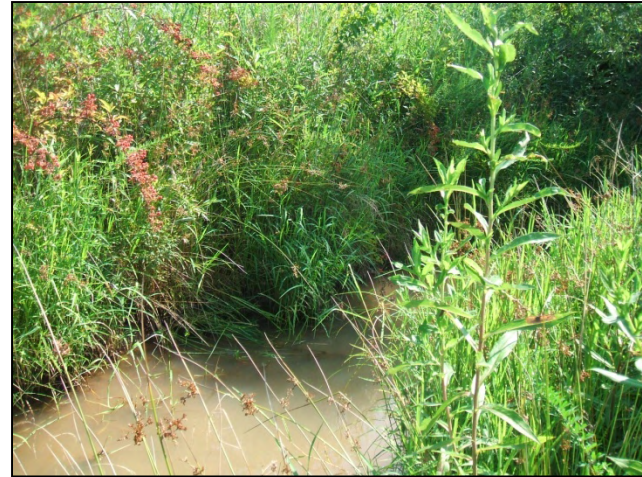
Photo Point 20-View Downstream
Main Channel (7/2010)

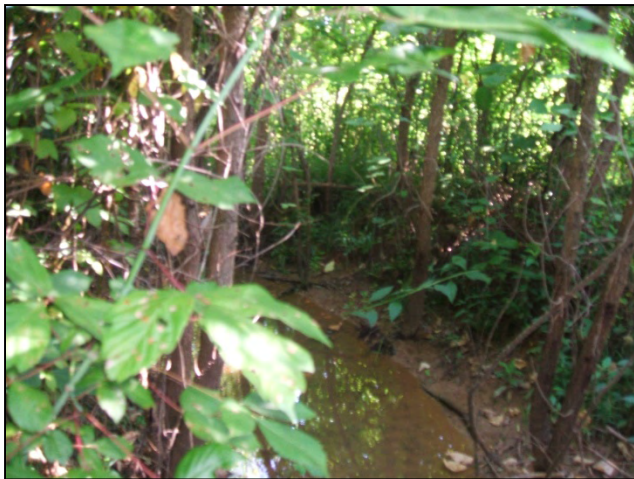
Photo Point 21-View Upstream
Main Channel (7/2010)

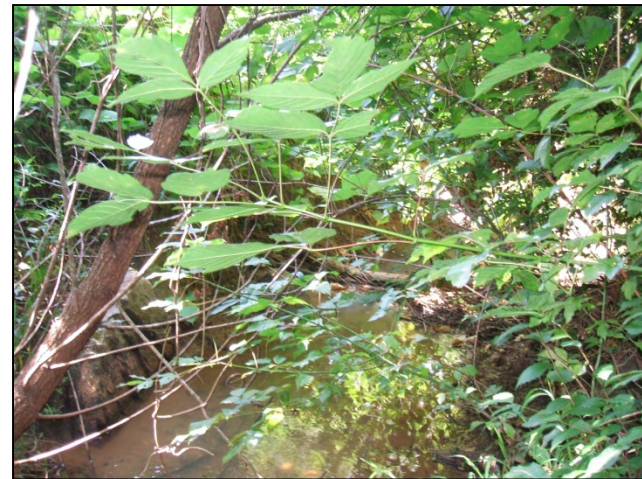
Photo Point 21-View Downstream
Main Channel (7/2010)

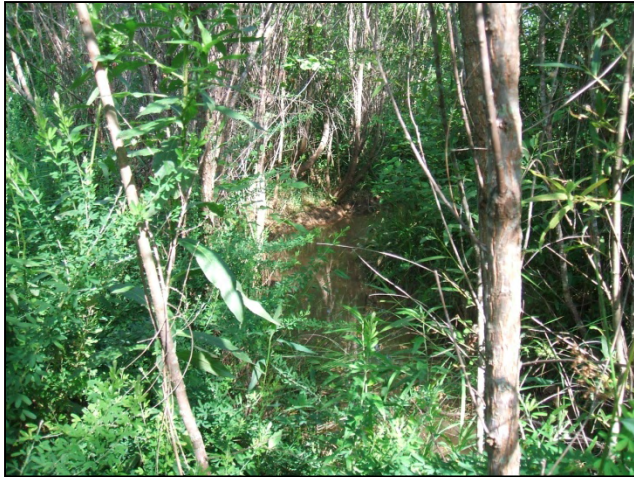
Photo Point 22-View Upstream
Main Channel (7/2010)

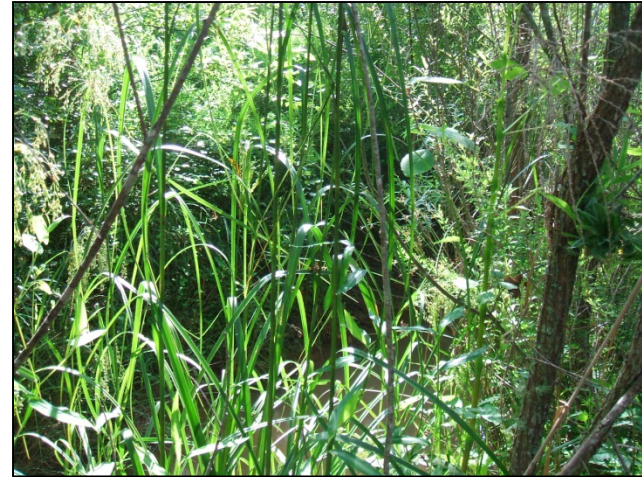
Photo Point 22-View Downstream
Main Channel (7/2010)

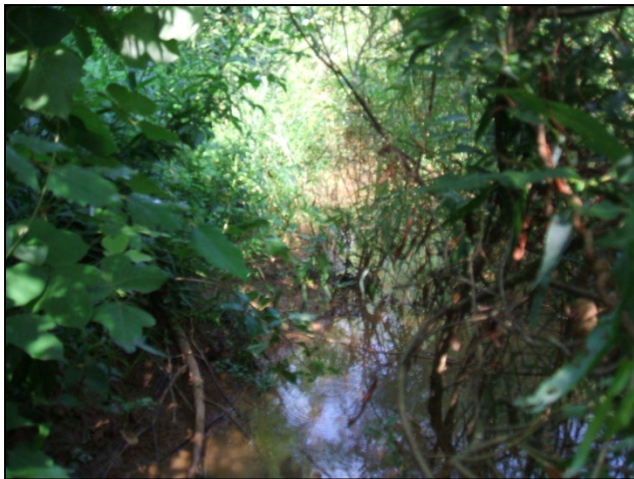
Photo Point 23-View Upstream
Main Channel (7/2010)

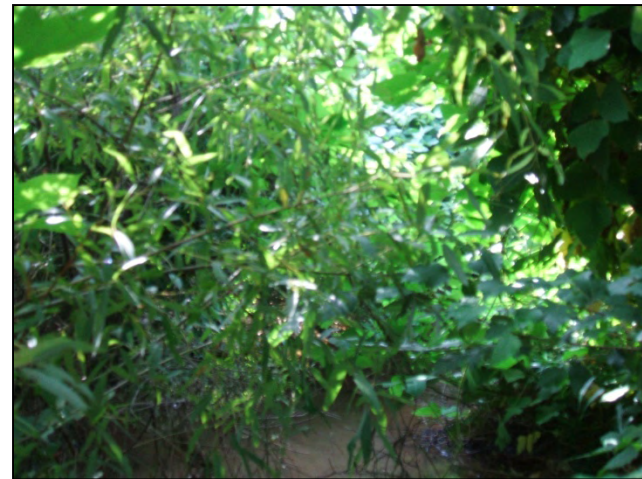
Photo Point 23-View Downstream
Main Channel (7/2010)

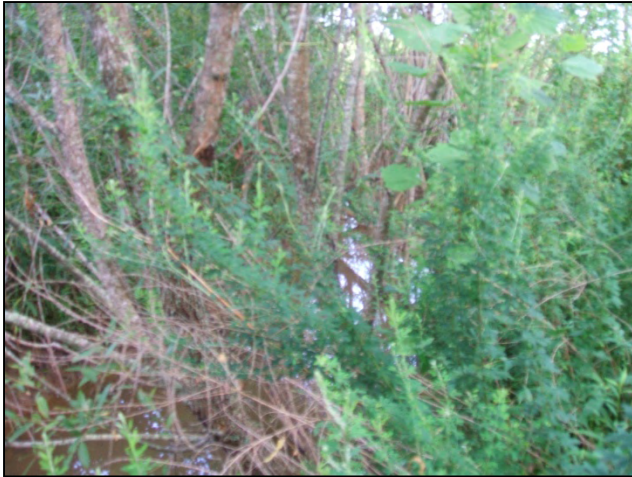
Photo Point 24-View Upstream
Main Channel (7/2010)

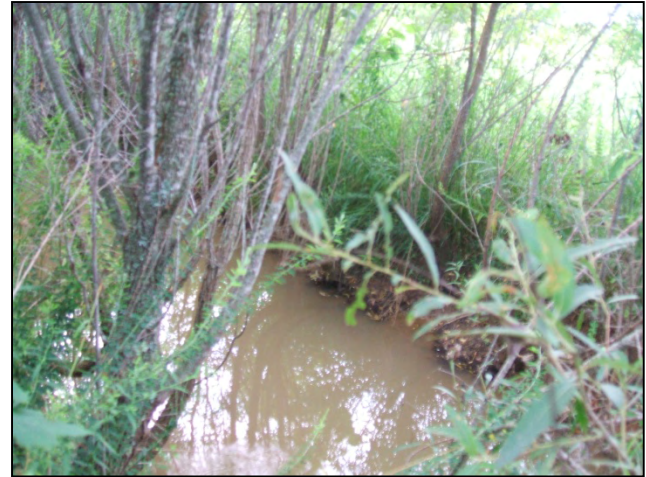
Photo Point 24-View Downstream
Main Channel (7/2010)

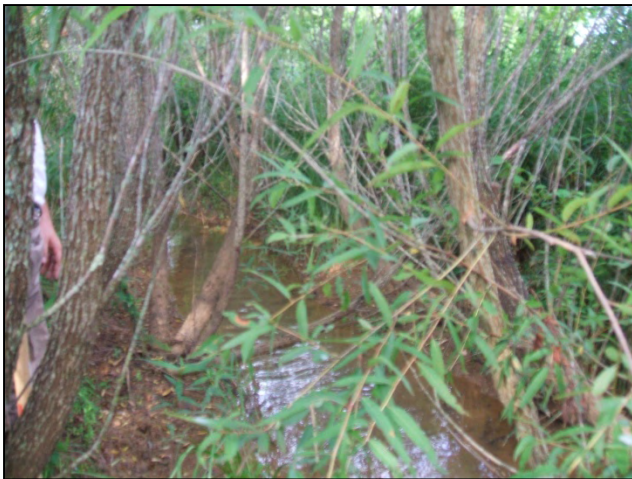
Photo Point 25-View Upstream
Main Channel (7/2010)

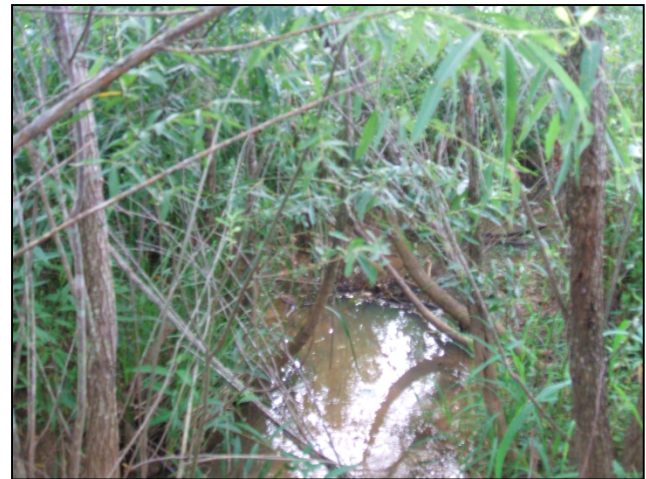
Photo Point 25-View Downstream
Main Channel (7/2010)

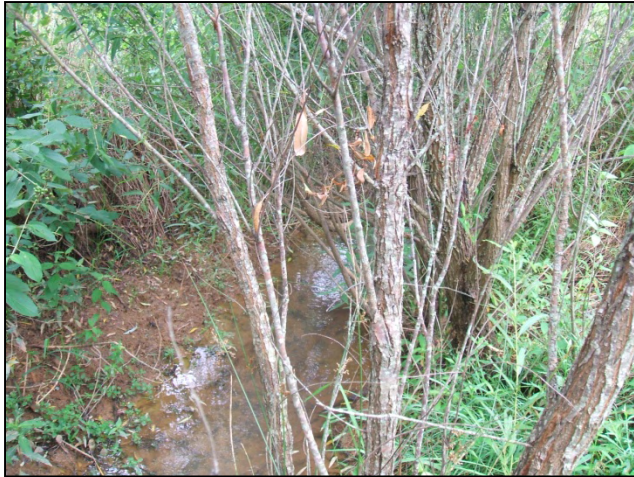
Photo Point 26-View Upstream
Main Channel (7/2010)

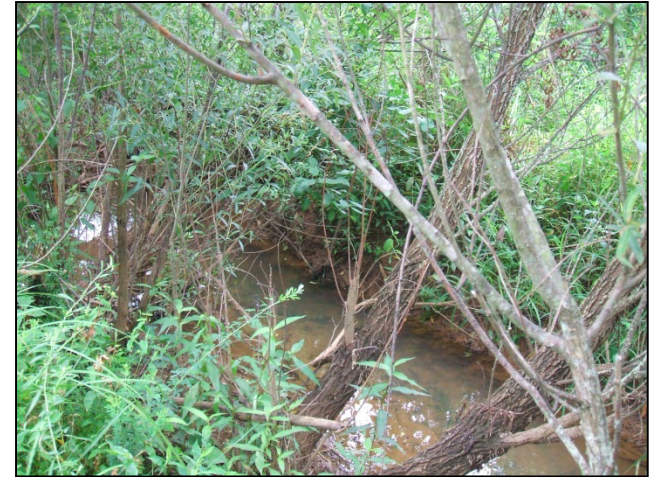
Photo Point 26-View Downstream
Main Channel (7/2010)

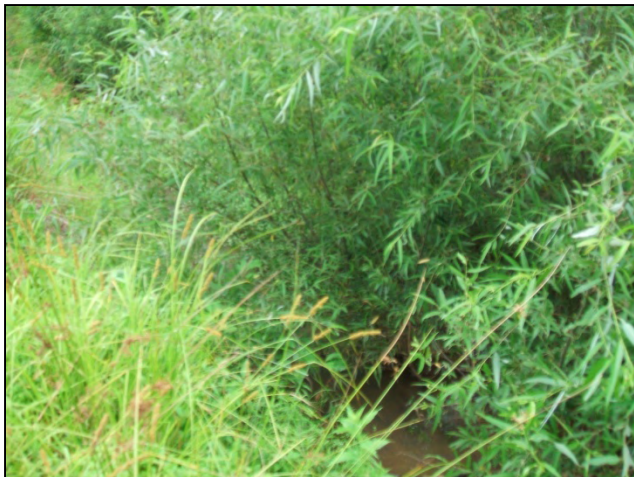
Photo Point 27-View Upstream
Main Channel (7/2010)

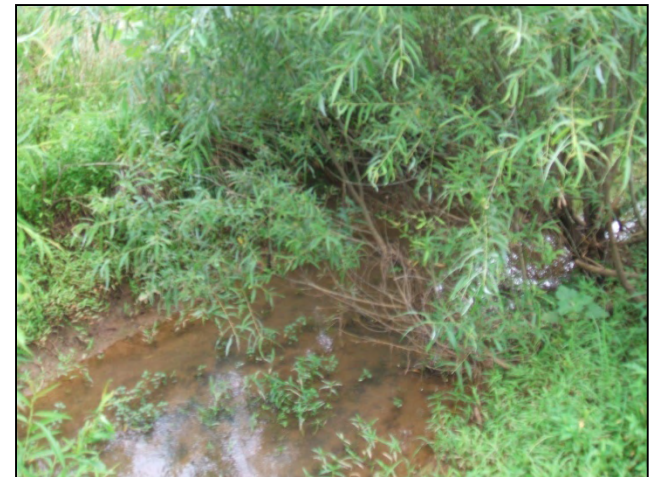
Photo Point 27-View Downstream
Main Channel (7/2010)

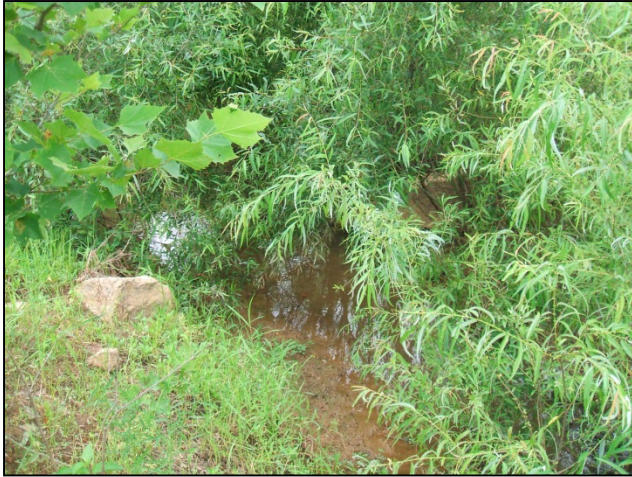
Photo Point 28-View Upstream
Main Channel (7/2010)

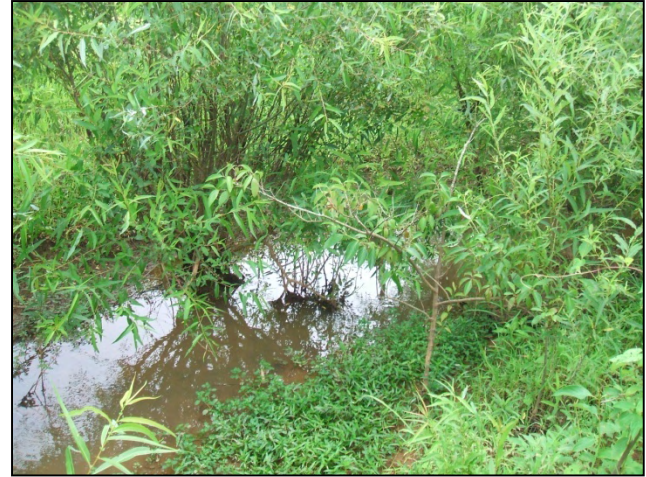
Photo Point 28-View Downstream
Main Channel (7/2010)

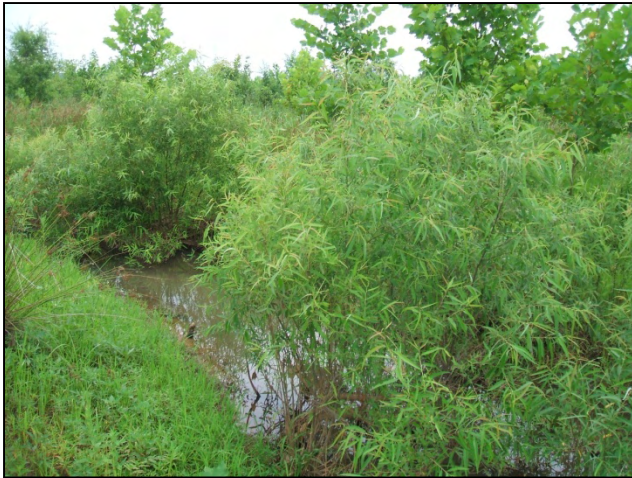
Photo Point 30-View Upstream
Main Channel (7/2010)

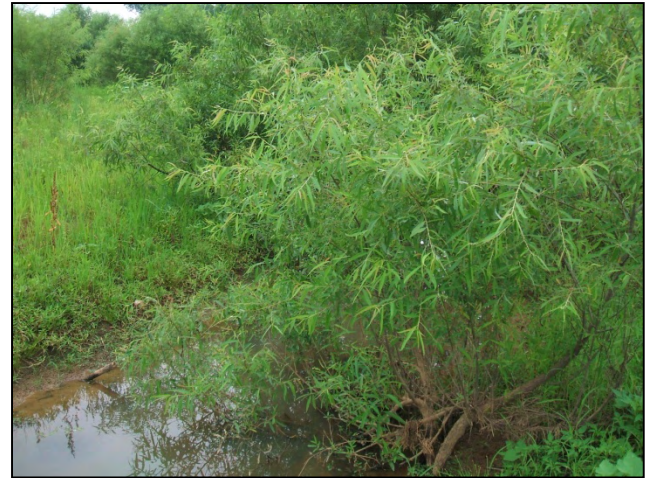
Photo Point 30-View Downstream
Main Channel (7/2010)

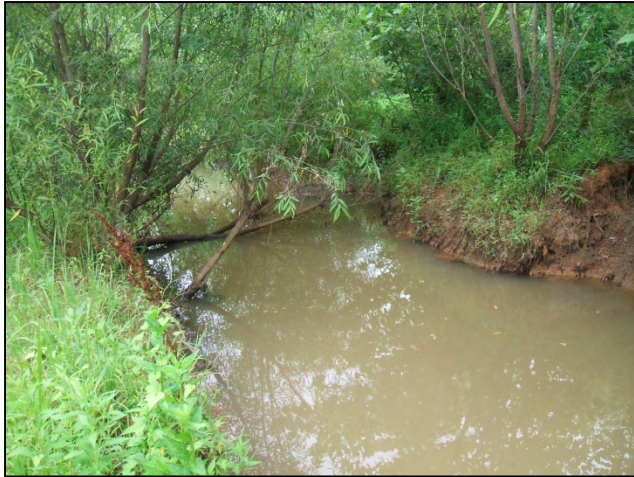
Photo Point 31-View Upstream
Main Channel (7/2010)

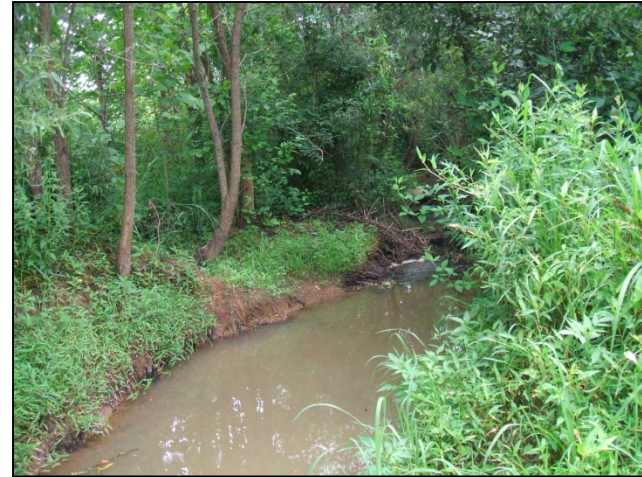
Photo Point 31-View Downstream
Main Channel (7/2010)

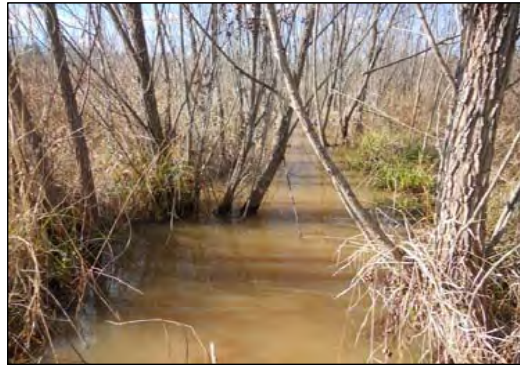
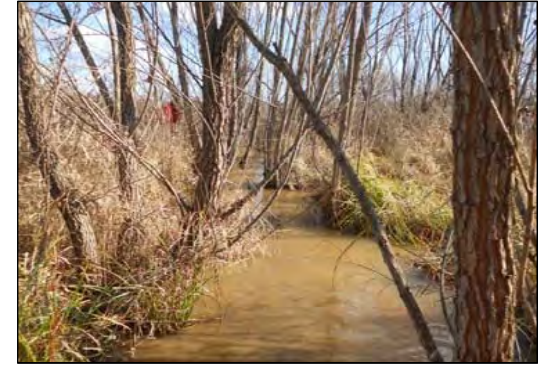
Project Name	Shepherds Tree
EEP Project Number	333
Cross-Section ID	XS-6, Riffle
Survey Date	11/2010

SUMMARY DATA	
Bankfull Elevation (ft)	94.37
Bankfull Cross-Sectional Area (ft²)	2.75
Bankfull Width (ft)	5.78
Flood Prone Area Elevation (ft)	95.15
Flood Prone Width (ft)	>100
Bankfull Mean Depth (ft)	0.48
Bankfull Max Depth (ft)	0.78
W/D Ratio	12.04
Entrenchment Ratio	>2.2
Bank Height Ratio	4.41
