# SILVER CREEK RESTORATION PROJECT (FINAL) ANNUAL MONITORING REPORT FOR 2010 (YEAR 5)

Project Number D04006-5

**Prepared for:** EBX Neuse-I, LLC      **Prepared by:** Michael Baker Engineering, Inc.

January 2011

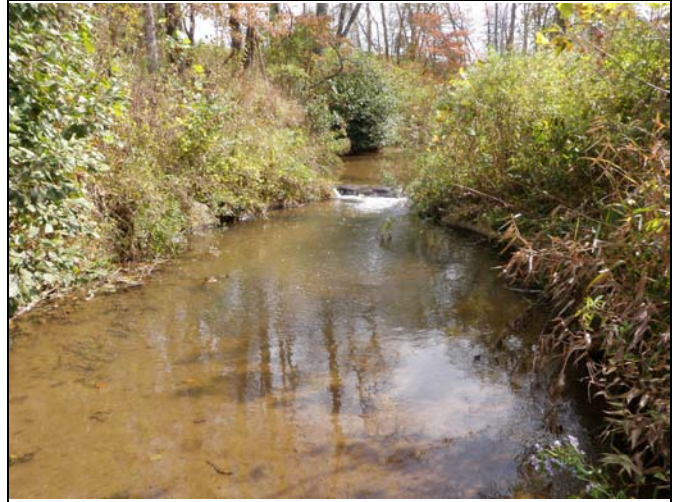
M4 Photo Point 3 – Problem cross-vane at station  
63+50
