# Mitigation Plan for Stream Mitigation of Silver Creek and Unnamed Tributary

Silver Creek and Unnamed Tributary  
Burke County, NC  
SCO # D05016-1

**Submitted:** September 11, 2007

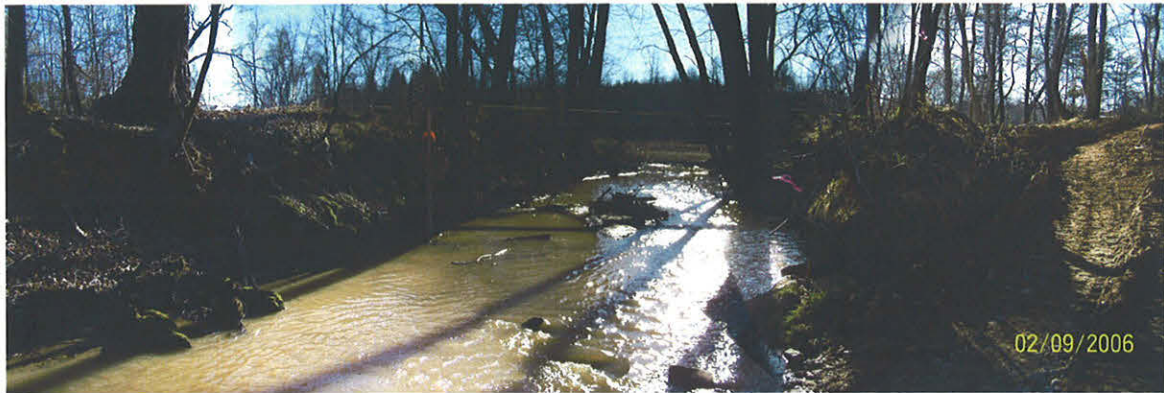
Top of Mainstem Reach – Pre-Restoration

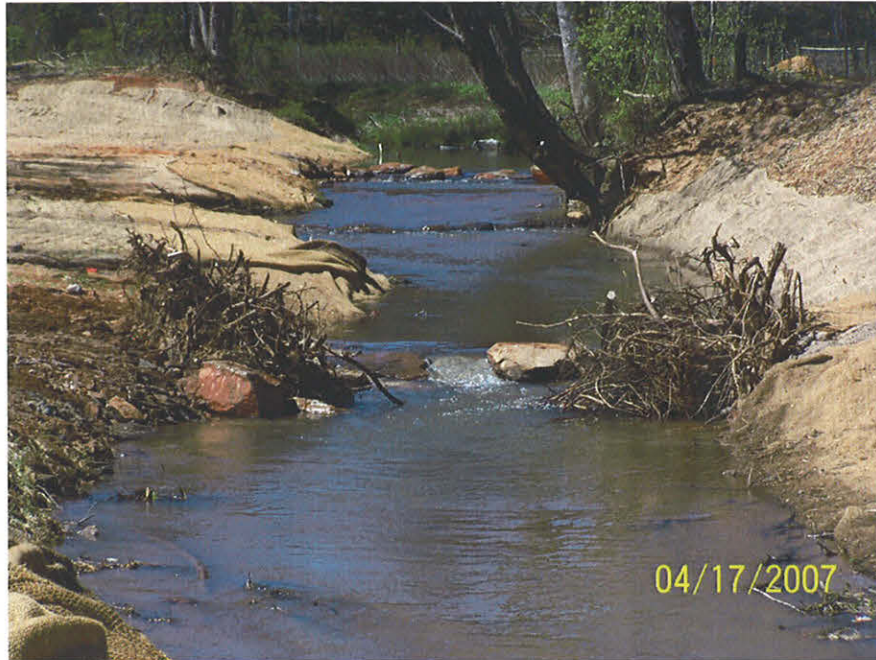
Top of Mainstem Reach – Post Restoration – Upstream J-Hook Rock Vane No. 1 – Downstream Cross-Vane No. 1 with Root Wad/Boulder Cut-Off Sills – Looking Upstream

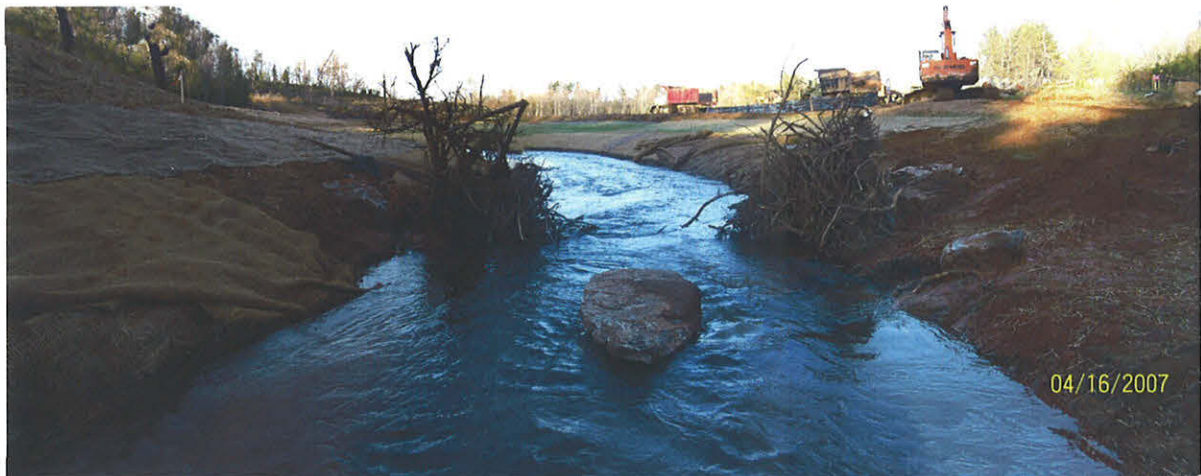
Mainstem Reach - Cross-Vane No. 1 with Root Wad/Boulder Cut-Off Sills, looking Downstream

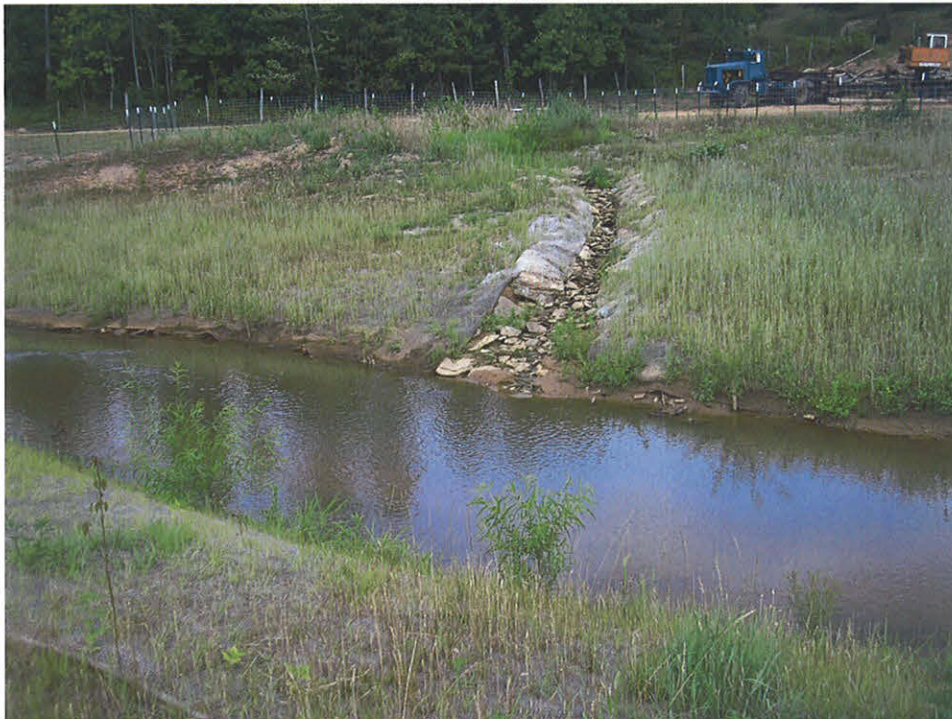
UT-B – Drain from Farm Pond - Post Restoration

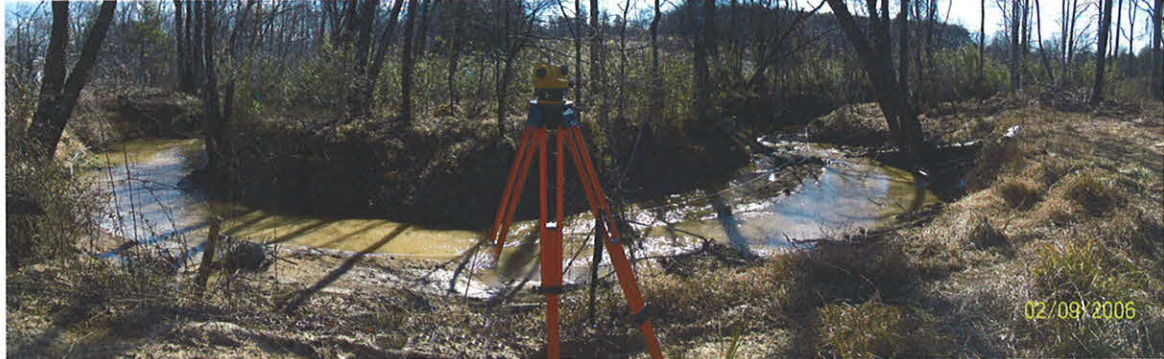
Mainstem Reach – Over Tightened Meander – Pre-Restoration

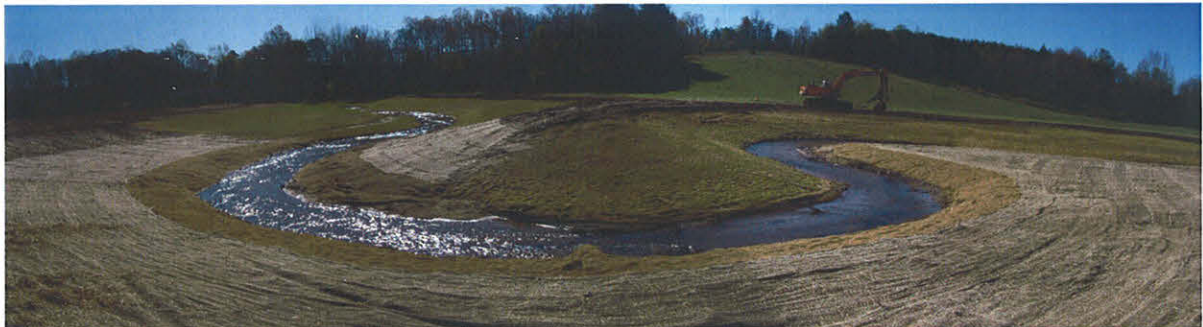
Mainstem Reach – Over Tightened Meander – Post-Restoration Prior to Rock Vane, Log Vane - J-Hook – Root Wad Combination Channel Stabilization Structures Installation

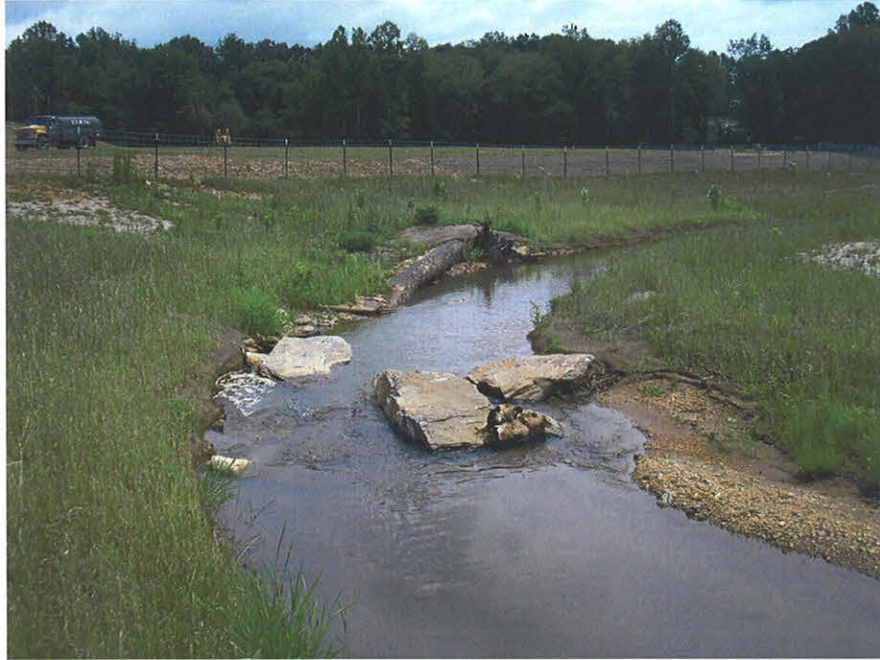
Mainstem Reach – Over Tightened Meander – Post-Restoration - Log Vane - J-Hook – Root Wad  
Combination Structure - Lower Bend – Looking Downstream

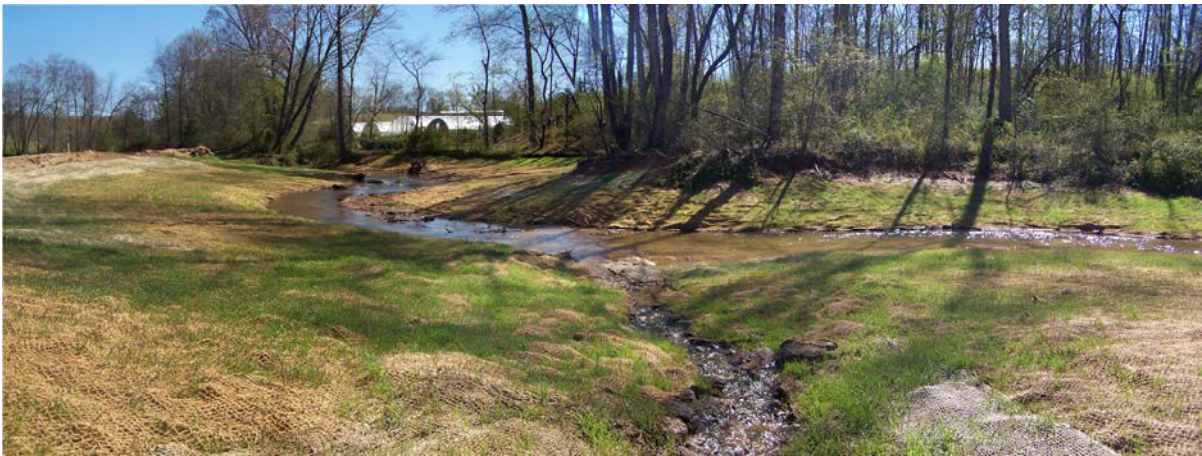
Confluence of UT-C with Silver Creek Mainstem

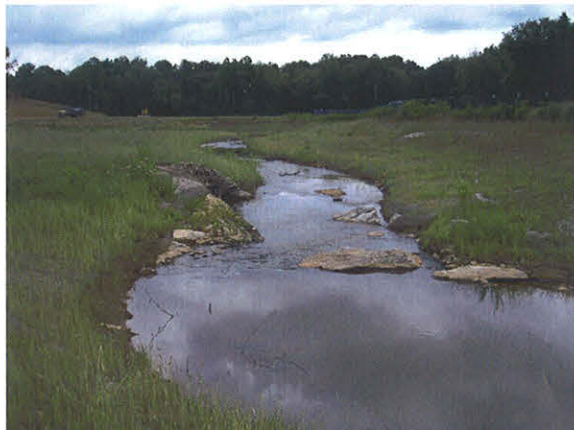
**Photograph No. 5-** J-Hook 2 Looking Downstream

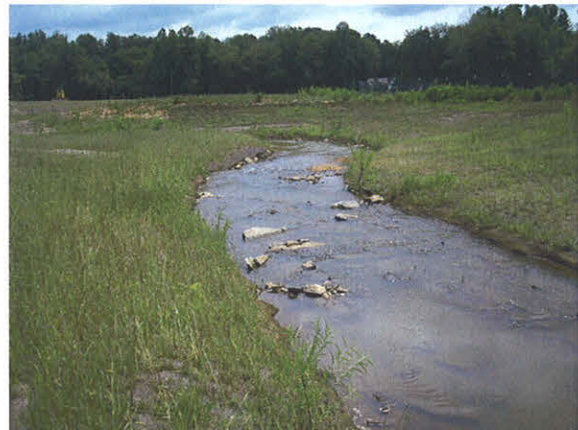
**Photograph No. 6-** Riffle 1 Looking Downstream
