Year 2 Monitoring Report for Stream Restoration of Silver Creek and Unnamed Tributaries

Burke County, NC
SCO # D05016-01

Submitted: December 2008

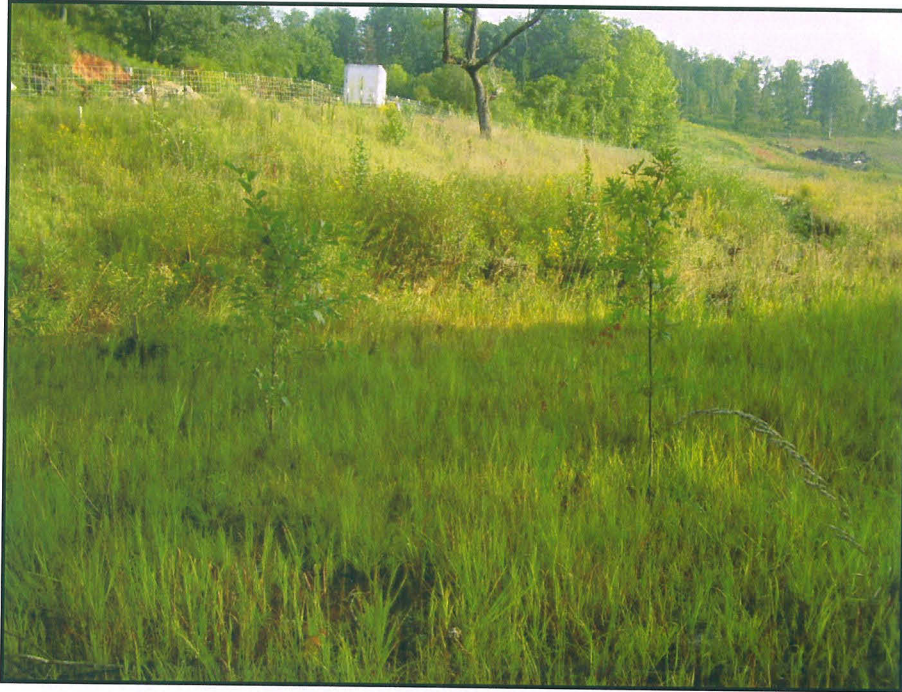
**Vegetation Plot 1 on Mainstem
Monitoring Year 2
(EMH&T, September 8, 2008)**

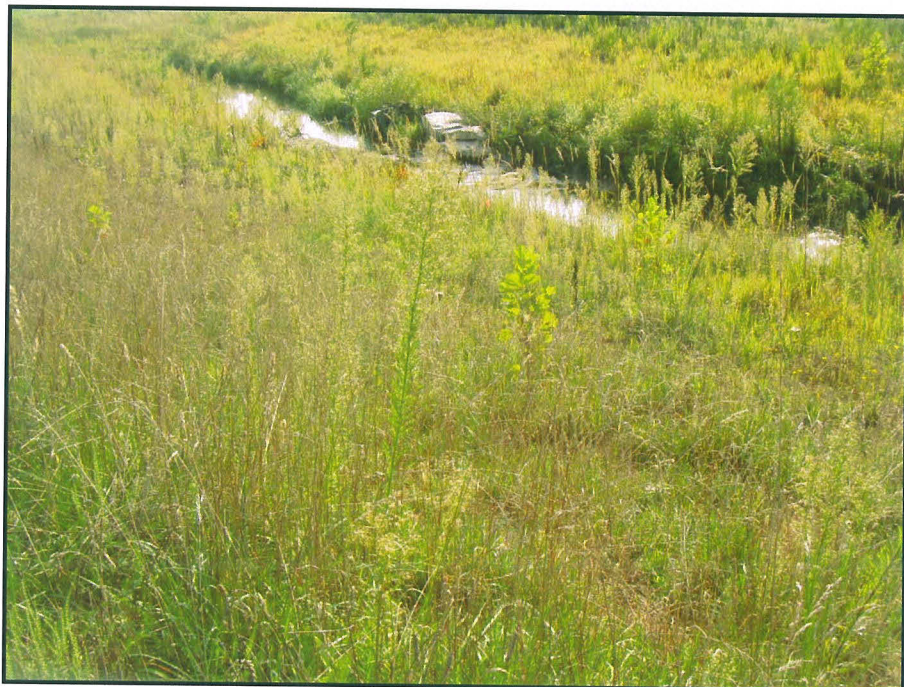
**Vegetation Plot 2 on Mainstem
Monitoring Year 2
(EMH&T, September 8, 2008)**

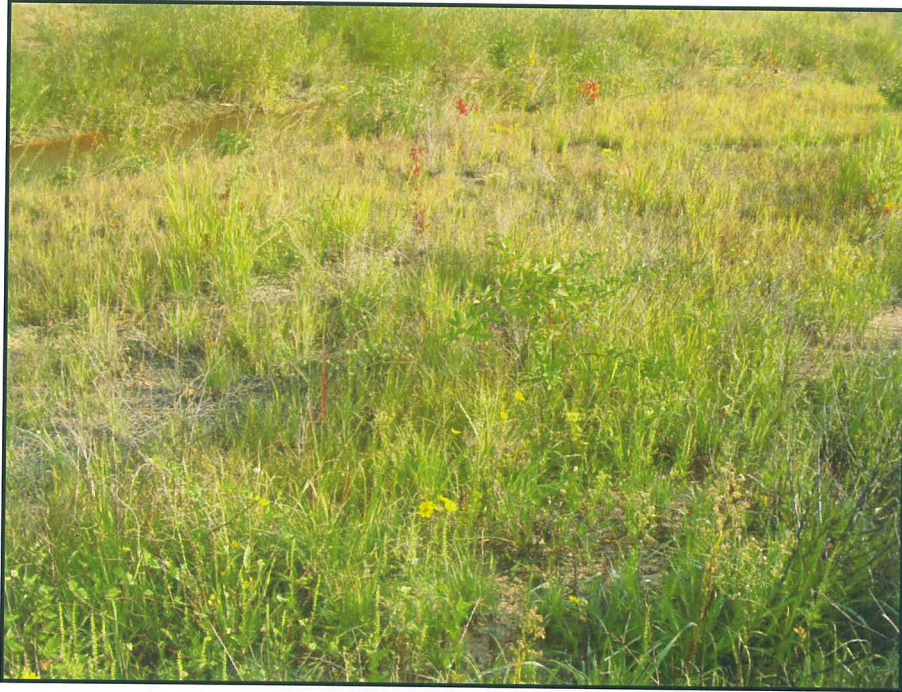
**Vegetation Plot 3 on Mainstem
Monitoring Year 2
(EMH&T, September 8, 2008)**

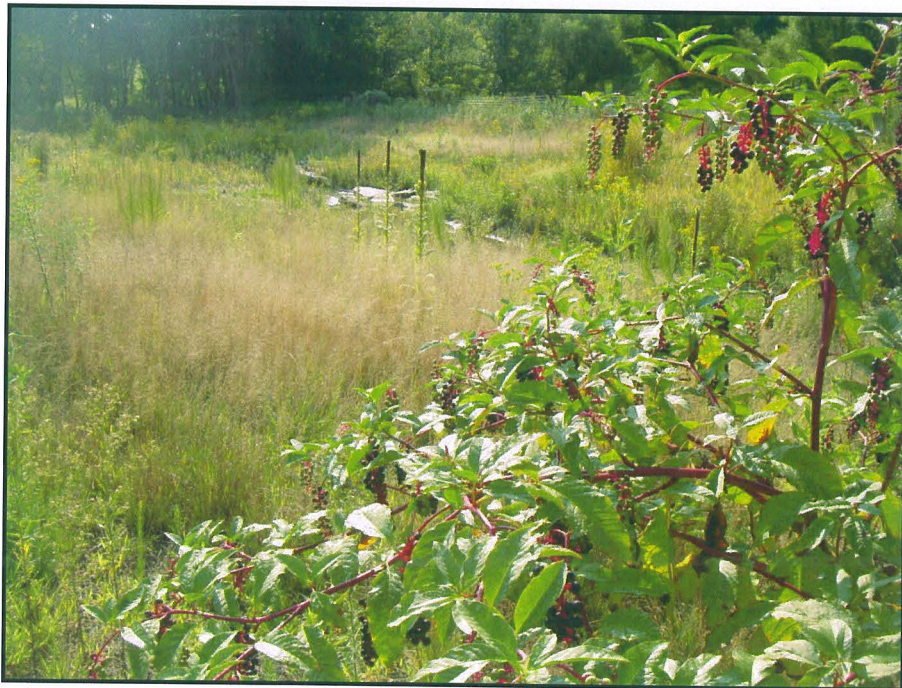
**Vegetation Plot 4 on Mainstem
Monitoring Year 2
(EMH&T, September 8, 2008)**

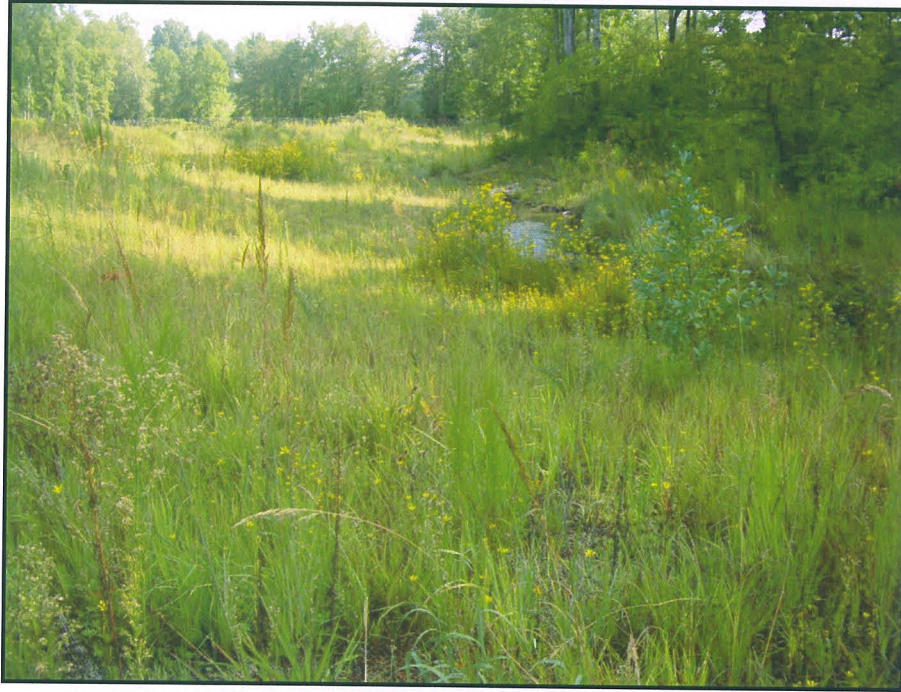
**Vegetation Plot 5 on Mainstem
Monitoring Year 2
(EMH&T, September 8, 2008)**

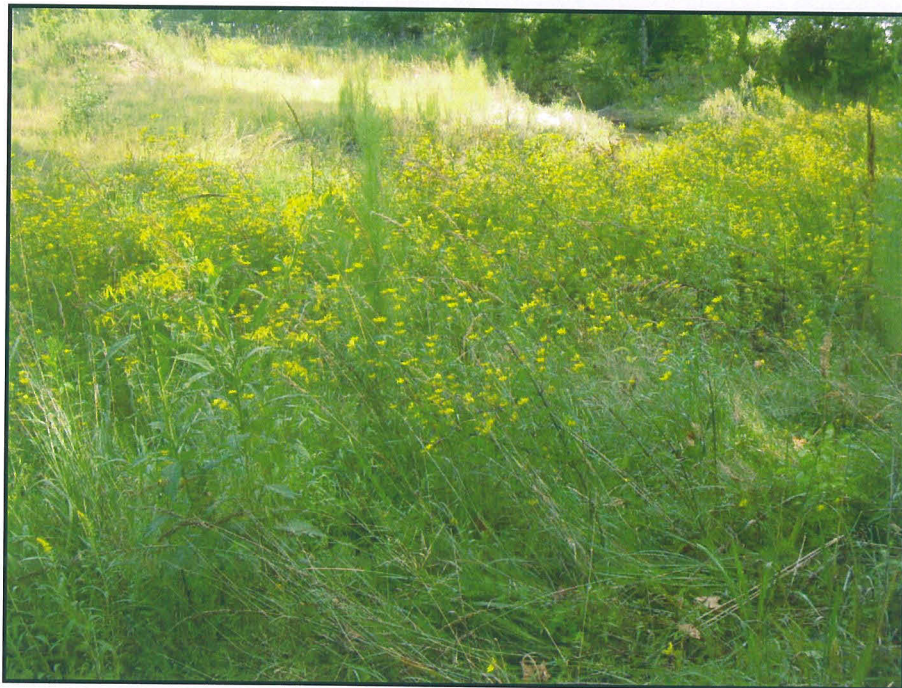
**Vegetation Plot 6 on Mainstem
Monitoring Year 2
(EMH&T, September 8, 2008)**

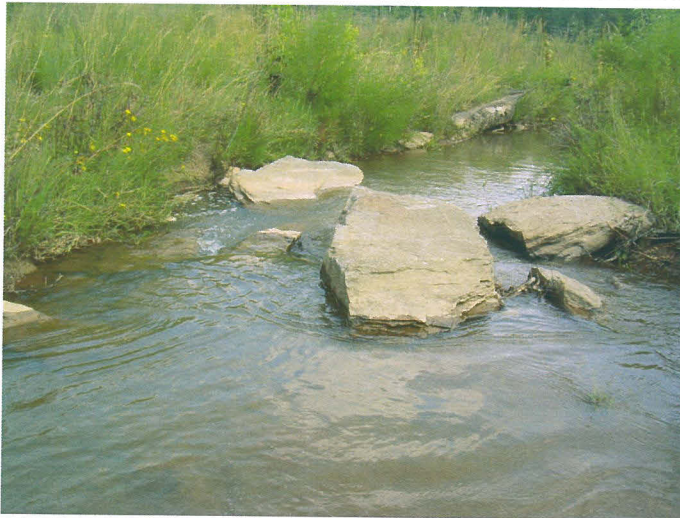
CROSS SECTION: 3
FEATURE: Pool at J-Hook # 4

Pool Cross-Section 3 at J-Hook, Log Vane, Rootwad Combination Structure (September 8, 2008)

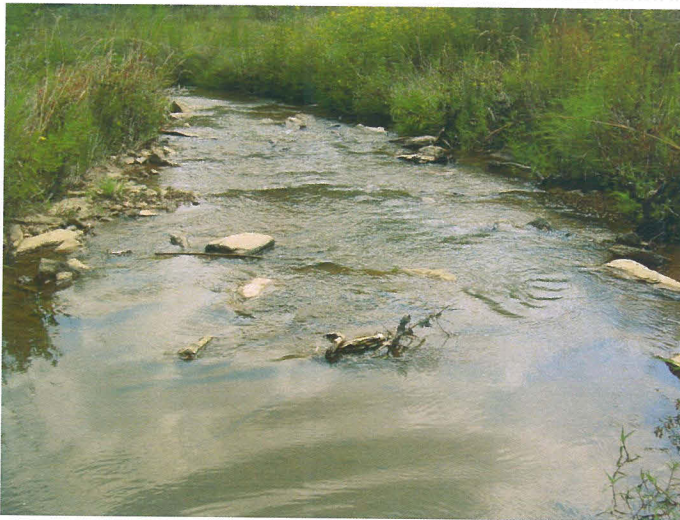
CROSS SECTION: 4
FEATURE: Riffle

**Riffle Cross-Section 4, looking downstream
 (September 8, 2008)**

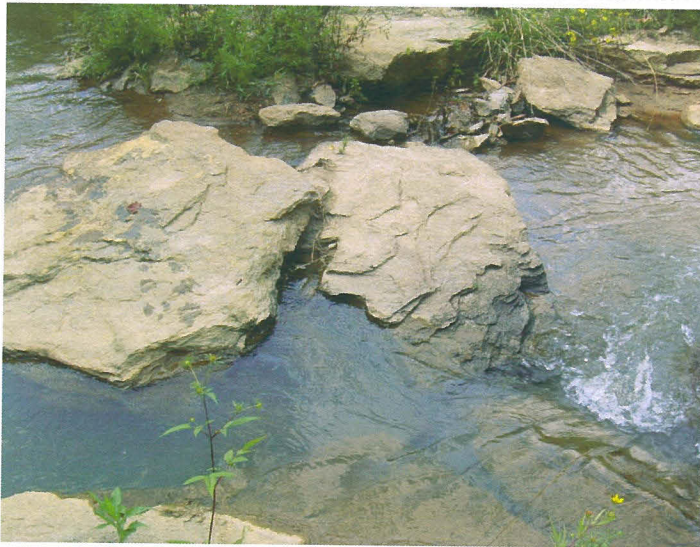
CROSS SECTION: 5
FEATURE: Riffle at J-Hook # 8

Riffle Cross-Section 5, looking from right to left across channel (September 8, 2008)

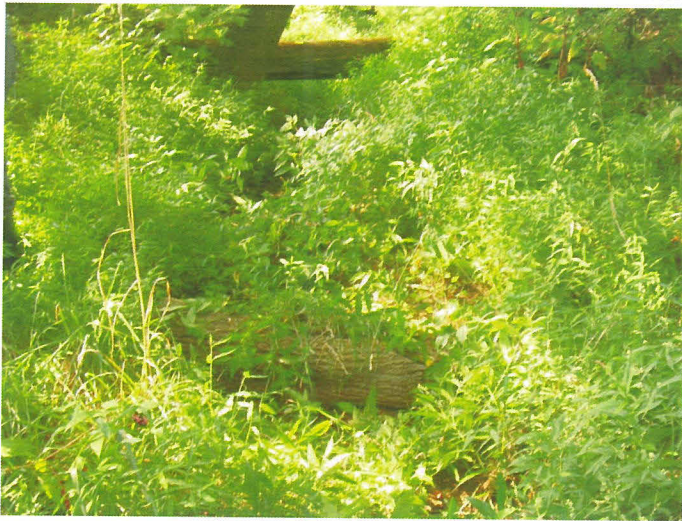
CROSS SECTION: 2
FEATURE: Pool

UTA Pool Cross-Section 2, looking upstream
(September 8, 2008)

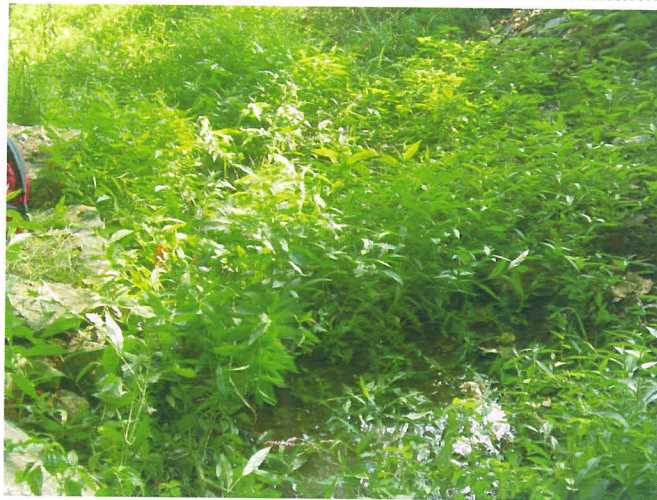
CROSS SECTION: 3
FEATURE: Pool

UTA Pool Cross-Section 3, looking from right to left across channel (September 8, 2008)

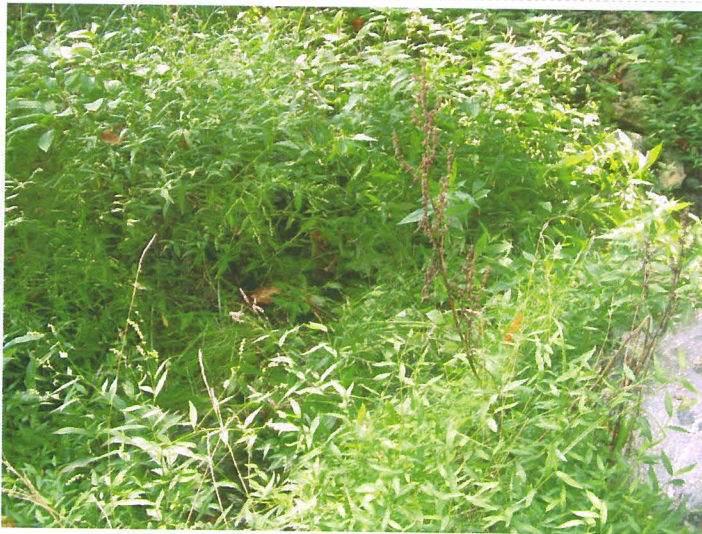
CROSS SECTION: 4
FEATURE: Riffle

UTA Riffle Cross-Section 4, looking right to left across channel (September 8, 2008)

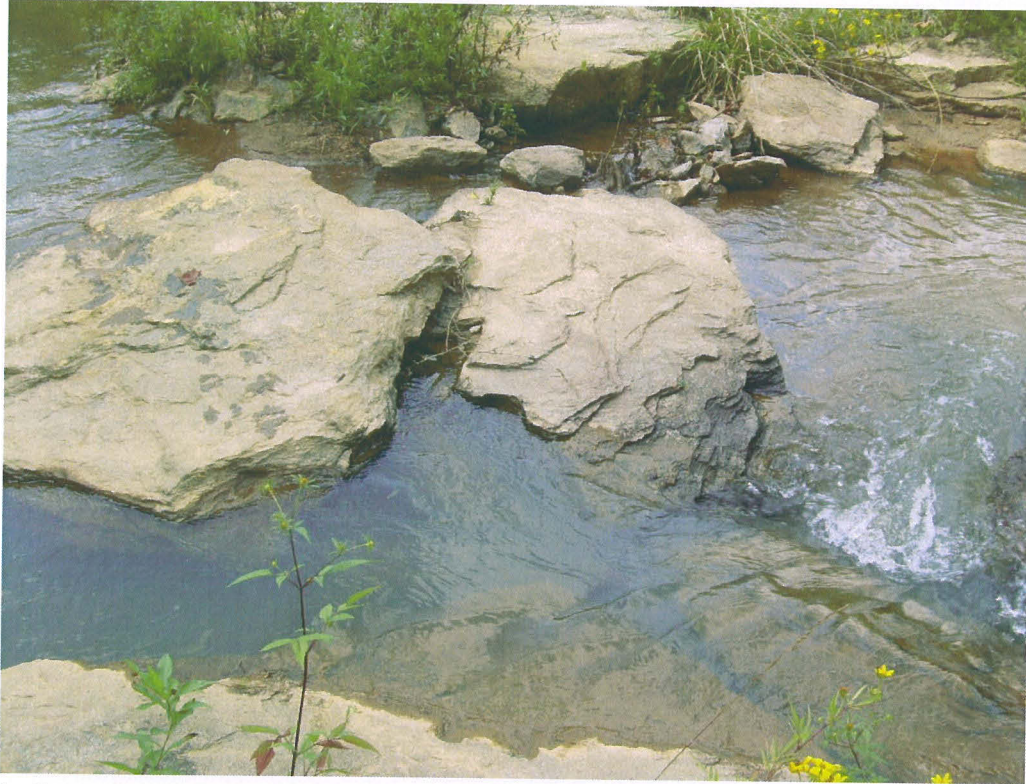
Riffle Cross-Section 5, looking from right to left across channel (September 8, 2008)

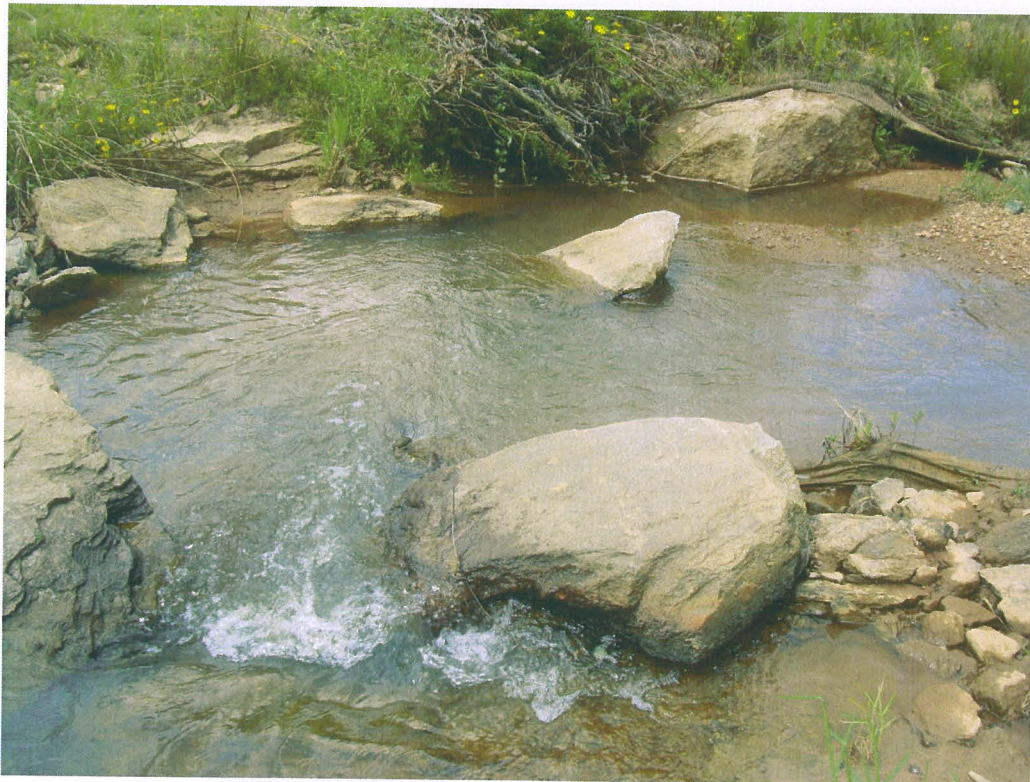
Pool Cross-Section 6, looking from right to left across channel (September 8, 2008)

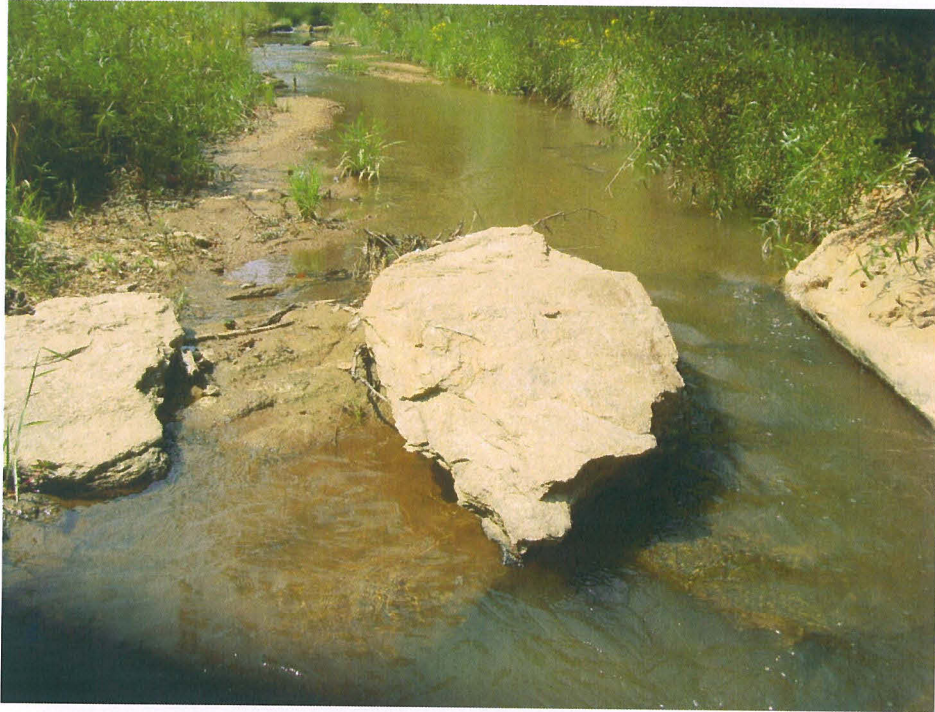
Riffle Cross-Section 1, looking downstream (September 8, 2008)

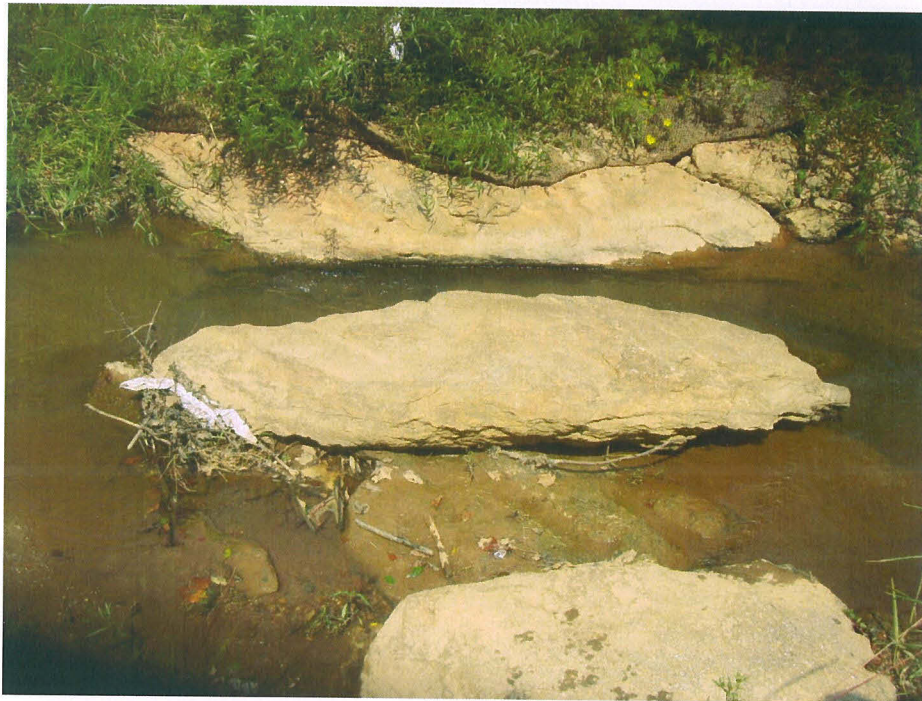
Riffle Cross-Section 1, looking right to left (September 8, 2008)

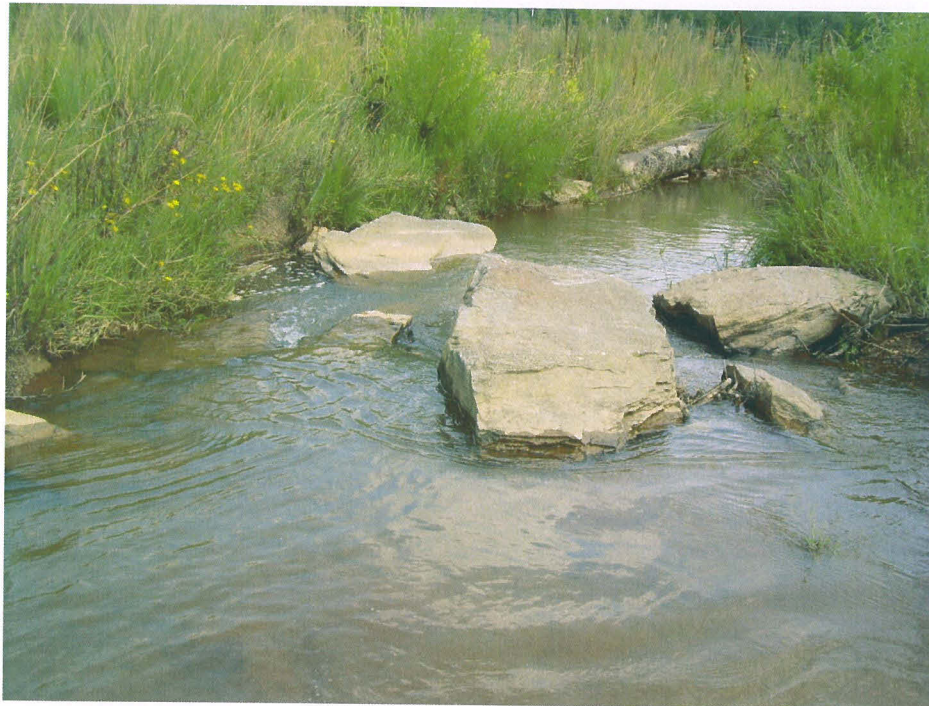
**Pool Cross-Section 3 at J-Hook, Log Vane, Rootwad Combination Structure
(September 8, 2008)**

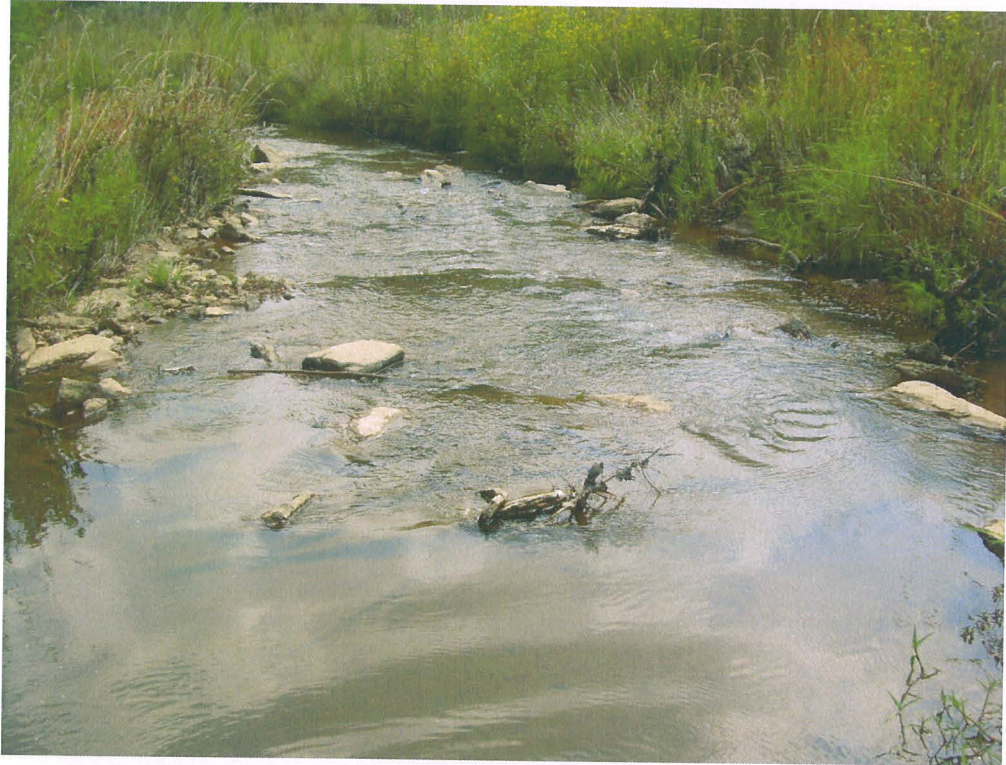
Riffle Cross-Section 4, looking downstream (September 8, 2008)
