Year 3 Monitoring Report for Stream Restoration of Silver Creek and Unnamed Tributaries

Burke County, NC
SCO # D05016-01

Submitted: December 2009

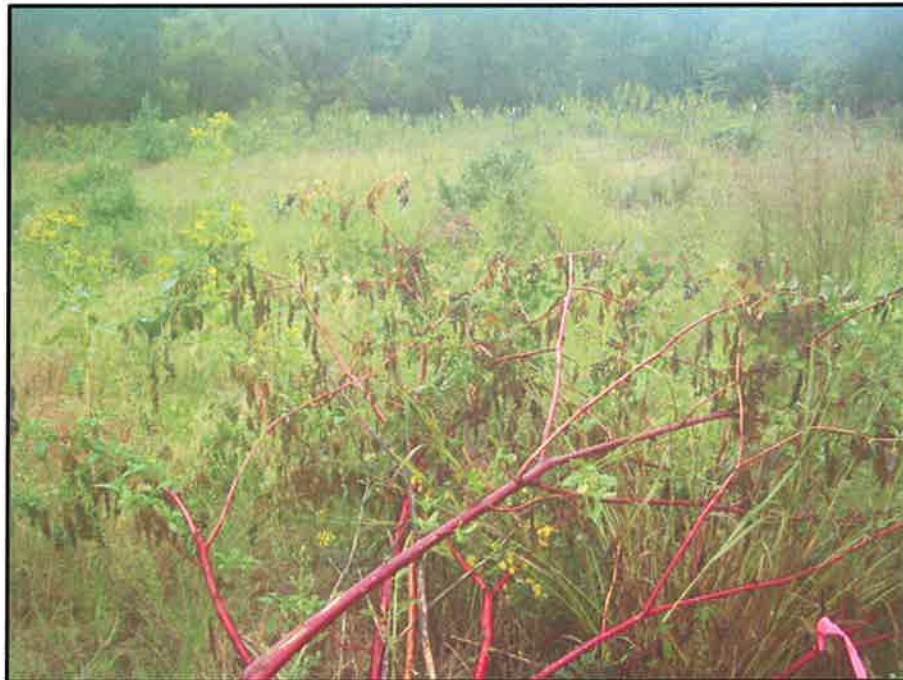
**Vegetation Plot 4 on Mainstem
Monitoring Year 3
(EMH&T, Inc. 9/17/09)**

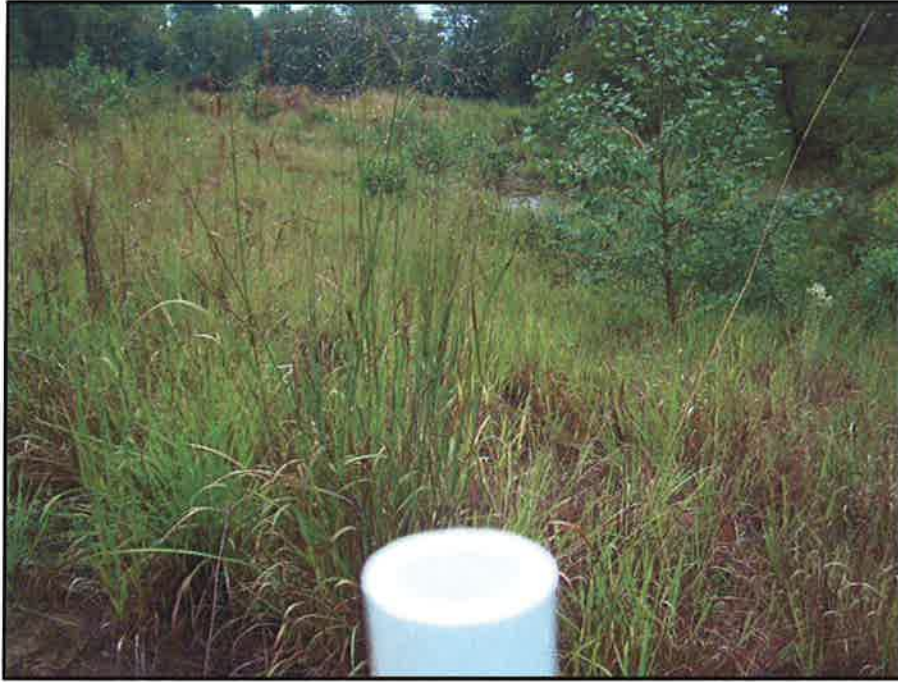
Vegetation Plot 5 on Mainstem
Monitoring Year 3
(EMH&T, Inc. 9/17/09)

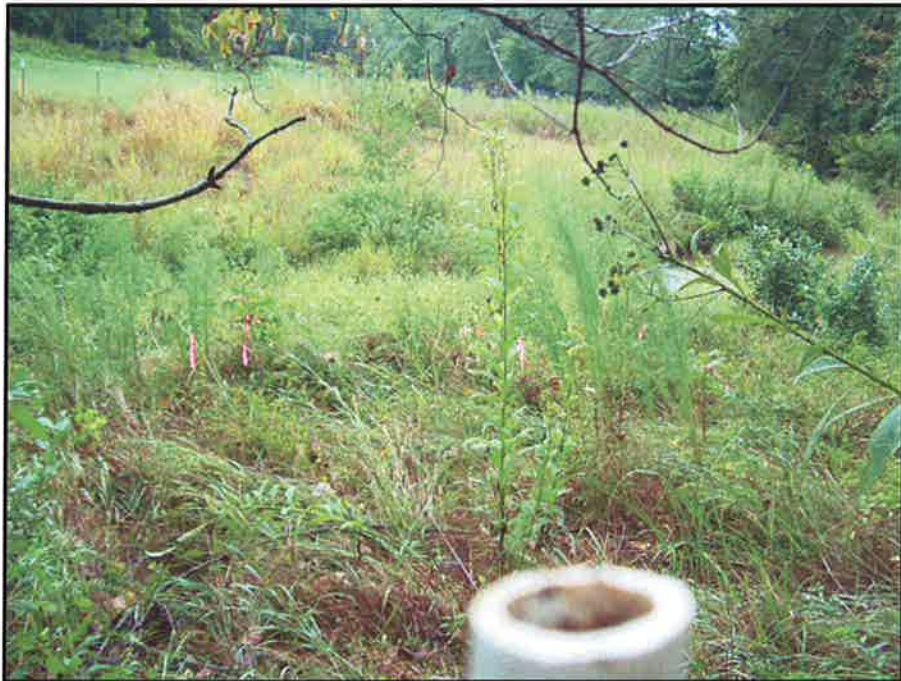
Vegetation Plot 6 on Mainstem
Monitoring Year 3
(EMH&T, Inc. 9/17/09)

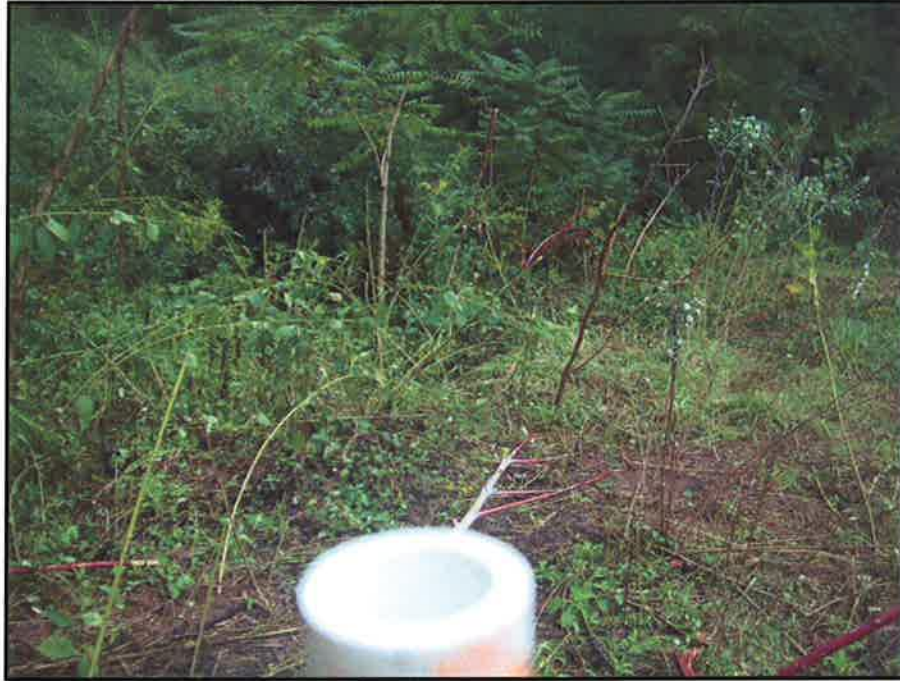
Vegetation Plot 1 on Tributary A
Monitoring Year 3
(EMH&T, Inc. 9/17/09)

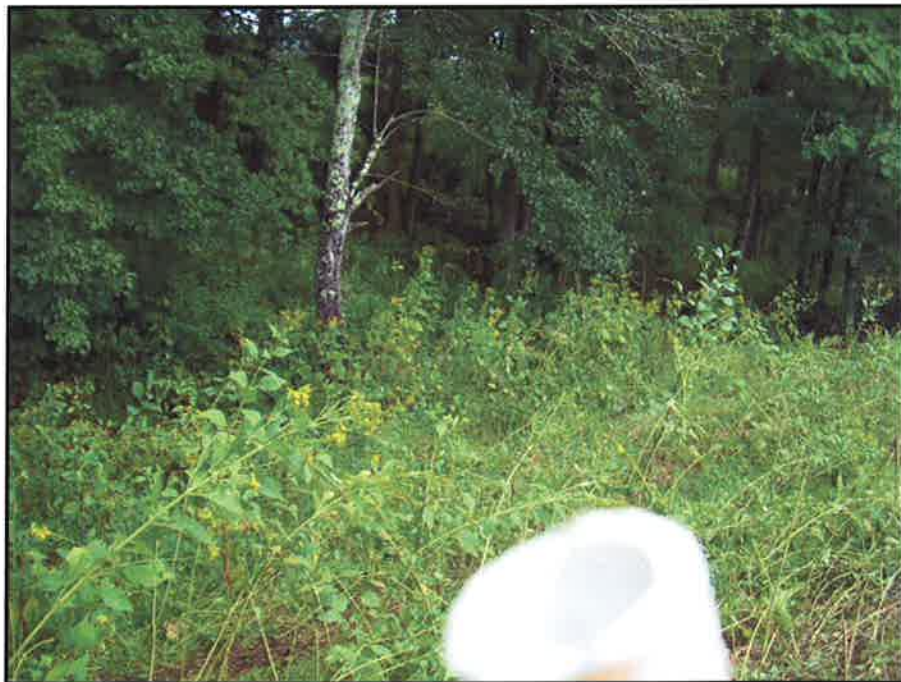
Vegetation Plot 2 on Tributary A
Monitoring Year 3
(EMH&T, Inc. 9/17/09)

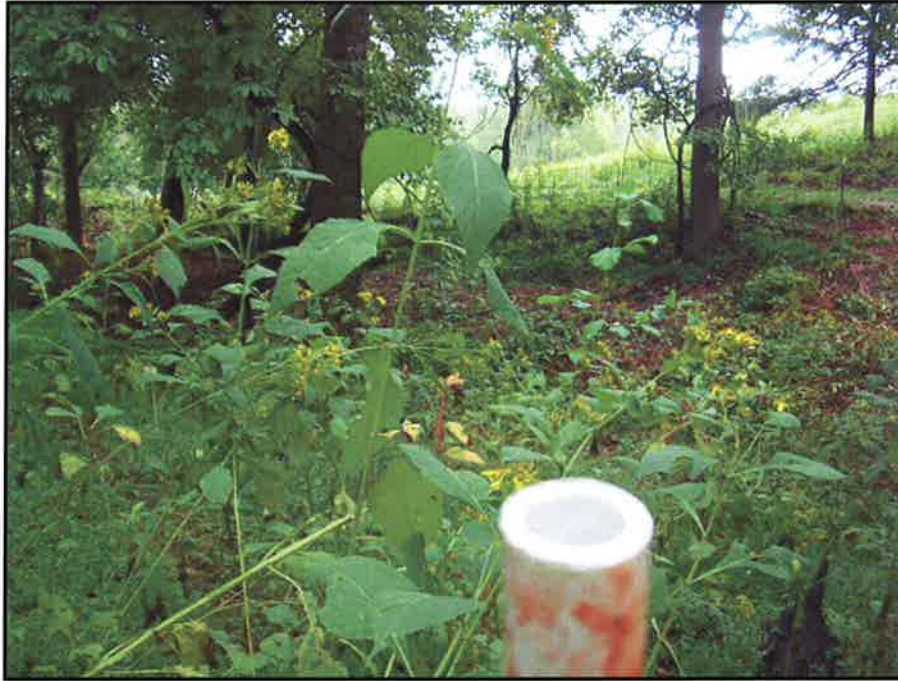
Vegetation Plot 3 on Tributary A
Monitoring Year 3
(EMH&T, Inc. 9/17/09)

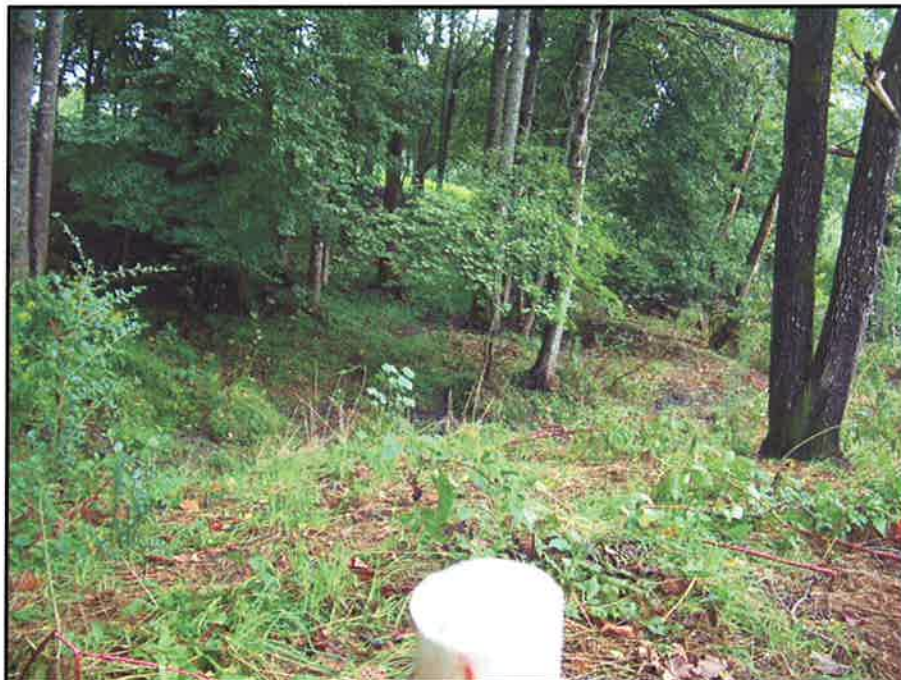
Vegetation Plot 4 on Tributary A
Monitoring Year 3
(EMH&T, Inc. 9/17/09)

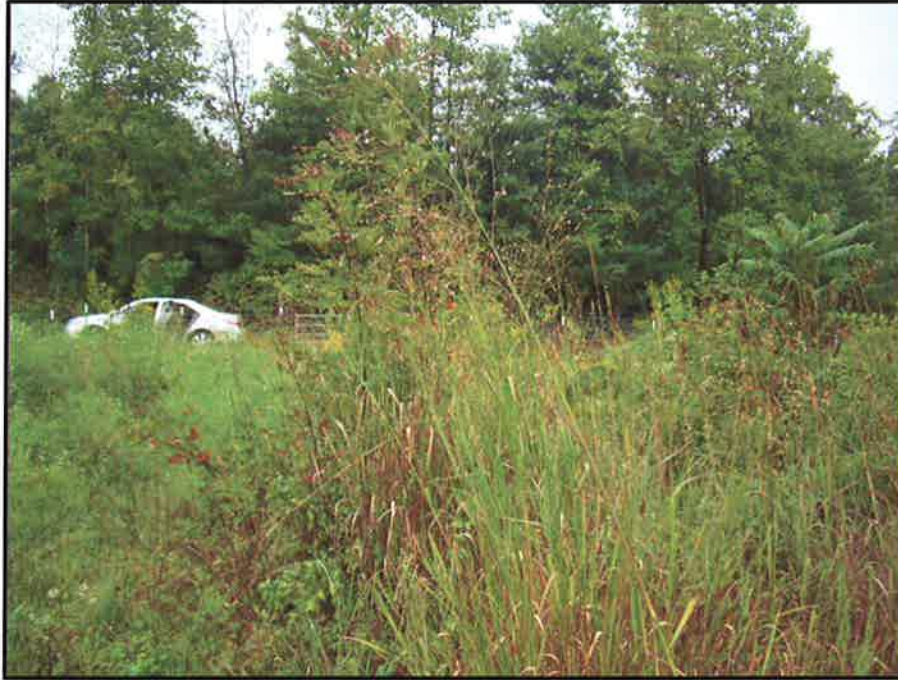
Vegetation Plot on Tributary B
Monitoring Year 3
(EMH&T, Inc. 9/17/09)

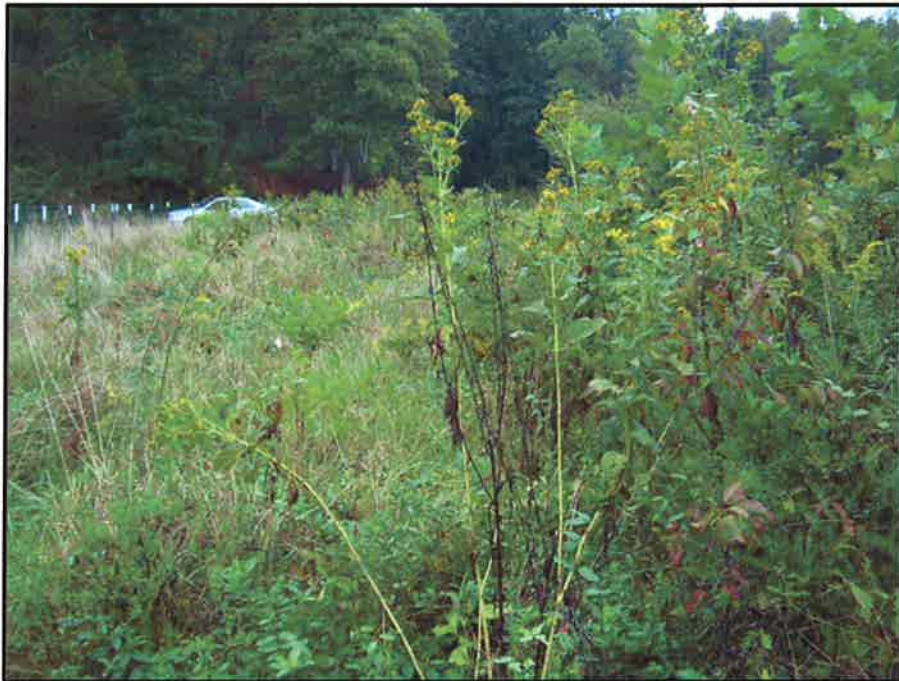
Vegetation Plot on Tributary C
Monitoring Year 3
(EMH&T, Inc. 9/17/09)

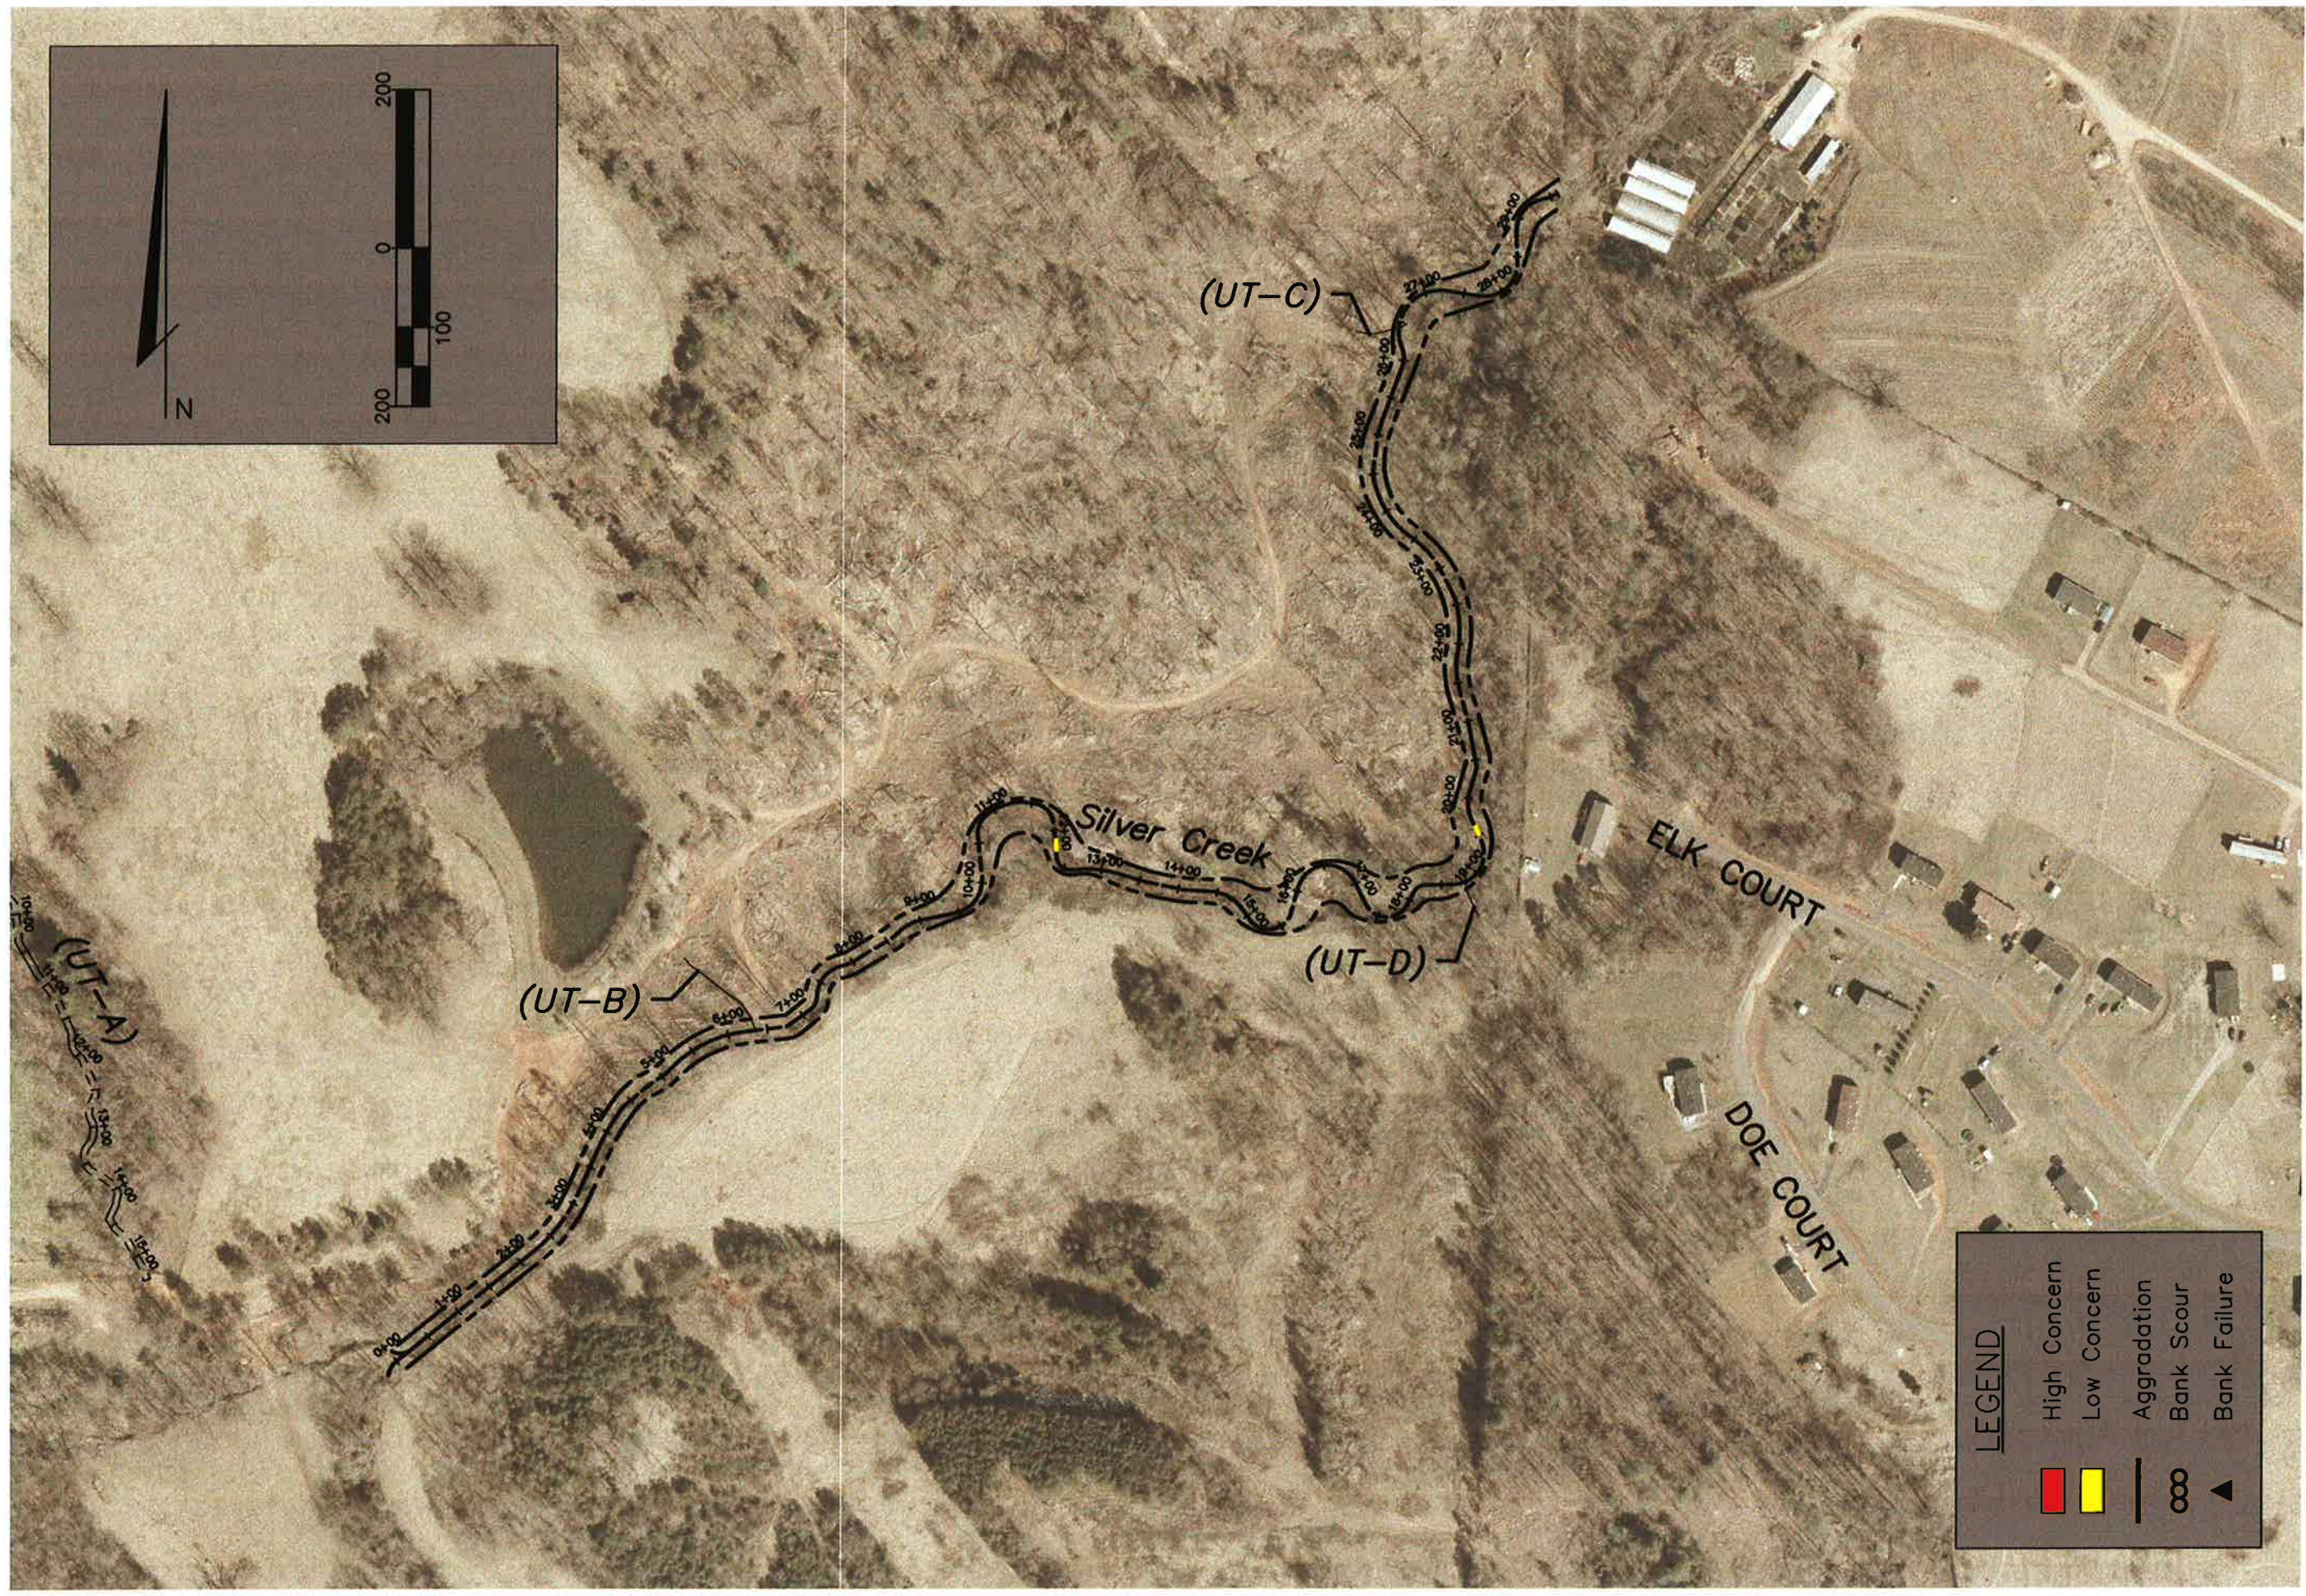
Table Xc. Stream Problem Areas – Year 3 Silver Creek Stream Restoration / EEP Project No. D05016-1			
Feature Issue	Station Numbers	Suspected Cause	Photo Number
Aggradation	12+20 Mainstem	Mid-channel bar downstream of J-hook	SPA 1
	19+50 Mainstem	Mid-channel bar downstream of J-hook	
Bank scour	0+25 UTA	Bank scour/ sloughing on right bank	SPA 2,3
	2+40 – 2+60 UTA	Bank scour/ sloughing by log vane along left bank	
	3+55 UTA	Bank scour/ sloughing on right bank	
	5+60 UTA	Bank scour/ sloughing on left bank	
	8+50 UTA	Vertical bank along the right bank	
	10+50 UTA	Bank scour/ sloughing	
Other	11+00 - 13+00 UTA	Nearly vertical banks – have been reshaped, damaged by cattle intrusion	SPA 4,5
	Throughout UTA; most extensive from 11+00 to downstream project terminus	Cattle intrusion into stream channel and along stream banks

Two small areas of aggradation were noted along the Silver Creek Mainstem. The mid-channel bars that have formed downstream of J-hook features are small and are not posing a threat to stream stability. These features are noted as problem areas of low concern in order that they be watched in future years of monitoring.

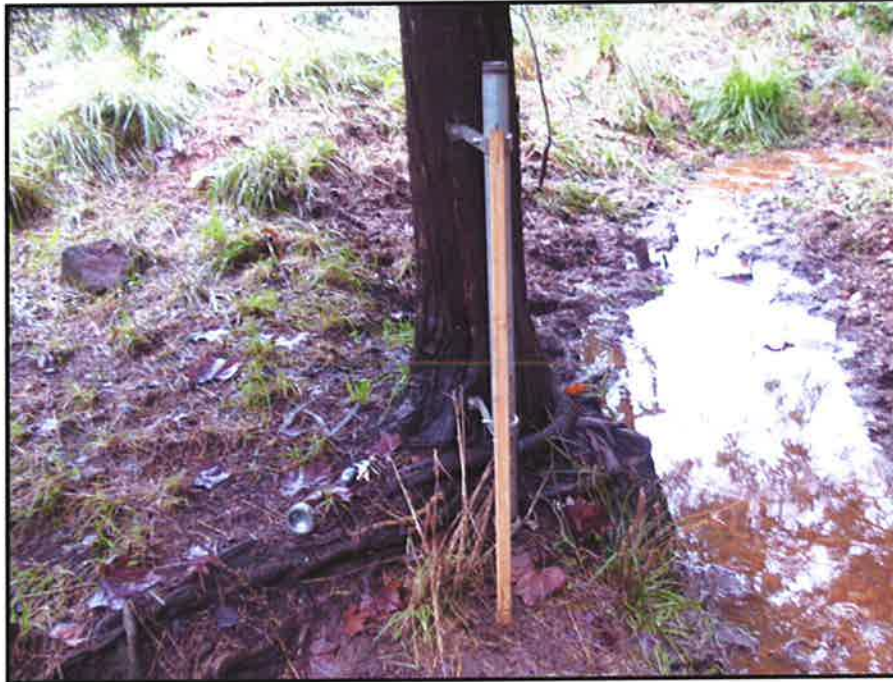
BF 1
Crest Gage on Silver Creek UT.
(EMH&T, Inc. 9/21/09)
