Year 4 Monitoring Report for Stream Restoration of Silver Creek and Unnamed Tributaries

Burke County, NC
SCO # D05016-01

Submitted: February 2011

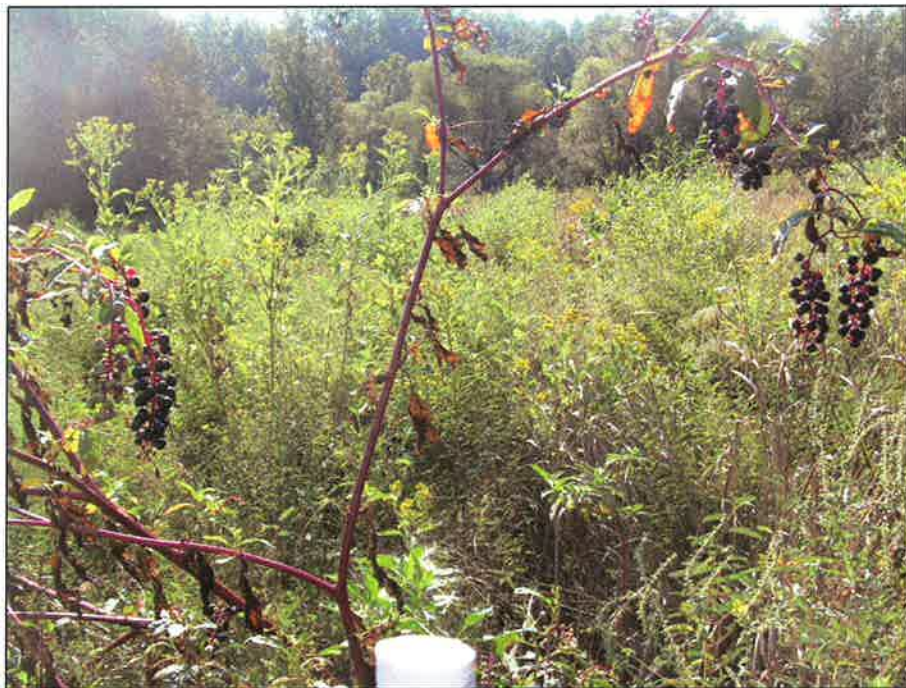
Vegetation Plot 4 on Mainstem
Monitoring Year 4
(EMH&T, Inc. 9/17/10)

The average stem density for the site meets the minimum criteria of 288 stems per acre after four years. However, two of the ten vegetation plots fall below this threshold number. The largest deficit occurred along the Unnamed Tributary, where cattle intrusion had killed several trees and severely damaged others. In previous years, seedling mortality had been an issue along the entire length of the unnamed tributary. While the woody plantings were focused on areas of open canopy in the existing tree cover, the presence of large trees and the well-developed existing vegetative cover shades the smaller seedlings and provides substantial competition for resources. Plots 4 and 5 along the mainstem exhibited decent survivability when compared to 2009; however, both plots remain slightly under the goal woody stem count of 288 stems/acre. The presence of dry sandy soil could partially explain the lower stem counts of Plots 4 & 5.

To address the issue of low plant stem counts on those plots affected by cattle intrusion, specific areas will be targeted for replanting within the Silver Creek and Unnamed Tributary riparian corridors, which will include the deficient sample plots and surrounding areas within the buffer. All deficient portions of the riparian corridors will be supplemented with additional native tree and shrub plantings. These supplemental plantings will follow the specifications of the project proposed in the project Restoration Plan and Mitigation Plan documents. Consideration will be given to using larger woody stock, such as three-gallon potted material versus bare root specimen in performing the remedial plantings. These larger saplings should have a more developed root system and thus be better able to compete with the existing vegetation. Species more suitable for full or partial shade will also be included in the species mix to provide better survivability under the existing canopy. Supplemental replanting will occur during spring 2011.

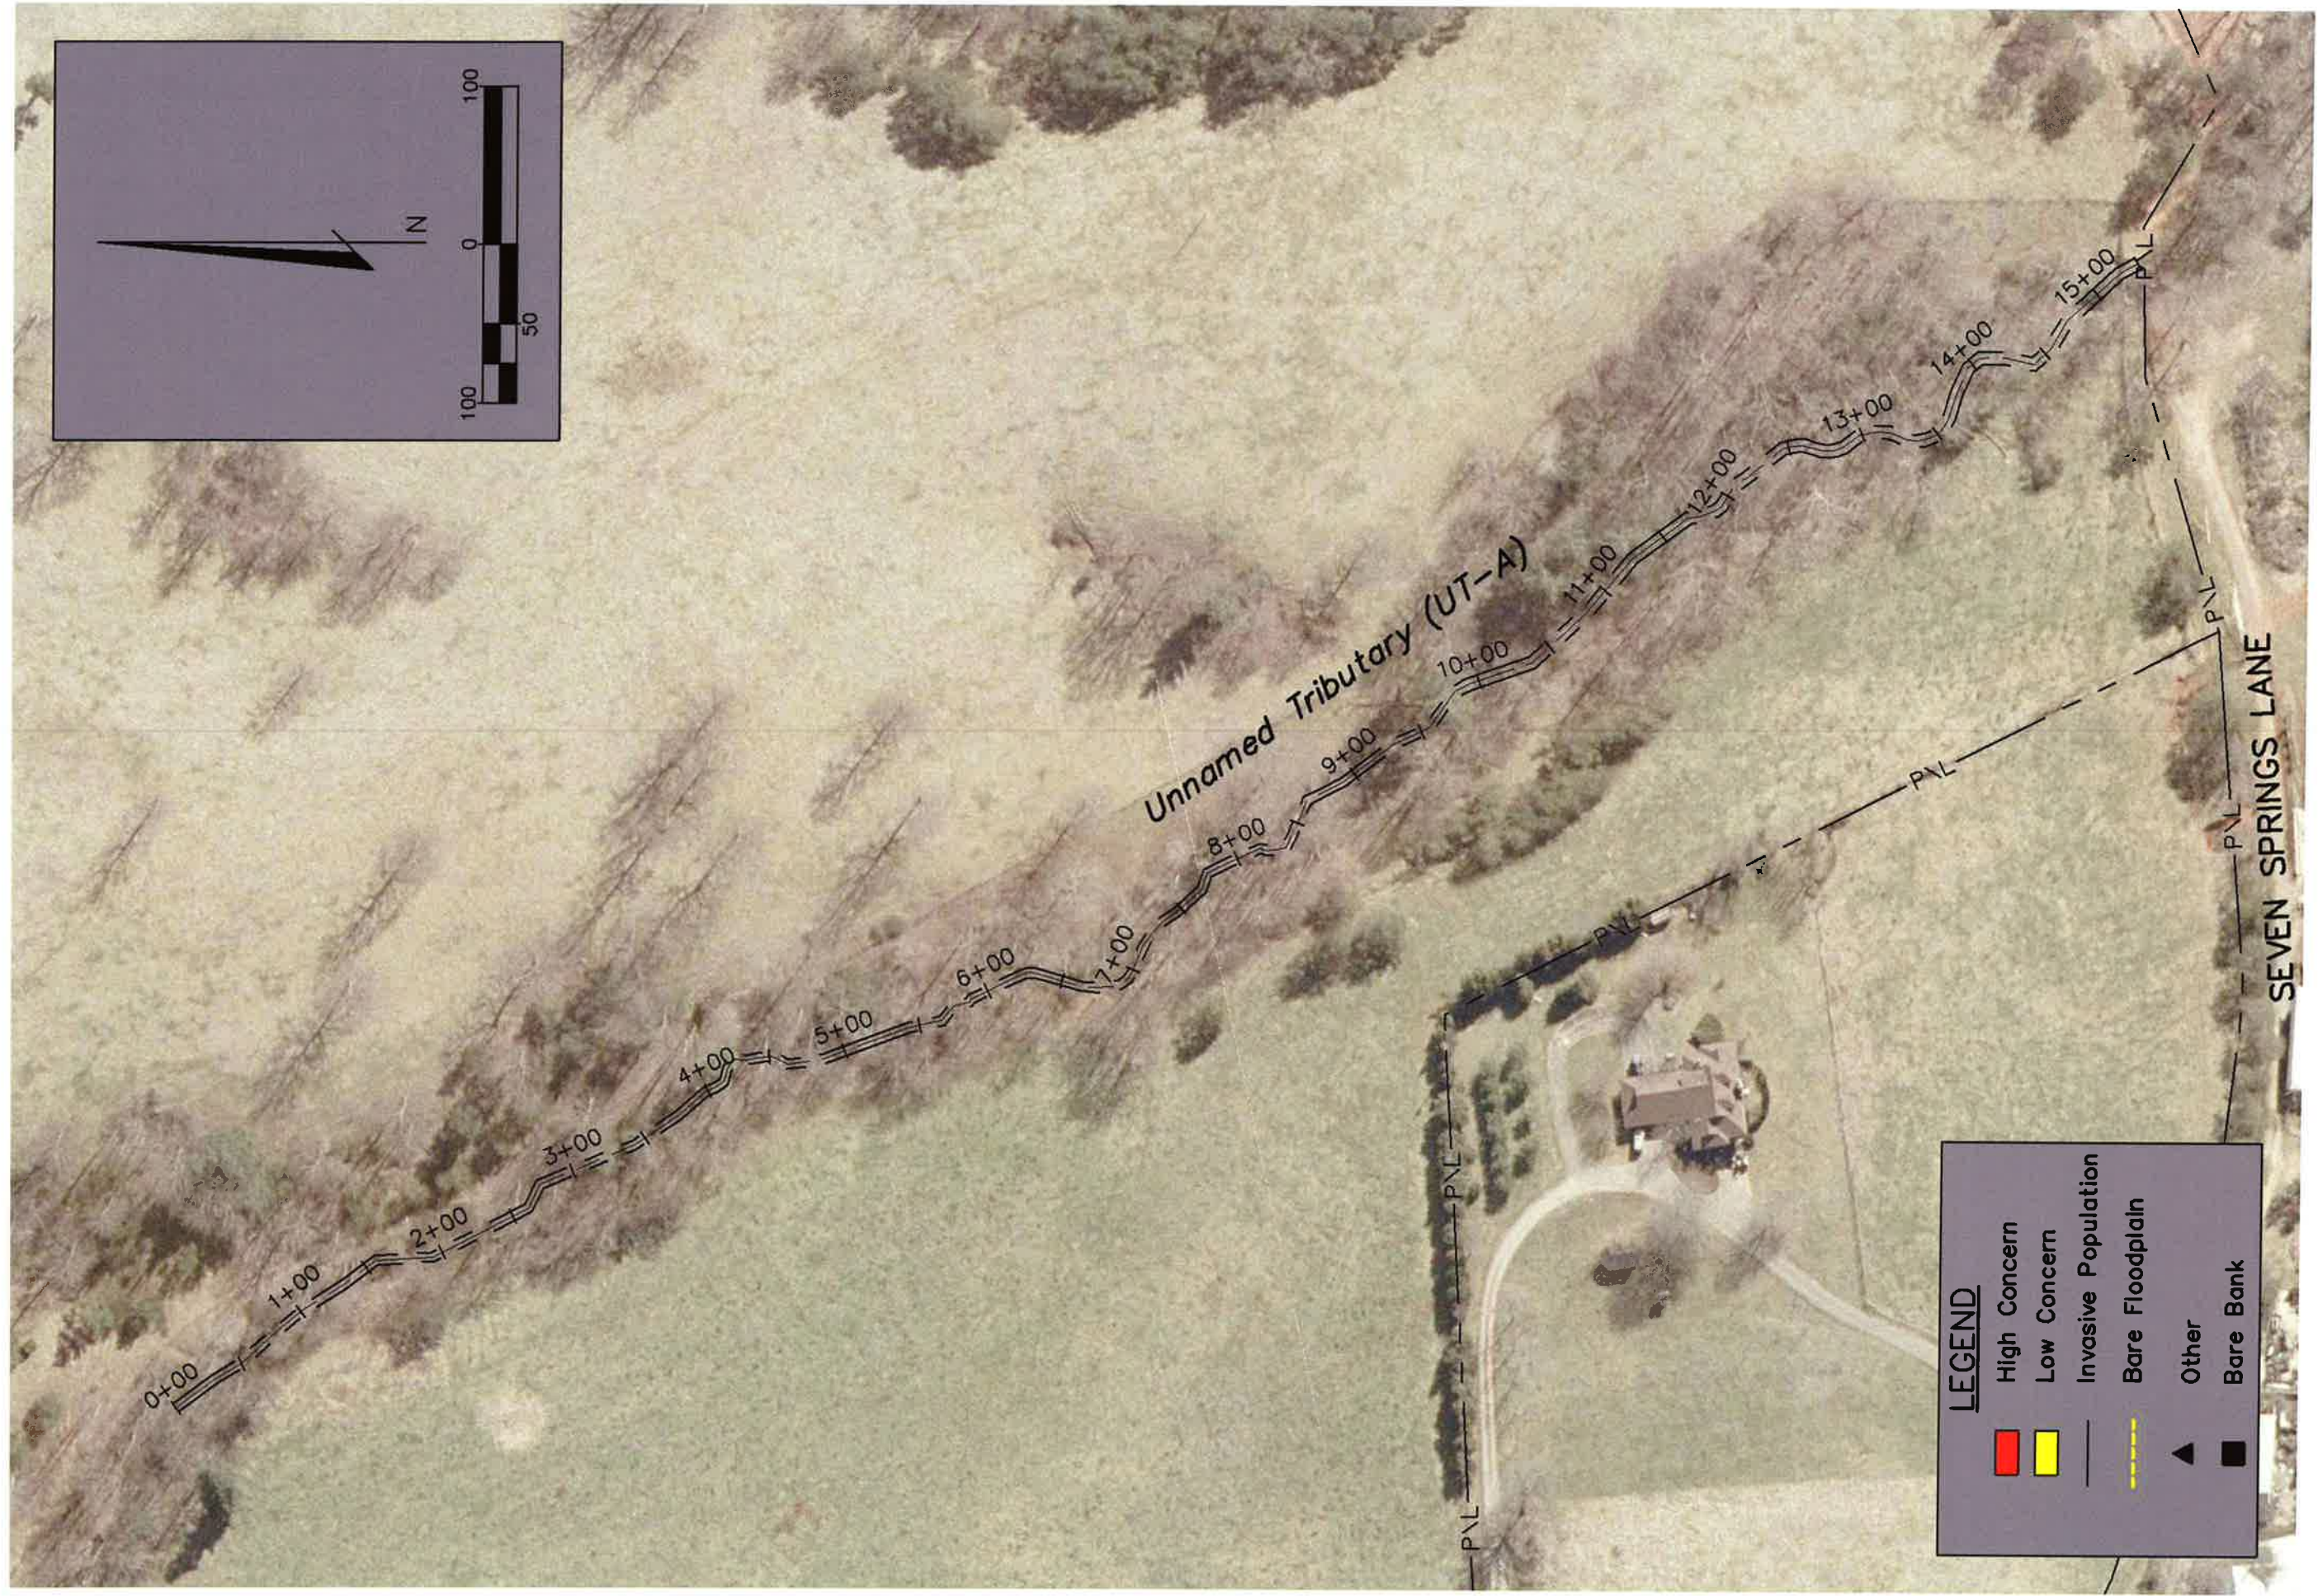
Table VII. Vegetative Problem Areas Silver Creek Stream Restoration / EEP Project No. D05016-1			
Feature/Issue	Station # / Range	Probable Cause	Photo #
Bare Floodplain	Mainstem: 12+00-16+50	Sparse vegetation along riparian corridor; likely due to poor soil	VPA 1

A few areas along the Silver Creek Mainstem were noted to have low overall herbaceous cover along the riparian corridor. These areas are patchy and scattered throughout the corridor, with none of the areas showing banks that are completely bare. Along the majority of the riparian corridor, vegetation cover has increased since Year 3 monitoring, as is depicted in the fixed station photos (Appendix B). Because of extensive vegetation growth, all other areas along the riparian corridor have been removed from Table VII and the Vegetation Problem Area Plan view (Appendix A). Between stations 12+00 and 16+50, bare soil remains evident on both sides of the corridor. It is fully expected that vegetation will continue to spread into this section over the next year. Accordingly, this stretch of the mainstem remains on Table VII and is mapped on the Vegetation Problem Area Plan View as an area of low concern.

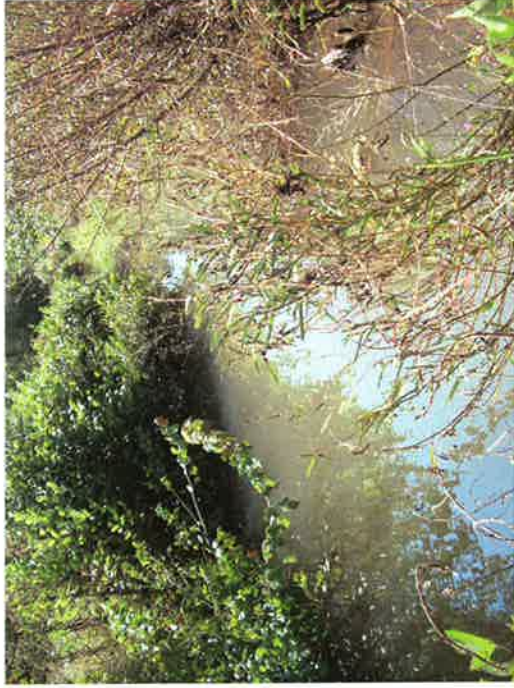
Pool Cross-Section 2, looking upstream

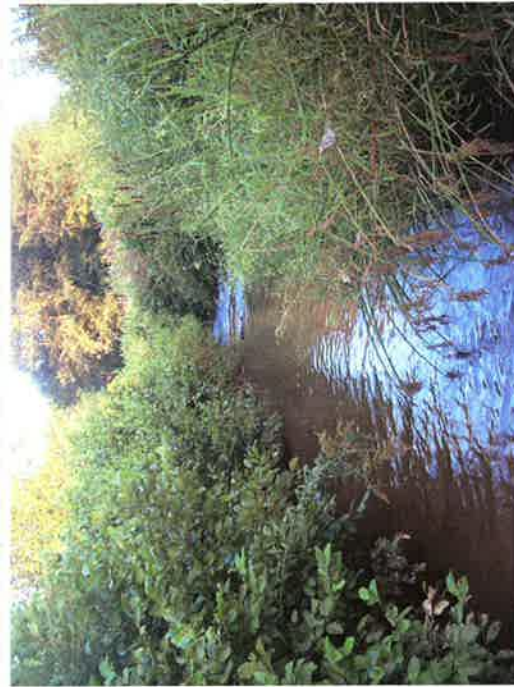
CROSS SECTION: 3

Pool Cross-Section 3, looking downstream

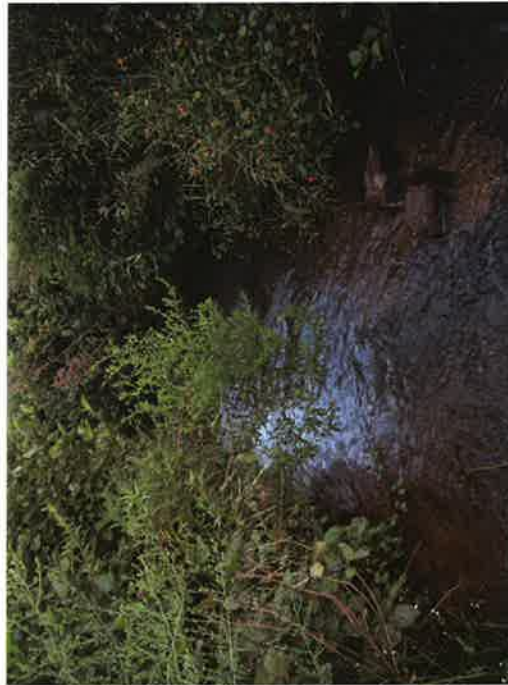
CROSS SECTION: 4

Riffle Cross-Section 4, looking downstream

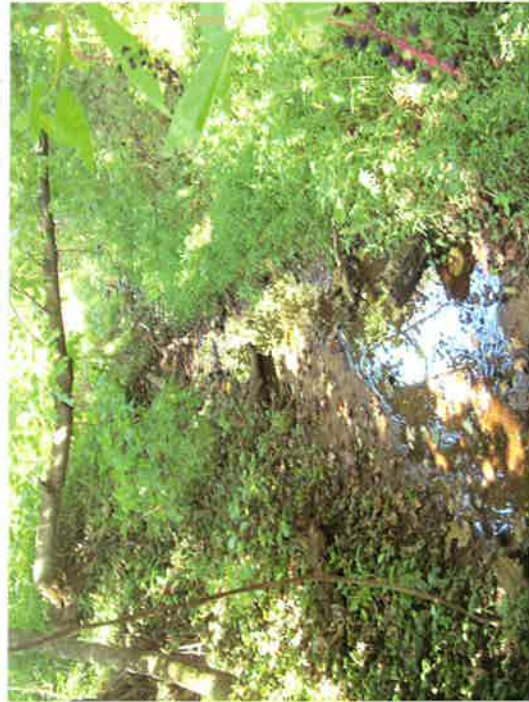
CROSS SECTION: 1

UTA Cross-Section 1, looking upstream

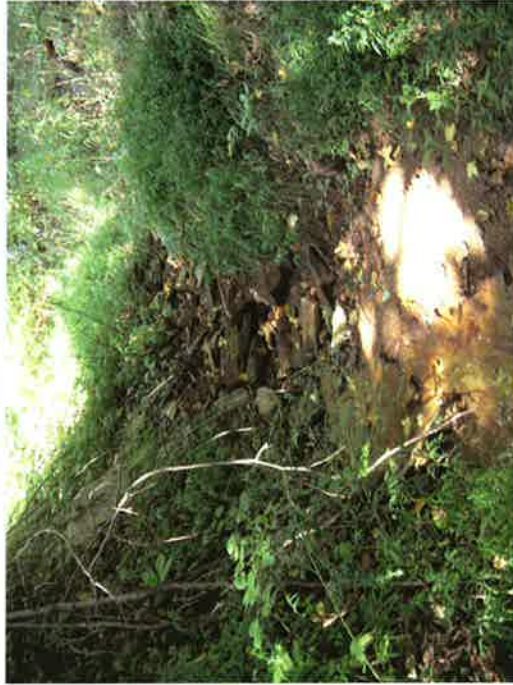
CROSS SECTION: 2

UTA Pool Cross-Section 2, looking upstream

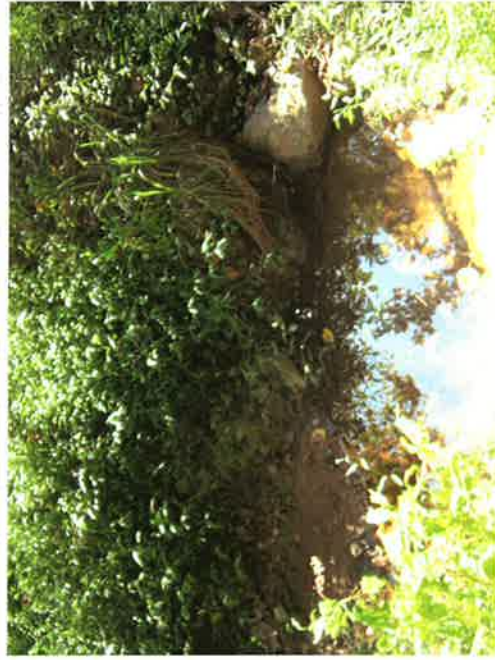
CROSS SECTION: 3

UTA Pool Cross-Section 3, looking from left to right bank

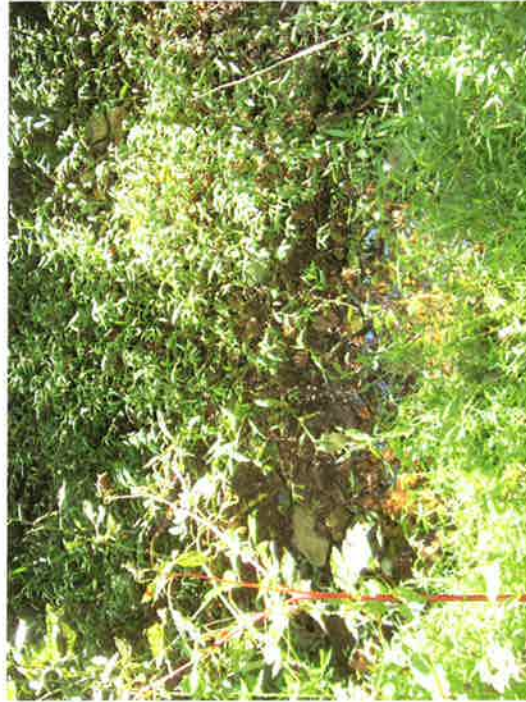
CROSS SECTION: 4

UTA Riffle Cross-Section 4, looking left to right bank

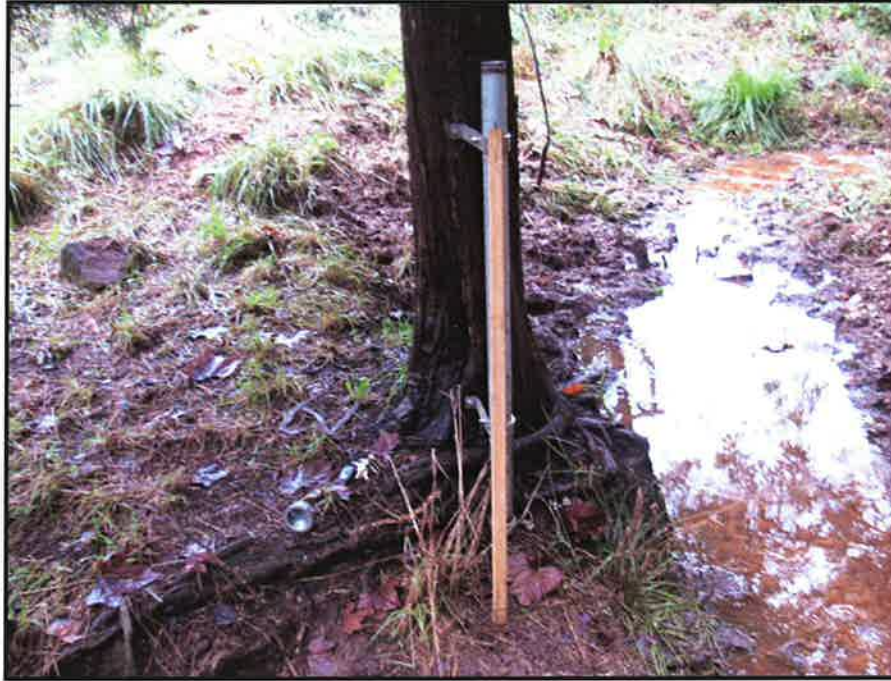
BF 1
Crest Gage on Silver Creek UT.
(EMH&T, Inc. 9/21/09)

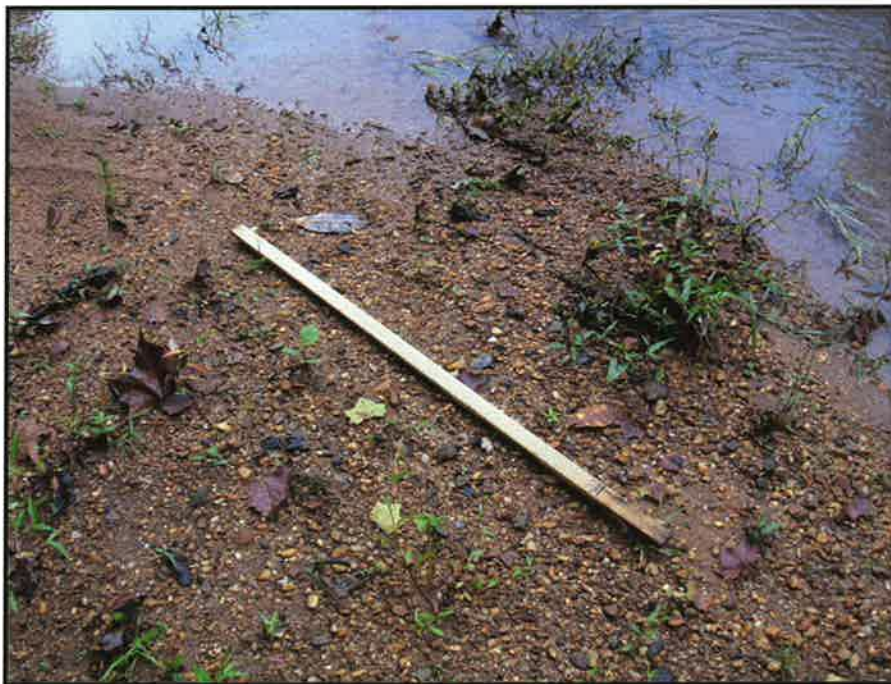
BF 2
Crest Gage on Silver Creek Mainstem.
(EMH&T, Inc. 9/21/09)

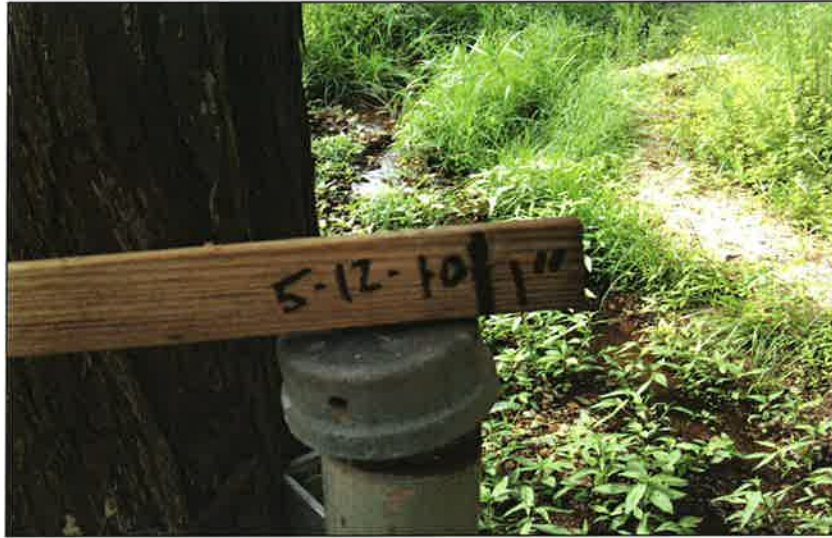
BF 3
Crest Gage on Silver Creek UT.
(EMH&T, Inc. 5/12/10)

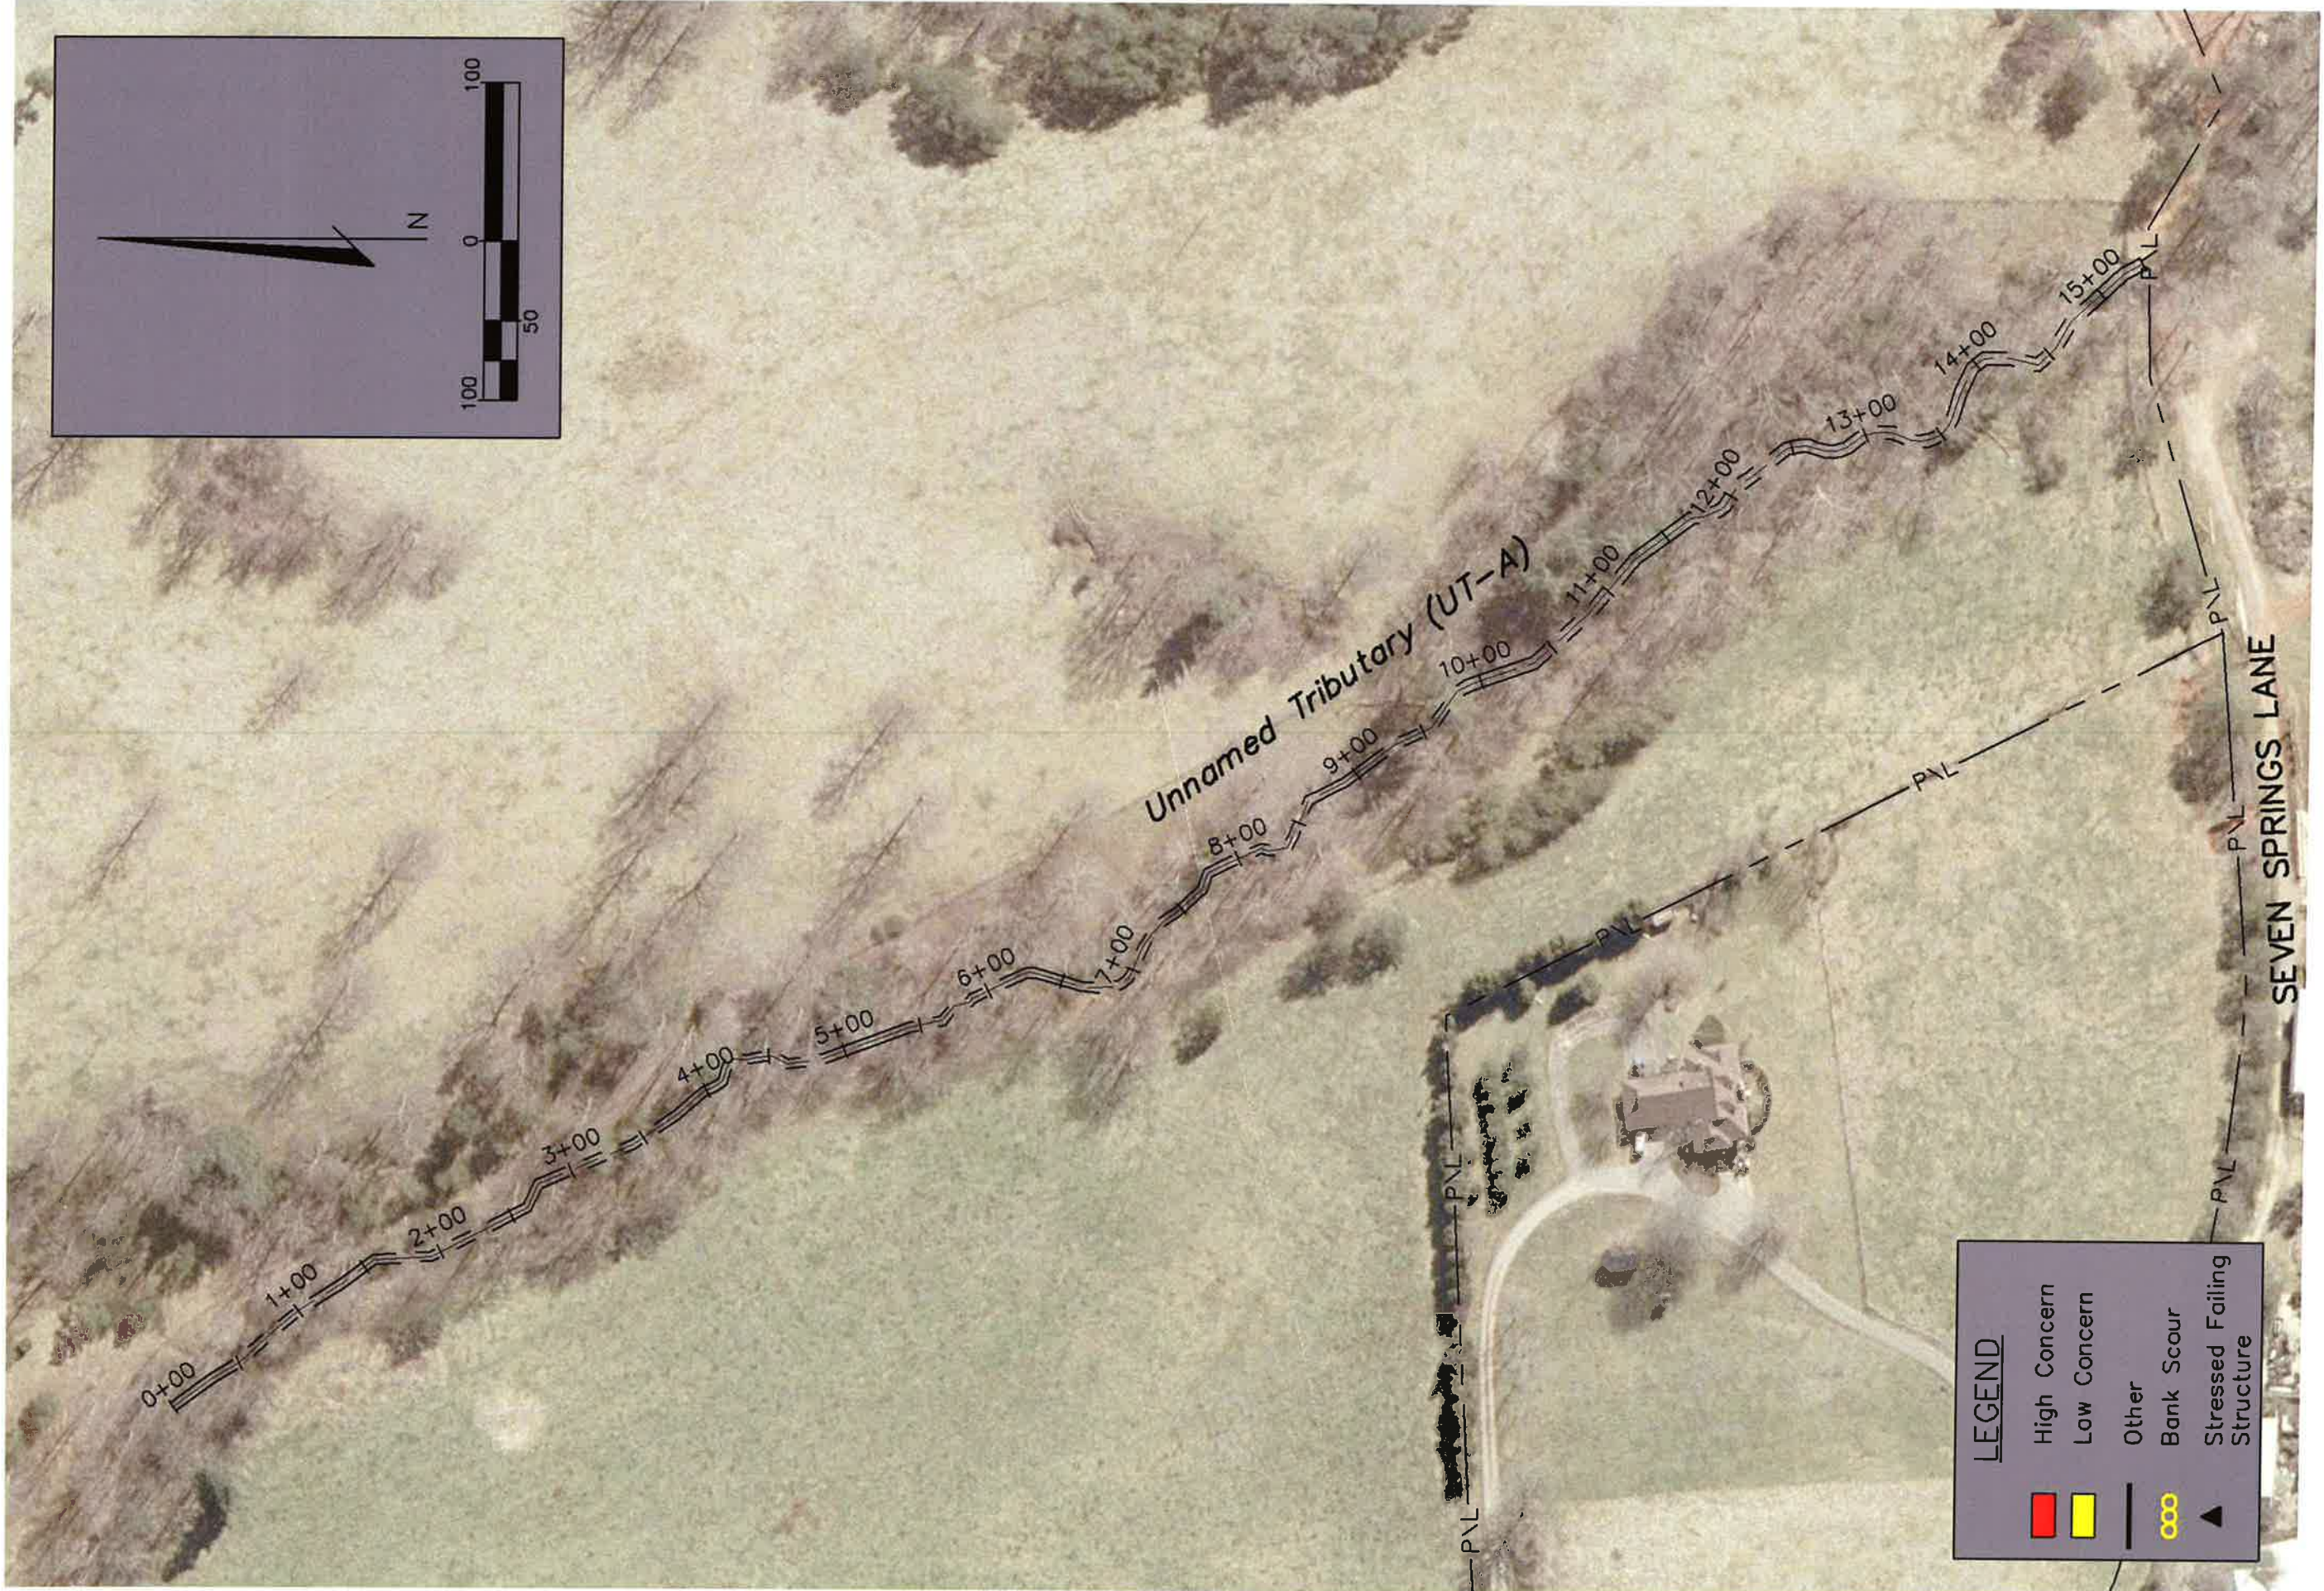
- High Concern
- Low Concern
- Other
- Bank Scour
- Stressed Failing Structure
