Subject: Year 5 Monitoring Report for Stream Restoration of Silver Creek and Unnamed Tributaries
SCO# D05016-01

Year 5 Monitoring Report for Stream Restoration of Silver Creek and Unnamed Tributaries

Burke County, NC
SCO # D05016-01

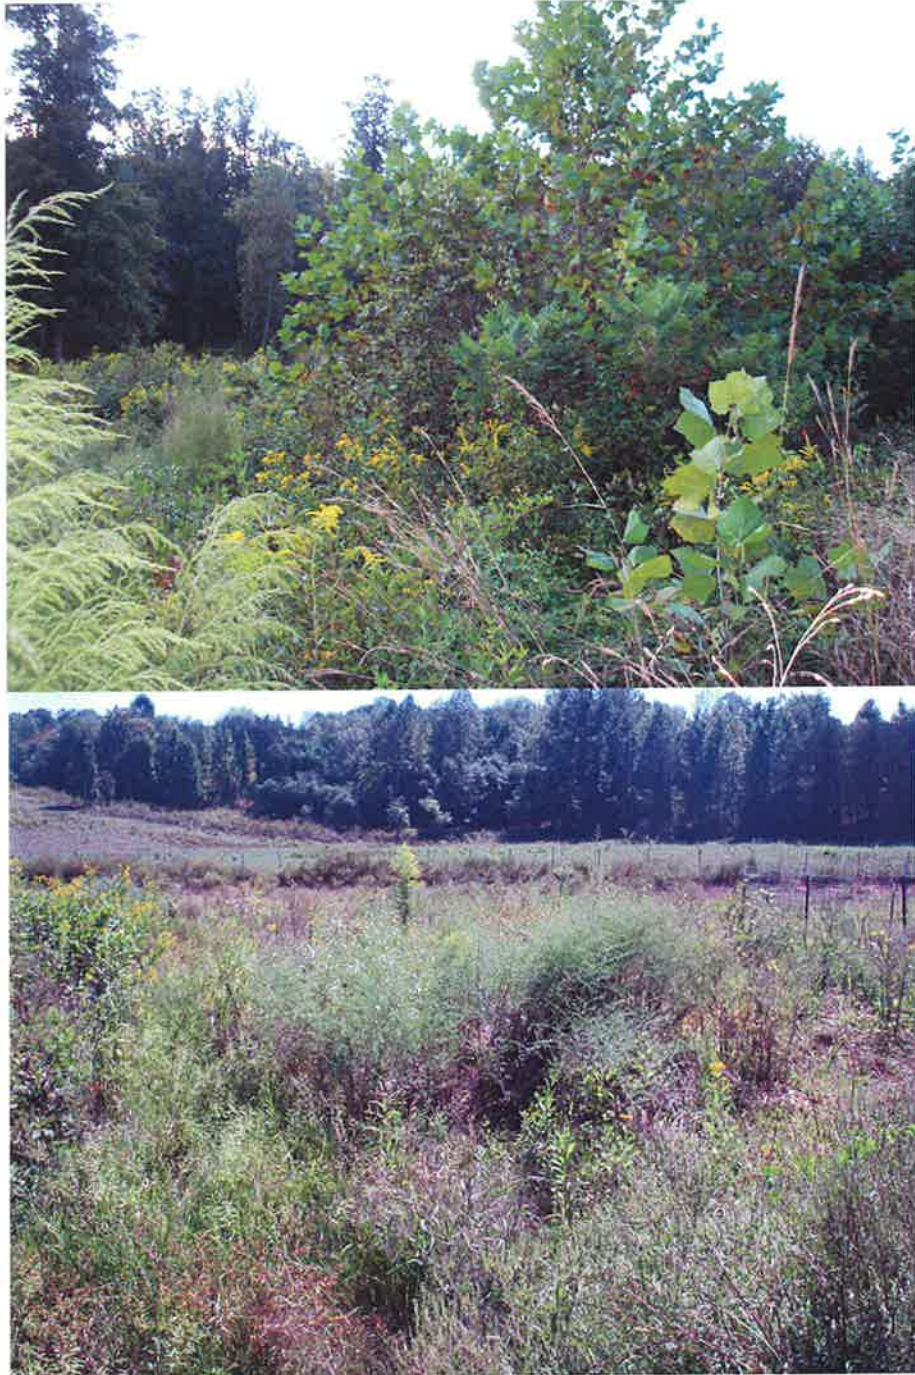
Vegetation Plot on Tributary B

Year 5 – top photo – facing upstream on Trib. B (EMH&T, 9/16/11)

Year 1- bottom photo – facing downstream on Trib. B toward Silver Creek (EMH&T, 9/20/06)

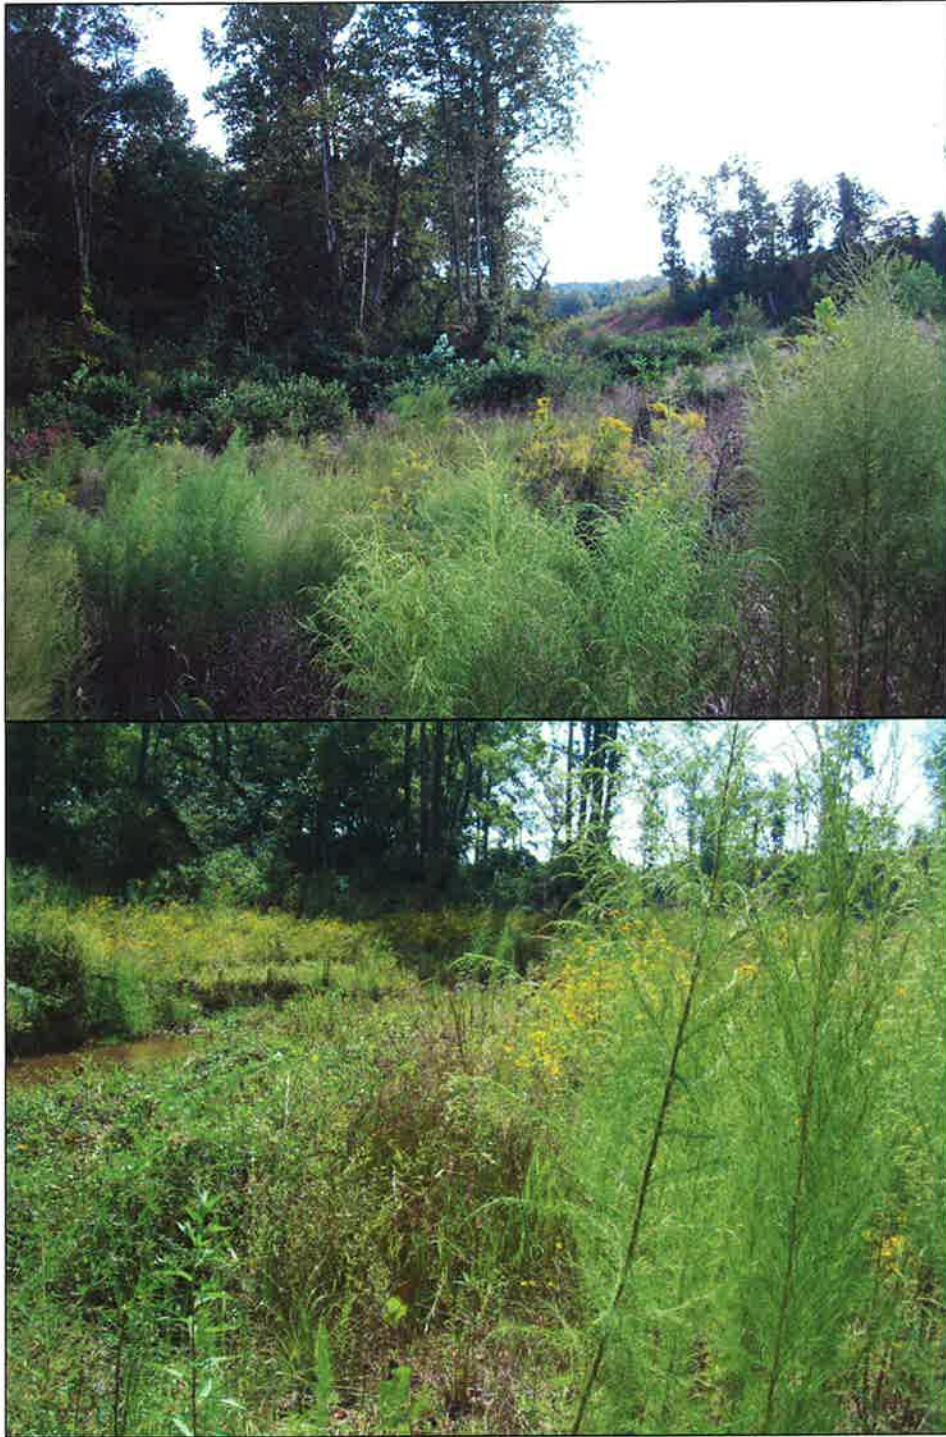
Fixed Station 1

Overview of the Silver Creek Mainstem, facing upstream from the downstream project terminus.

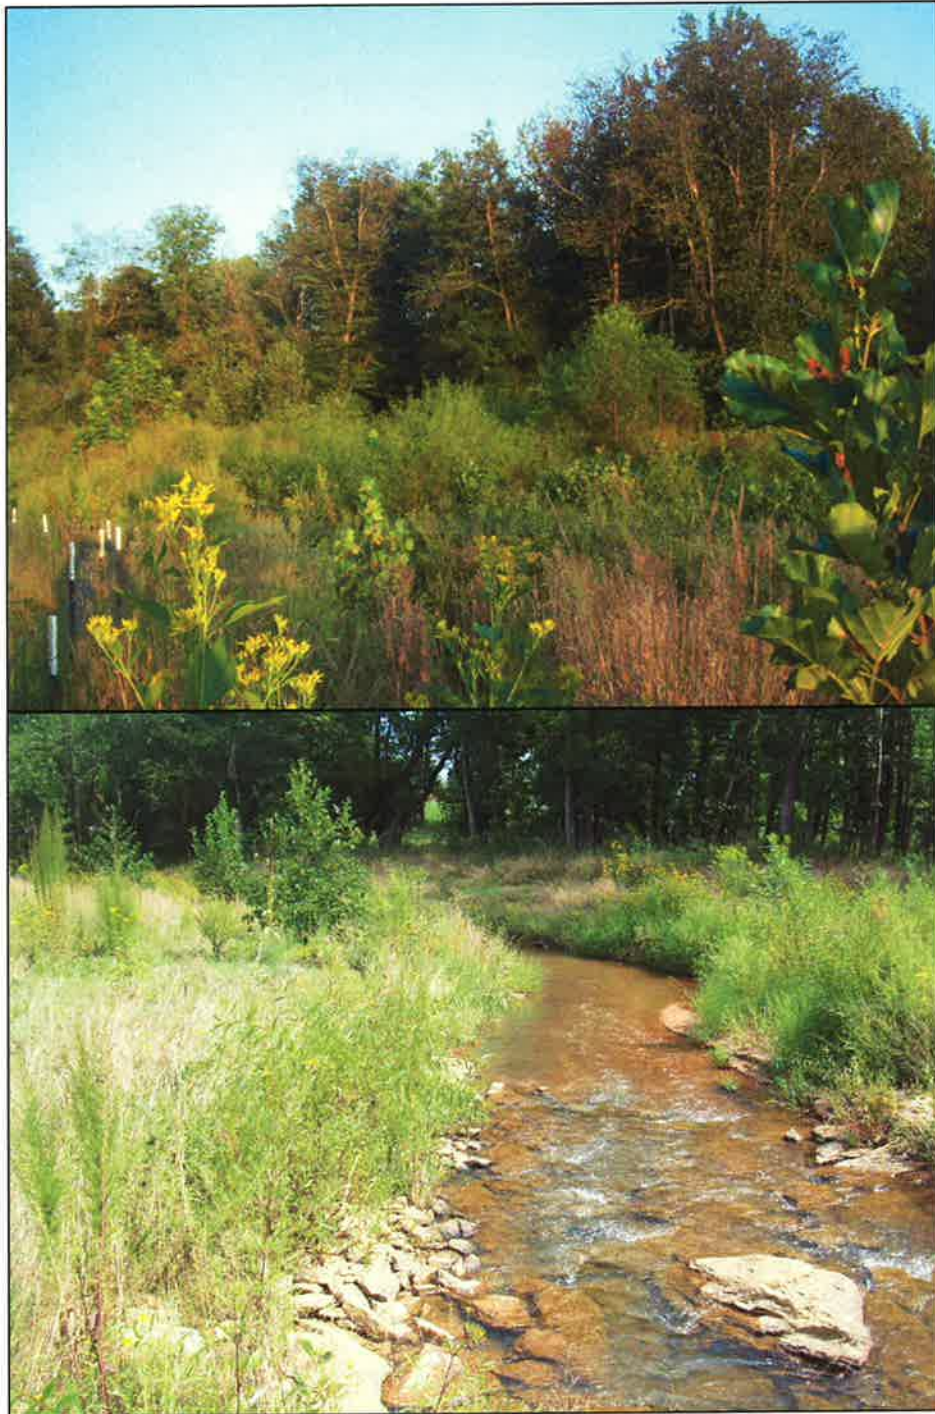
Fixed Station 2

Overview of the Silver Creek Mainstem near Riffle #3, facing downstream.

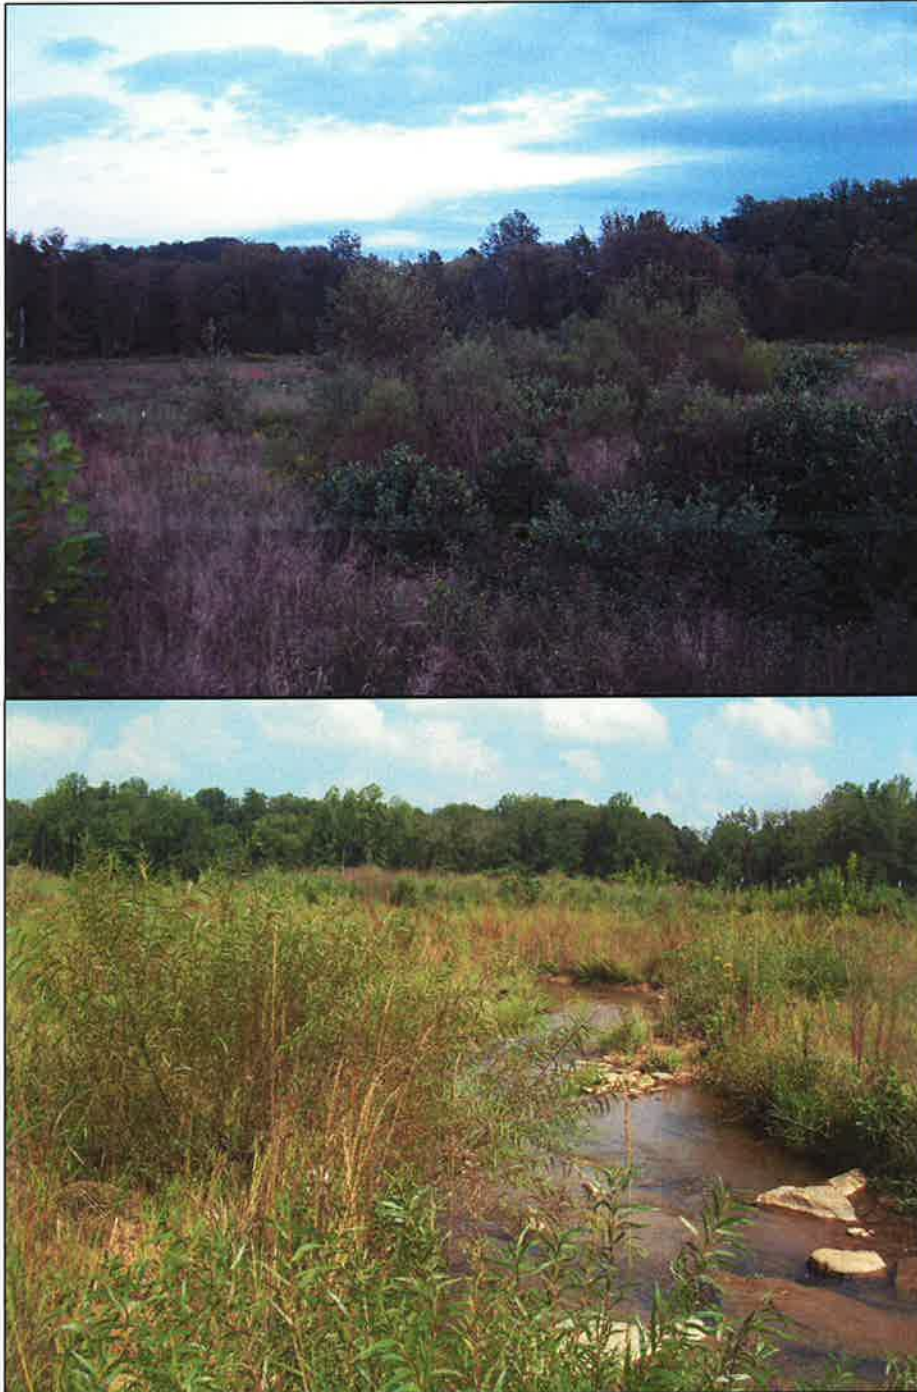
Fixed Station 3

Overview of the Silver Creek Mainstem at Riffle #1, facing downstream.

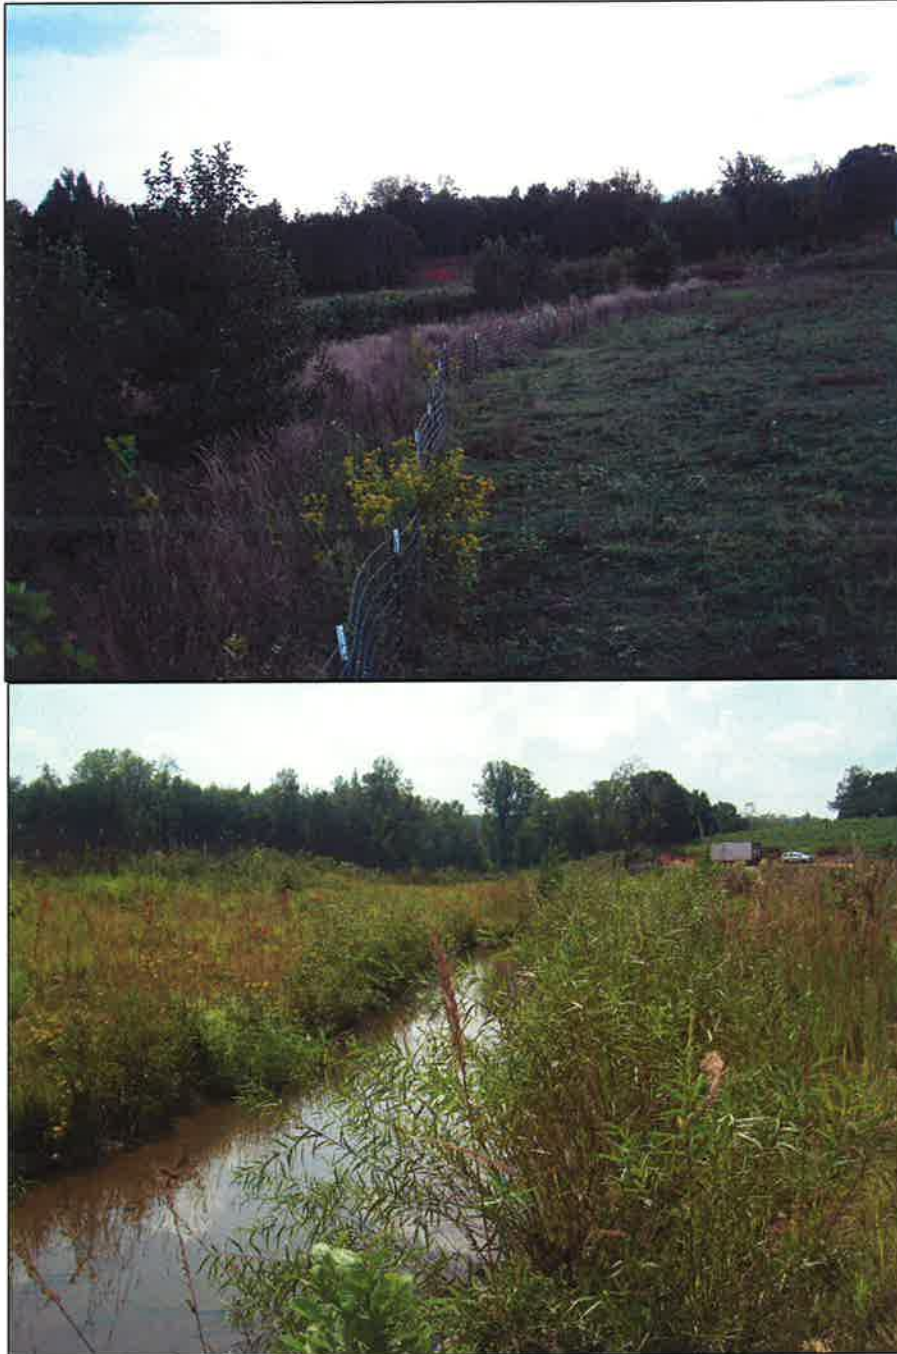
Fixed Station 4

Overview of the Silver Creek Mainstem at Riffle #1, facing upstream.

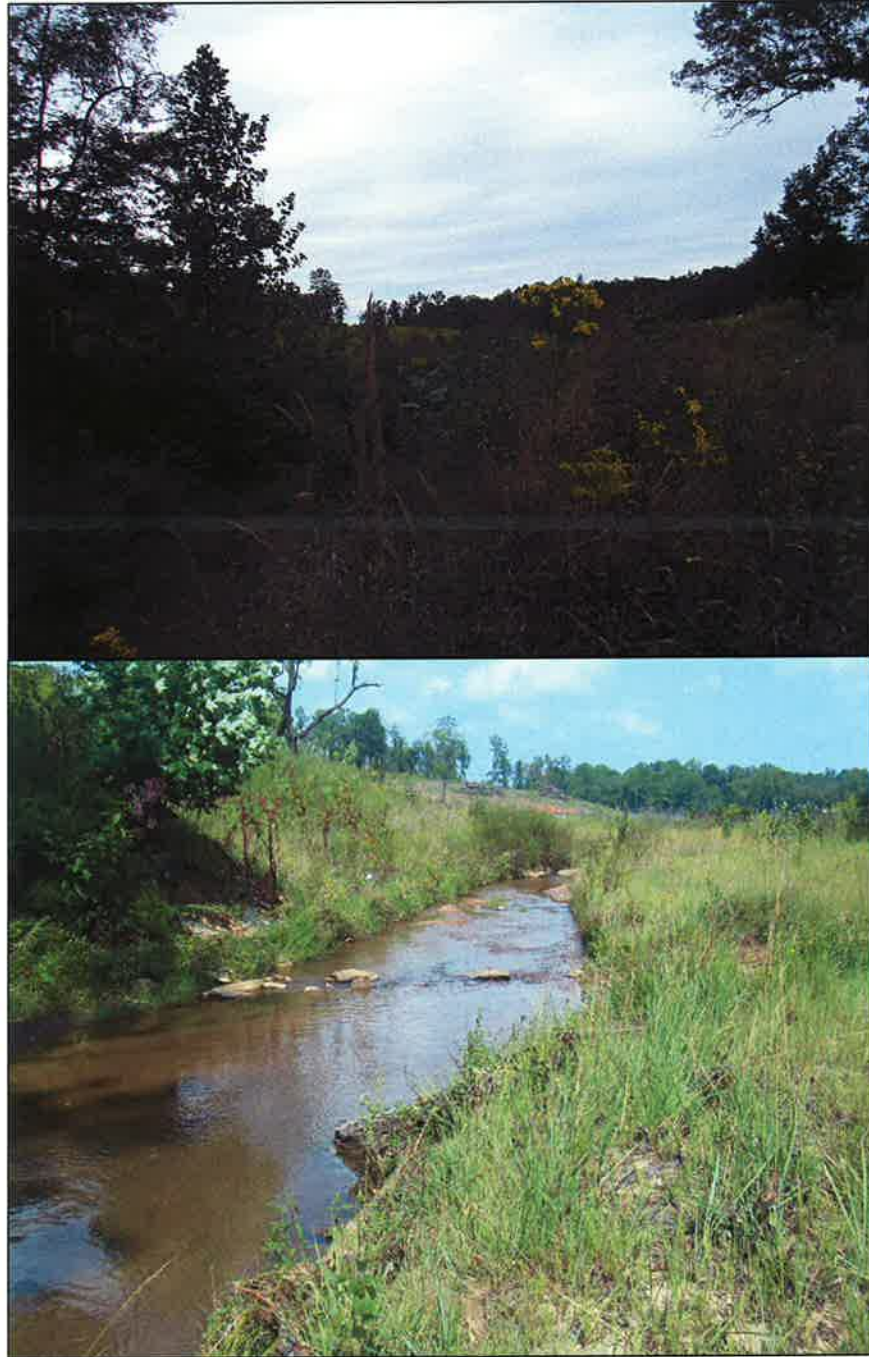
Fixed Station 5

Overview of the Silver Creek Mainstem, facing downstream near station 2+60.

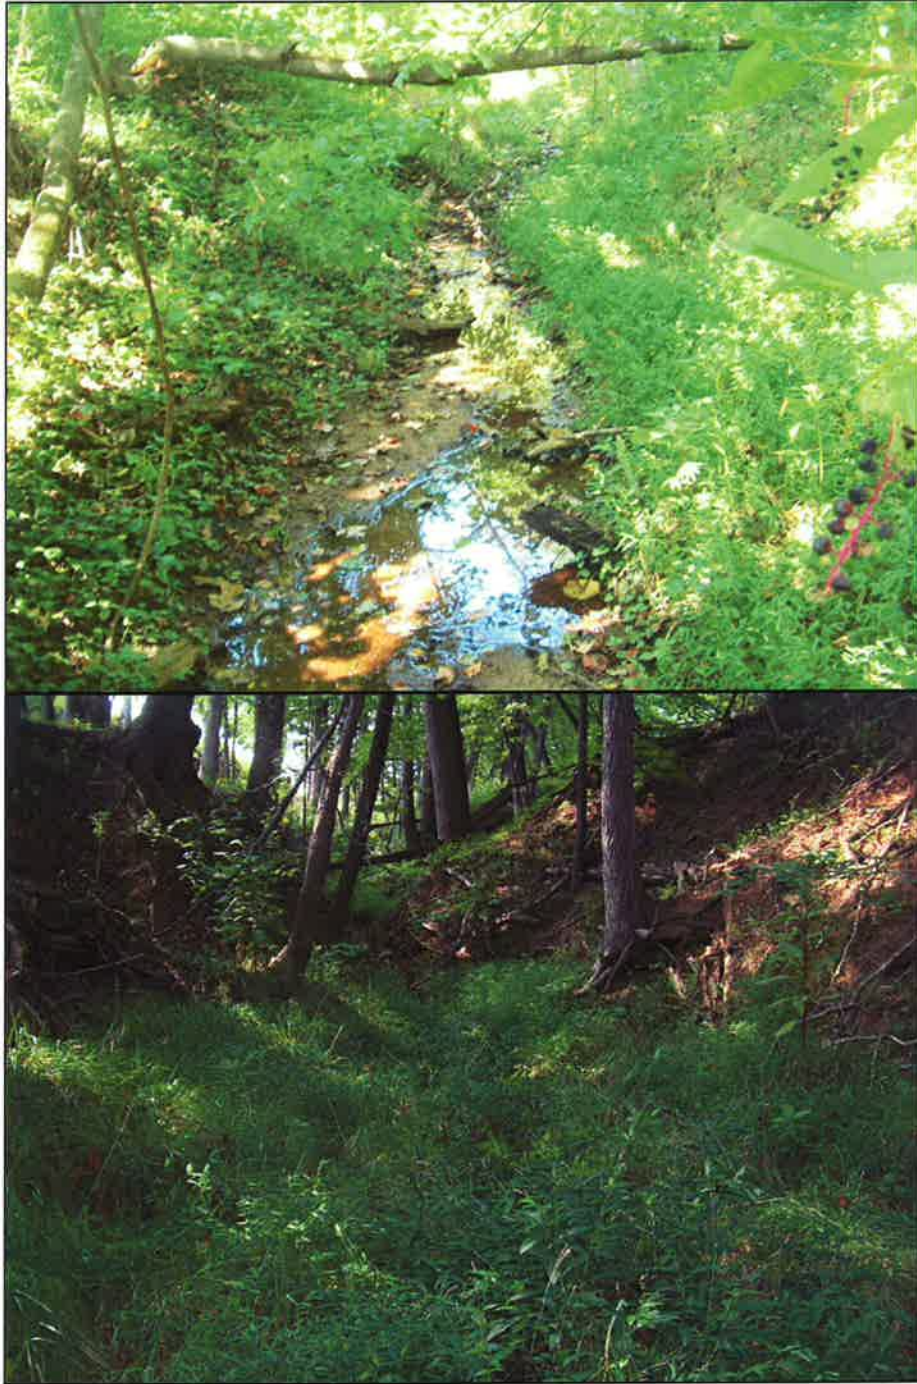
Fixed Station 6

Overview of UT-A, facing upstream near station 0+50.

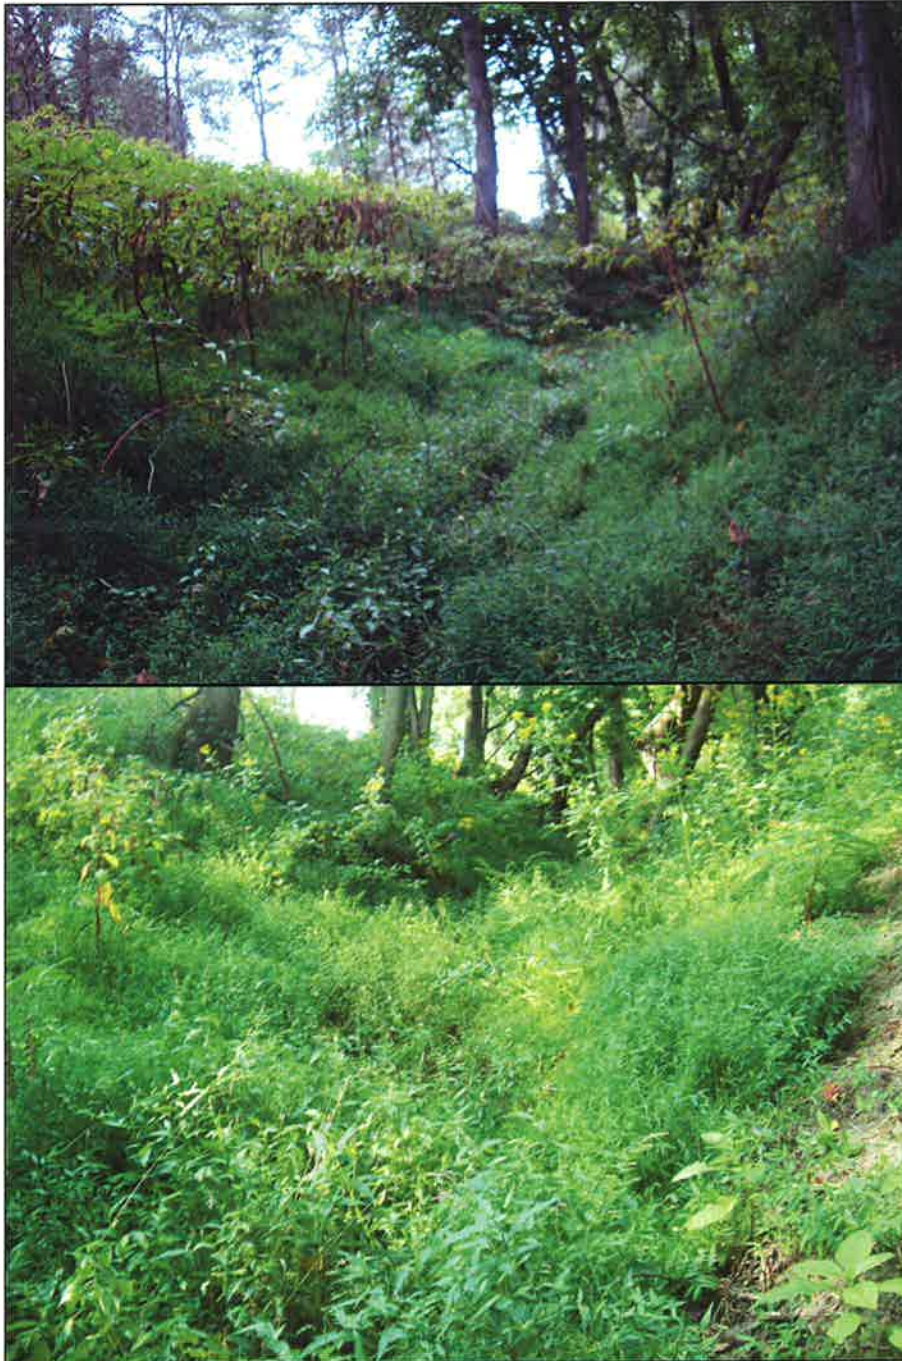
Fixed Station 8

Overview of UT-A, facing upstream near station 11+00.

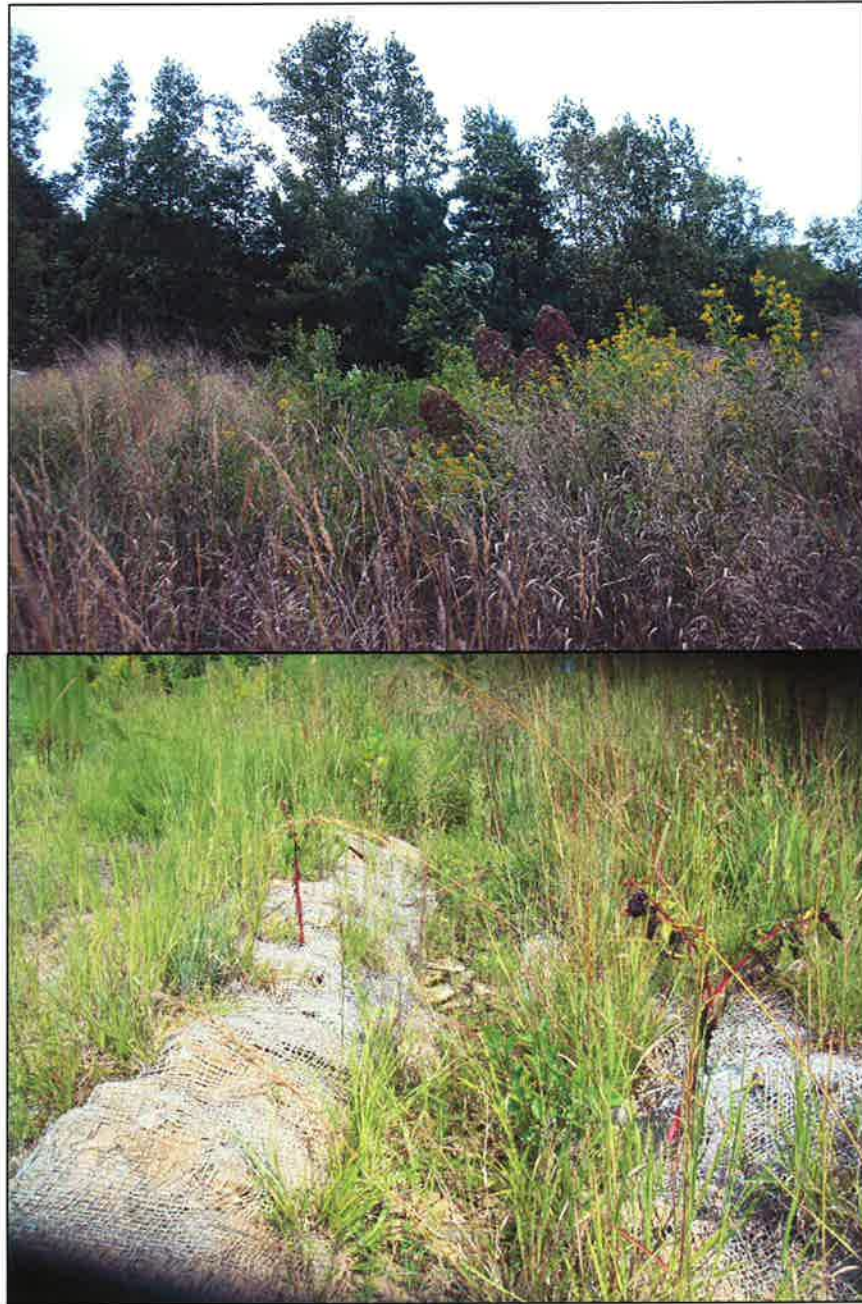
Fixed Station 9

Overview of UT-B, facing upstream from the confluence of UT-B with Silver Creek.

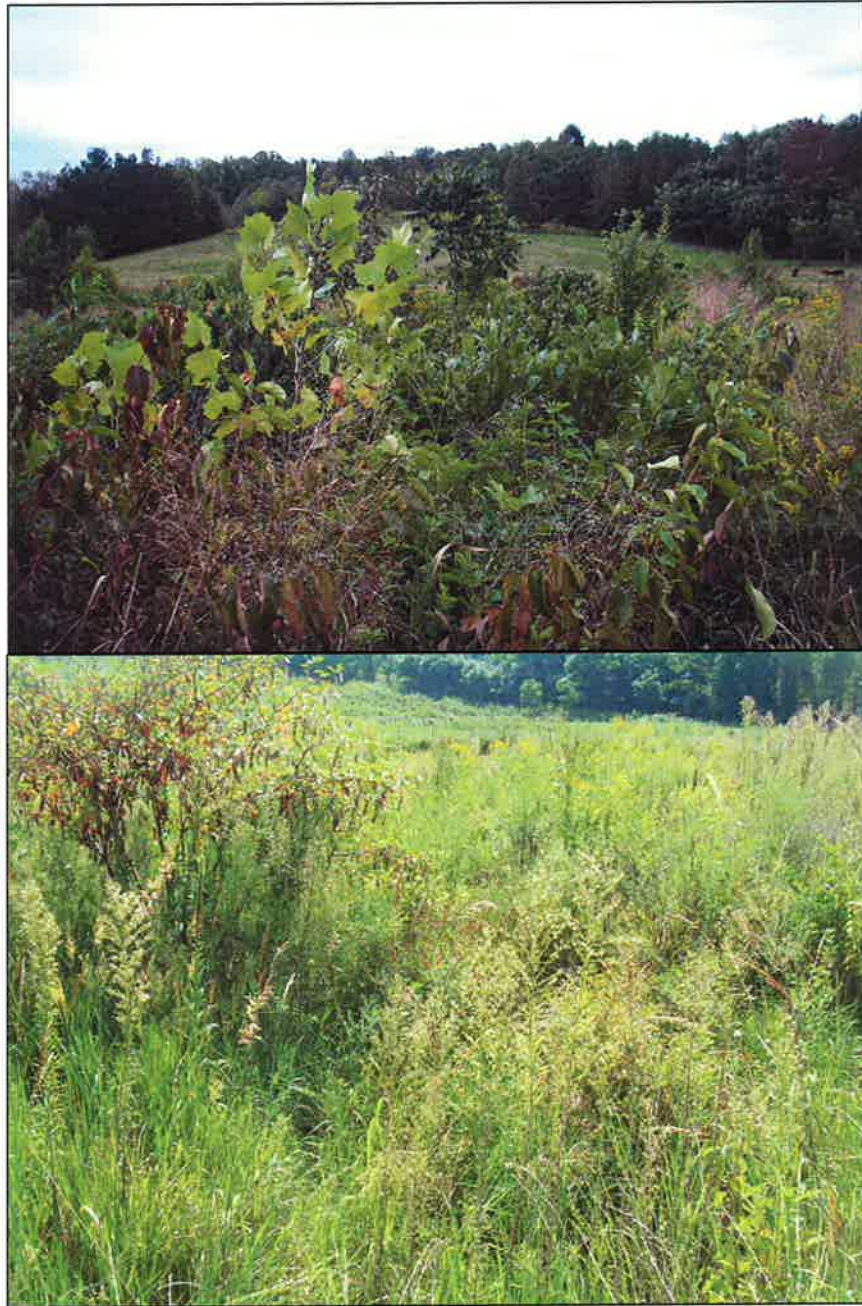
Fixed Station 10

Overview of UT-B, facing downstream towards the confluence of UT-B with Silver Creek.

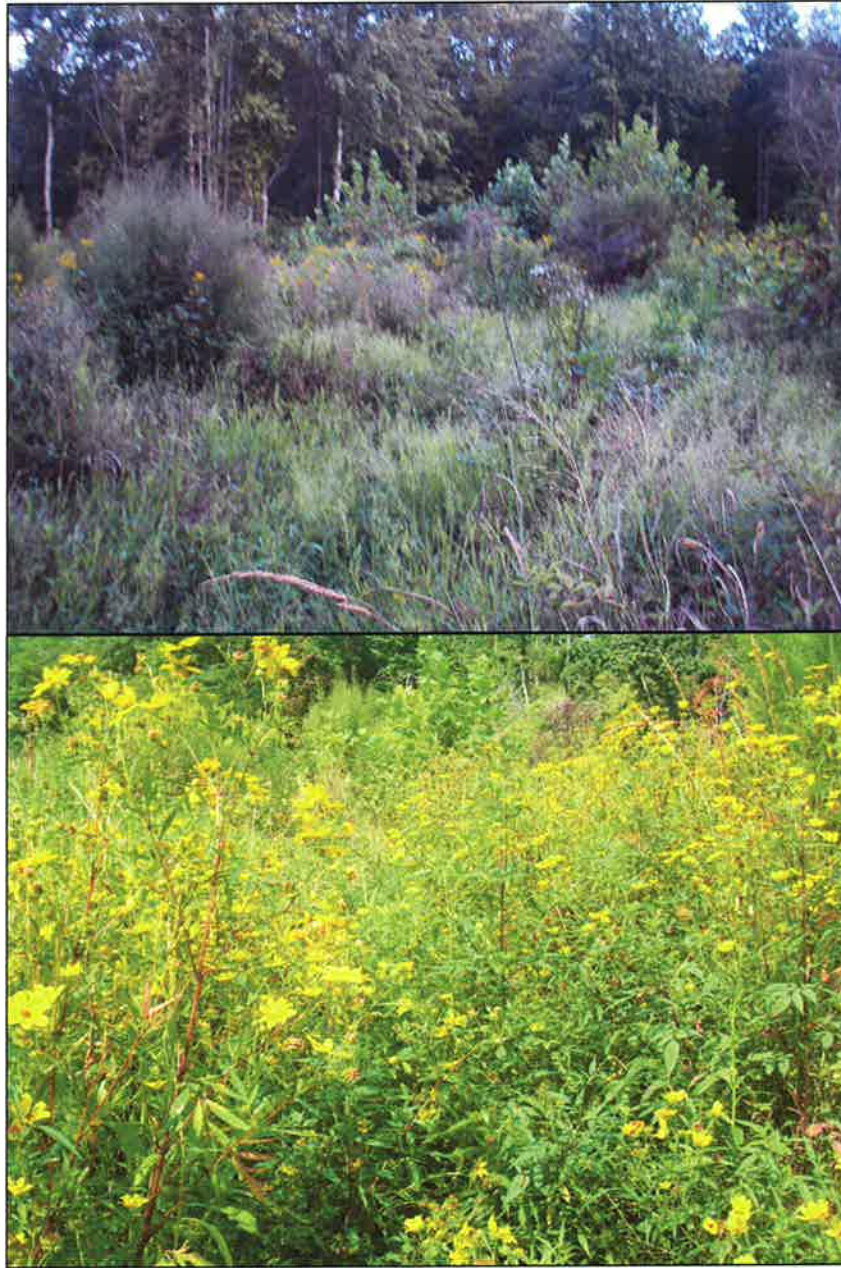
Fixed Station 11

Overview of UT-C, facing upstream from the confluence of UT-C with Silver Creek.

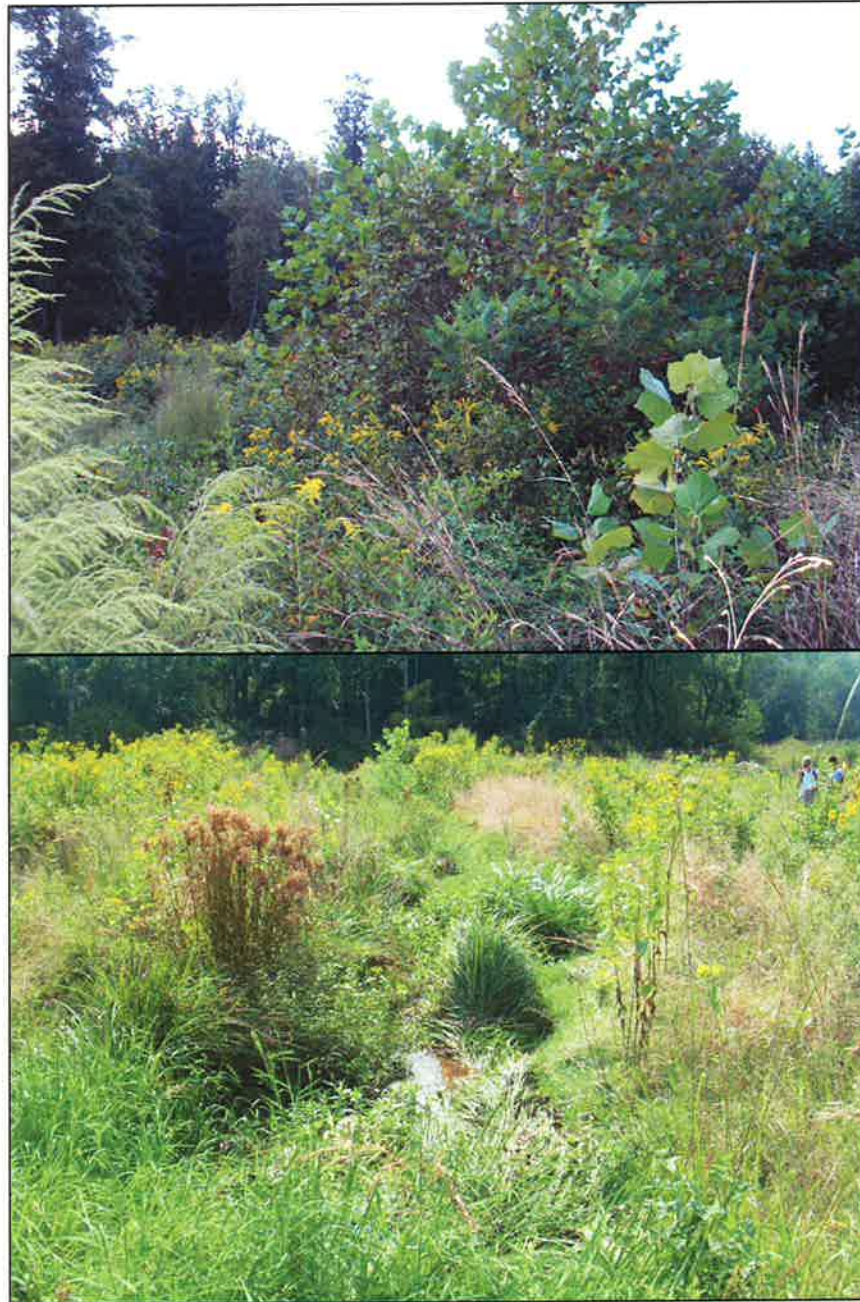
Fixed Station 12

Overview of UT-C, facing downstream towards the confluence of UT-C with Silver Creek.

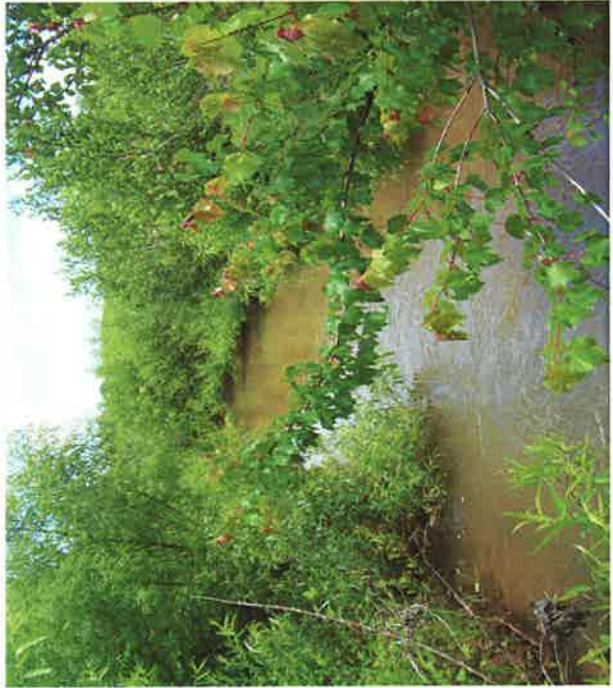
Riffle Cross-Section 1, looking downstream

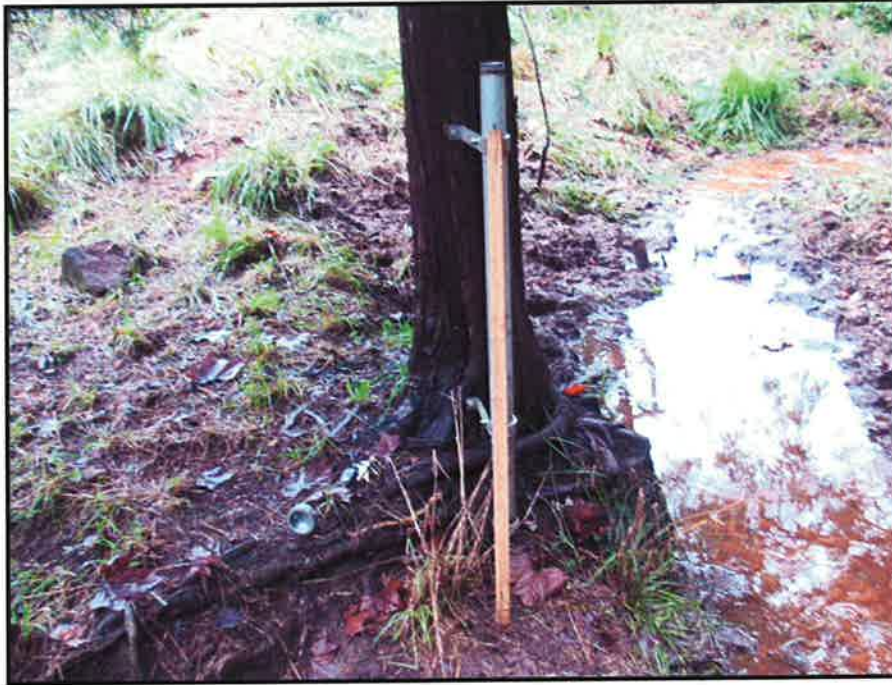
BF 1
Crest Gage on Silver Creek UT (Year 3).
(EMH&T, 9/21/09)

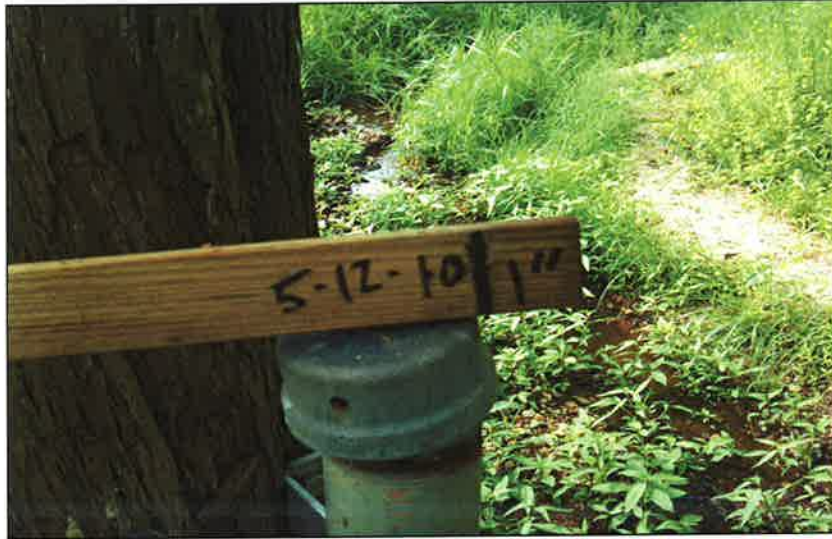
BF 3
Crest Gage on Silver Creek UT (Year4).
(EMH&T, 5/12/10)

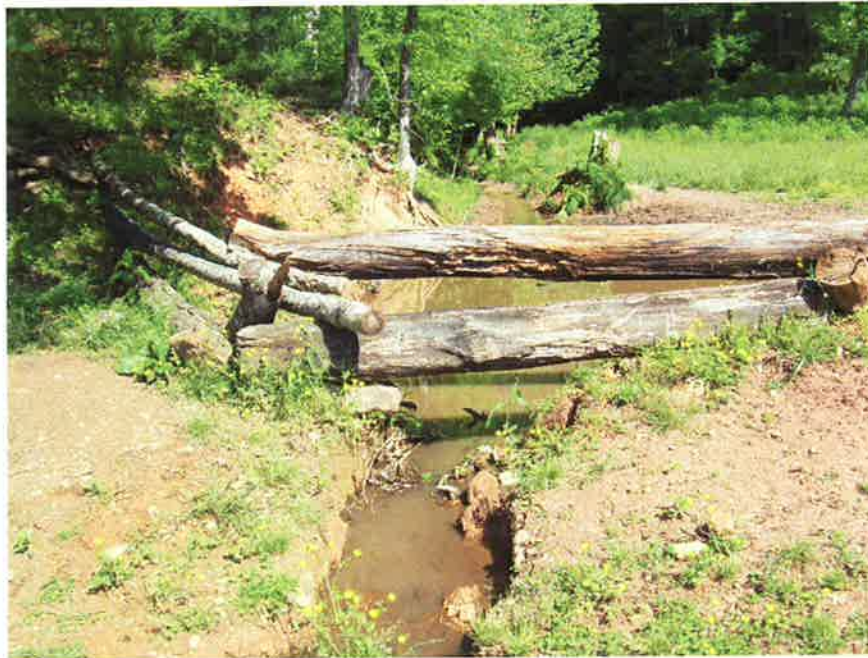
SPA 2

**New cattle watering access point located immediately upstream of the upstream terminus of UT-C within project boundaries. Photo taken facing upstream on UT-C at the nexus of the cattle watering access point and the limit of the project boundary.
(EMH&T, 5/20/11)**

- ❖ Provide offline watering for cattle. WRC will work with the local NRCS office to provide offline watering that meets their recommended specifications.
- ❖ The existing cattle watering/crossing located on the tributary stream will be modified so that it can only be utilized as a cattle crossing. After the modifications are complete the cattle will no longer have direct access to the stream.
- ❖ WRC will continue invasive species control and supplemental planting in the tributary stream corridor.

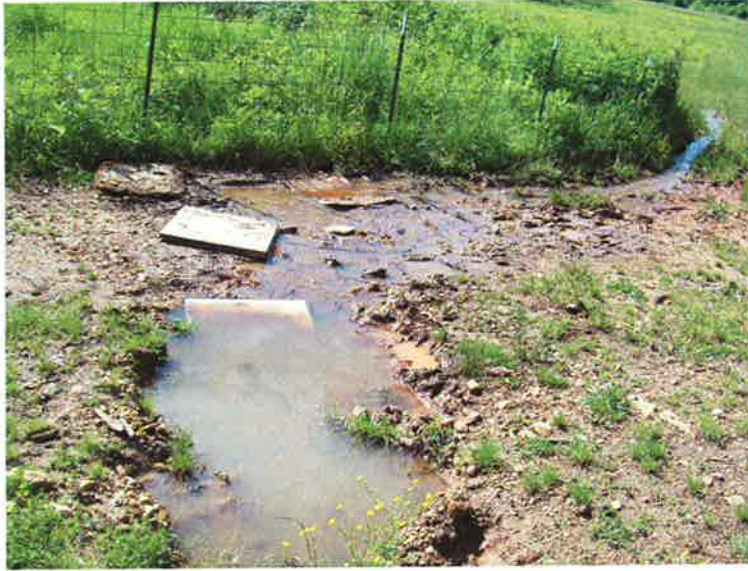
SPA 3

New cattle watering access point located immediately upstream of the upstream terminus of UT-C within project boundaries. Photo taken facing downstream on UT-C at the nexus of the cattle watering access point and the limit of the project boundary (fence). The rerouting of the UT-C flow around the project fence can be seen in the above photograph.

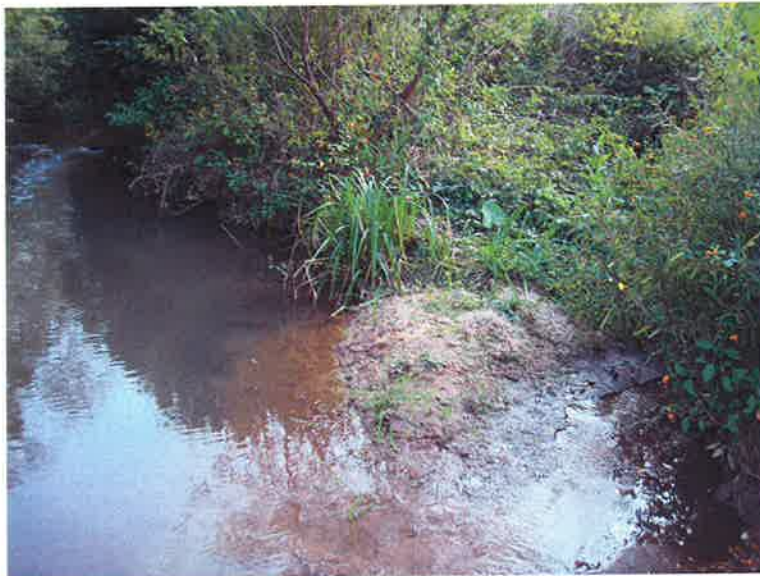
SPA 4

Sedimentation along the left bank of Silver Creek mainstem at station 26+25 (at the confluence of Silver Creek and Unnamed Tributary C (UT -C)). This aggradation is being caused by excessive sediment loading on UT-C which has resulted from a new cattle watering access point located further upstream on the tributary.

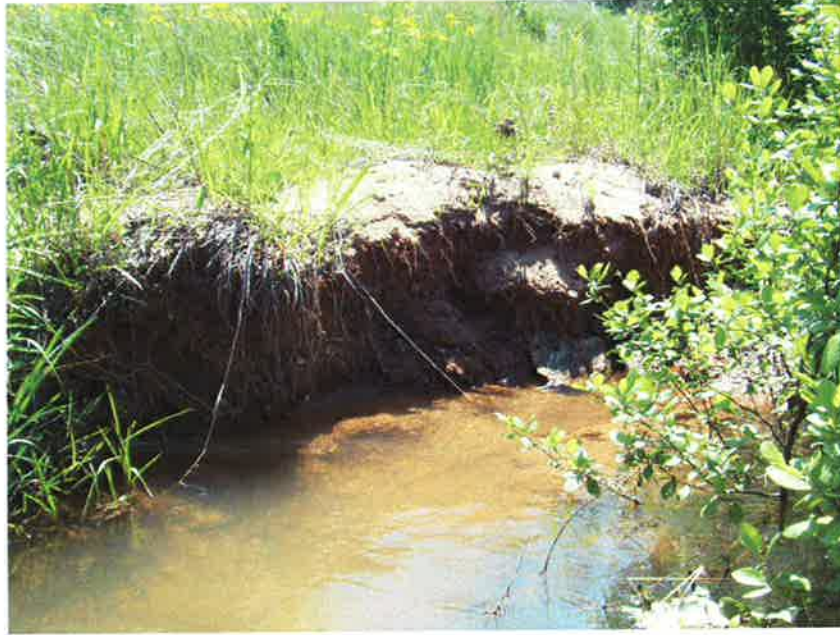
SPA 5

**Bank failure and sloughing along the right bank at station 10+00
on the Silver Creek mainstem.**
