# **FINAL (MYO) BASELINE MONITORING REPORT** **SIX RUNS STREAM AND WETLAND MITIGATION PROJECT**

Sampson County, North Carolina  
Cape Fear River Basin  
HUC 03030006

NCDMS Project #100170  
DMS Contract #0303-01  
RFP: 16-20190303 (Issued 12/20/2019)  
USACE Action ID: SAW-2020-01964 | DWR Project #20201798 v1

**August 2023**

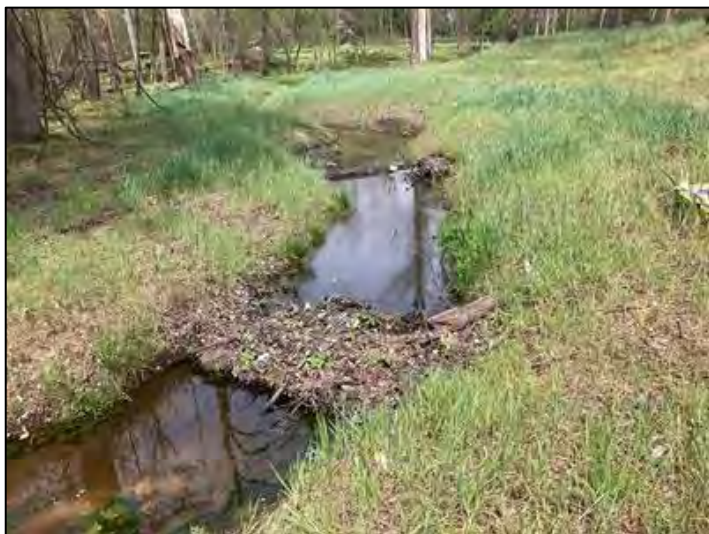
PALS on BB-B (03/28/2023)

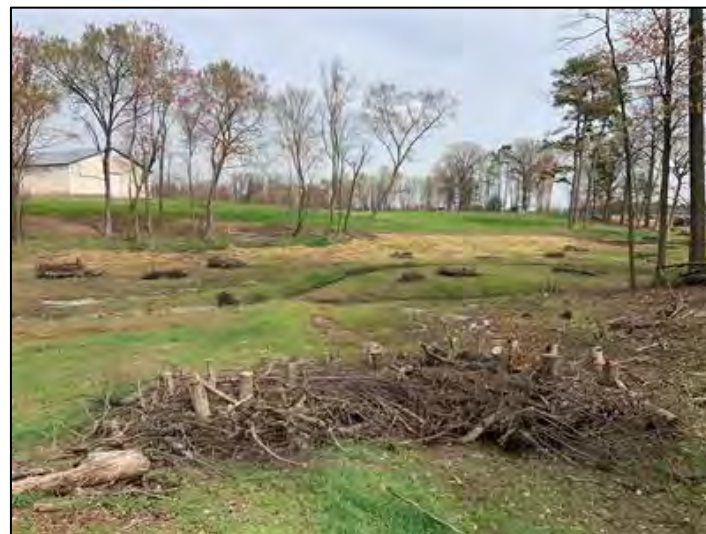
ESP (03/01/2023)

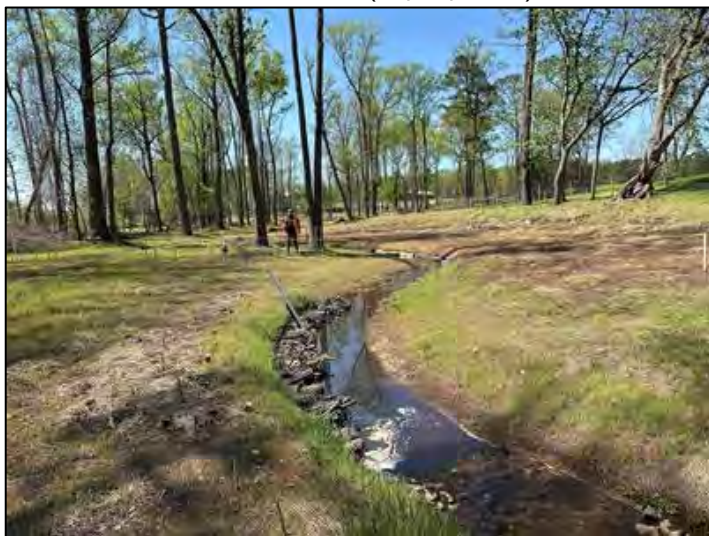
BB-C (downstream) (03/23/2023)

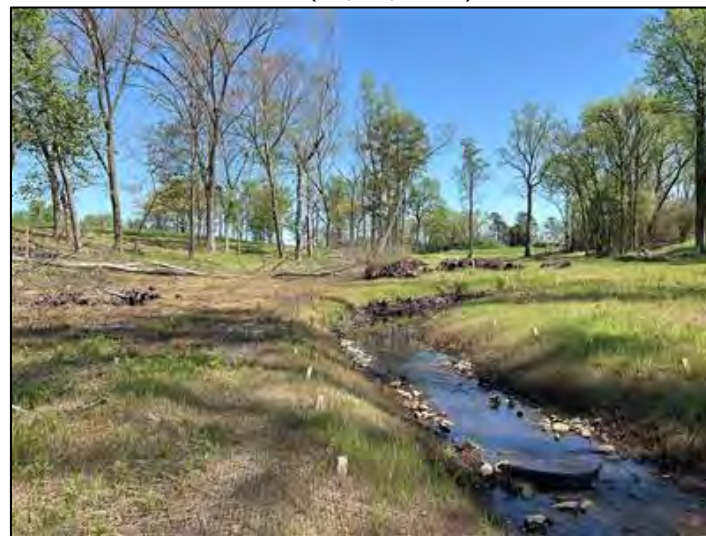
BB-C (upstream) (03/30/2023)

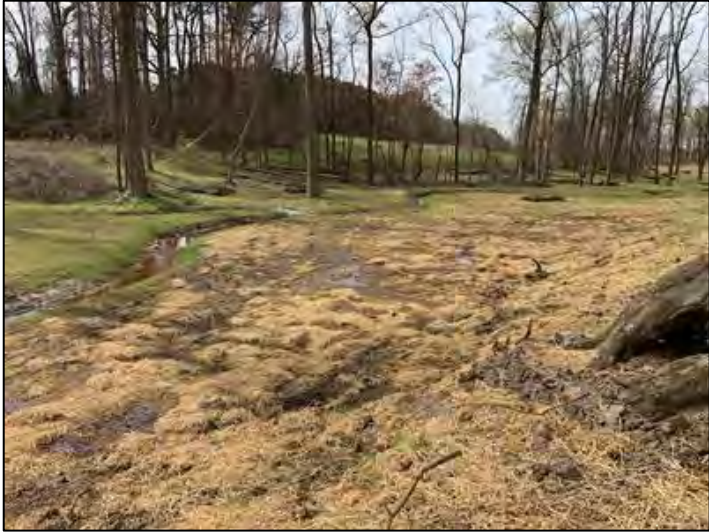
Floodplain (03/01/2023)

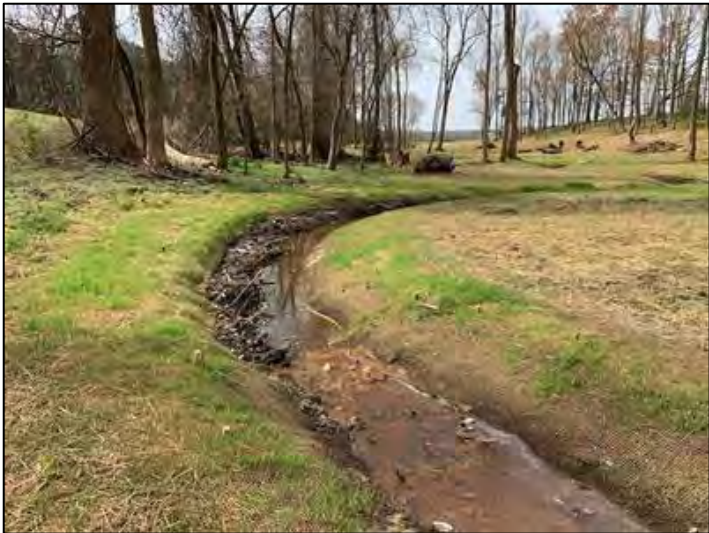
Brush toe (03/01/2023)

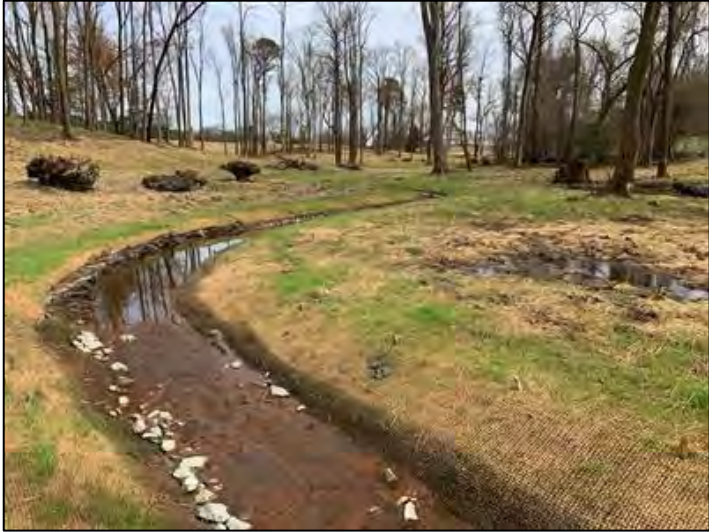
Floodplain (03/01/2023)

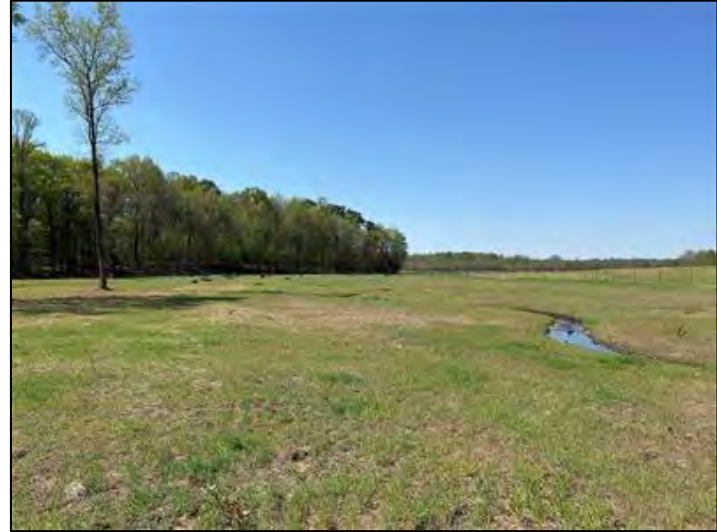
Floodplain (03/30/2023)

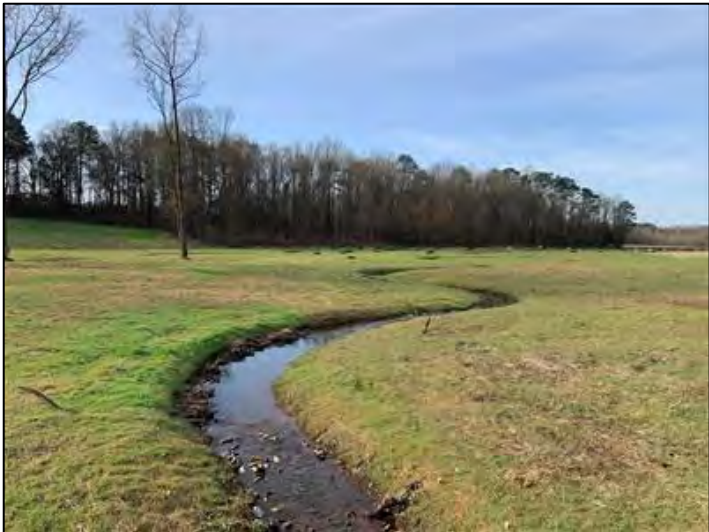
DE4-B (downstream) (03/23/2023)

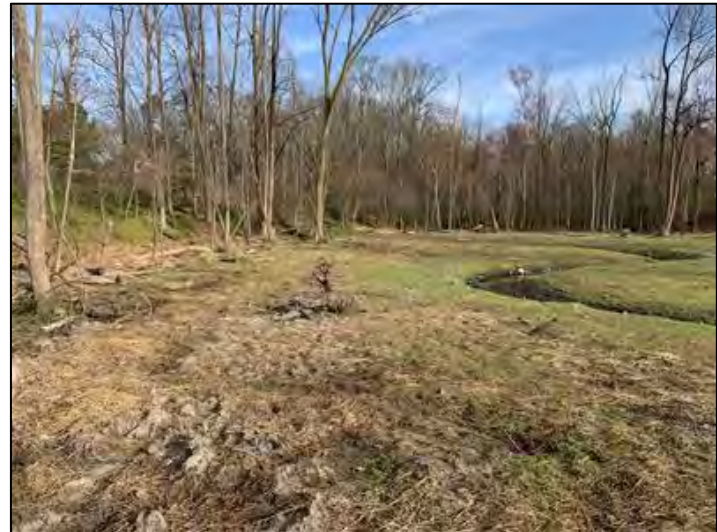
Wetland and stream (03/01/2023)

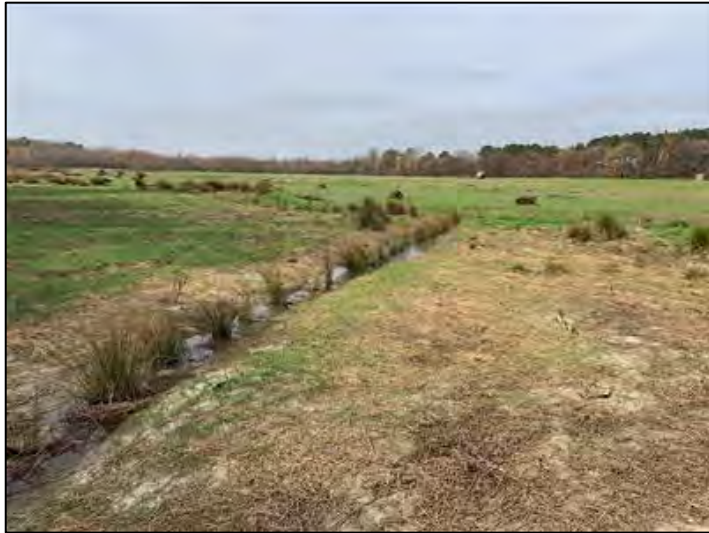
Juncus swale (03/01/2023)

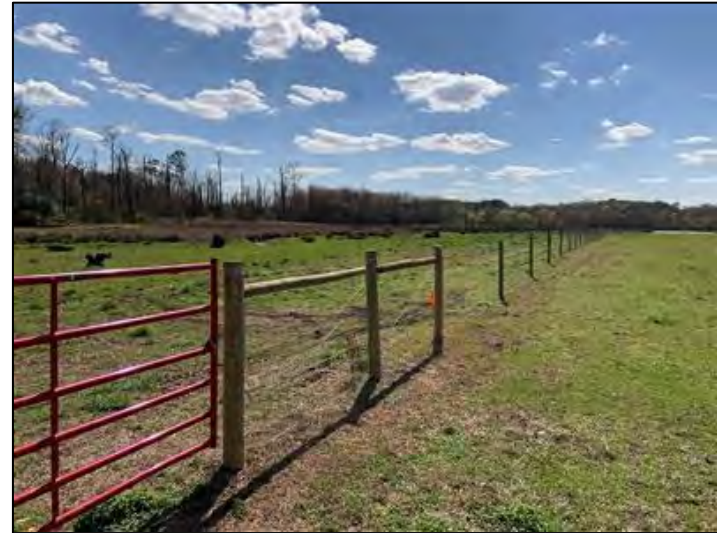
Fence (03/14/2023)

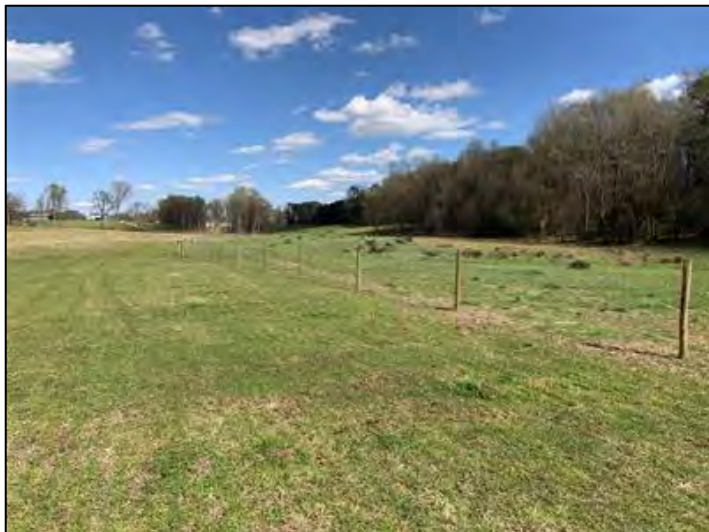
Fence (03/14/2023)

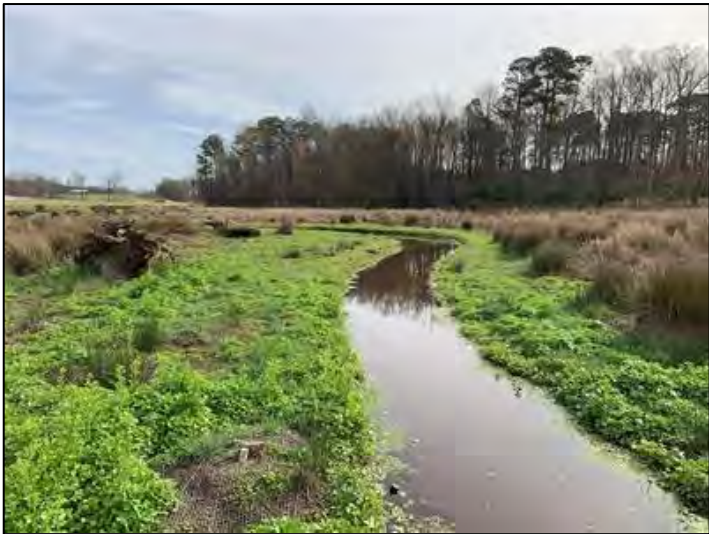
BB-C (upstream) (03/01/2023)

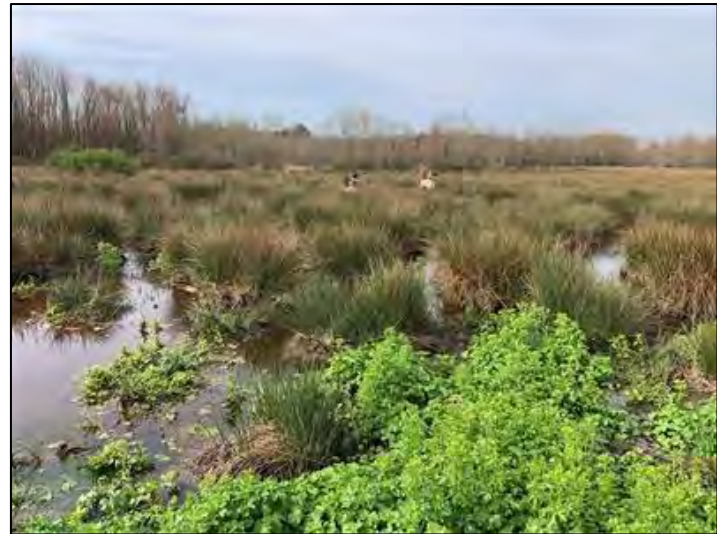
Braiding downstream of BB-C terminus (03/01/2023)

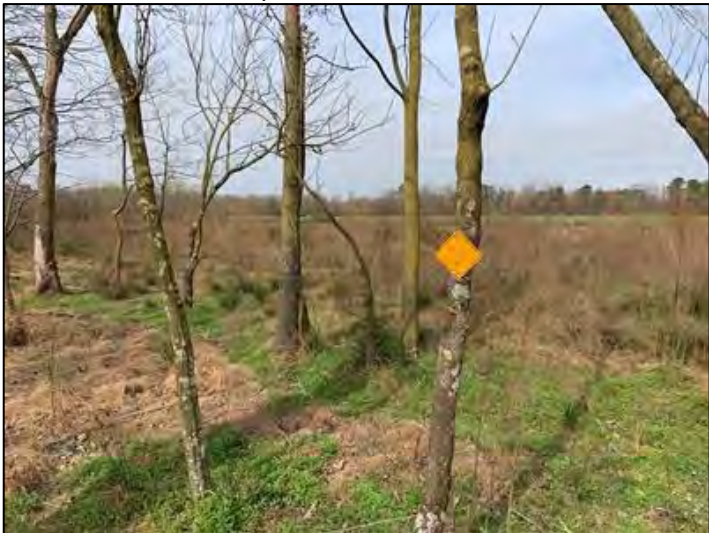
Sign (03/01/2023)

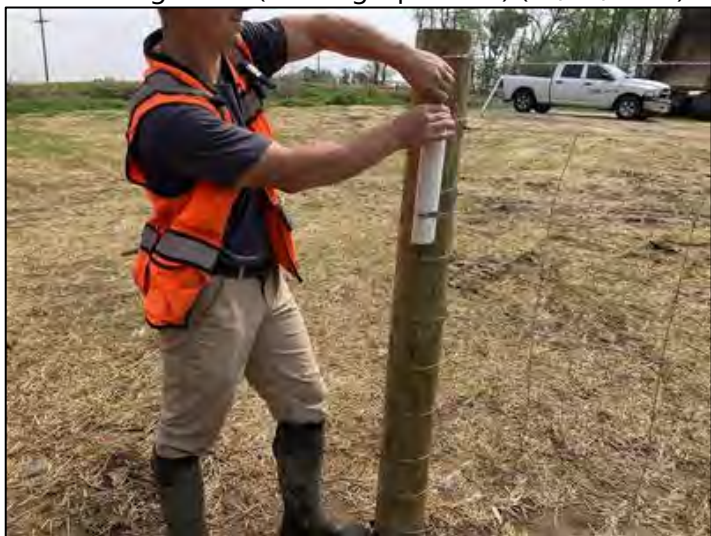
Ambient (03/28/2023)

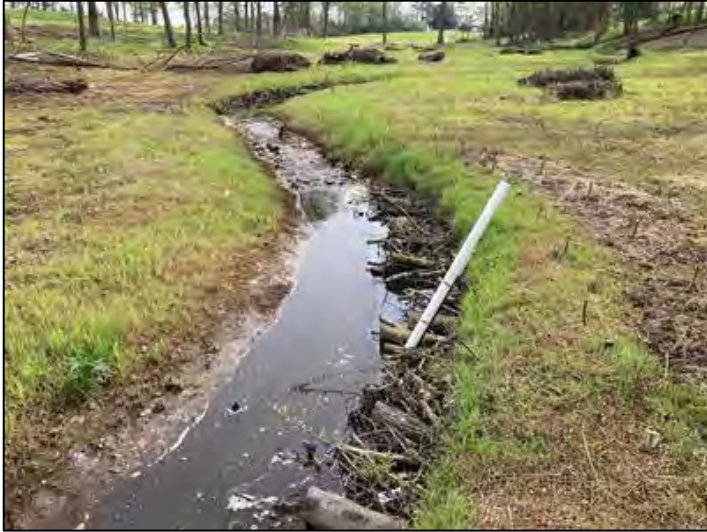
Stage Recorder BB-C\_US (Looking Upstream) (03/28/2023)

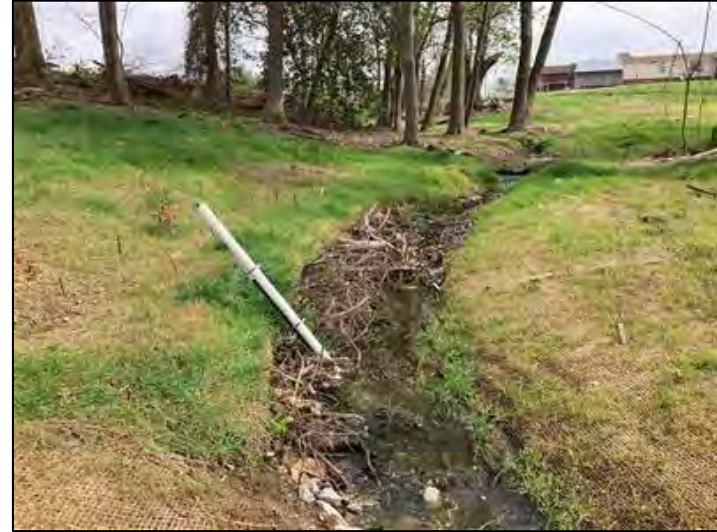
Flow Gauge DE2-B (Looking Upstream) (03/28/2023)
