ANNUAL MONITORING REPORT SMITH AND AUSTIN CREEKS

**STREAM RESTORATION
WAKE COUNTY, NORTH CAROLINA
(EEP Project Number 343)
Monitoring Year 5 of 5 (2007)**

February 2008

Prepared by:
Axiom Environmental, Inc.
2126 Rowland Pond Drive
Willow Spring, North Carolina 27592

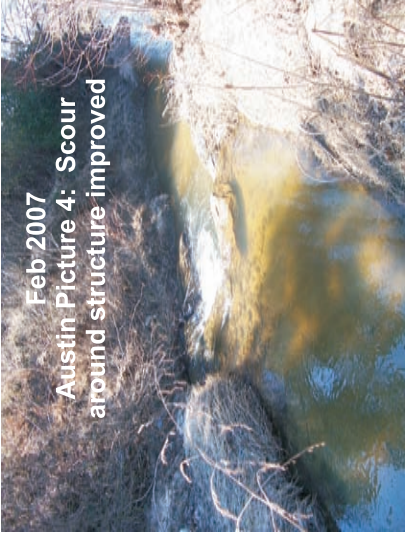
Feb 2007
 Austin Picture 4: Scour
 around structure improved

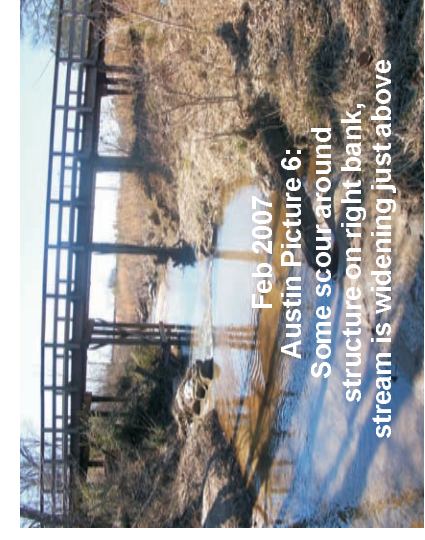
Feb 2007
 Austin Picture 6:
 Some scour around
 structure on right bank,
 stream is widening just above

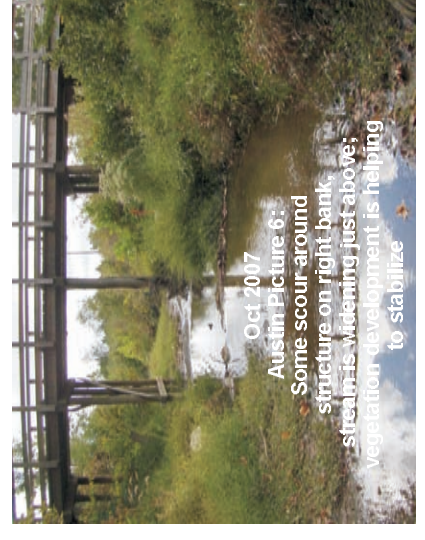
Oct 2007
 Austin Picture 6:
 Some scour around
 structure on right bank,
 stream is widening just above;
 vegetation development is helping
 to stabilize

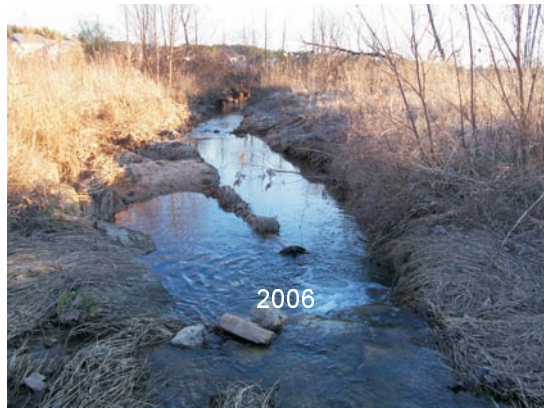
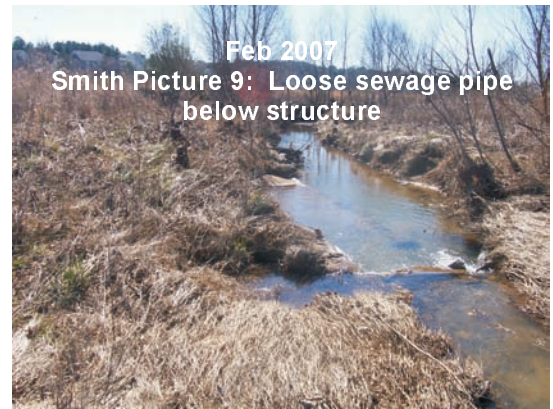
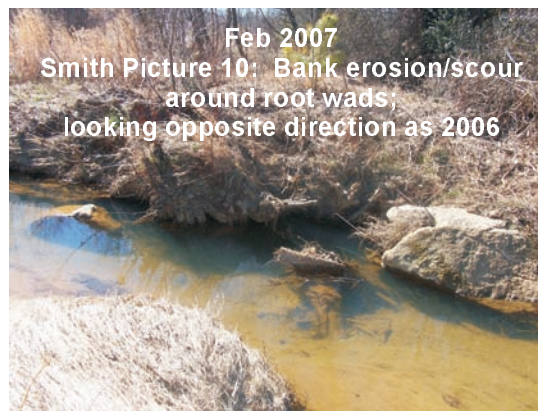
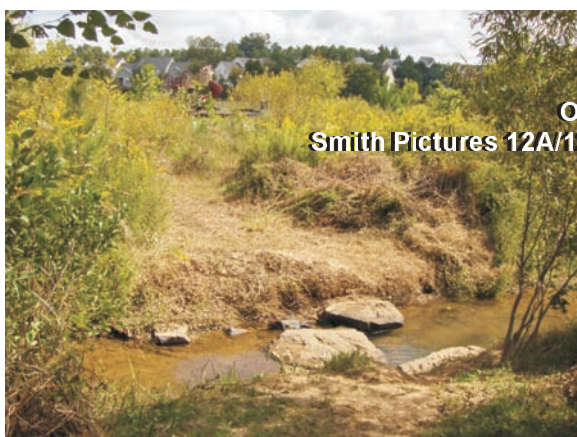
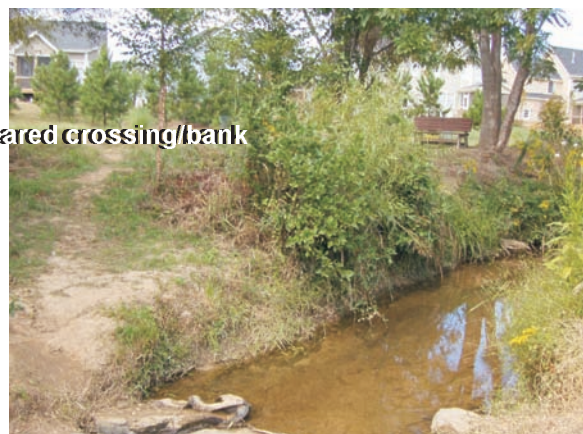
Smith and Austin Creeks
Smith Creek (continued): Example Problem/Watch Areas
Taken February and October 2007

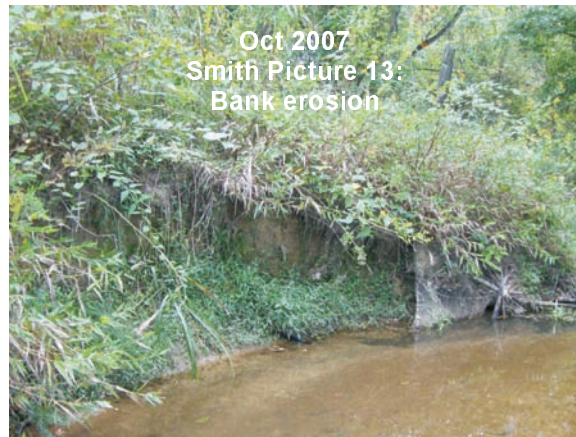
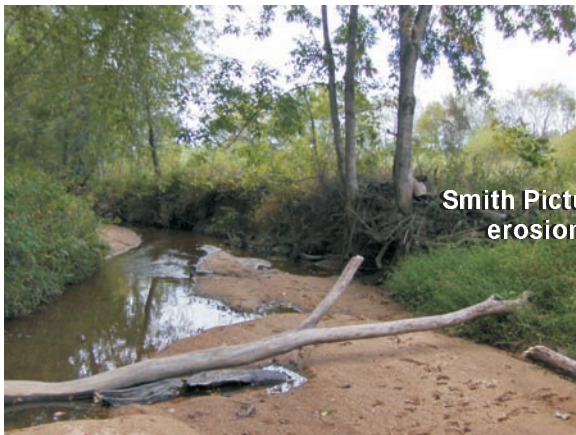
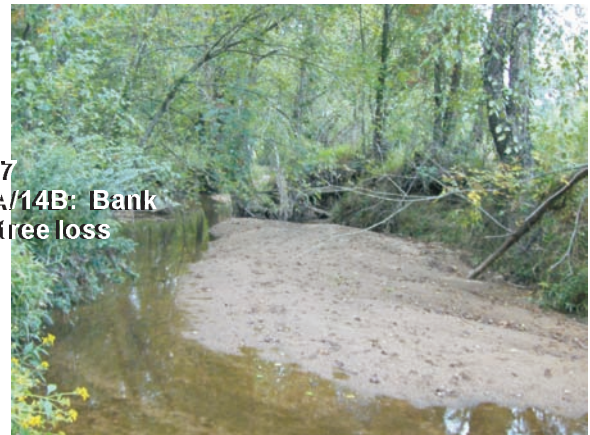
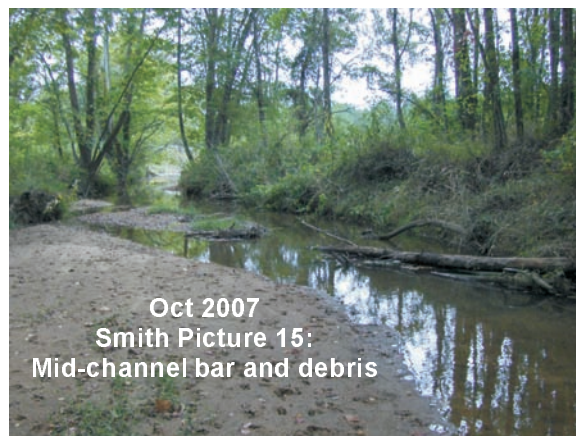
Smith and Austin Creeks
Smith Creek (continued): Example Problem/Watch Areas
Taken February and October 2007
