ANNUAL MONITORING REPORT SMITH AND AUSTIN CREEKS

**STREAM RESTORATION
WAKE COUNTY, NORTH CAROLINA
(EEP Project Number 343)
Monitoring Year 6 of 6 (2008)**

December 2008

Prepared by:
Axiom Environmental, Inc.
2126 Rowland Pond Drive
Willow Spring, North Carolina 27592

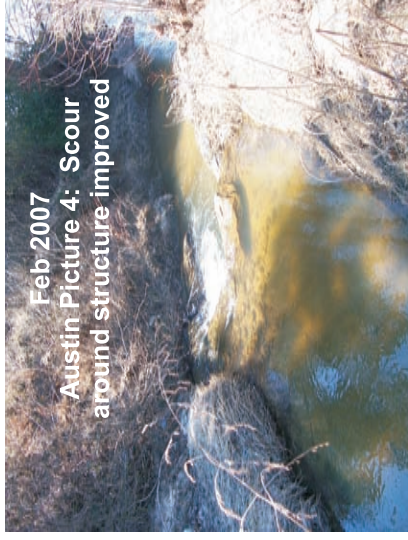
Oct 2007

Austin Picture 4: Scour around structure; vegetation is beginning to establish and erosion is less

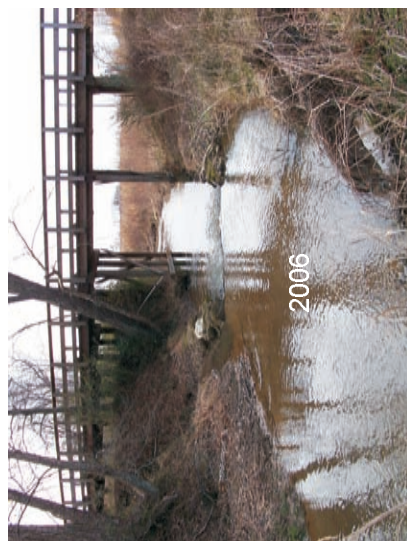
Feb 2008

Austin Picture 5: Several rocks washed out/removed; some erosion around remaining structure arm

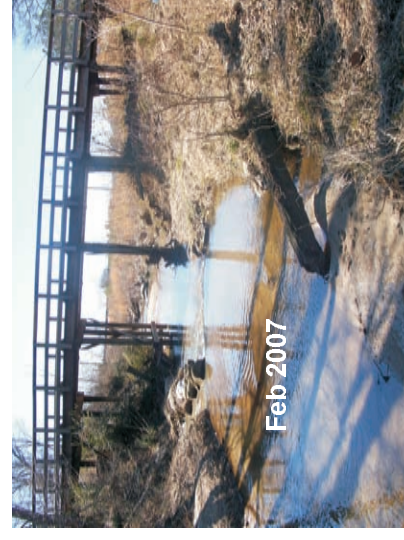
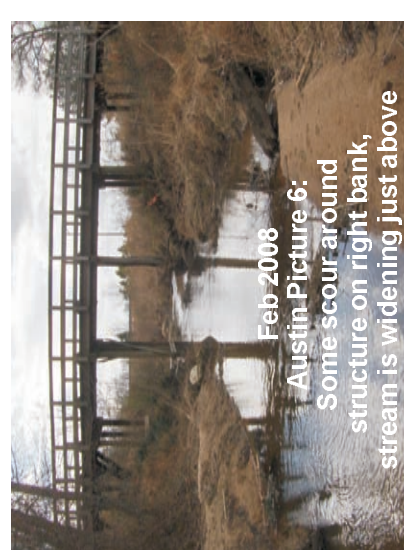
Feb 2007

Austin Picture 6: Some scour around structure on right bank, stream is widening just above
