Snowbird Creek Tributaries Mitigation Project

Year 2 Monitoring Report - Final

Graham County, North Carolina

Monitoring Firm: Michael Baker Engineering, Inc. (Baker)

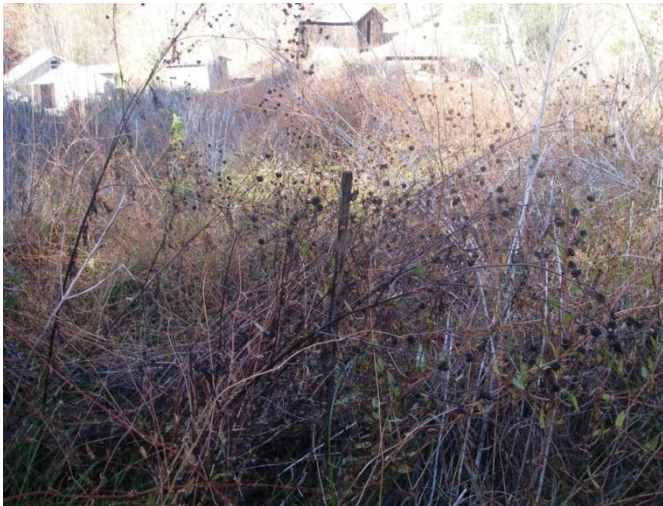
Photo 1: Veg Plot 1

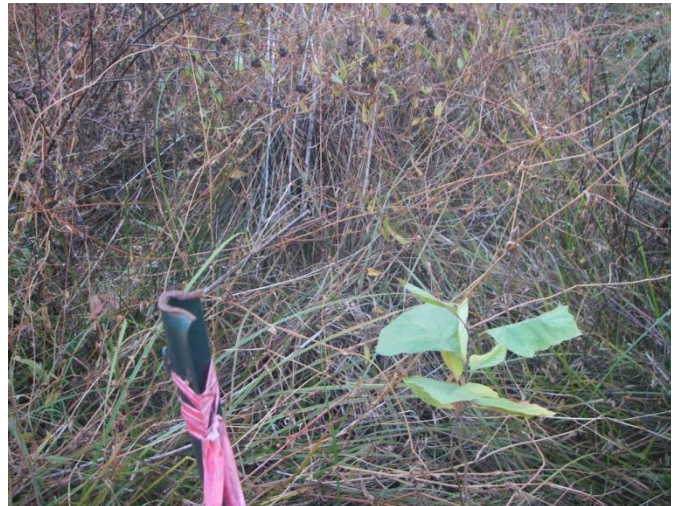
Photo 2: Veg Plot 1-Herbaceous Plot

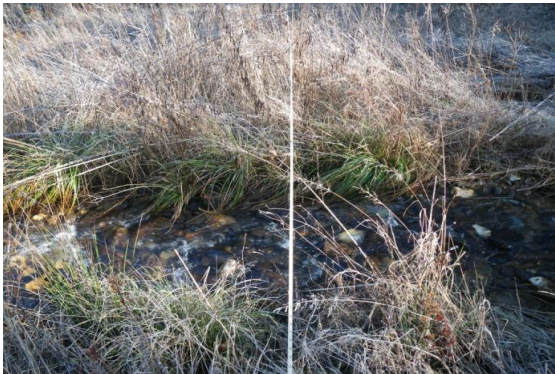
Photo 1: XS-1 facing right bank

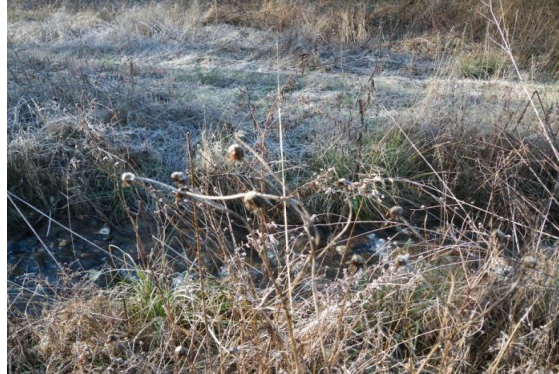
Photo 2: XS-1 facing left bank

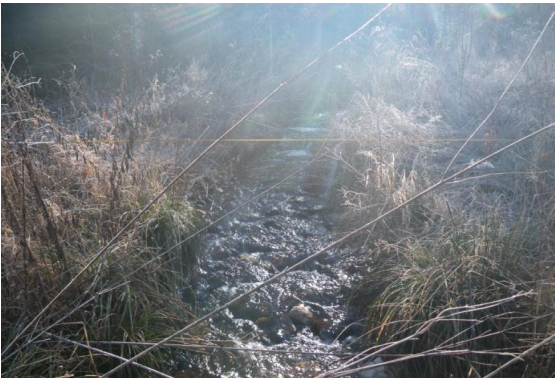
Photo 3: XS-1 facing upstream

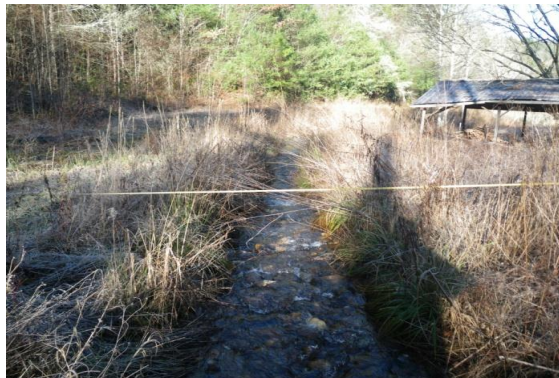
Photo 4: XS-1 facing downstream

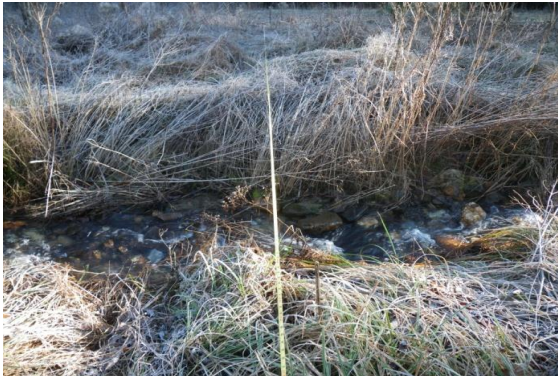
Photo 1: XS-2 facing right bank

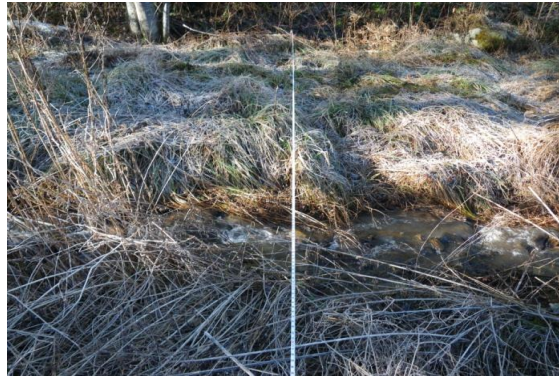
Photo 2: XS-2 facing left bank

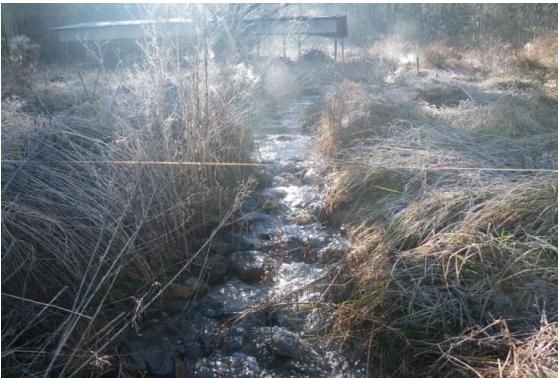
Photo 3: XS-2 facing upstream

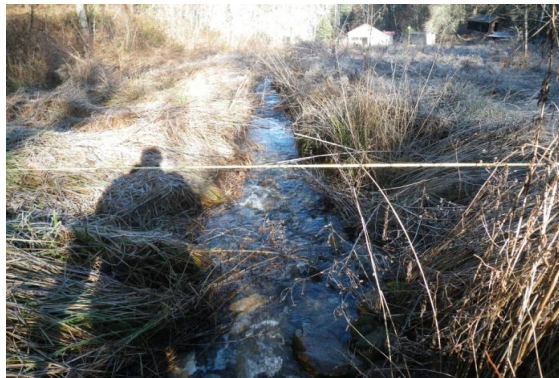
Photo 4: XS-2 facing downstream

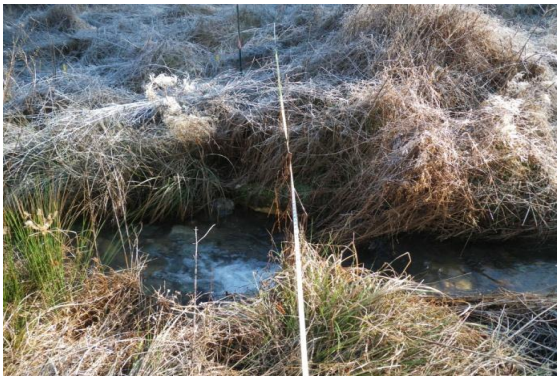
Photo 1: XS-3 facing right bank

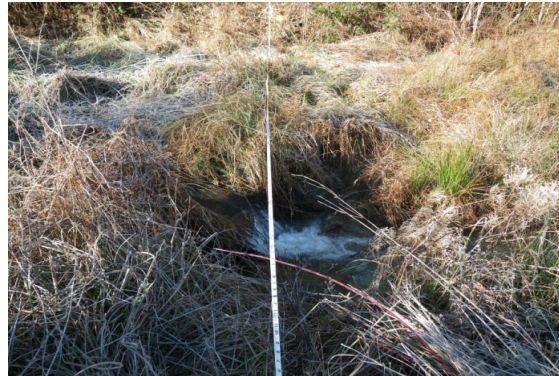
Photo 2: XS-3 facing left bank

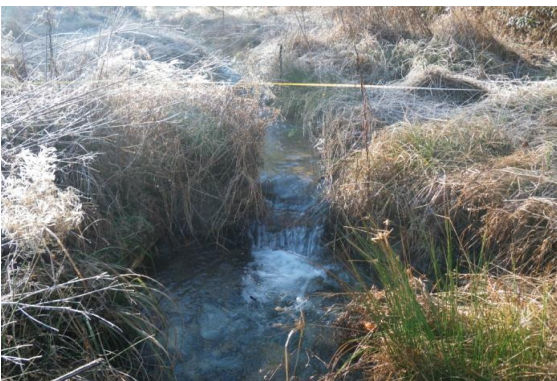
Photo 3: XS-3 facing upstream

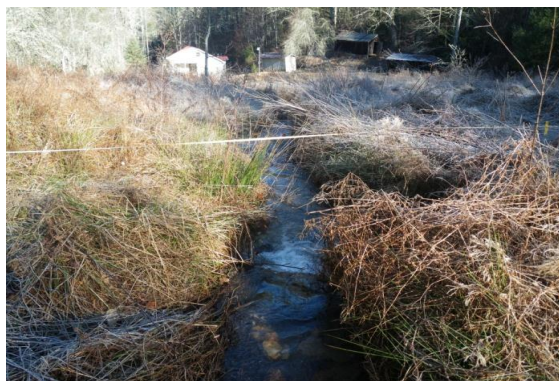
Photo 4: XS-3 facing downstream

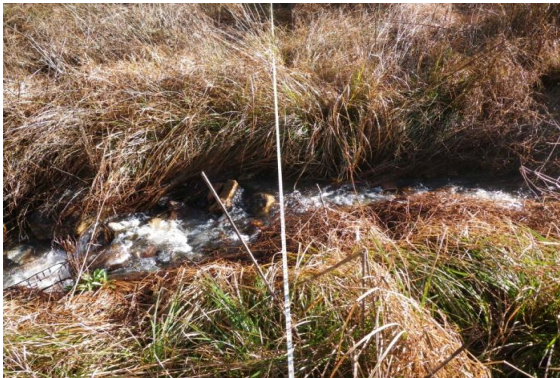
Photo 1: XS-4 facing right bank

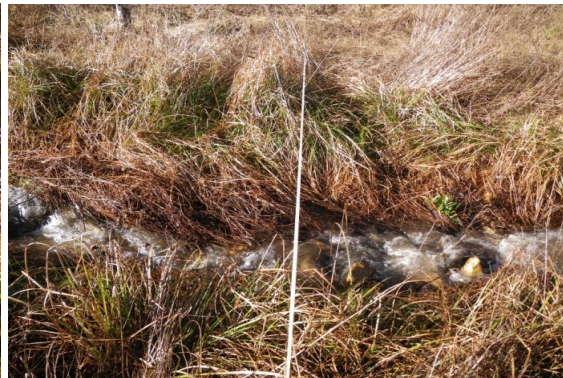
Photo 2: XS-4 facing left bank

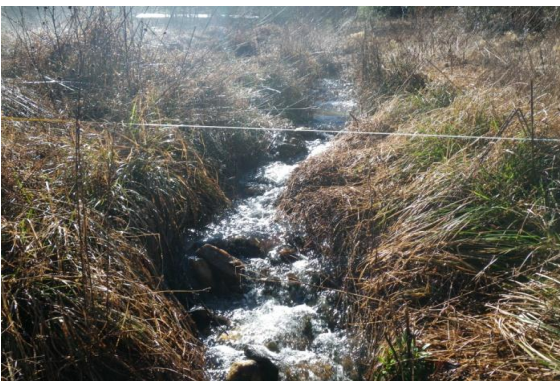
Photo 3: XS-4 facing upstream

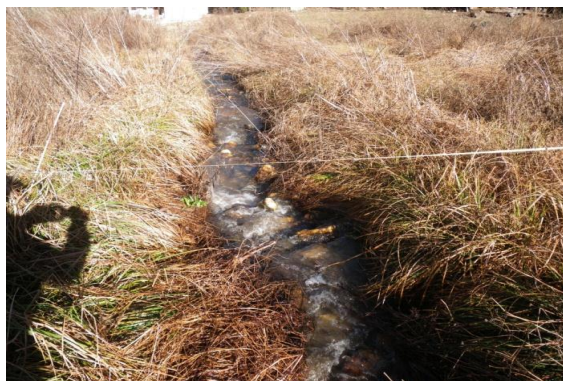
Photo 4: XS-4 facing downstream

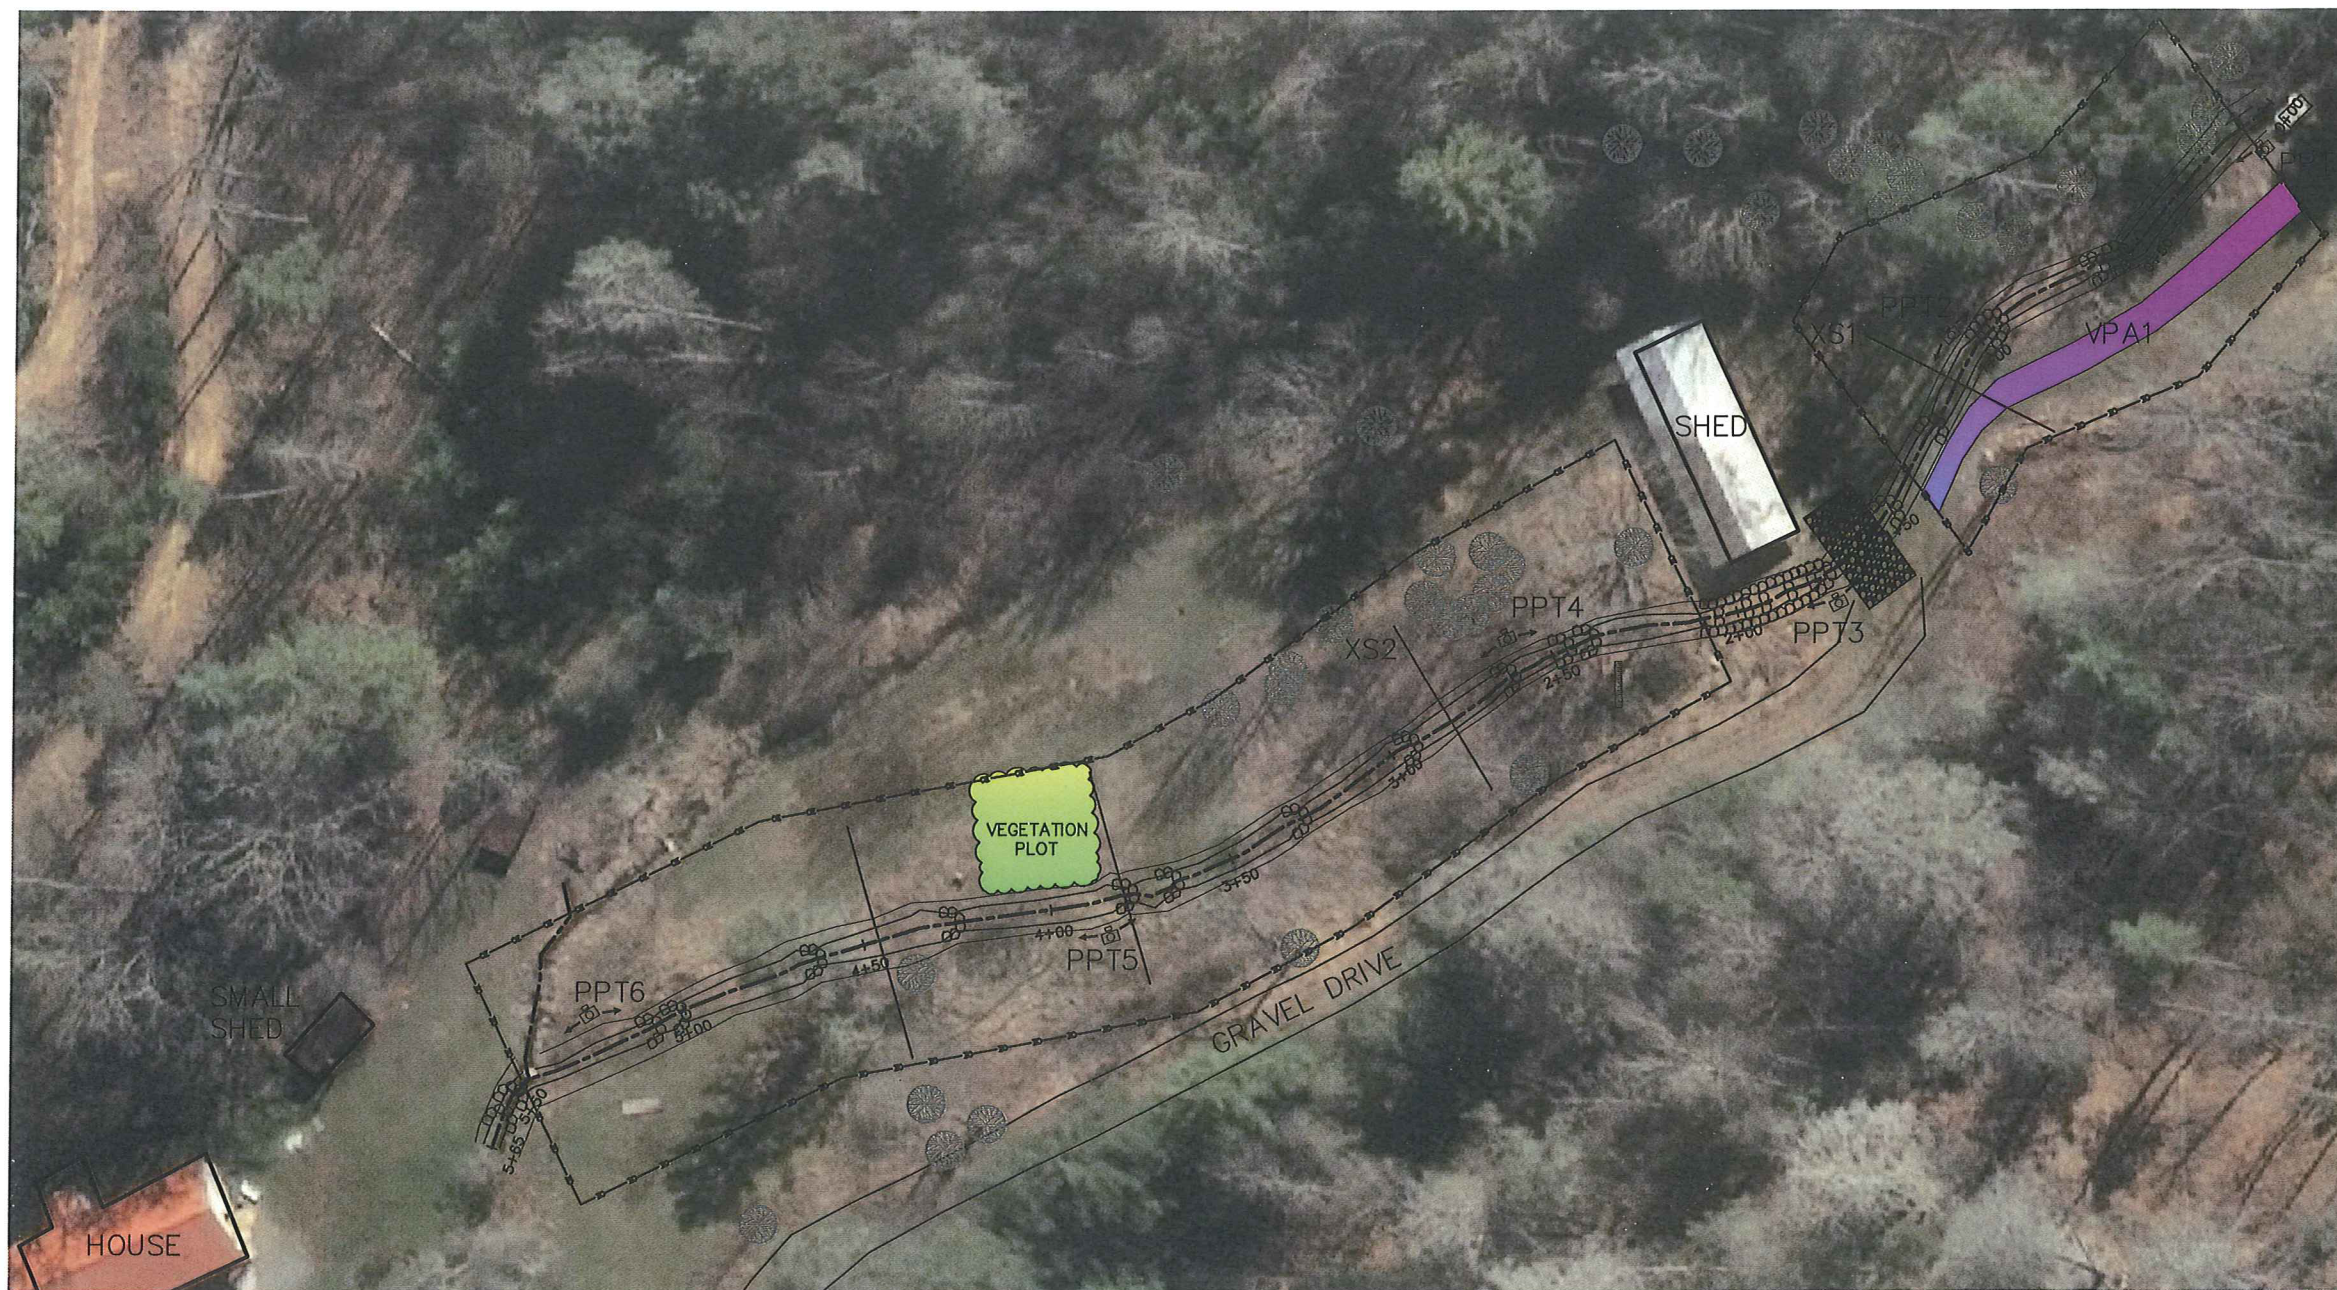
SNOWBIRD UT3 REACH 2
CURRENT CONDITION
PLAN VIEW
YEAR 2 MONITORING

Only one vegetation problem area was identified during the Year 2 monitoring period. It is a small strip of impacted buffer paralleling the upstream limits of UT3-Reach 2. This buffer impact is approximately 30 feet wide by 130 (from station 0+10 to 1+40) feet long and is located within the left floodplain; it is caused by local residents encroaching on a portion of the easement in order to gain vehicle access to existing logging roads (trails) that continue on the property further upstream of the project reach/easement limits. Vegetation within this impacted swath of buffer is sparse from the mowing over and flattening by vehicles to the extent that a defined path has become apparent. Baker is coordinating with the contractor and land owner to correct this situation by relocating the easement encroached portion of the vehicle access to outside of and adjacent to the easement to avoid further encroachment. The impacted buffer within the easement will be reseeded and replanted after construction of the relocated vehicle access. This is scheduled to be completed by the end of 2013 and will be documented within the Year 3 monitoring report. Supplemental information can be found in Appendix F which includes a planview figure, photos, and a summary table.

STREAM PROBLEM AREAS (NO STREAM PROBLEM AREAS)
