**Snow Creek Stream Restoration
2009 Final Monitoring Report
Monitoring Year Five**

Ecosystem Enhancement Program Project Number 00344

Submitted: April 23, 2010

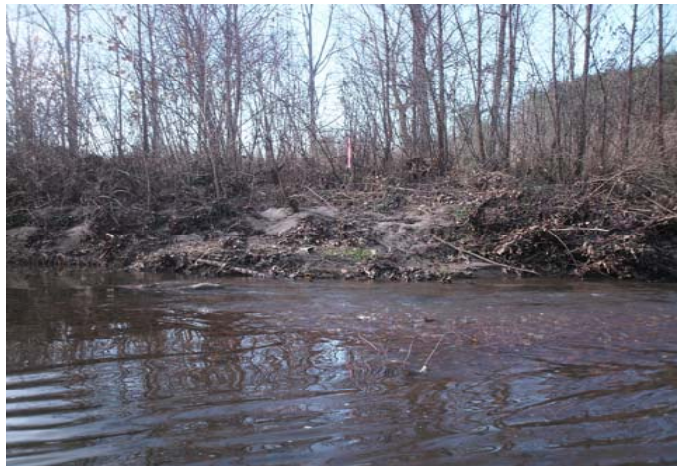
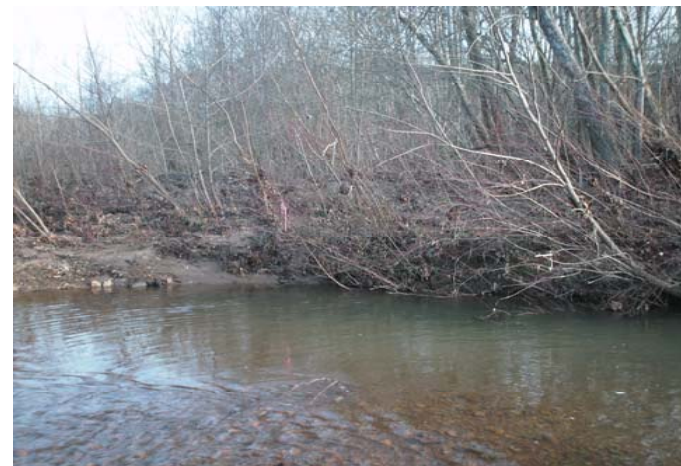
Note: Visual evaluations in 2006 did not indicate the cross section had shifted as may be indicated by overlay.

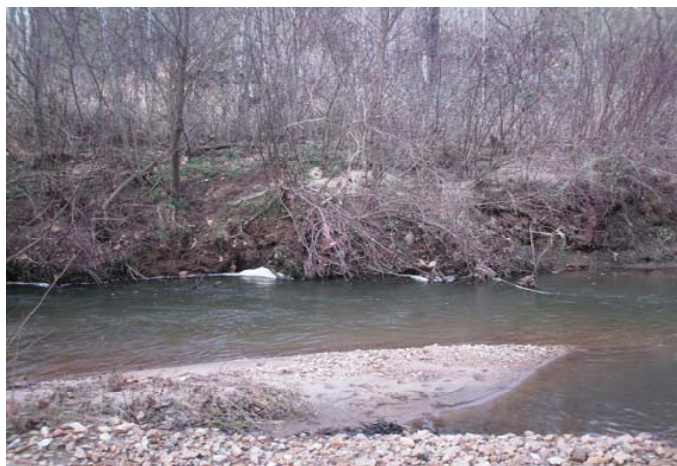
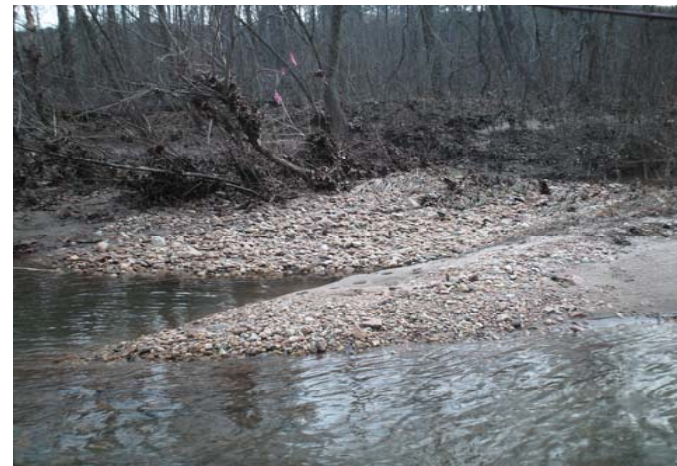
Note: Year 1 data appears to be missing a bed shot. Visual evaluations of the site do not indicate massive cutting between 2005 and 2006.

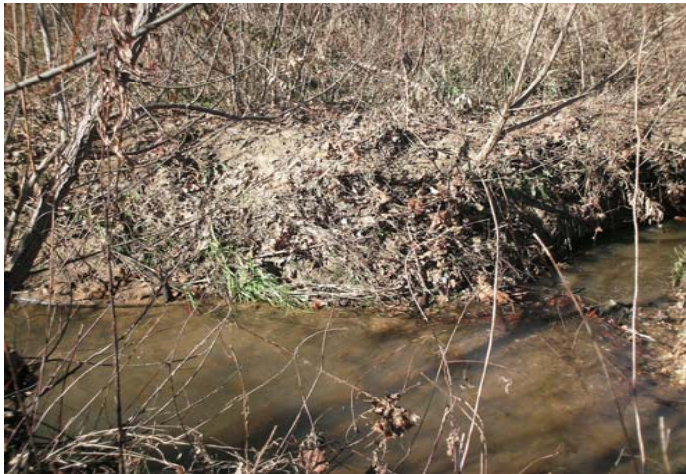
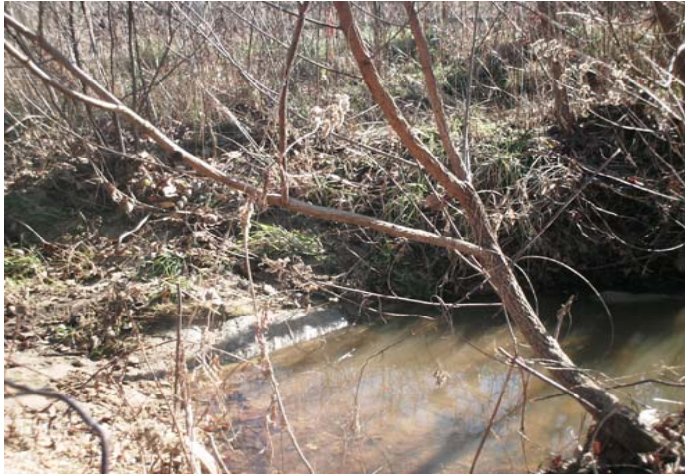
UT to Snow Creek XS 1, Pool, Year 1, 2, 3, 4, & 5 Overlay

Notes: Left pin reestablished during 2008 survey.

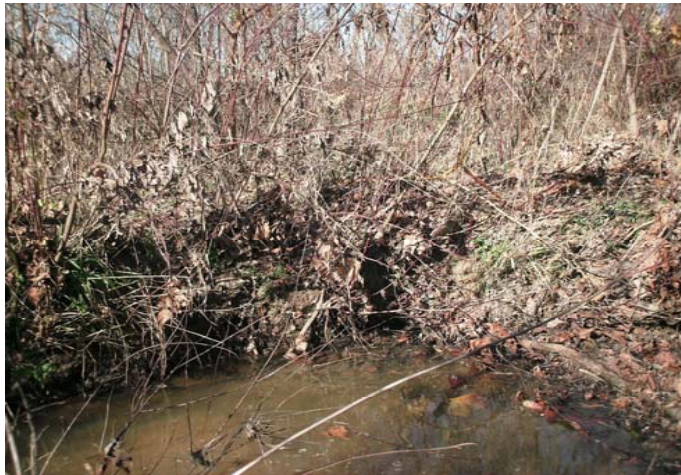
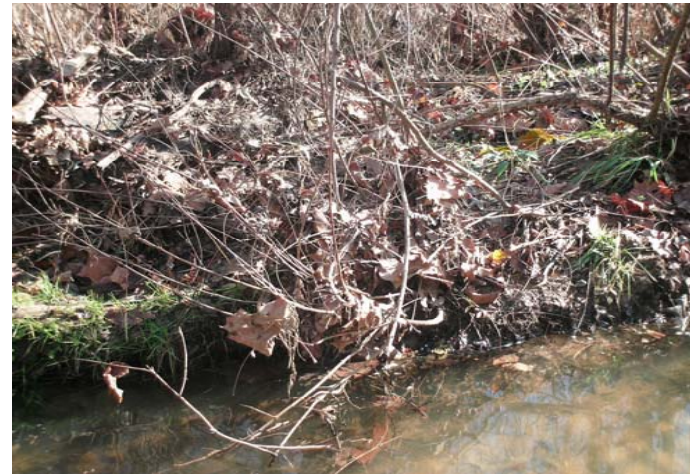
UT to Snow Creek XS 2, Riffle, Year 1, 2, 3, 4, & 5 Overlay

Notes: Left bank pin reestablished during 2006 survey.
