**South Fork Mitigation Project
Catawba County, North Carolina**

Year 3 Monitoring Report

November 2007

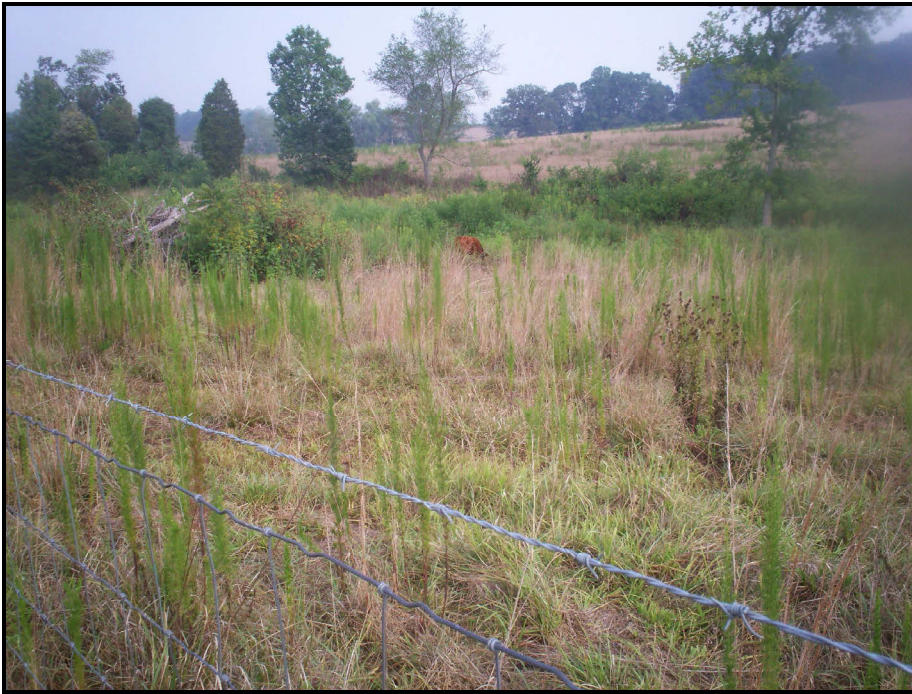
SPA 11. Cows in Easement in UT5 South.
