**Year 1 Monitoring Report for Stream Mitigation of South Muddy Creek
Tributaries
(Queen Property)**

South Muddy Creek Tributaries
McDowell County, NC
SCO # D04006-01

Submitted: September 2007

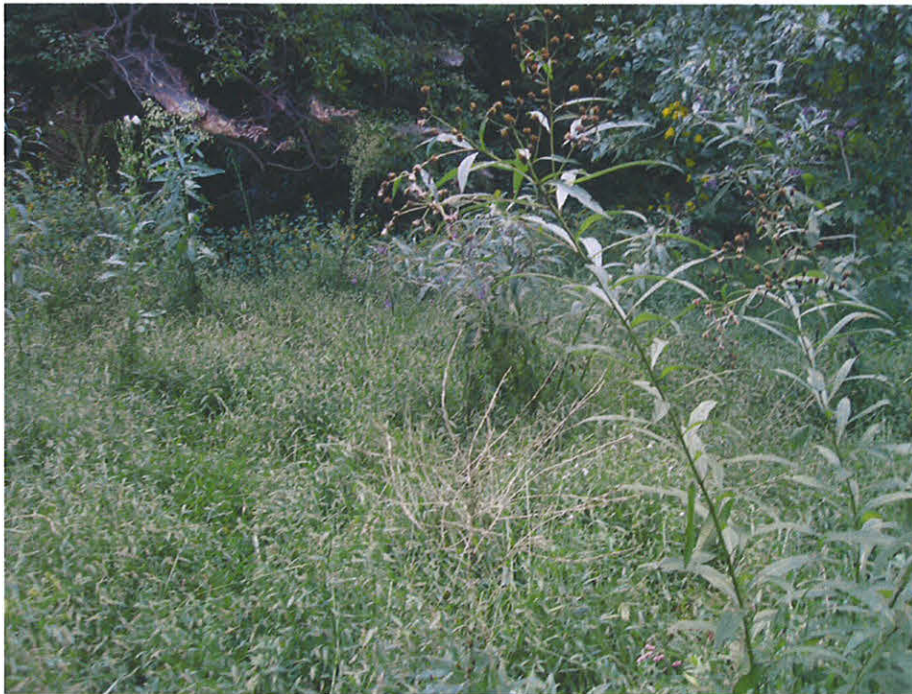
Vegetation Plot 30
Monitoring Year 1
(EMH&T, Inc. 9/19/06)

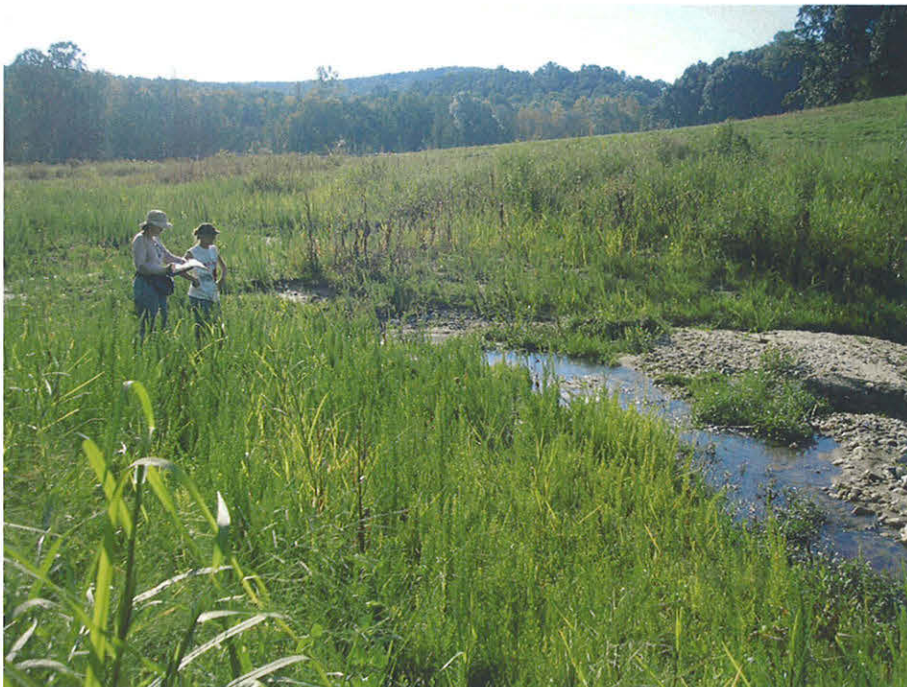
Fixed Station 8
Overview of valley along Tributary B, facing downstream.
(EMH&T, Inc. 9/19/06)
