Year 4 Monitoring Report for South Muddy Creek Tributaries (Queen Properties)

South Muddy Creek Tributaries
McDowell County, NC
SCO # D04006-01

Submitted: December 2009

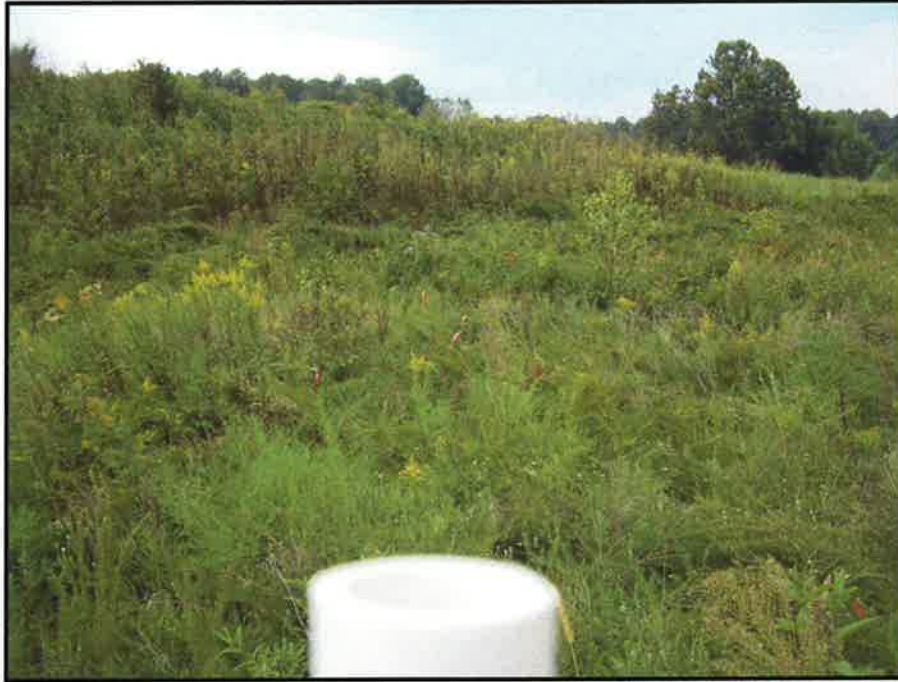
VPA 1

View of *Sericea lespedeza* growing along the riparian corridor of Tributary A (middle), near Vegetation Plot 4.

A few vegetative problem areas of low concern were noted in the project area, included scattered populations of problematic species. The problematic species have been and will continue to be proactively managed by herbicide treatment.

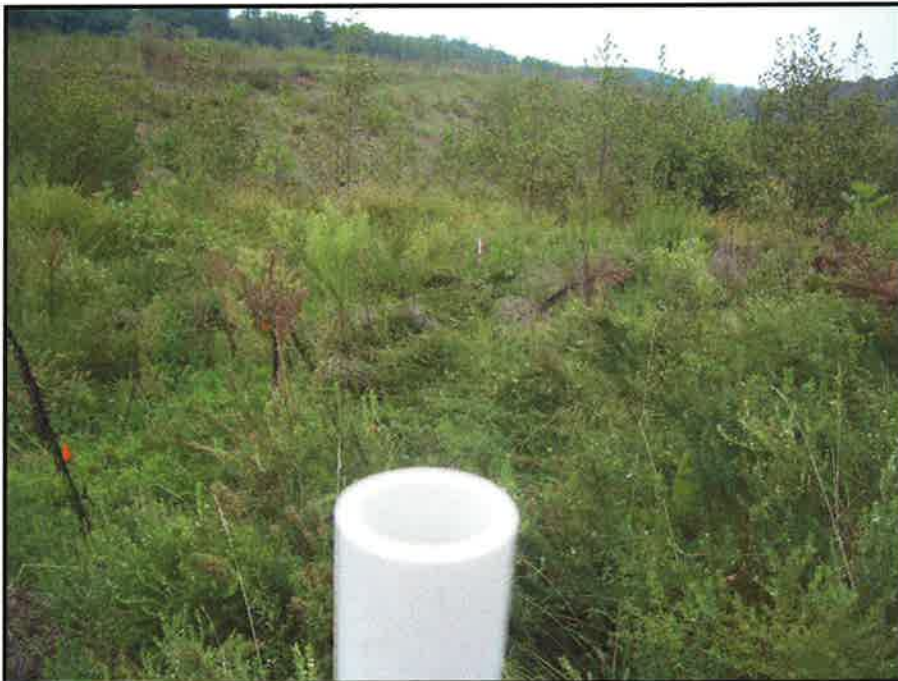
VPA 2

View of *Sericea lespedeza* growing along riparian corridor of Tributary A (lower), at Vegetation Plot 19.

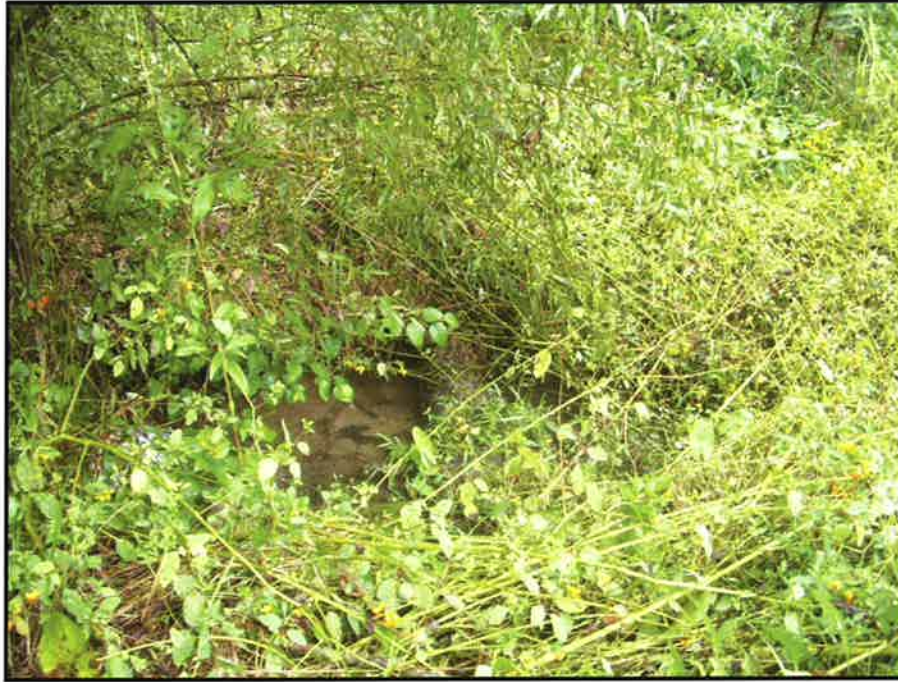
SPA 4
Close-up of bank scour along the right bank of Tributary C near station 4+11.
(EMH&T, Inc. 9/16/09)

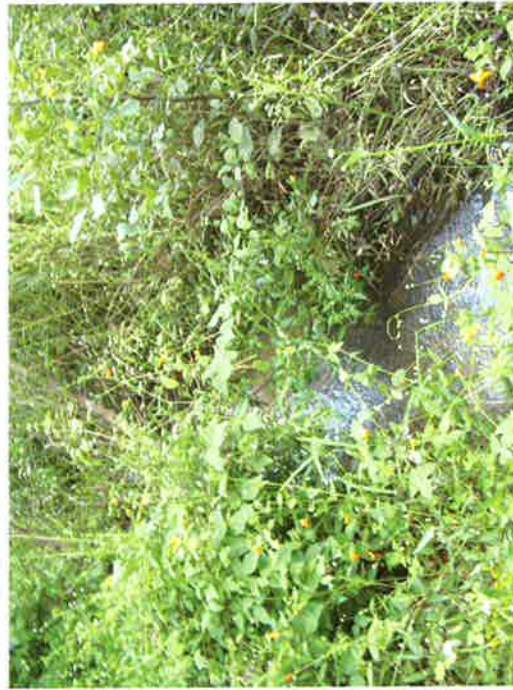
CROSS SECTION: 115+35.21
FEATURE: Riffle

**Cross-section photo – looking downstream
 Channel obscured by vegetation.**

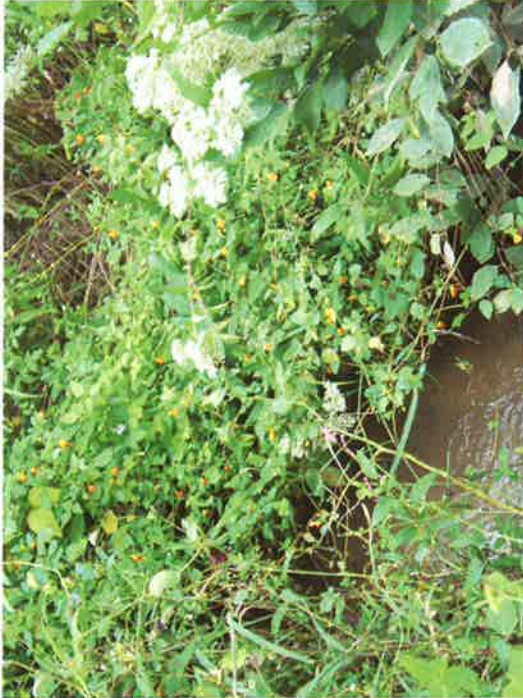
CROSS SECTION: 113+37.13
FEATURE: Pool

**Cross-section photo – looking downstream
 Channel obscured by vegetation.**

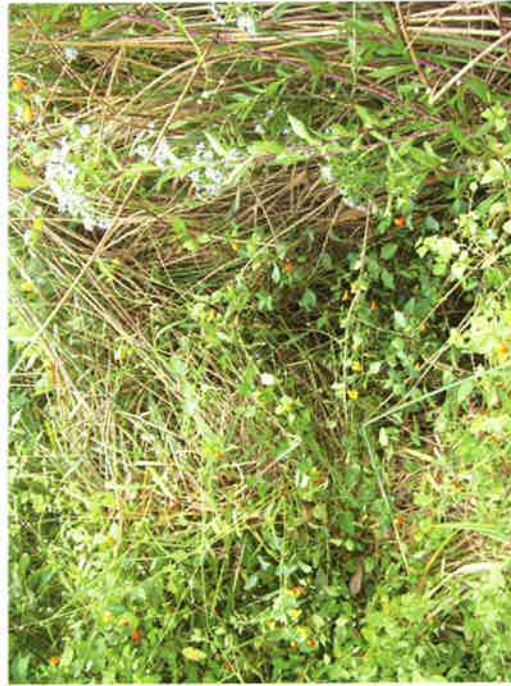
CROSS SECTION: 110+48.78

Cross-section photo – looking downstream
 Channel is obscured by vegetation.

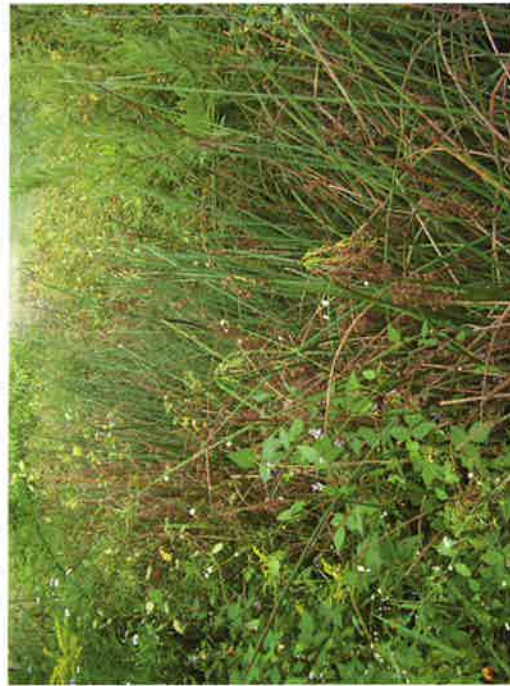
CROSS SECTION: 108+96.23

Cross-section photo – looking downstream
 Channel is obscured by vegetation.

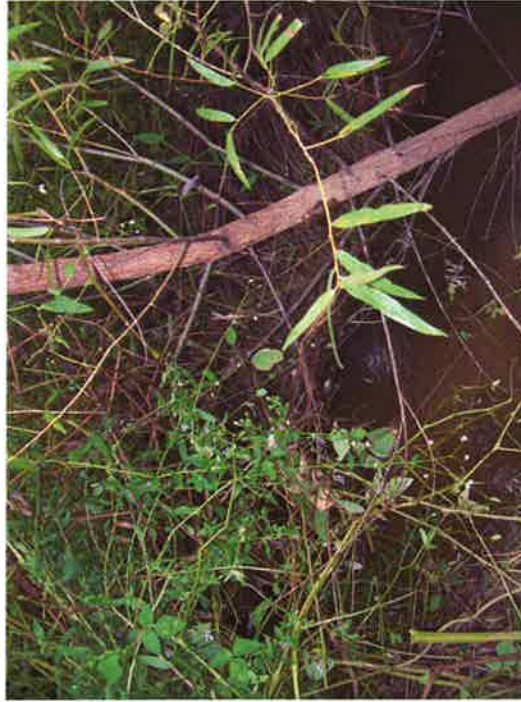
CROSS SECTION: 105+38.70

Cross-section photo – looking downstream
 Channel is obscured by vegetation.

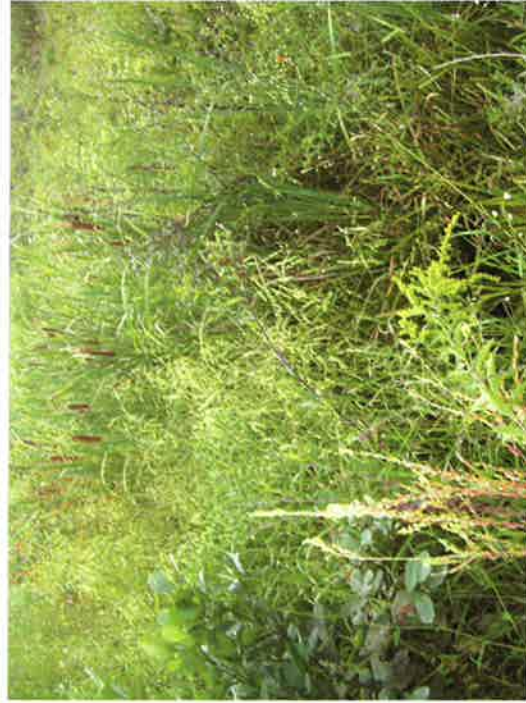
CROSS SECTION: 87+92.18
FEATURE: Pool

**Cross section photo – looking downstream
 Channel obscured by vegetation.**

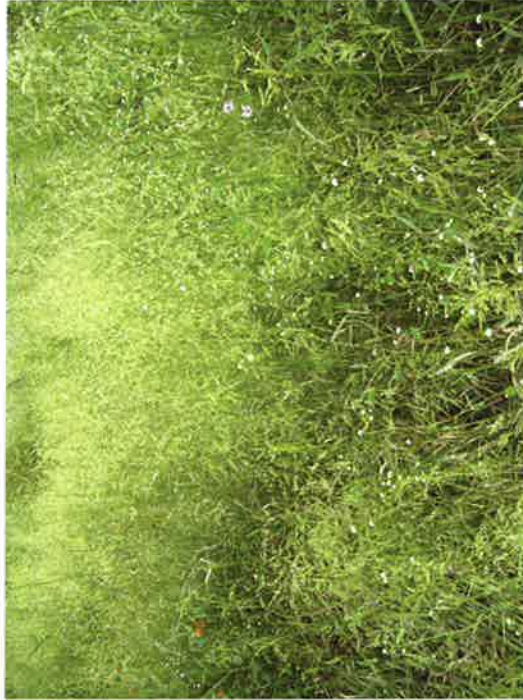
CROSS SECTION: 72+02.58
FEATURE: Pool

Cross section photo – looking downstream
 Channel obscured by vegetation.

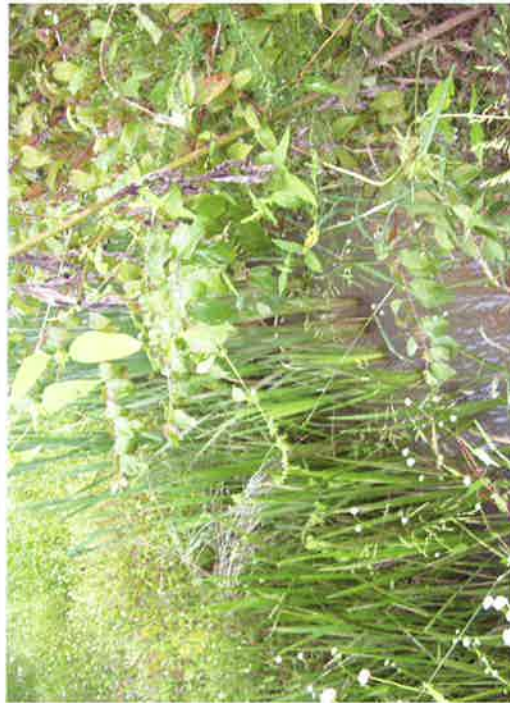
CROSS SECTION: 70+96.05
FEATURE: Riffle

Cross section photo – looking downstream
Channel is obscured by vegetation.

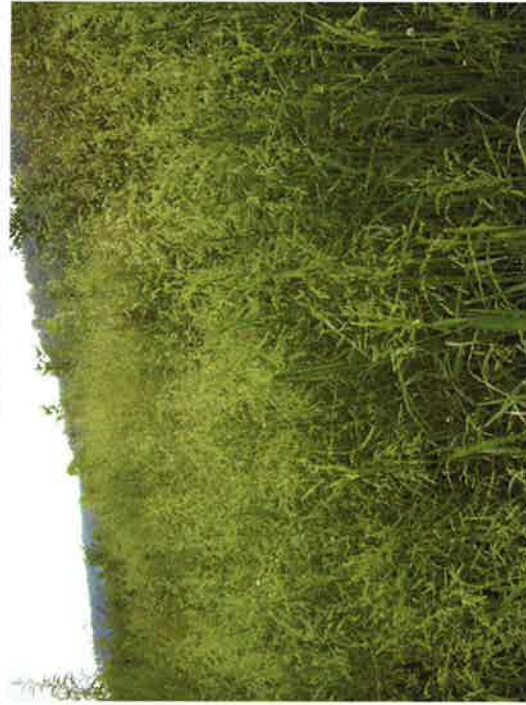
CROSS SECTION: 66+01.49
FEATURE: Pool

Cross section photo – looking downstream
 Channel is obscured by vegetation.

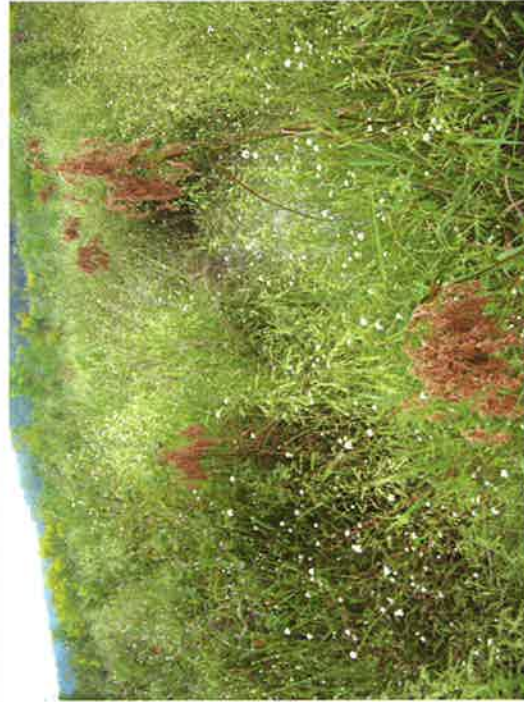
CROSS SECTION: 64+13.80

Cross section photo – looking downstream
 Channel obscured by vegetation.

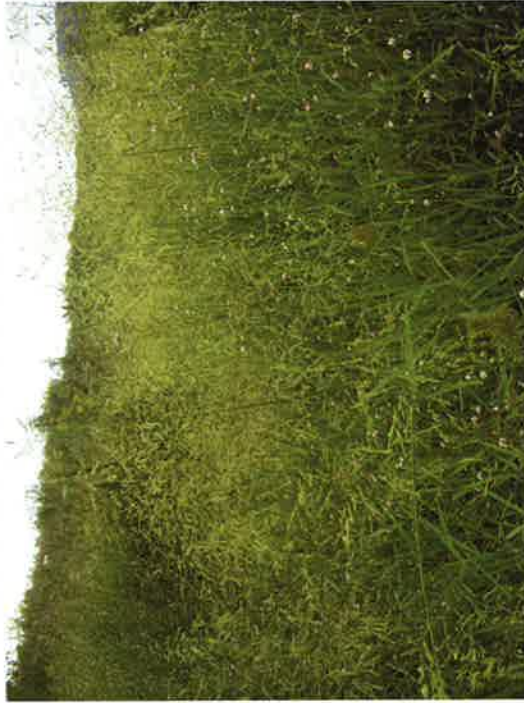
Cross section photo – looking downstream
 Channel is obscured by vegetation.

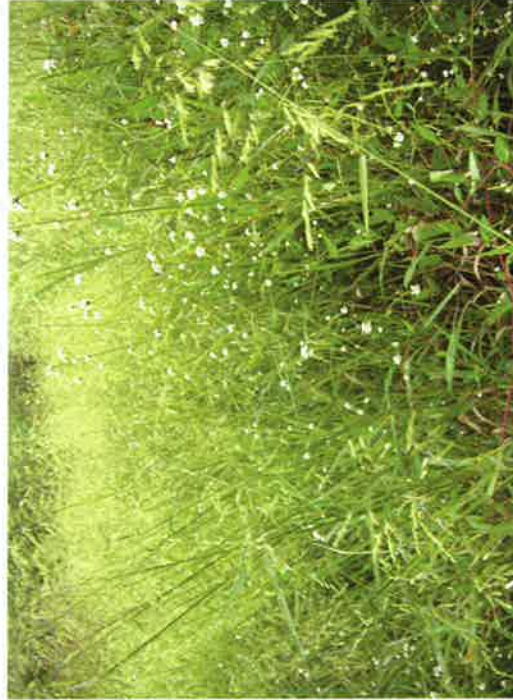
CROSS SECTION: 50+53.37
FEATURE: Riffle

Cross section photo – looking downstream
 Channel obscured by vegetation.

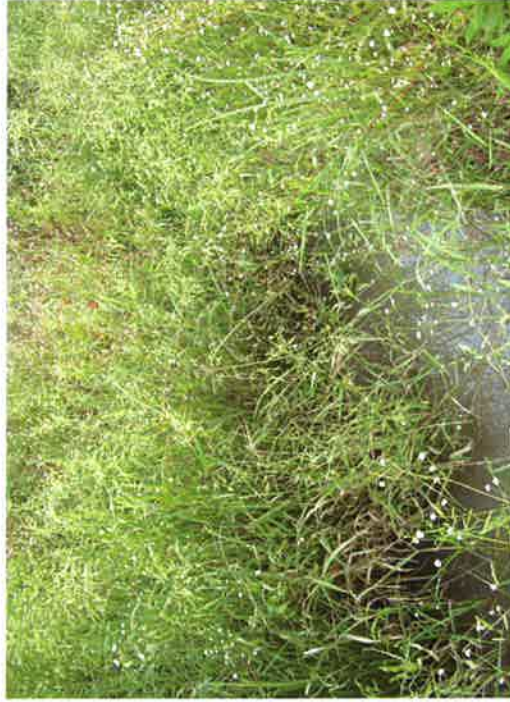
CROSS SECTION: 43+93.88
FEATURE: Pool

Cross section photo – looking downstream
 Channel obscured by vegetation.

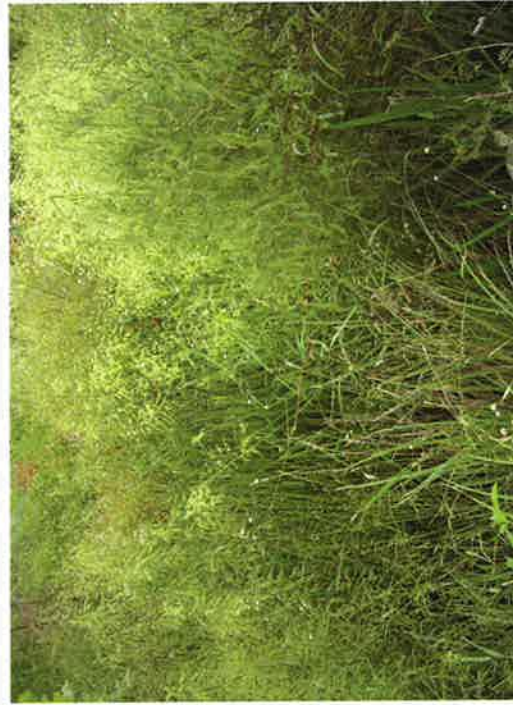
Cross section photo – looking downstream
 Channel obscured by vegetation.

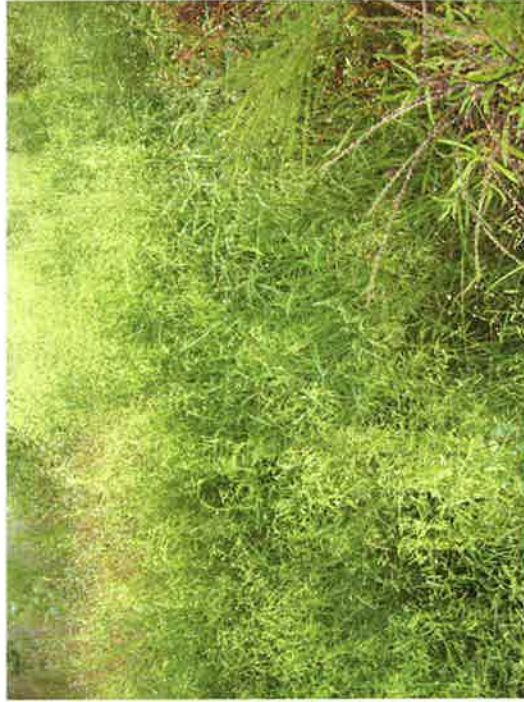
CROSS SECTION: 28+23.53

Cross section photo – looking downstream
 Channel obscured by vegetation.

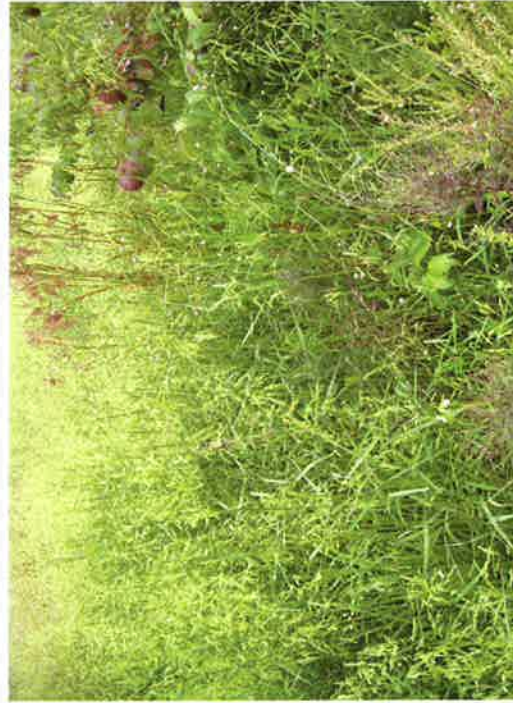
Cross section photo – looking downstream
 Channel is obscured by vegetation.

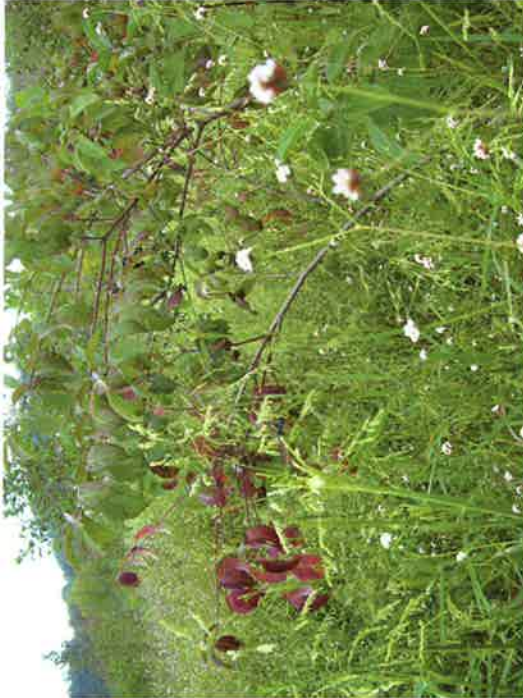
22+31.26
 Riffle

**Cross section photo – looking downstream
 Channel is obscured by vegetation.**

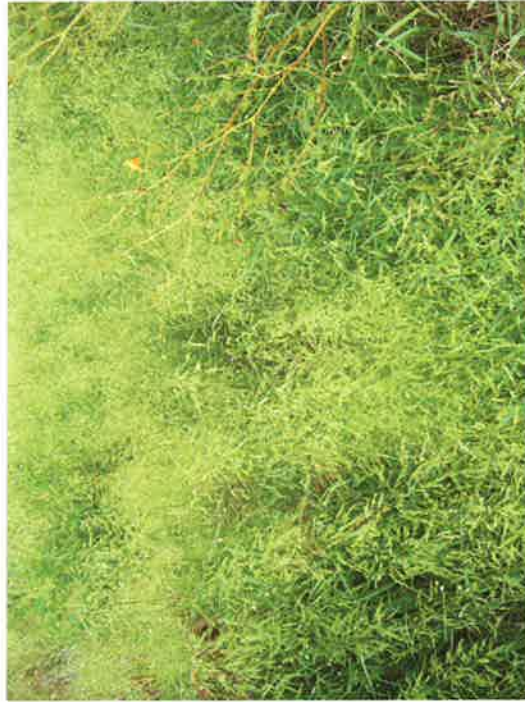
CROSS SECTION: 21+16.53

**Cross section photo – looking downstream
 Channel is obscured by vegetation.**

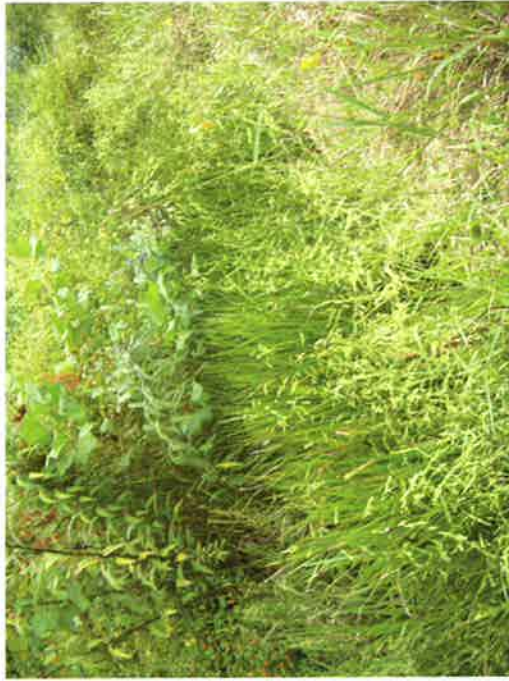
CROSS SECTION: 4+31

Cross section photo – looking downstream
 Channel obscured by vegetation.

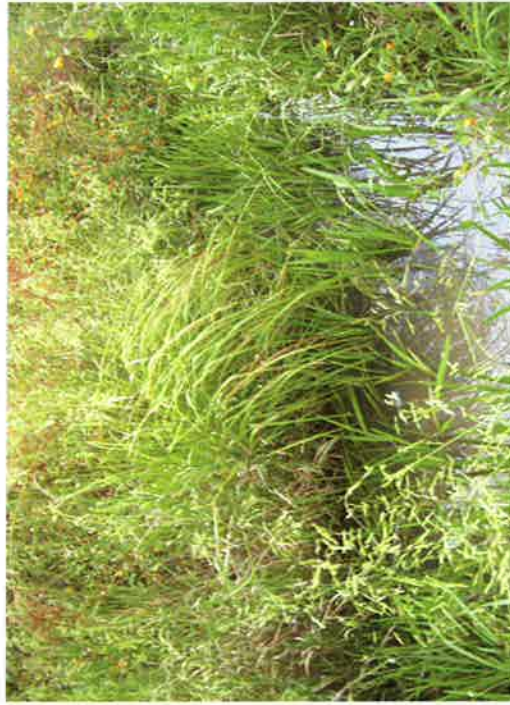
CROSS SECTION: 3+18.00

Cross section photo – looking downstream
 Channel obscured by vegetation.

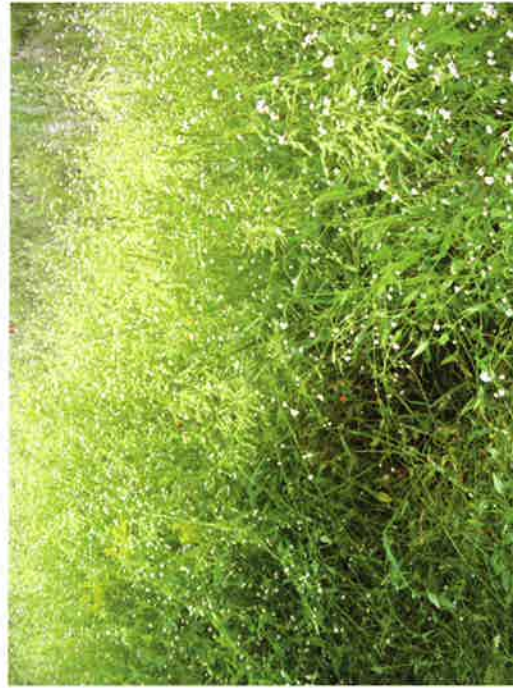
CROSS SECTION: 3+23
FEATURE: Pool

**Cross-section photo – looking downstream
 Channel completely obscured by vegetation.**

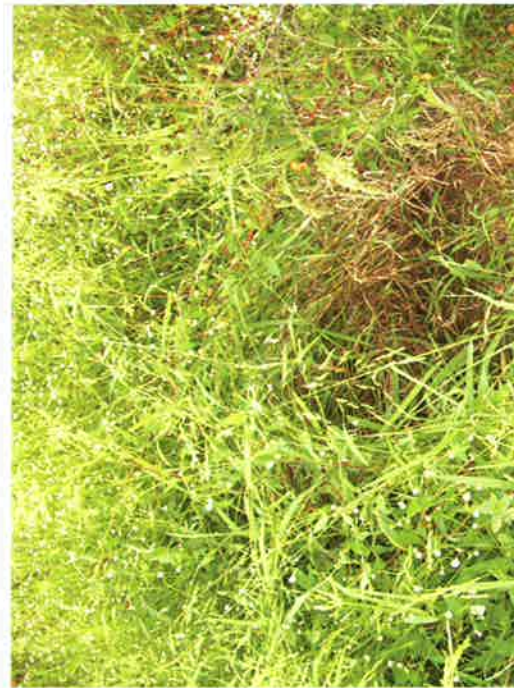
CROSS SECTION: 2+18

**Cross-section photo – looking downstream
 Channel obscured by vegetation.**

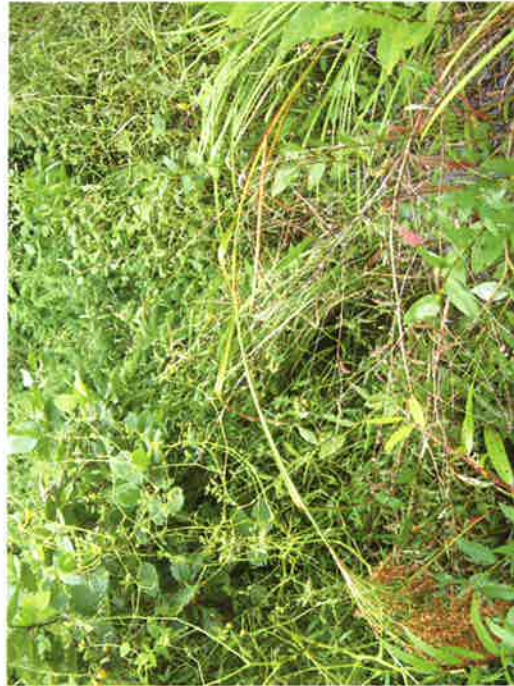
CROSS SECTION: 15+34.21

Cross-section photo – looking downstream
 Channel obscured by vegetation.

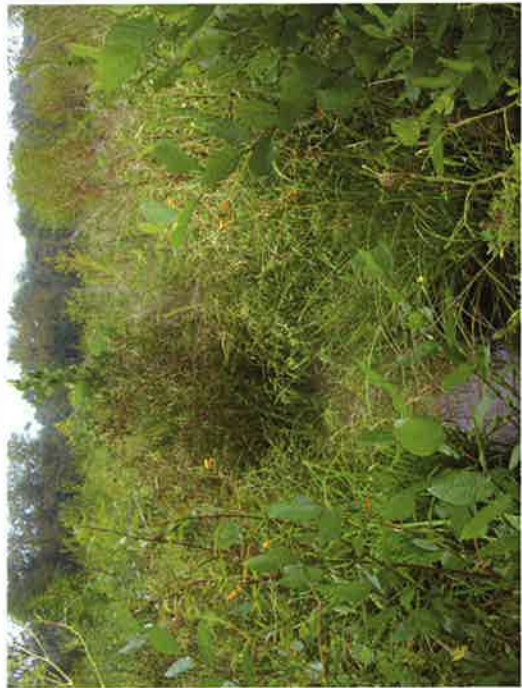
CROSS SECTION: 12+10.65

Cross-section photo – looking downstream
 Channel obscured by vegetation.

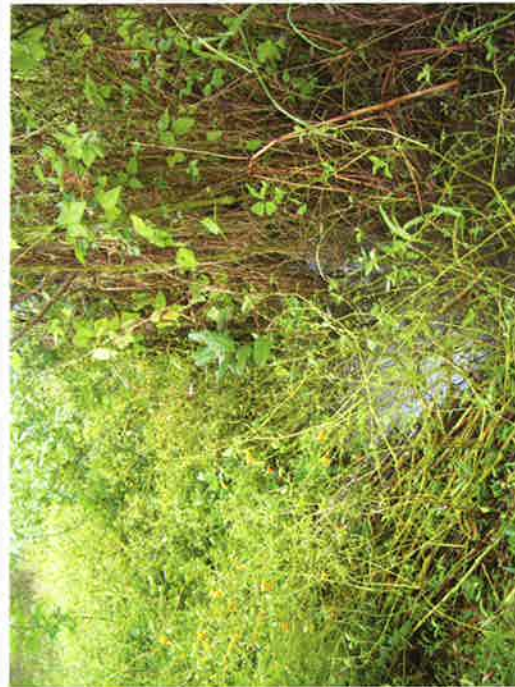
CROSS SECTION: 8+39.41

**Cross-section photo – looking downstream.
 Channel obscured by vegetation.**

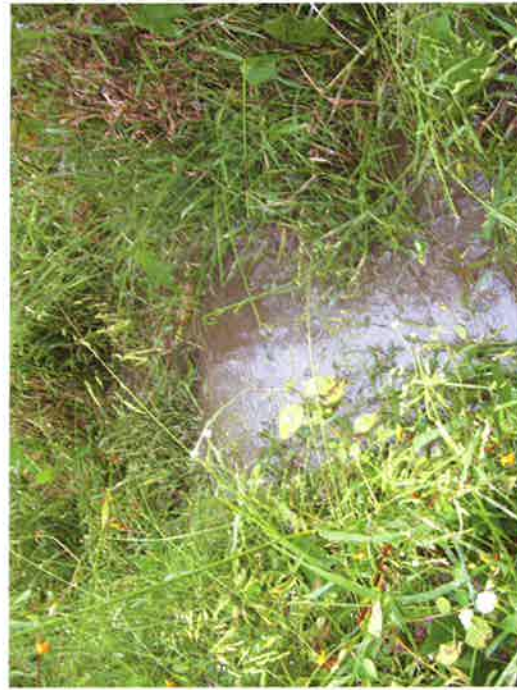
CROSS SECTION: 5+00.07
FEATURE: Riffle

Cross-section photo – looking downstream
 Channel obscured by vegetation.

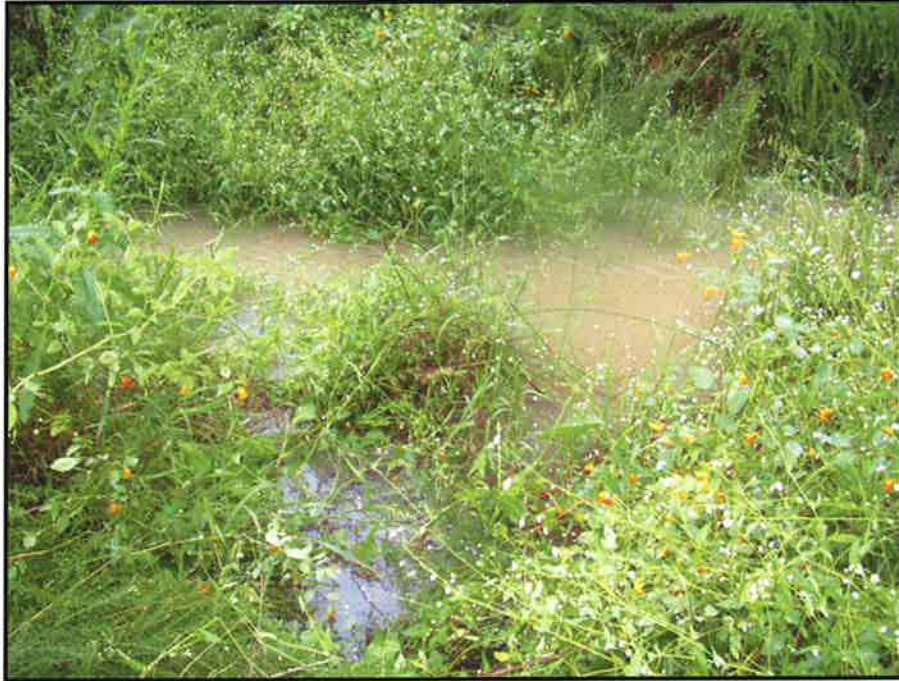
BF 5

Bankfull event in progress on Tributary A (Lower) near station 3+18, looking across the channel.

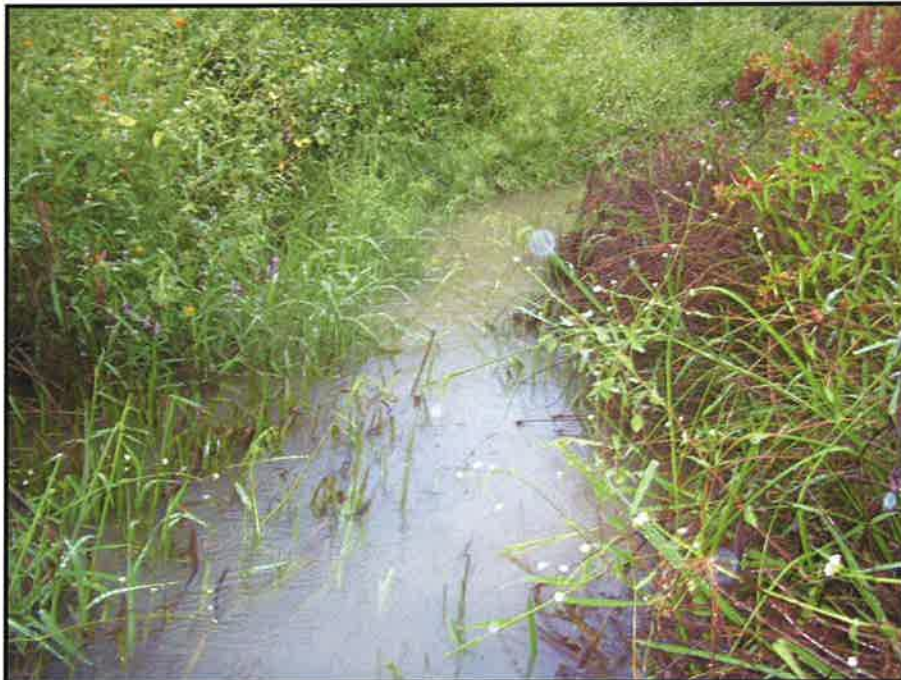
BF 6

Bankfull event in progress on Tributary A (Lower) near station 40+13, looking upstream.

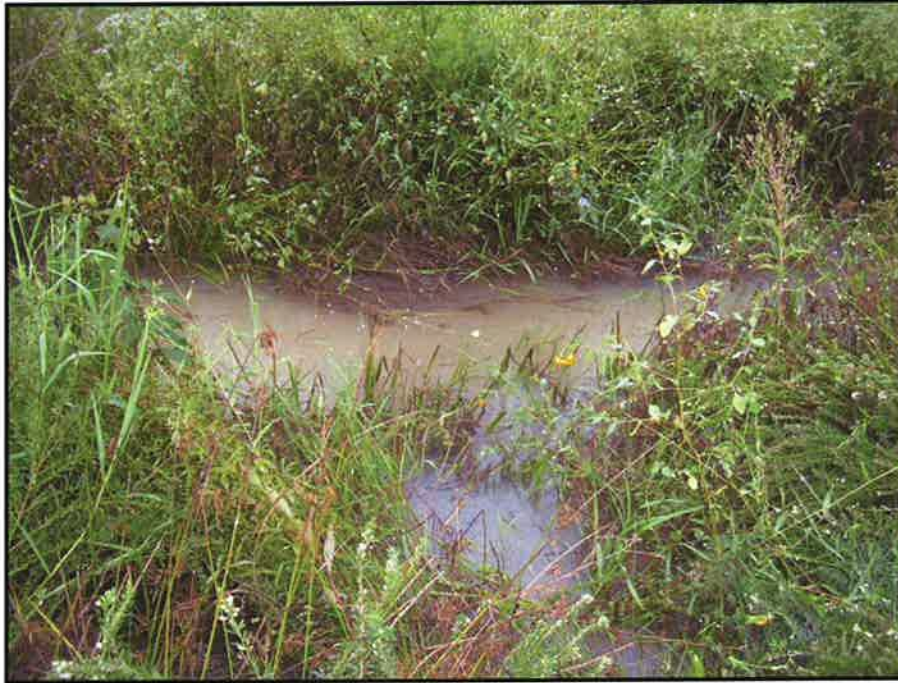
BF 7

Bankfull event in progress on Tributary A (Lower) near station 40+13, looking across the channel.

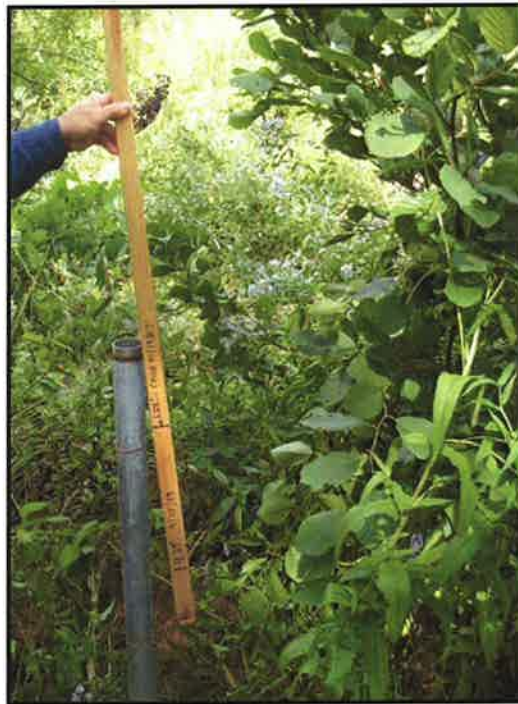
BF 8

Crest Gage on Tributary A (upper).

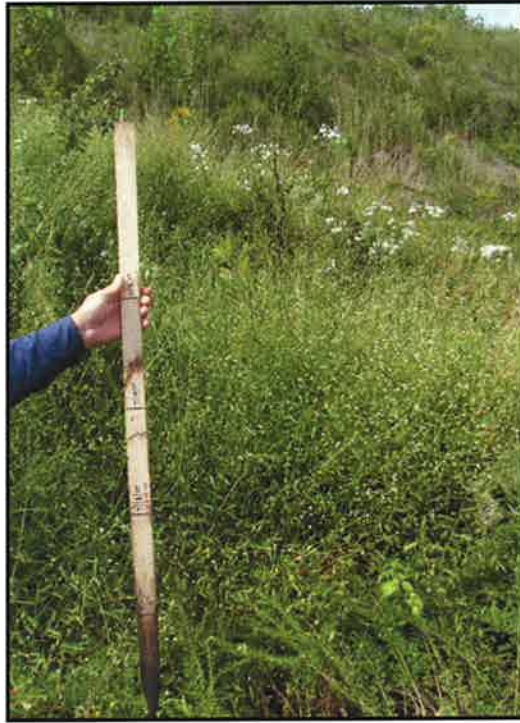
BF 9

Crest Gage on Tributary A (middle).
(EMH&T, Inc. 9/21/09)

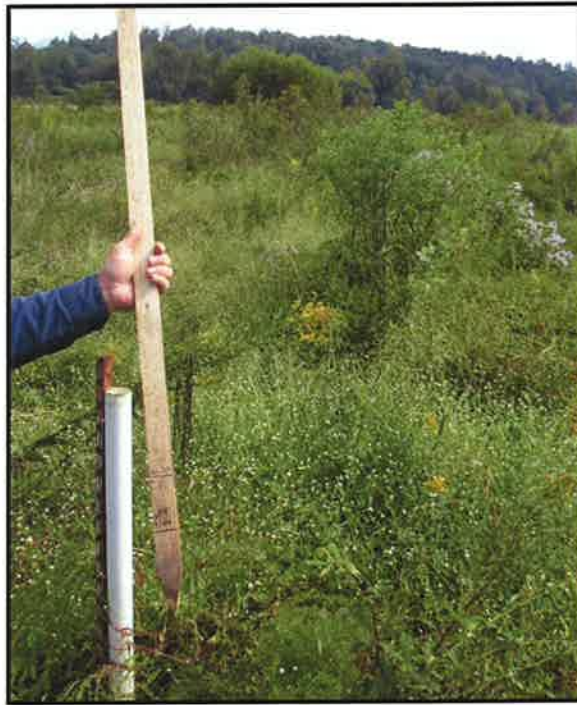
BF 10

Crest Gage on Tributary A2.
(EMH&T, Inc. 9/21/09)
