Subject: Year 5 Monitoring Report for Stream Mitigation of South Muddy Creek Tributaries
SCO# D04006-01

Year 5 Monitoring Report for South Muddy Creek Tributaries (Queen Properties)

South Muddy Creek Tributaries
McDowell County, NC
SCO # D04006-01

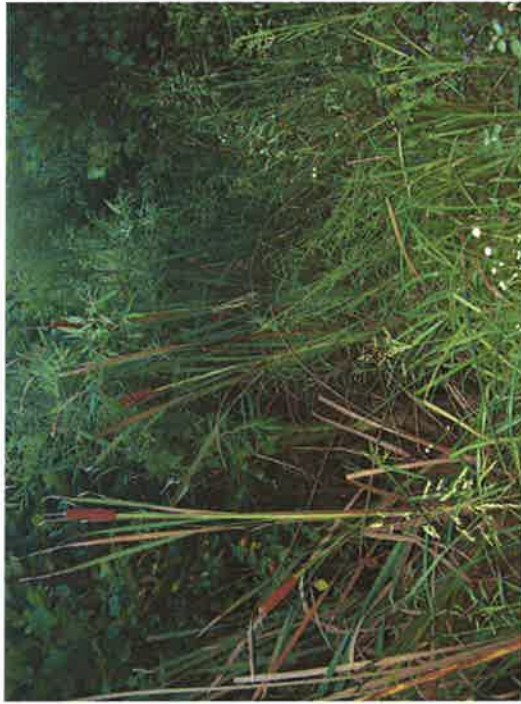
CROSS SECTION: 113+37.13

Cross-section photo – looking left to right bank
 Channel obscured by vegetation.

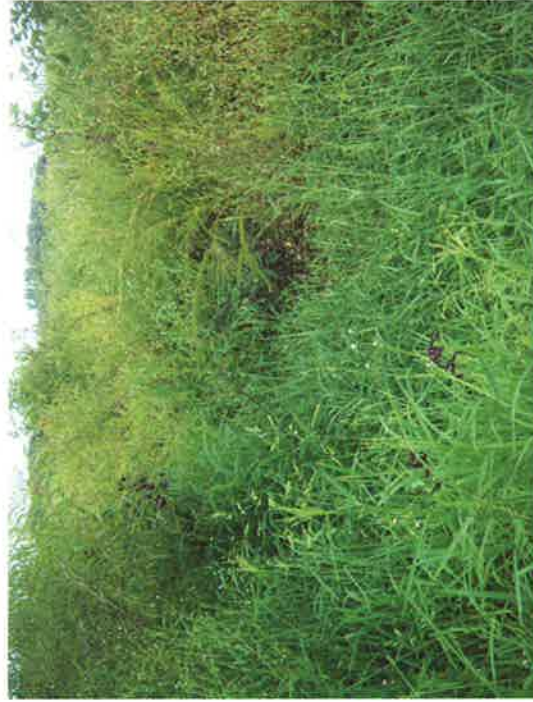
CROSS SECTION: 28+23.53

Cross section photo – looking downstream
Channel obscured by vegetation.

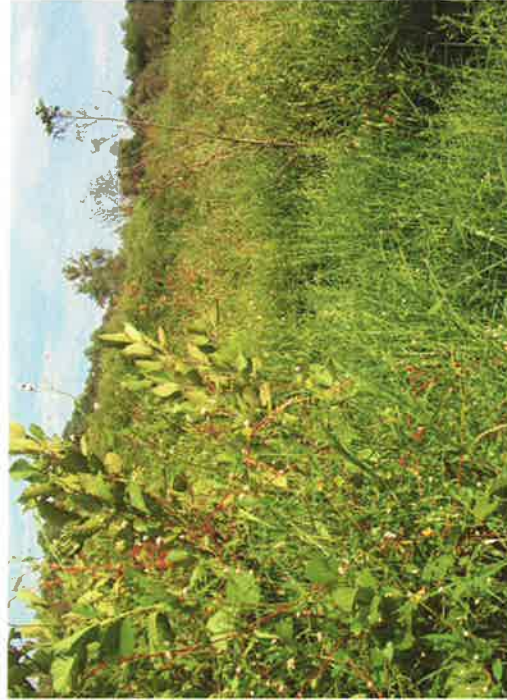
CROSS SECTION: 25+39.47

**Cross section photo – looking downstream
 Channel is obscured by vegetation.**

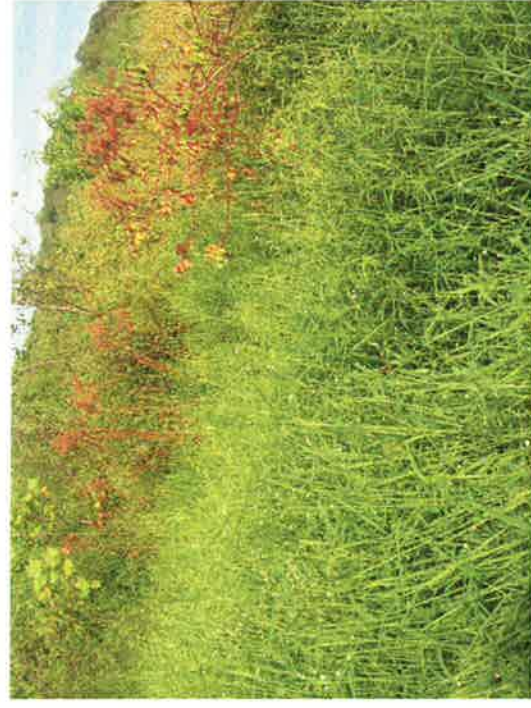
CROSS SECTION: 22+31.26
FEATURE: Riffle

Cross section photo – looking downstream
 Channel is obscured by vegetation.

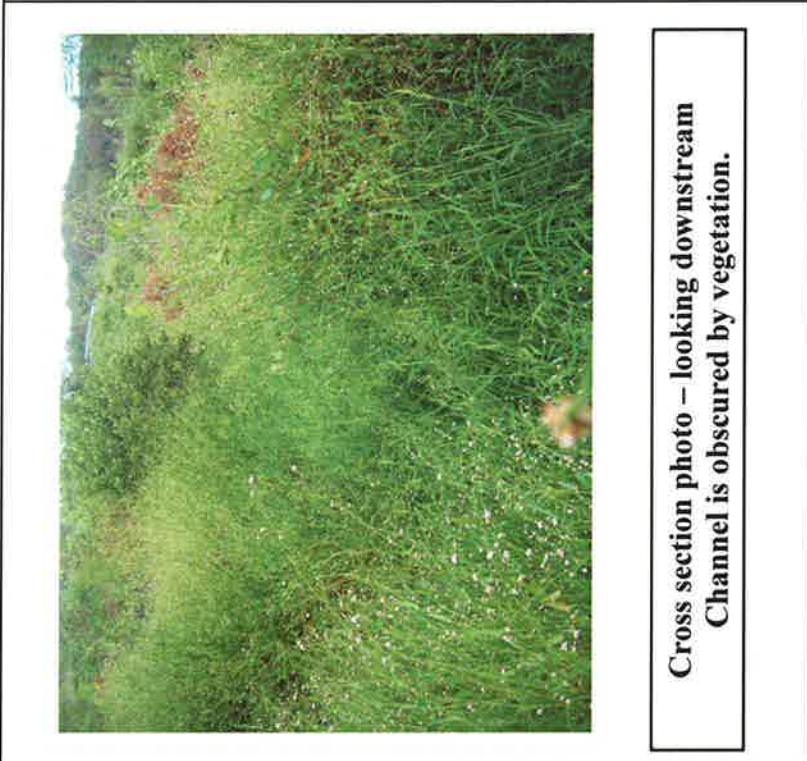
**Cross section photo – looking downstream
 Channel is obscured by vegetation.**

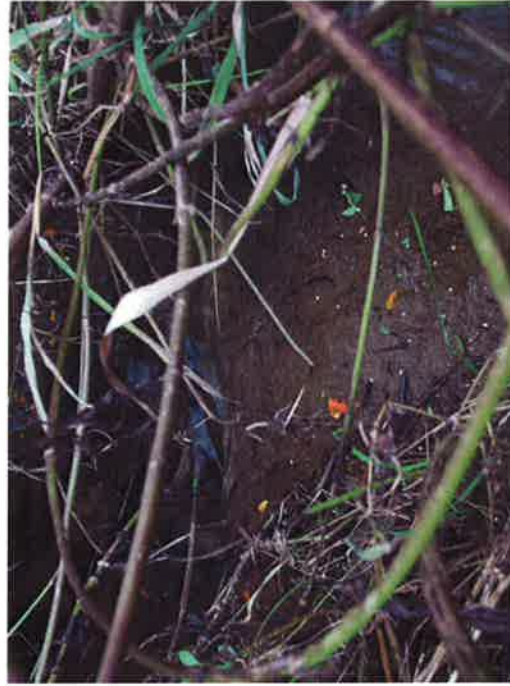
CROSS SECTION: 2+18

Cross-section photo – looking downstream
 Channel obscured by vegetation.

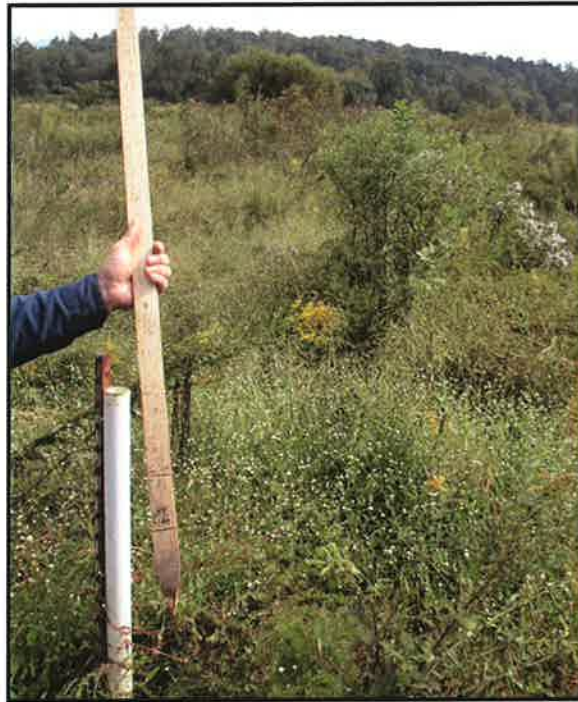
BF 10
Crest Gage on Tributary A2.
(EMH&T, Inc. 9/21/09)

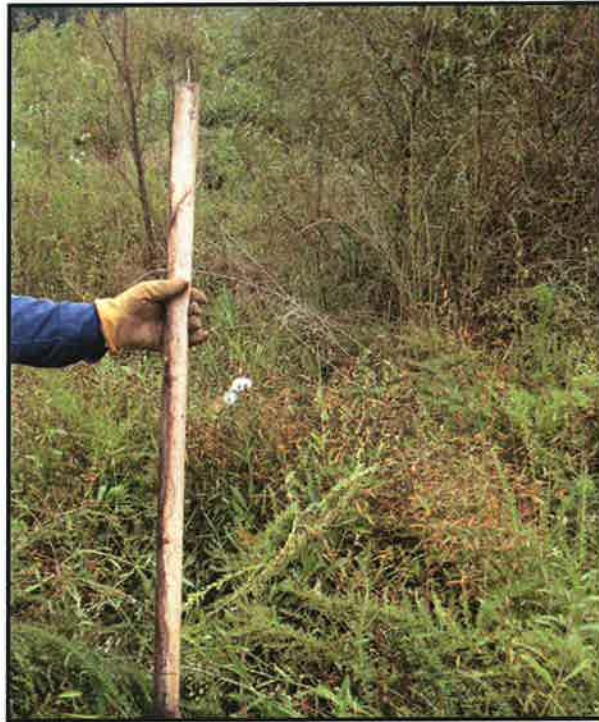
BF 11
Crest Gage on Tributary B.
(EMH&T, Inc. 9/21/09)

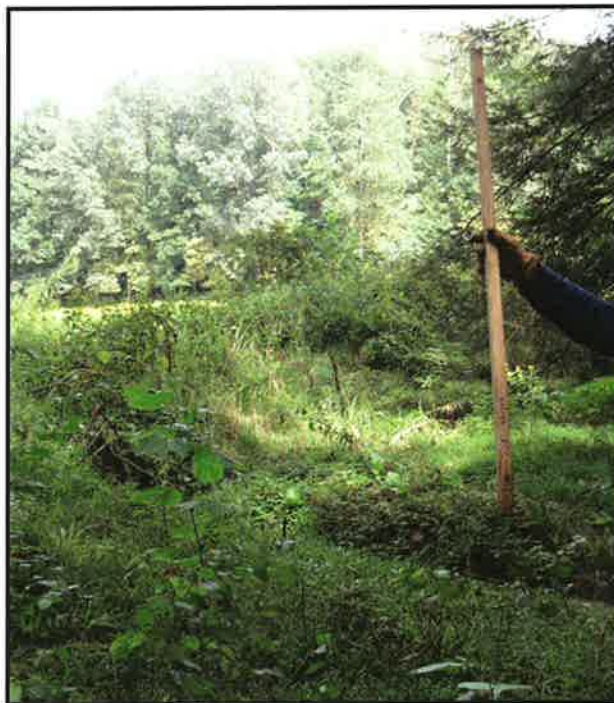
BF 12
Crest Gage on Tributary C.
(EMH&T, Inc. 9/21/09)

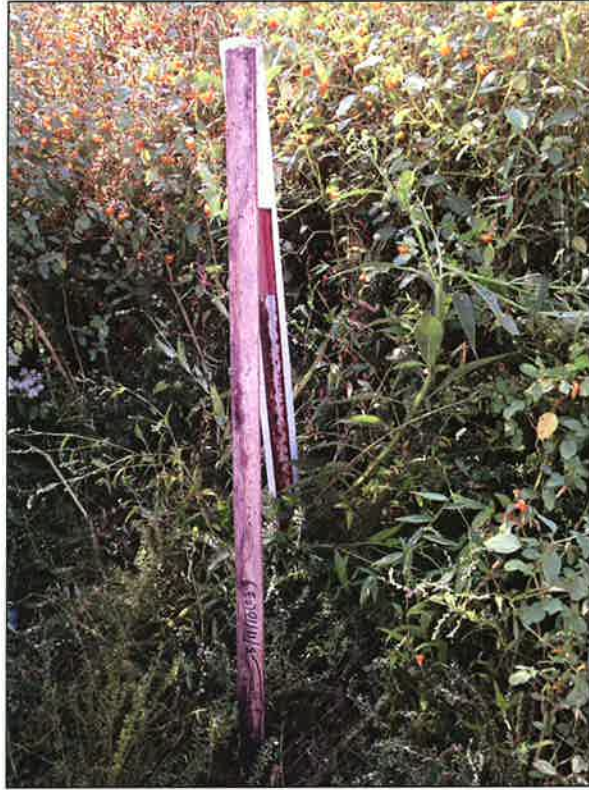
BF 15
Crest Gage on Tributary B.
(EMH&T, Inc. (documented, 5/11/10))
