St. Clair Creek Restoration Project Year 3 Final Monitoring Report

DMS Project ID No. 95015

Submission Date: January 2017

Report Prepared and Submitted by Michael Baker International

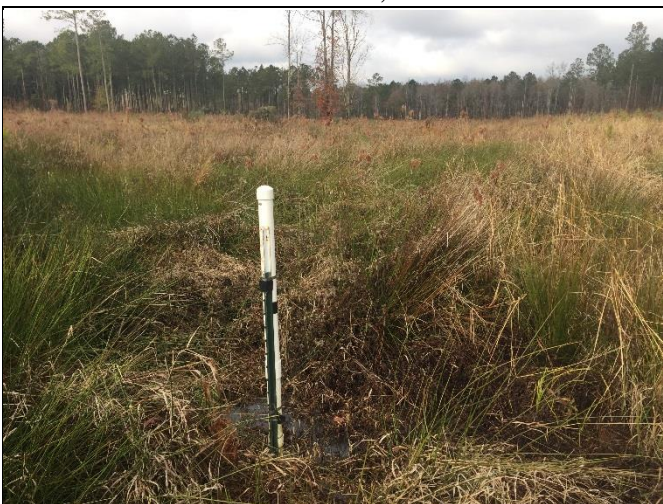
Flow Logger (UT2) – SCFL1, December 13, 2016
flow present
