| Mitigation Project Name | St Clair Creek Restoration Project | USACE Action ID | 2008-02655 |

Figure 2
Current Conditions Plan View: MY7
St. Clair Creek Site
Beaufort County, NC

**Figure 5. Observed Rainfall versus Historic Average
St. Clair Restoration Project (DMS No. 95015) MY7 2020**

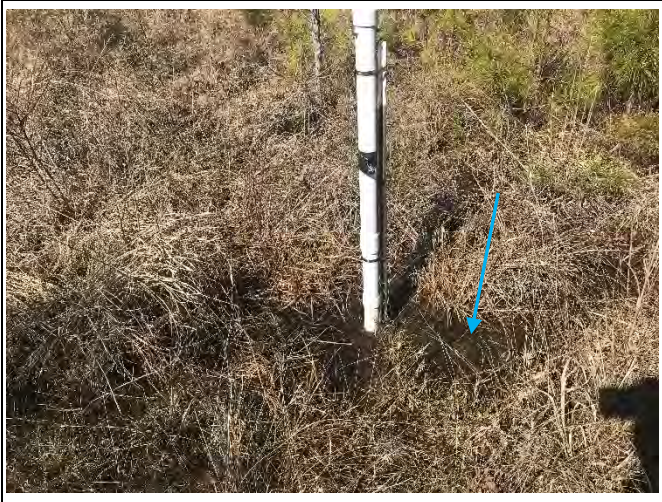
Flow Hydrology at Flow Gauge #4

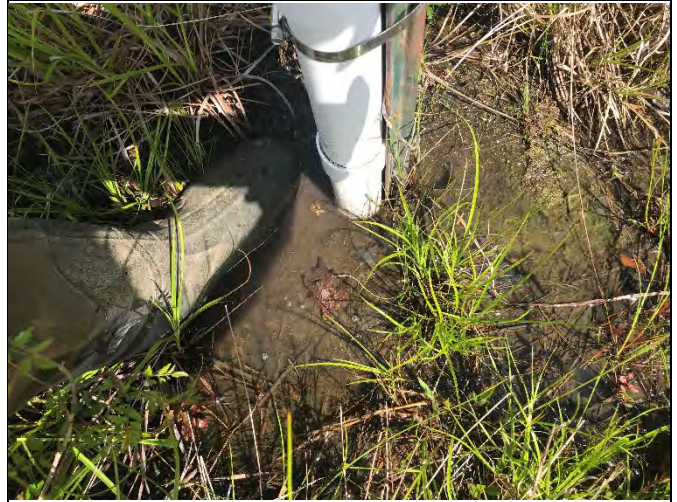
Flow Hydrology at Flow Gauge #4 (close-up)

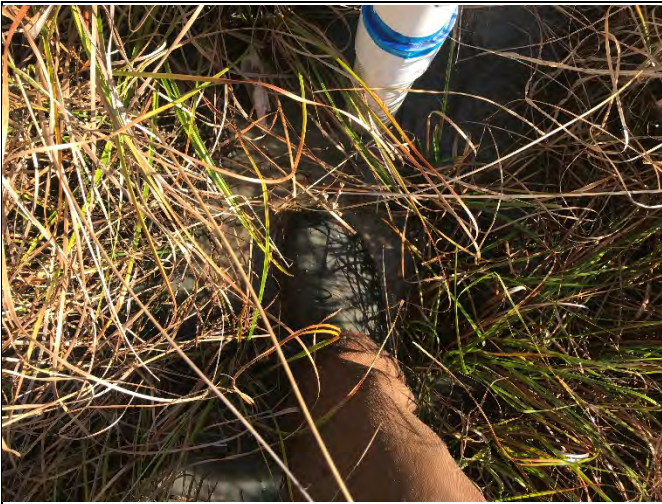
Flow Hydrology at Flow Gauge #7
