**Monitoring Year 3 FINAL Monitoring Report**  
**Stewarts Creek Tributaries Stream Restoration Project**  
**Surry County, North Carolina**  
**Yadkin River Basin, Hydrologic Unit Code (HUC) 03040101**

**Data Collection Period:**  
October 2022 – January 2023

**Submission Date:**  
February 2023

NCDEQ Contract No. 7183  
DMS ID No. 100023  
RFP# 16-006993 (Issued 9/16/2016)  
USACE Action ID No. SAW-2017-01508  
DWR ID No. 20171043

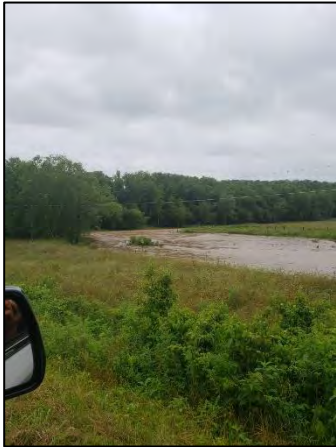
Moores Fork Reach 2 - Additional Flooding – MY2  
(6/14/2021)

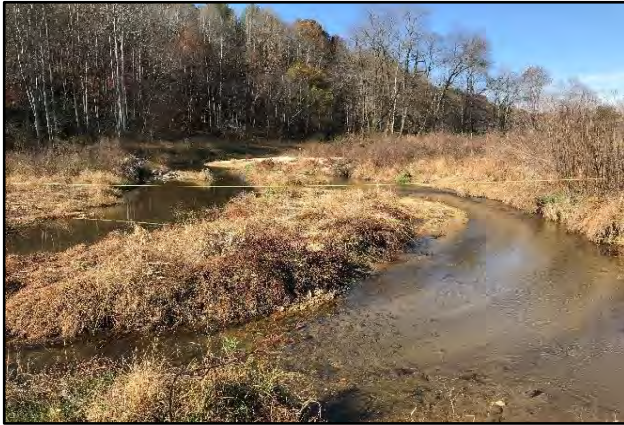
XS4 looking upstream

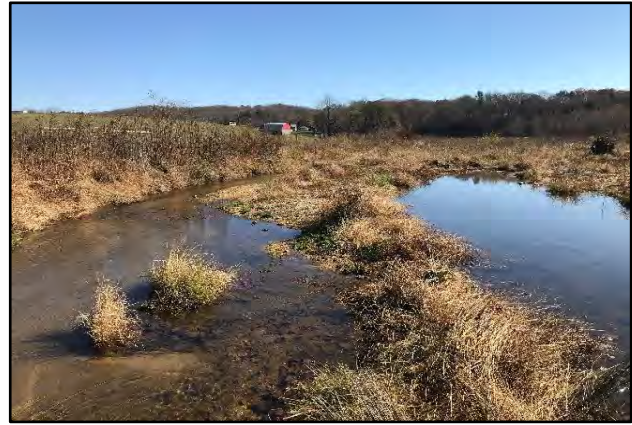
XS4 looking downstream

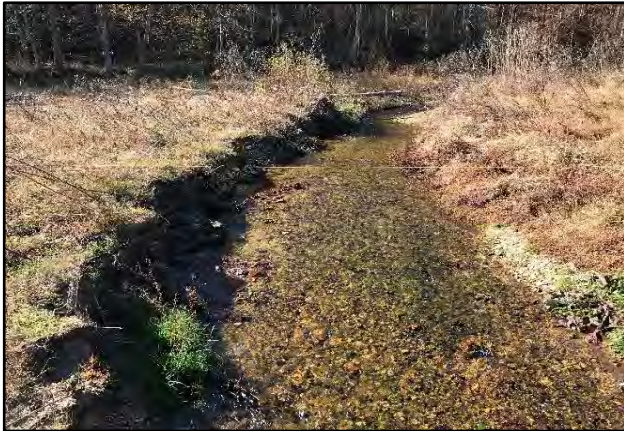
XS5 looking upstream

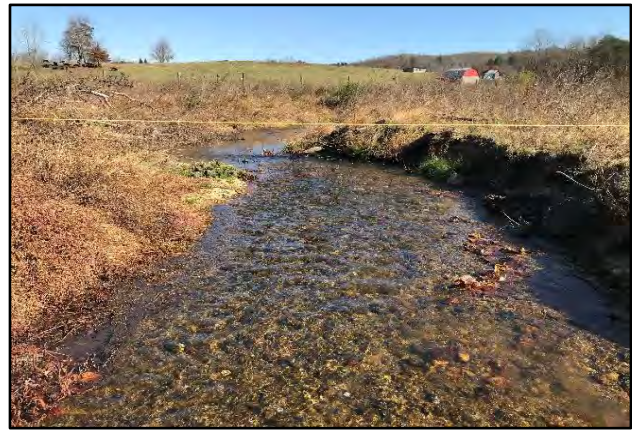
XS5 looking downstream

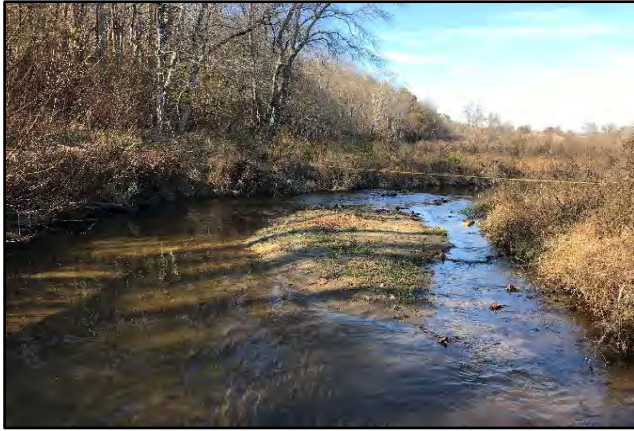
XS6 looking upstream

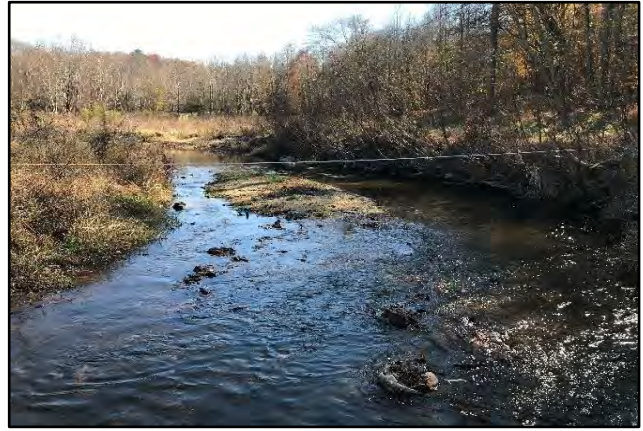
XS6 looking downstream

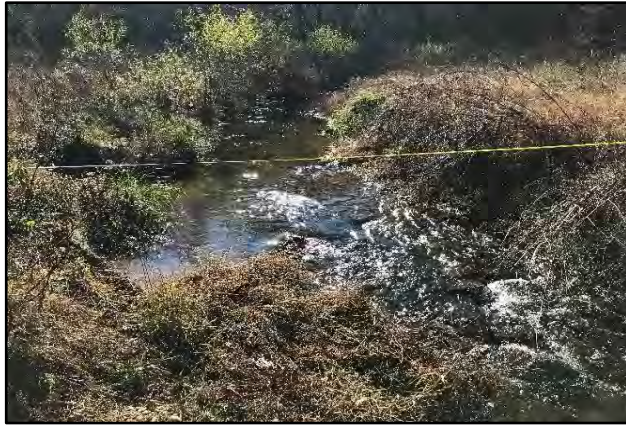
XS7 looking upstream

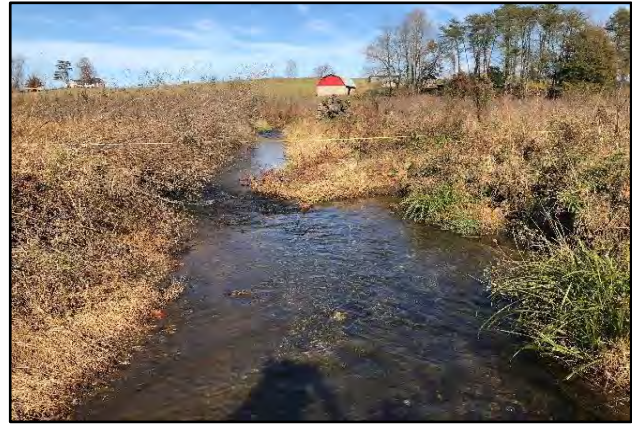
XS7 looking downstream

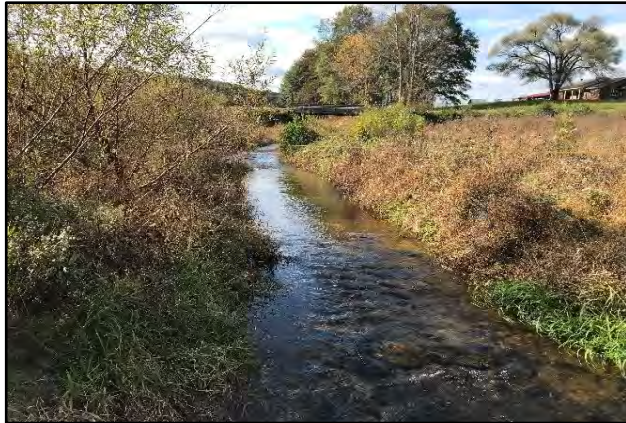
XS8 looking upstream

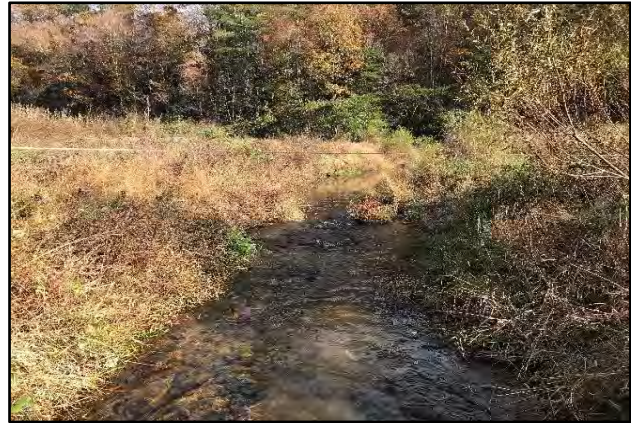
XS8 looking downstream

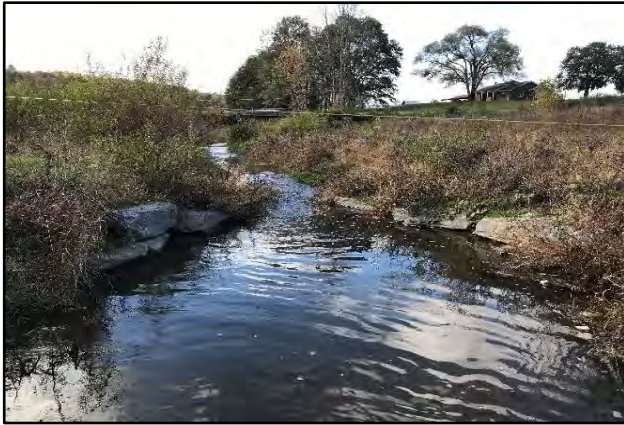
XS9 looking upstream

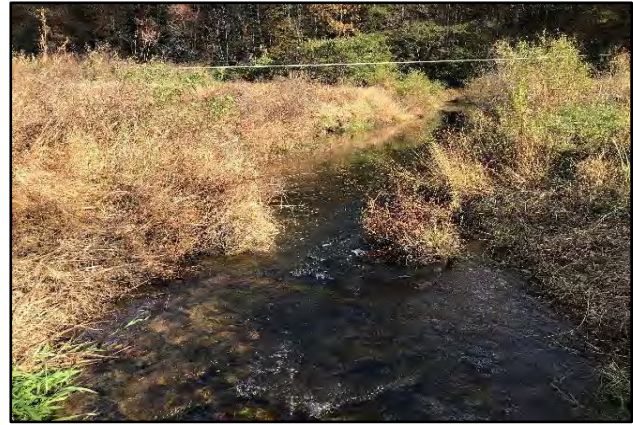
XS9 looking downstream
