# Stonebridge Stream Mitigation Project

## Year 1 Monitoring Report

December 2006

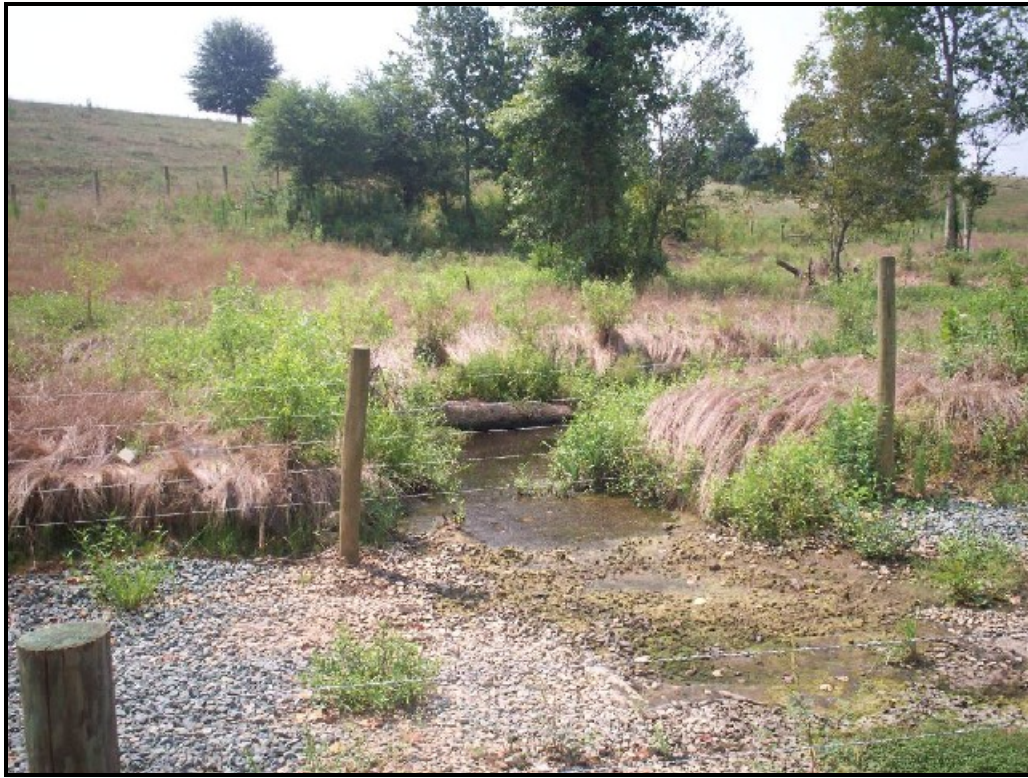
**Photo 3. Ford crossing-looking downstream at log toe protection.**

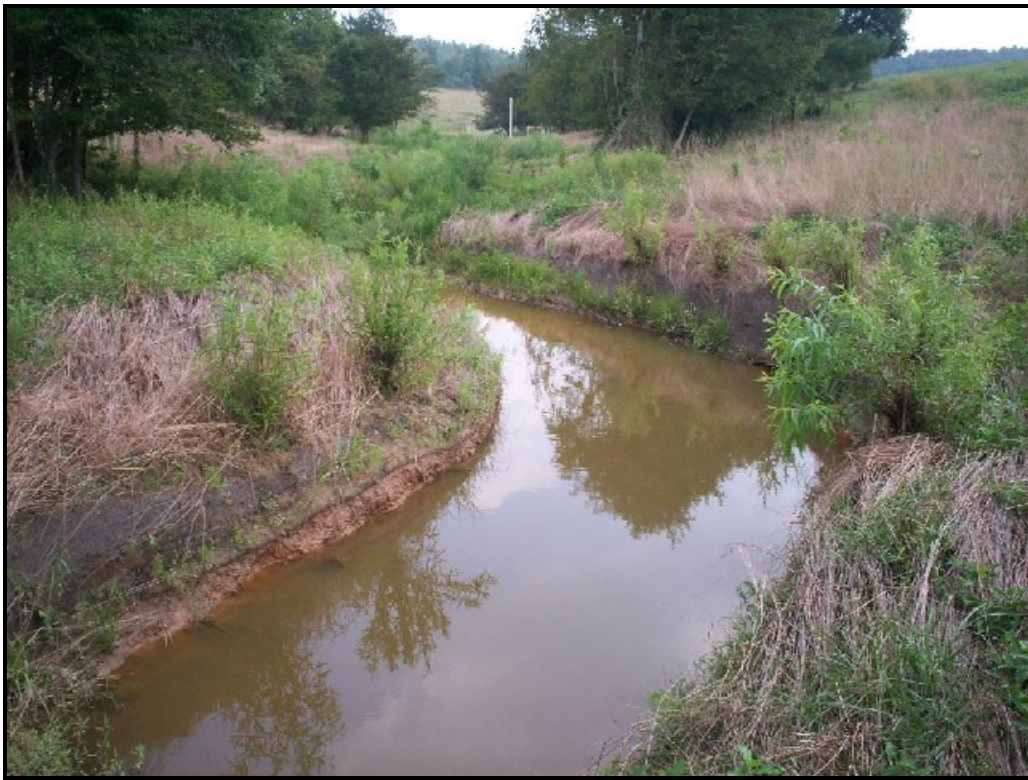
**Photo 4. Stream channel-looking upstream.**
