**Stonebridge Mitigation Project  
Moore County, North Carolina**

**Year 2 Monitoring Report**

**November 2007**

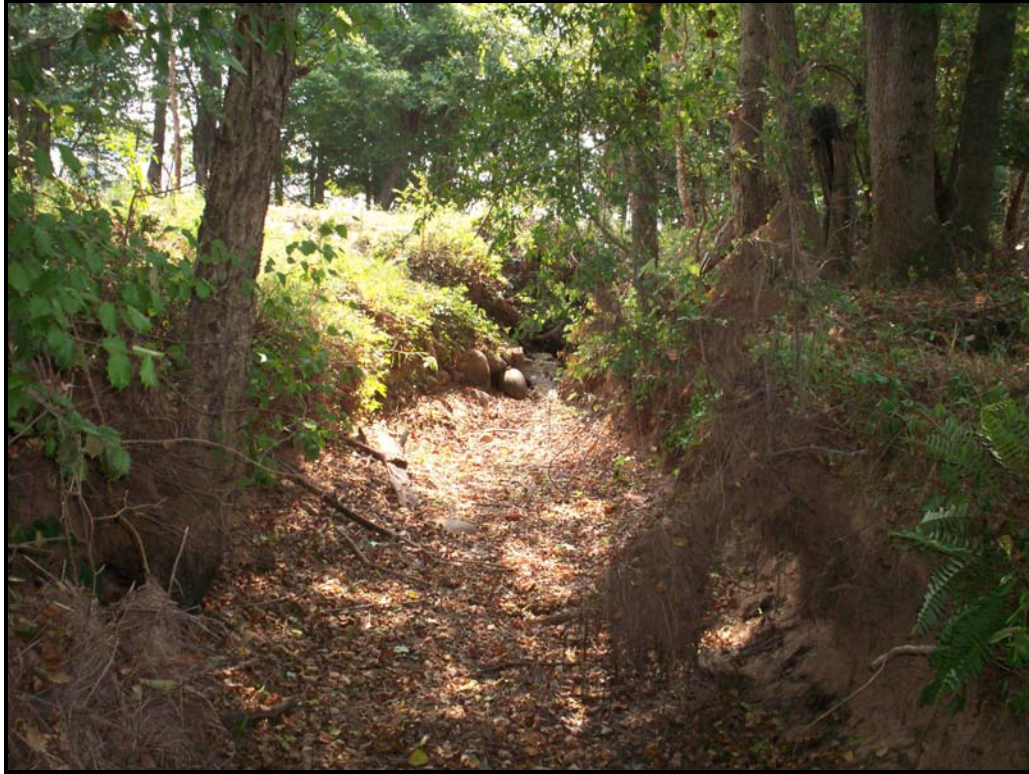
**Photo 7. Downstream end of the project-looking downstream.**
