MY2 MONITORING REPORT - Stream Mitigation

STRAWBERRY HILL MITIGATION PROJECT

Johnston County, North Carolina

NCDMS Project #100094

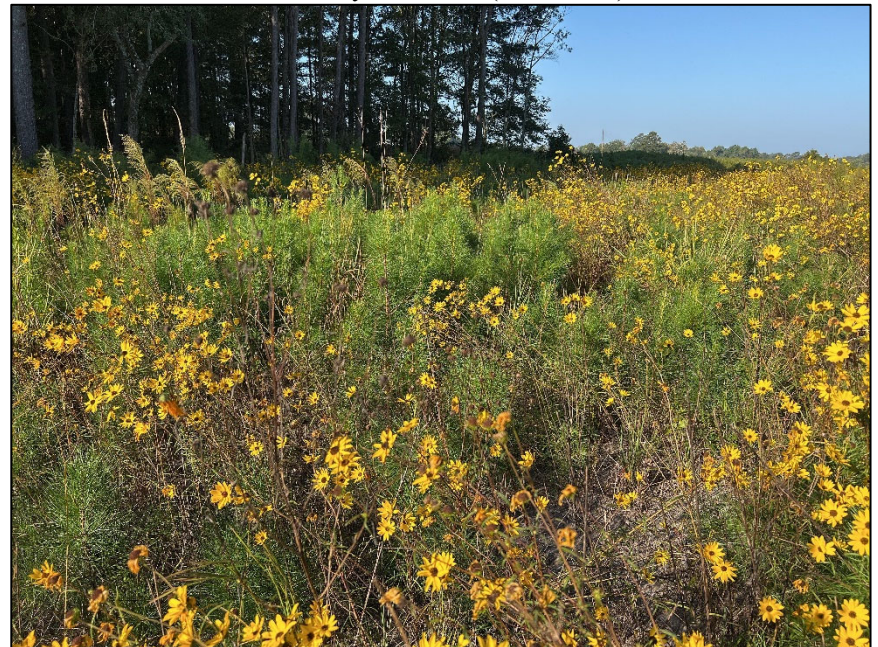
Pines in JH1-A Riparian Area (10/3/2023)

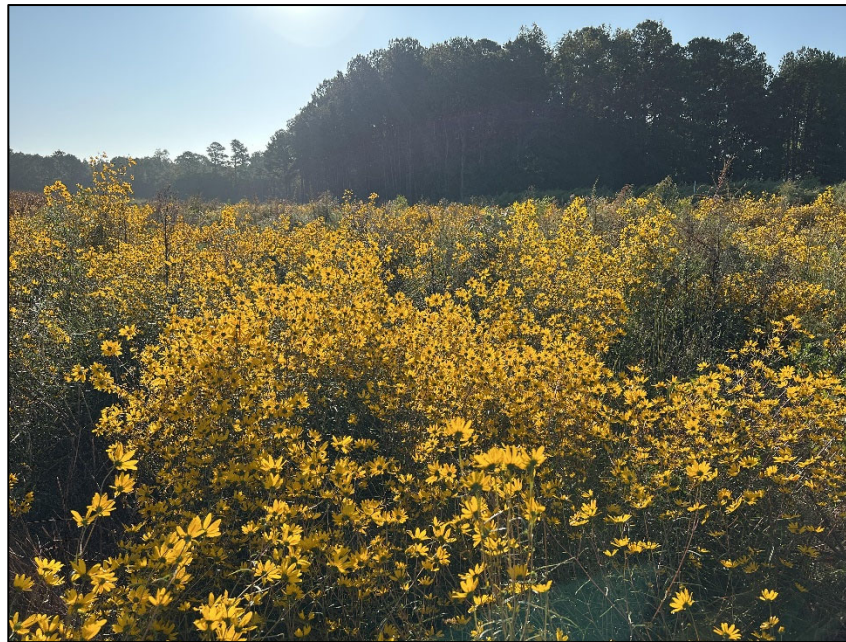
Sunflowers in JH1-A Riparian Area (10/3/2023)

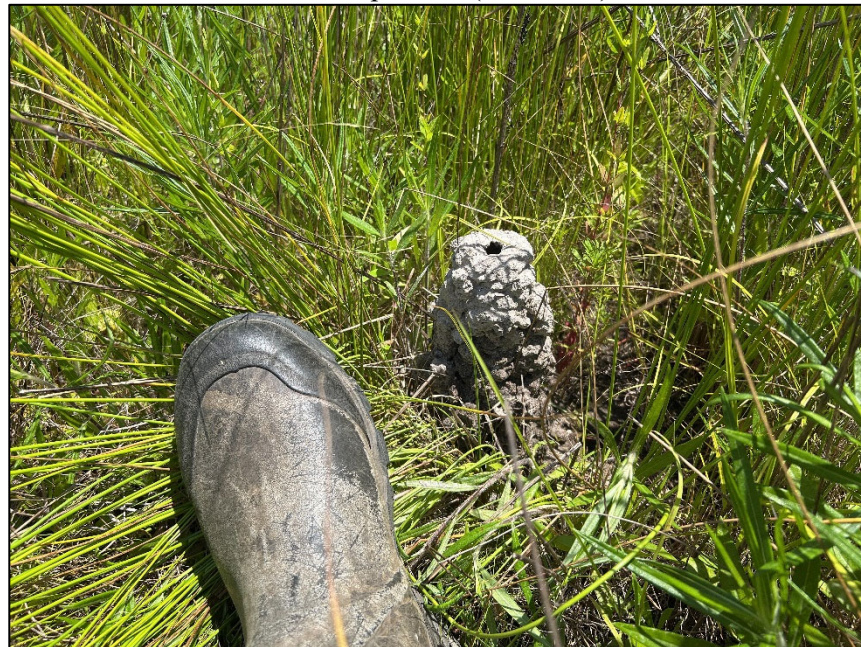
Crayfish Burrow in Riparian Wetland Area (6/13/2023)

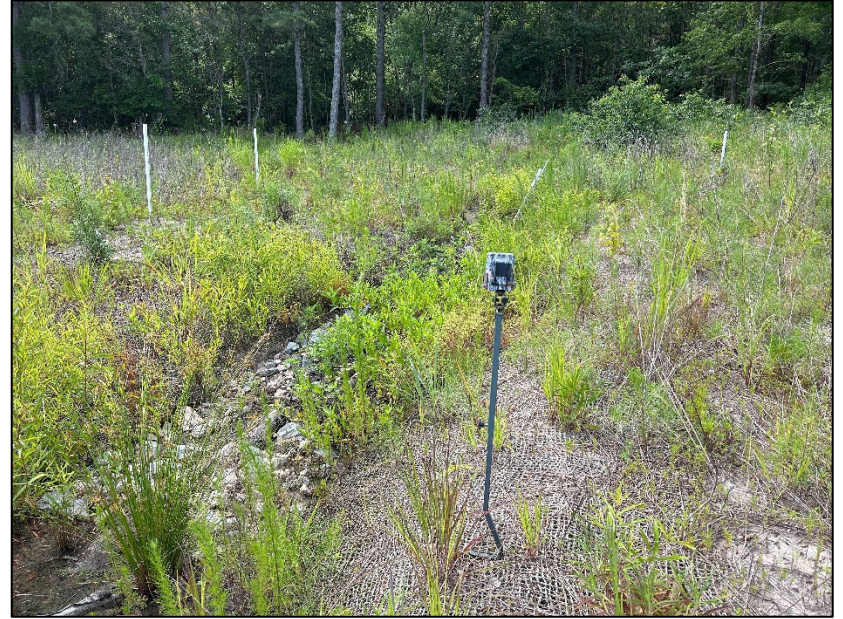
Flow Camera JH1-A (6/13/2023)

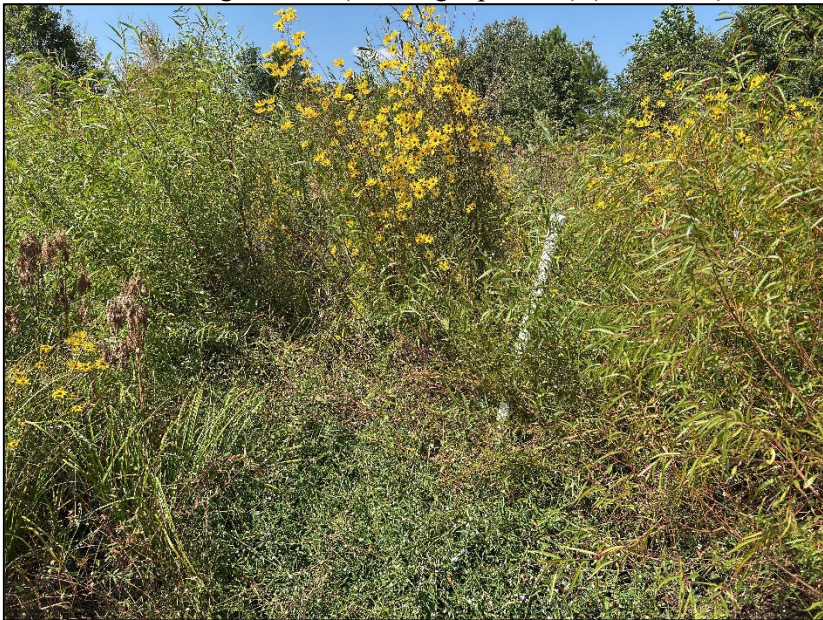
Stage Recorder JH1-B (Looking Downstream) (10/3/2023)
