# Stricker Branch Stream Restoration Project Contract # D06054-G

County: Cabarrus  
Cataloging Unit: Yadkin 03040105; Targeted Watershed 020040  
Monitoring Firm POC: Mid-Atlantic Mitigation, LLC  
Rich Mogensen (704) 782-4133  
Prepared For: Ecosystem Enhancement Program

## Year 1 (2008) Monitoring Report

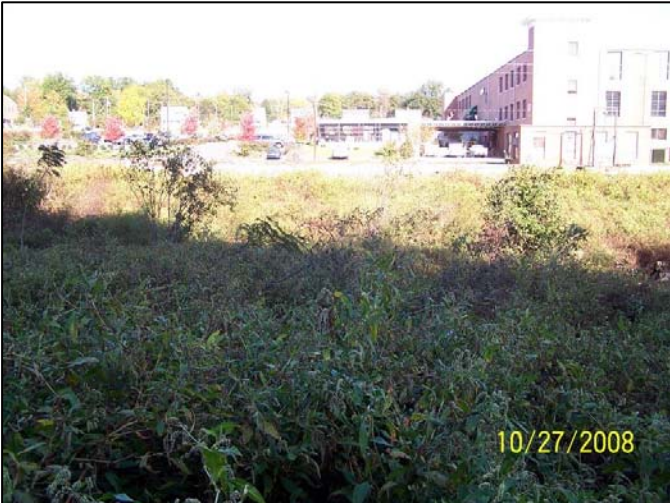
**Photo Point 3 (Veg Plot 6)**

As mentioned above in the Section 3.1.2, Plots 5 and 6 are overgrown with a particularly robust variety of polygonum, with stems up to an inch in diameter. Several live individuals were found hidden under this polygonum growth, however not all individuals were located and pulled free. This means that some missing individuals could still be alive and may re-emerge when the polygonum dies back and the herbaceous community finds equilibrium. While the stem counts on Plots 5 and 6 are below success criteria, MAM believes it is best to wait until after the Year 2 count to determine if any missing individuals can be located. If the polygonum over growth persists into year 2 and stem counts in these plots are still below success criteria, treatment of the polygonum and/or a supplemental planting will be considered. Herbaceous cover was 100% with polygonum dominating. Three “extra” river birches were noted in Plot 5 indicating that these may indeed be volunteers not individuals missed during the baseline count. Overall, without the missing and dead individuals, the plant count indicates 58% survival and 367 stems per acre for the site. Counting of four cottonwood volunteers and four river birches that are volunteers and /or may have been missed during the baseline count, brings the stem count to 420 overall.

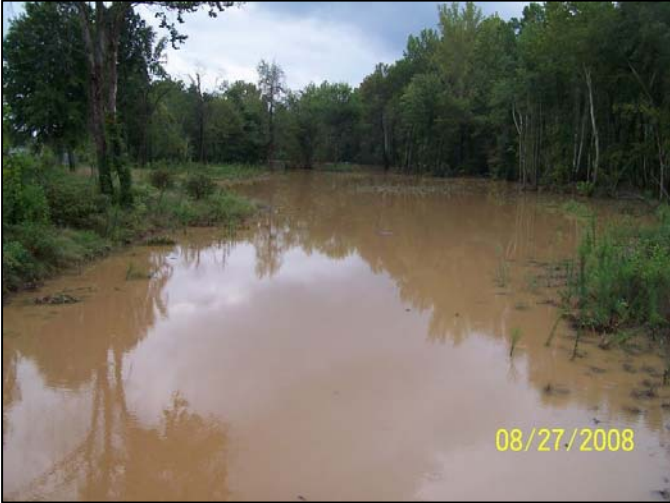
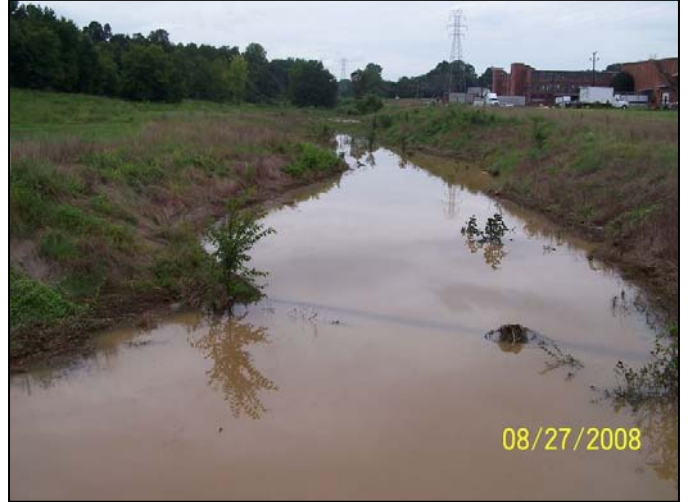
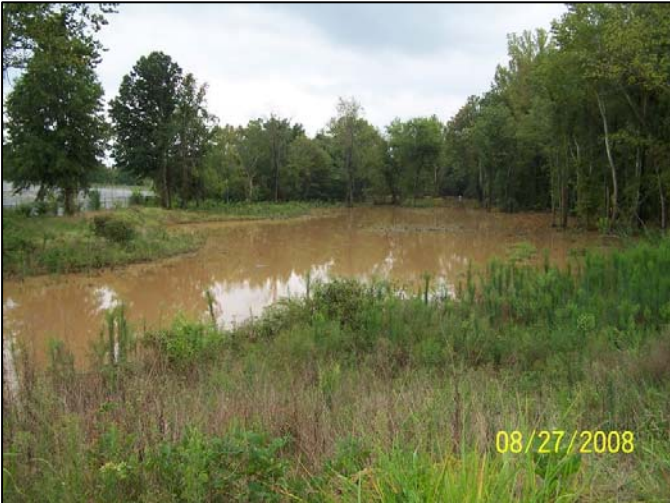
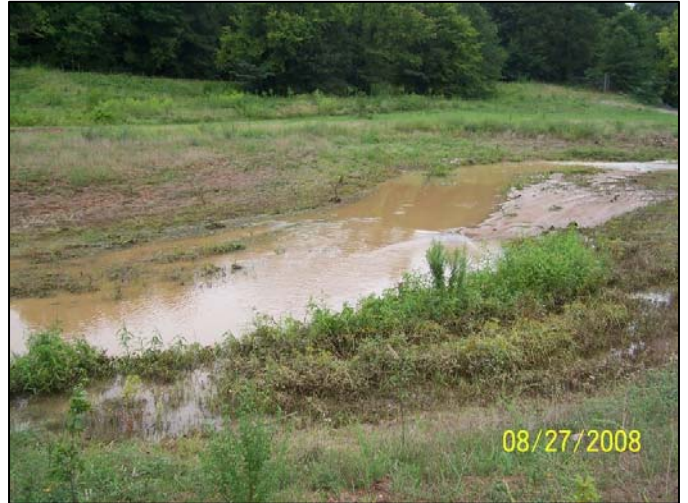
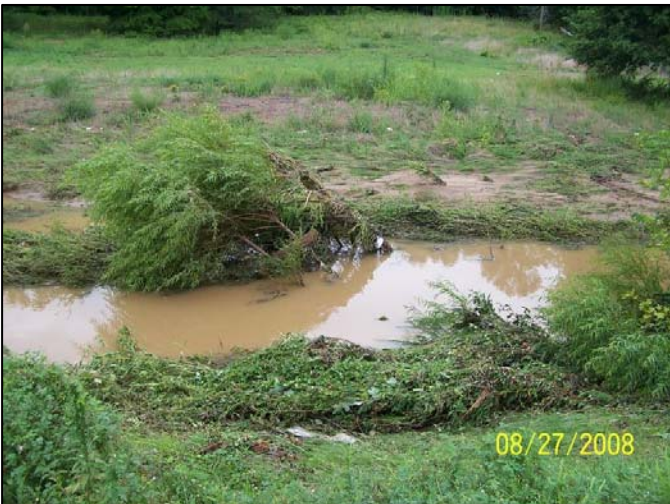
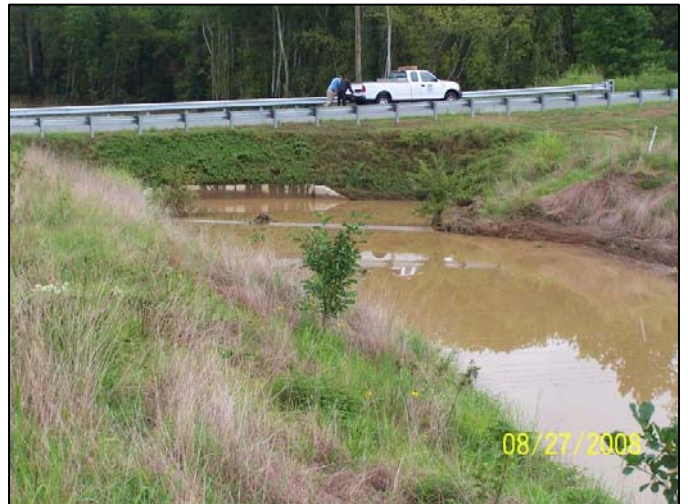
**Stricker Branch Flooding (8-27-2008)**

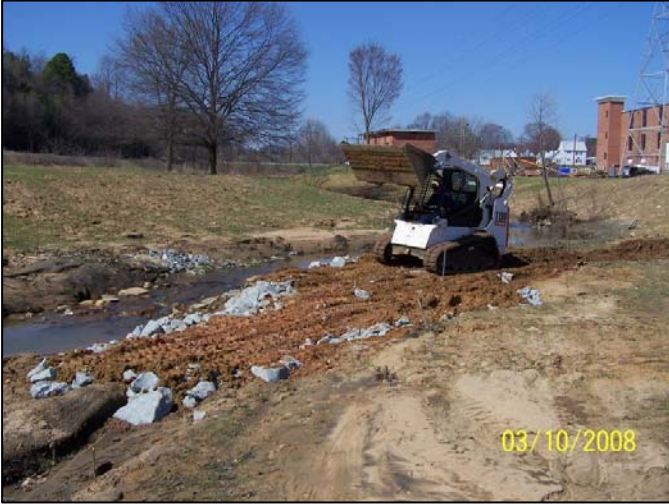
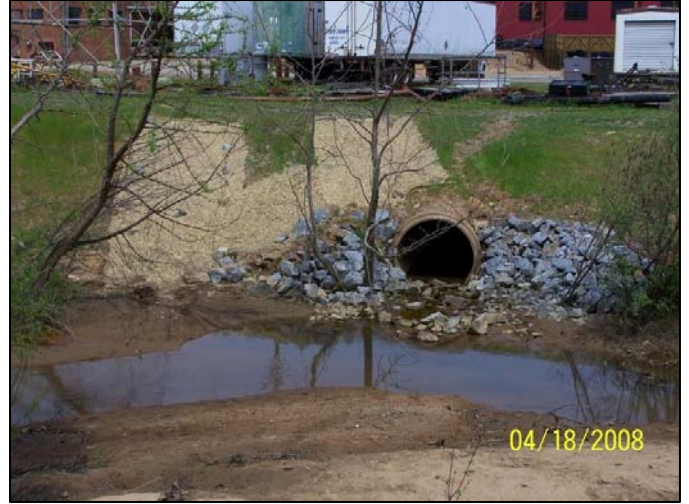
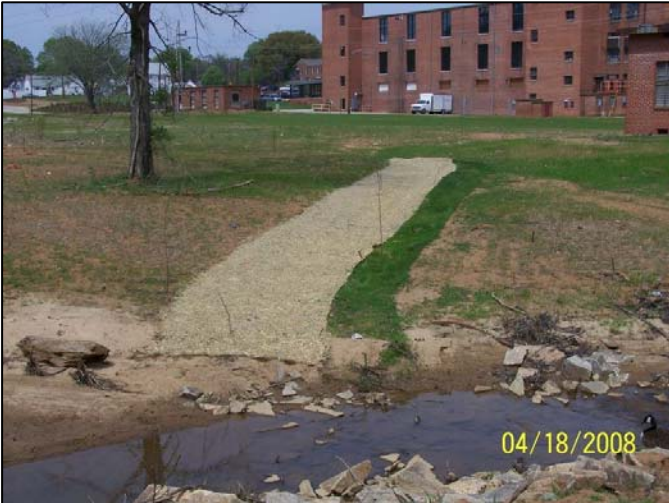
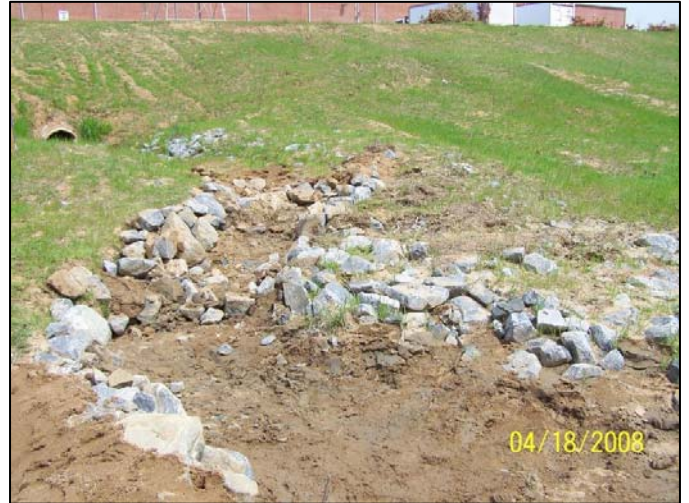
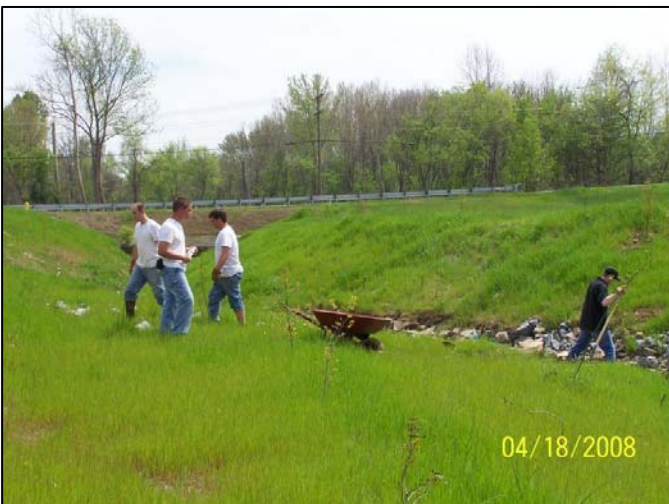
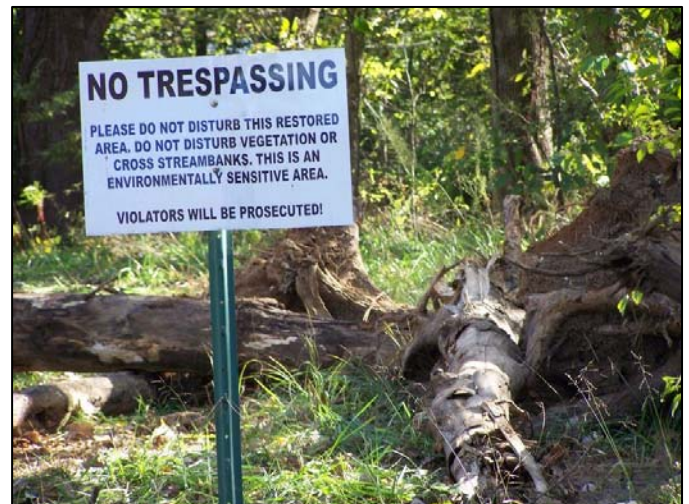
## Stricker Branch Repairs

Overall, the stream channel has stabilized well and weathered multiple bankfull events, including several high rainfall events and hurricane remnant rainfall events. Areas that sustained damage due to bankfull conditions were repaired by hand and the contractor was mobilized twice for more significant repairs which are documented in the photo log. The herbaceous vegetative cover has also developed a healthy and diverse community throughout most of the site. The planted trees and shrubs have also done well and are supplemented by an existing buffer community which will provide a seed source for volunteers well suited to the current site conditions.

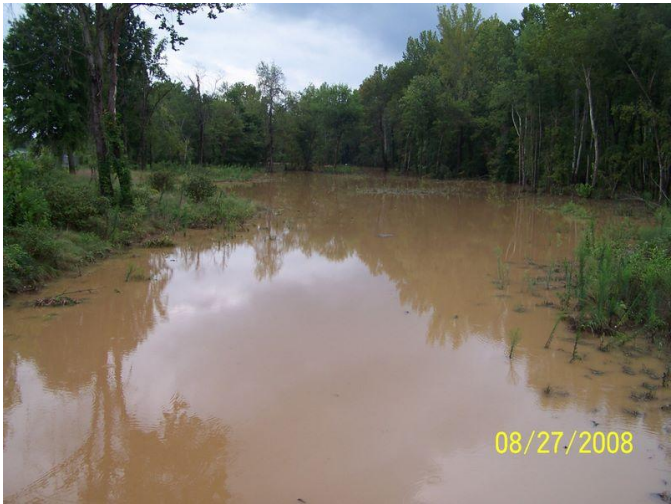
Lower section, below Sign Drive

Aftermath of hurricane remnant rain event August 25<sup>th</sup> through 28<sup>th</sup> totaling approximately 23 inches over 4 days.

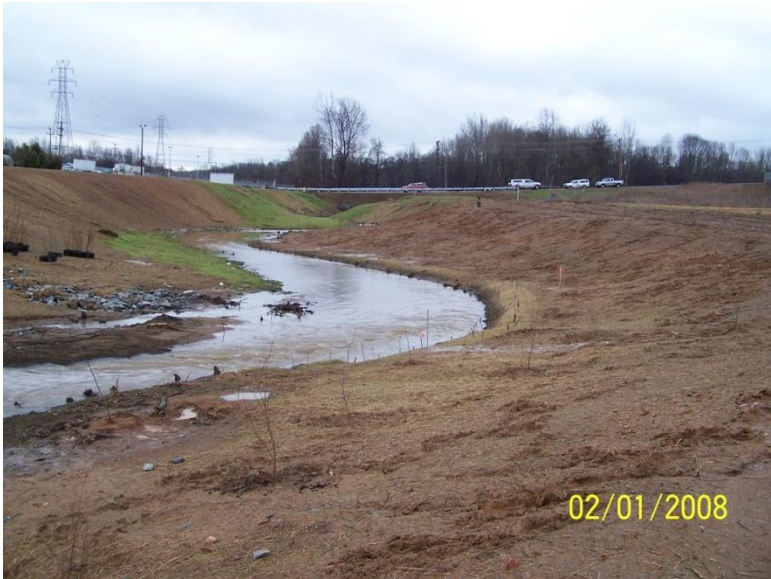
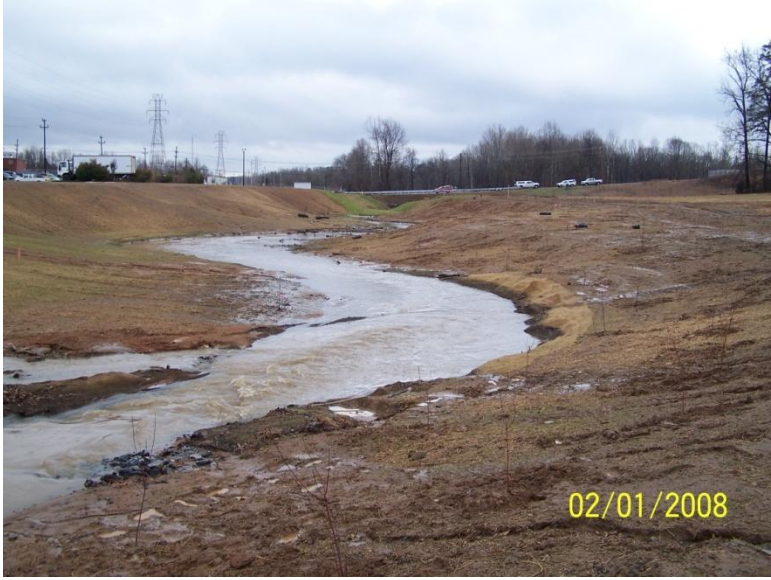
Bankfull event February 1<sup>st</sup> and 2<sup>nd</sup> 2008.

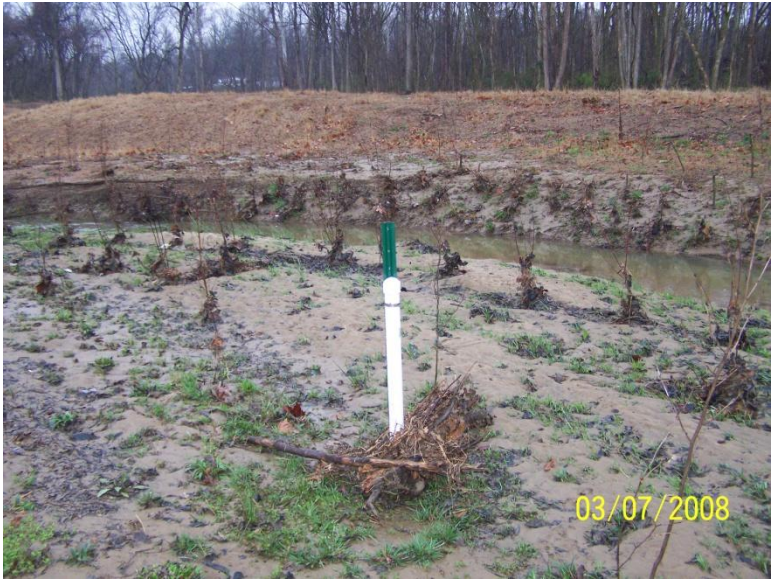
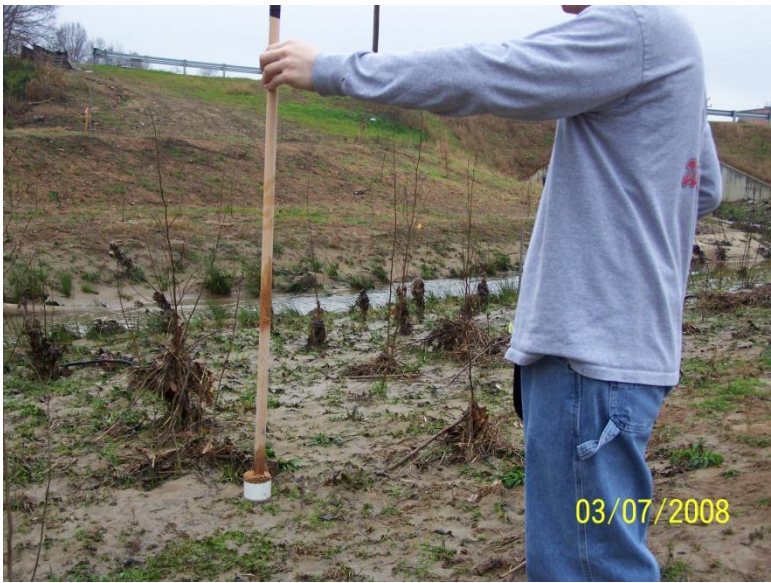
Bankfull event March 4<sup>th</sup>, 2008.

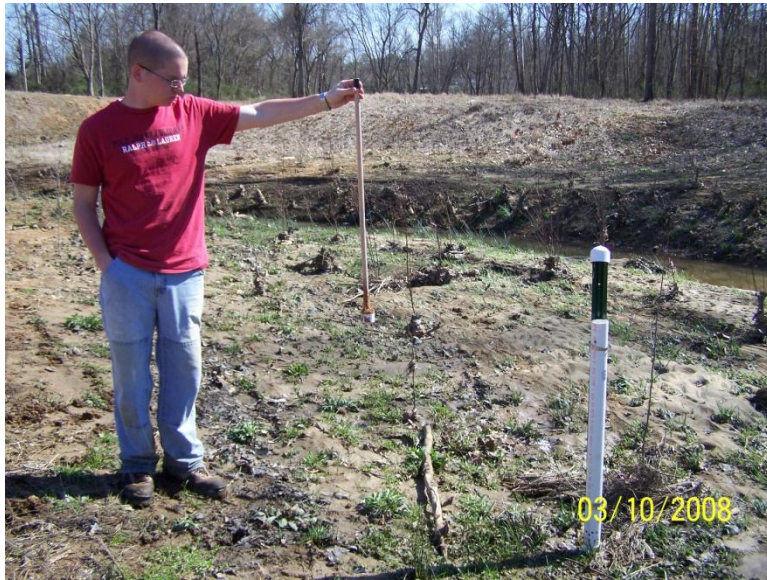
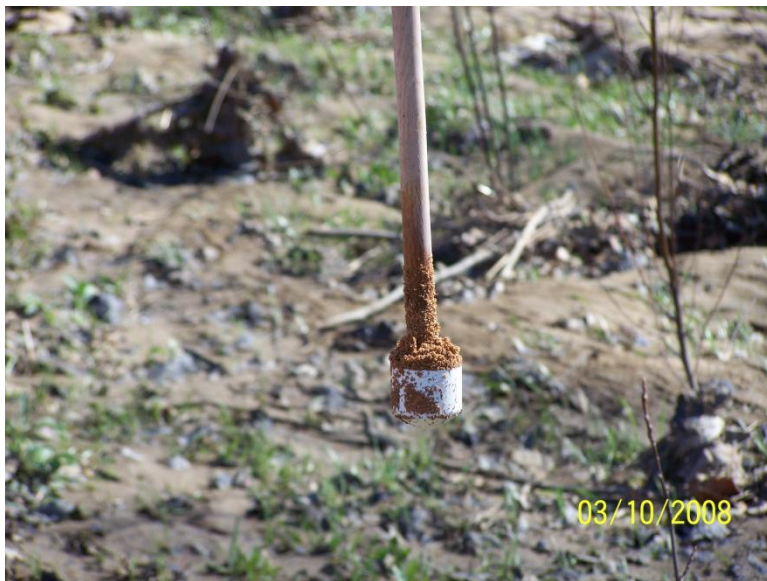
Bankfull event March 7<sup>th</sup>, 2008.

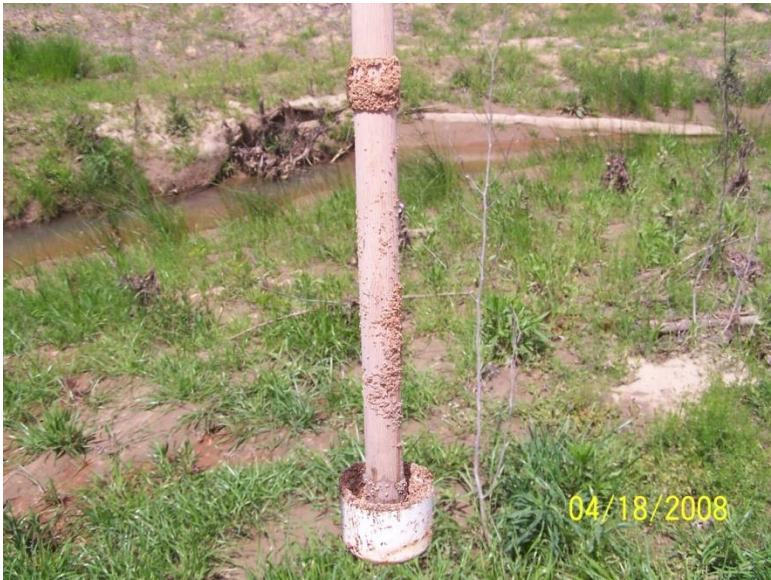
Bankfull event April 4<sup>th</sup> and 5<sup>th</sup>, 2008.

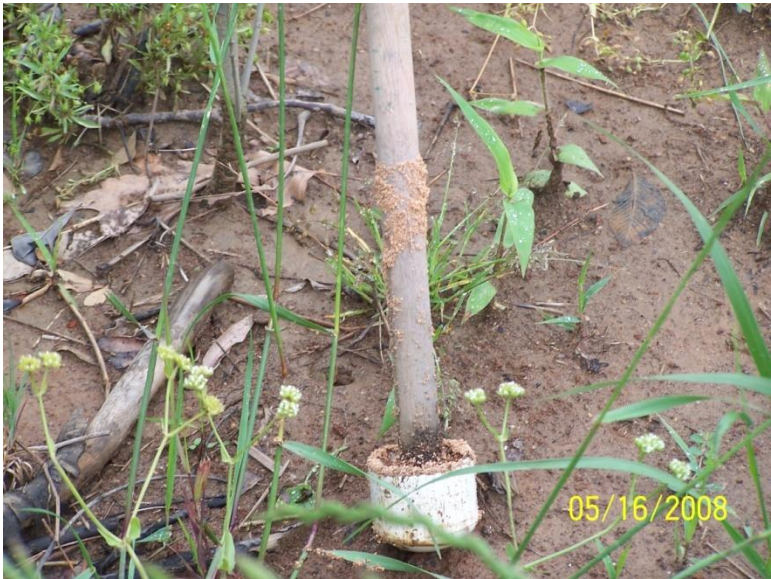
Bankfull event May 10<sup>th</sup> and 11<sup>th</sup>, 2008.

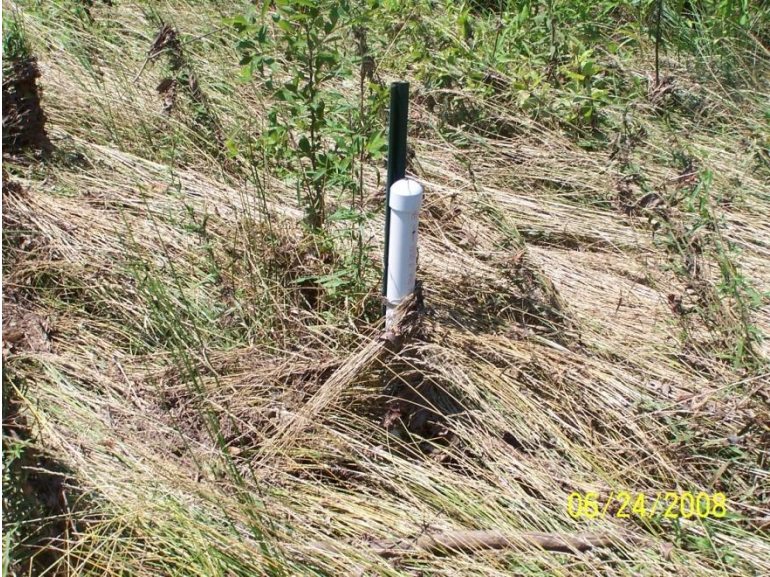
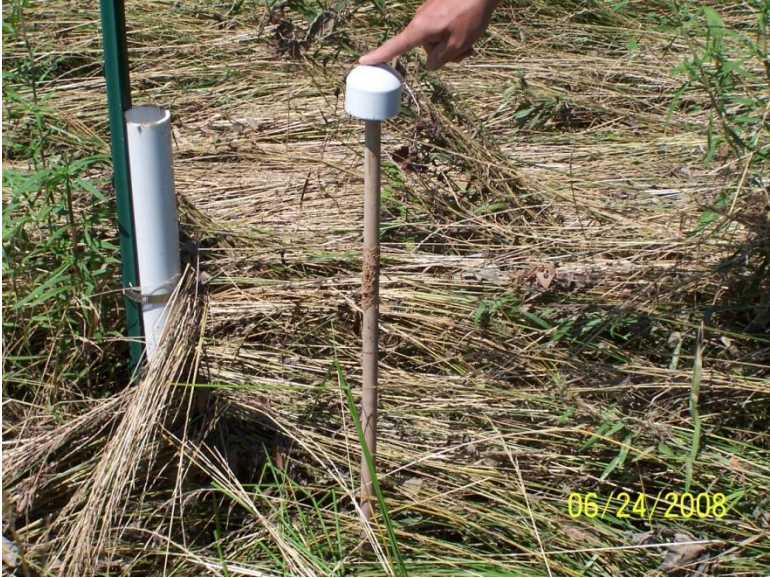
Bankfull event June 22<sup>nd</sup> and 23<sup>rd</sup>, 2008.
