**SUTHER STREAM & WETLAND RESTORATION SITE -- EEP #370
Cabarrus County NC -- PeeDee River HUC# 03040105-020060**

MY-3 (2014) ANNUAL MONITORING REPORT (Final)

**North Carolina Department of Environment & Natural Resources
Ecosystem Enhancement Program (DENR-EEP) -- Contract # 5764**

Data Collected: Aug-Sep 2014 Final Report Submitted: Mar 2015

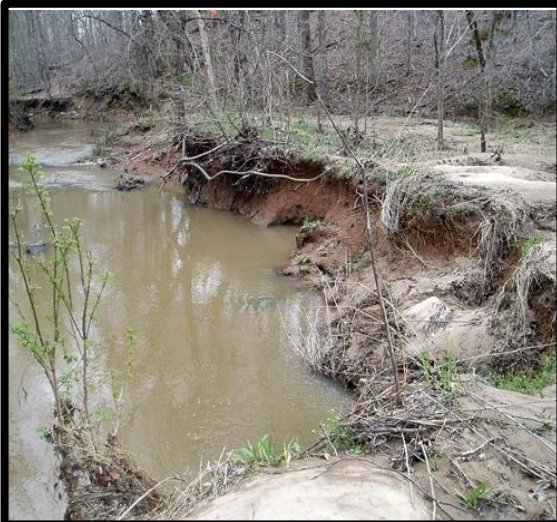
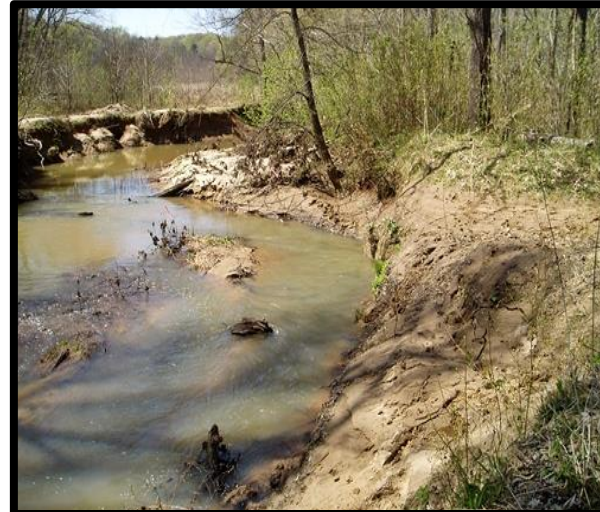
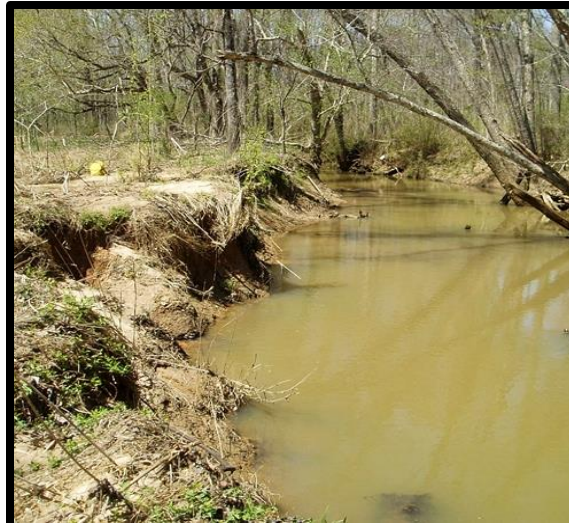
Station 16+50, south bank downstream.

Station 18+00, north bank upstream.

Station 17+00, south bank upstream.

Stream Problem Area 1: DBC bank erosion at stations 16+50 to 18+00. 10Apr2014.

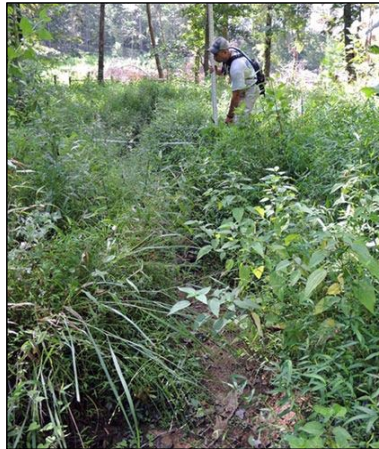
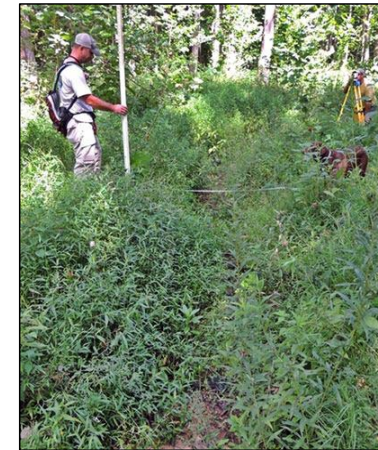
Figure 3.1. Cross Section Trib XS-1

Trib XS-1: Upstream

Trib XS-1: Downstream

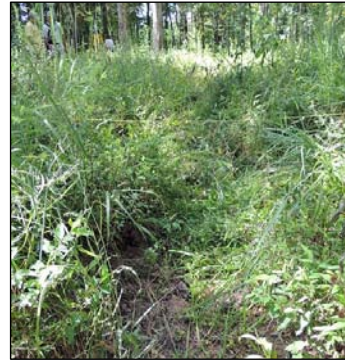
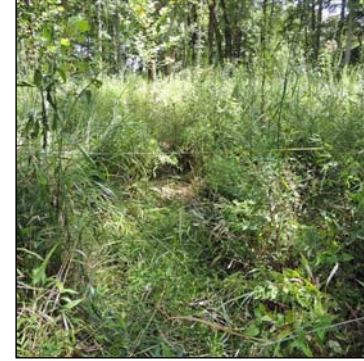
Figure 3.2. Cross Section Trib XS-4

Trib XS-4: Upstream

Trib XS-4: Downstream

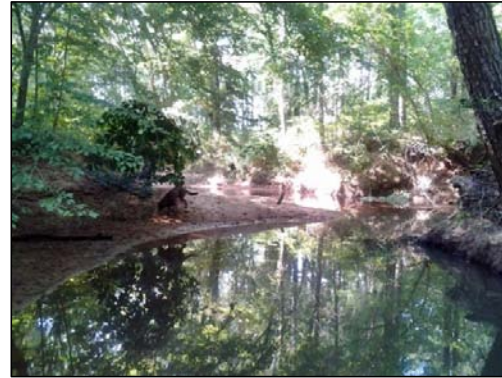
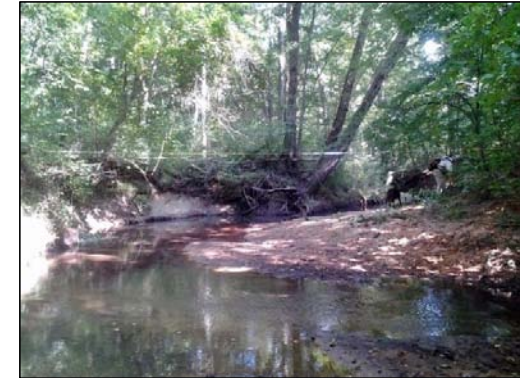
Figure 3.3. Cross Section DBC XS-2

XS-2: Upstream

XS-2: Downstream

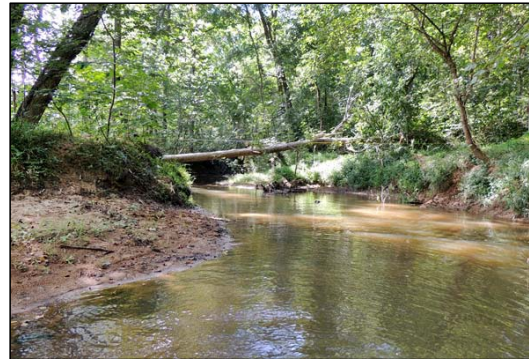
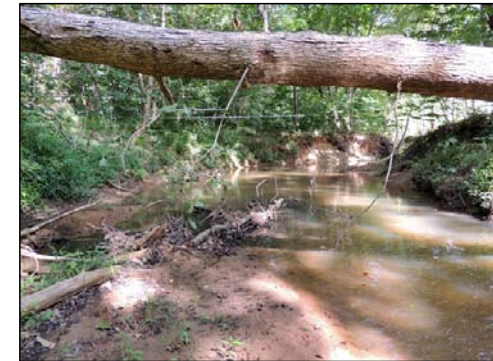
Figure 3.4. Cross Section DBC XS-3

XS-3: Upstream

XS-3: Downstream

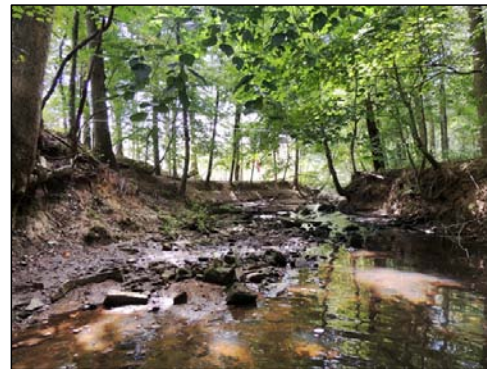
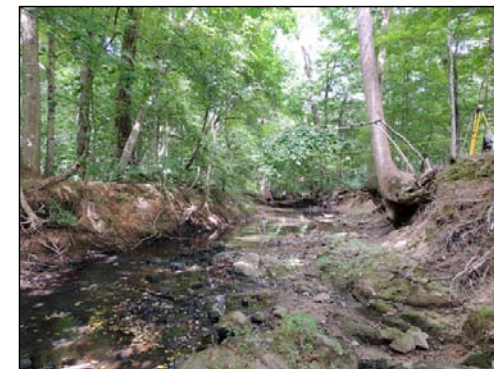
Figure 3.5. Cross Section DBC XS-4

XS-4: Upstream

XS-4: Downstream

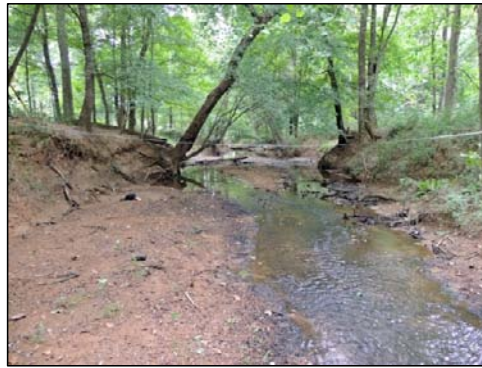
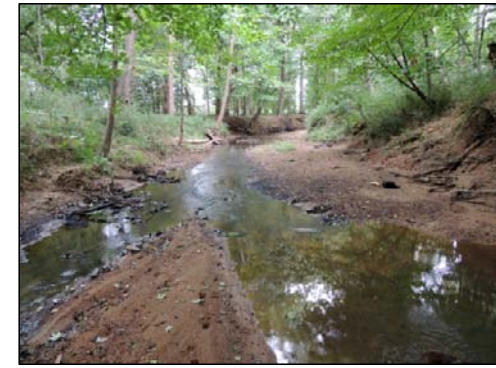
Figure 3.6. Cross Section DBC XS-5

XS-5: Upstream

XS-5: Downstream

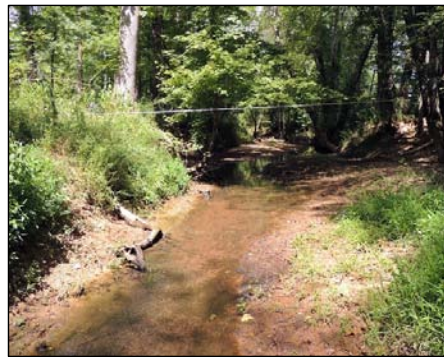
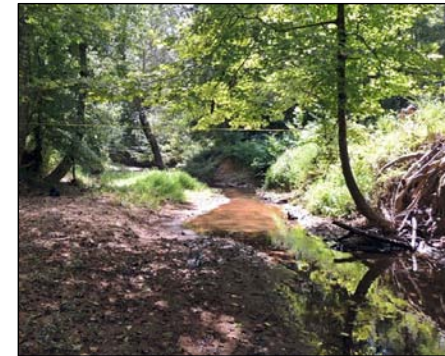
Figure 3.7. Cross Section DBC XS-6

XS-6: Upstream

XS-6: Downstream

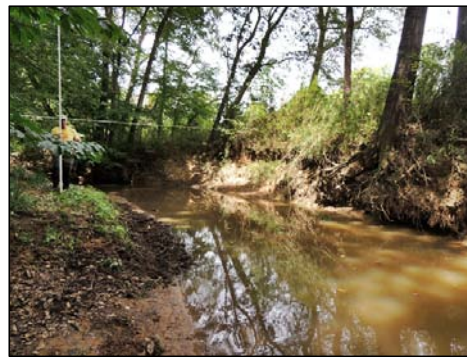
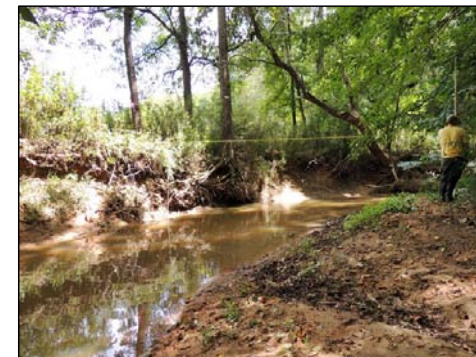
Figure 3.8. Cross Section DBC XS-7

XS-7: Upstream

XS-7: Downstream
