**SUTHER STREAM & WETLAND RESTORATION SITE -- DMS #370  
Cabarrus County NC -- PeeDee River HUC# 03040105-020060**

**MY-4 (2015) ANNUAL MONITORING REPORT (Draft)**

**North Carolina Department of Environmental Quality  
Division of Mitigation Services (DENR-DMS) -- Contract # 5764**

**Data Collected: Sep-Oct 2015**

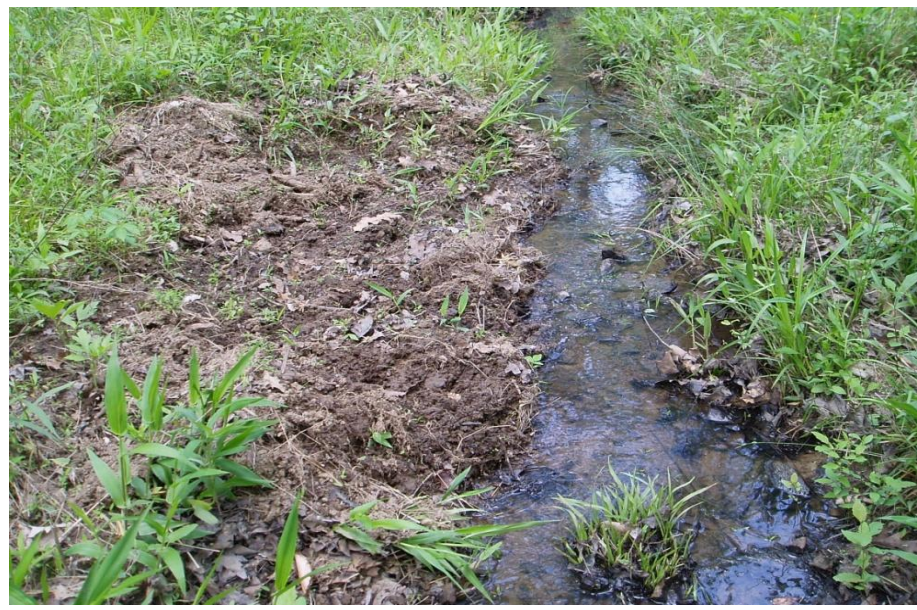
**Hog-rooting along streambank: Tributary station 3+40, May 2015**

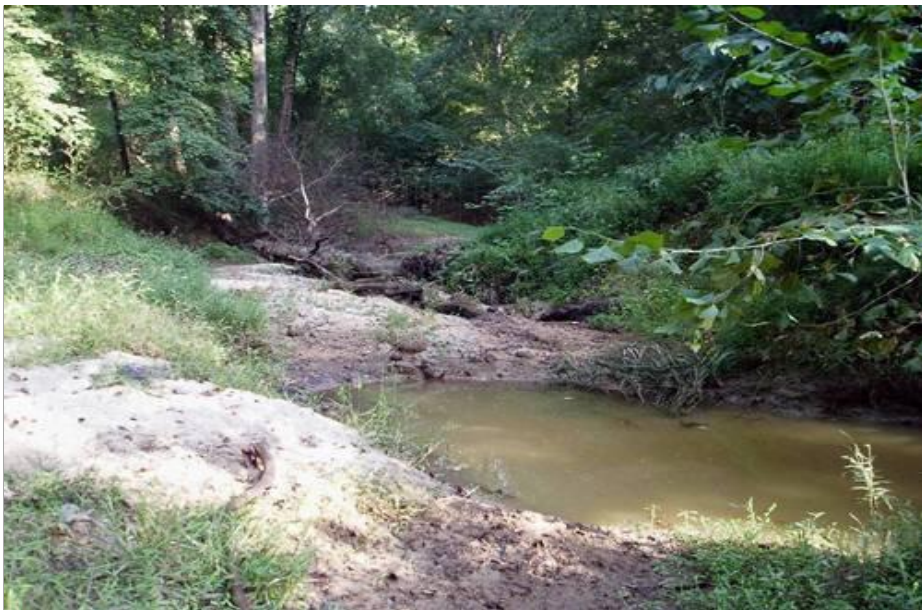
**Bed scour in DBC at Trib confluence, face dnst, Sep 2015**

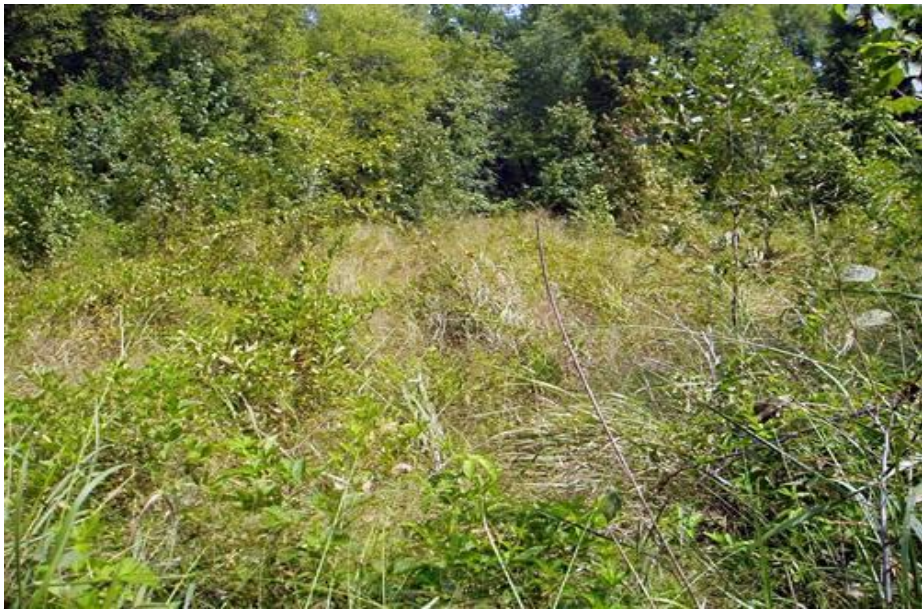
**Woody seedlings /scrub in field S of DBC sta 13+00, Sep 2015**

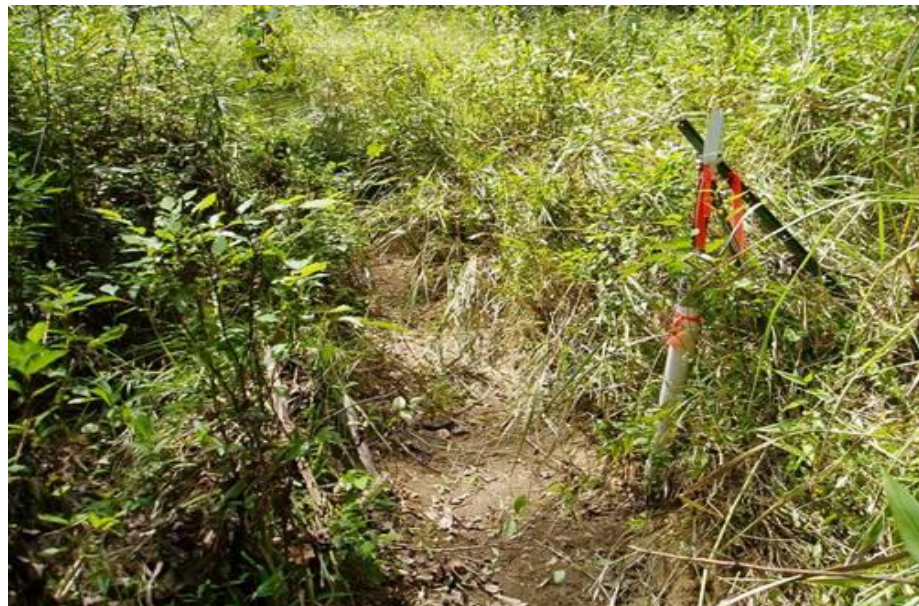
**Hobo gauge moved to Trib sta 4+82 on 07 Aug 2015**

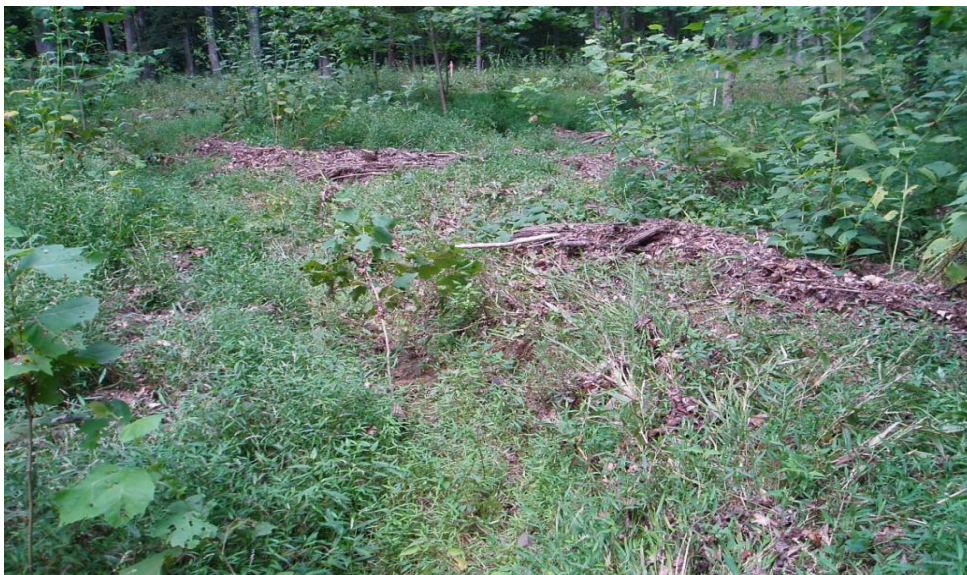
**Wrack deposits on floodplain near Tributary station 01+50, 02 Sep 2015**
