**SUTHER STREAM & WETLAND RESTORATION SITE -- DMS #370
Cabarrus County NC -- PeeDee River HUC# 03040105-020060**

MY-5 (2016) ANNUAL MONITORING REPORT

**North Carolina Department of Environmental Quality
Division of Mitigation Services (DENR-DMS) -- Contract # 5764**

Data Collected: Sept 2016

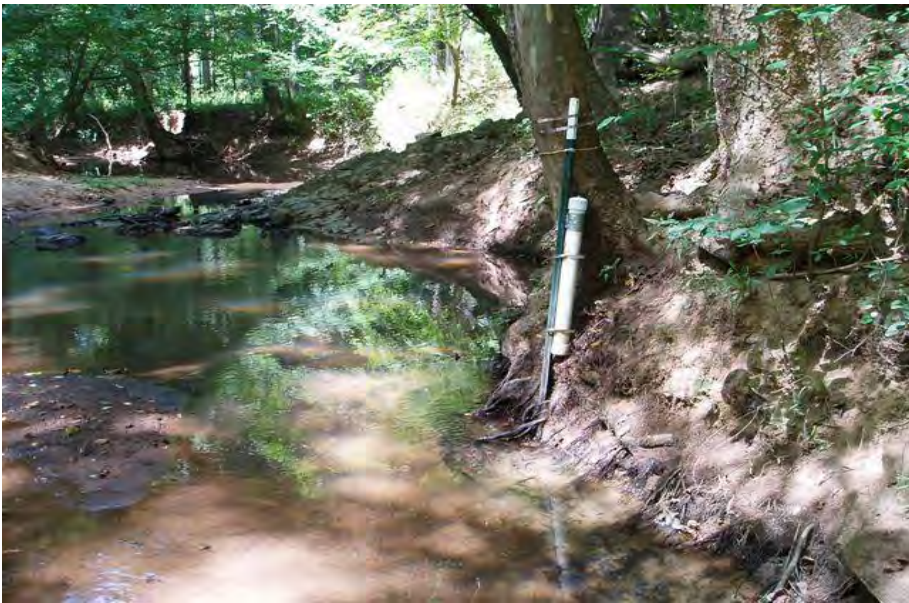
Hobo gauge at DBC sta 37+60, 4/2014 to 8/2015 (photo Sept 2014)

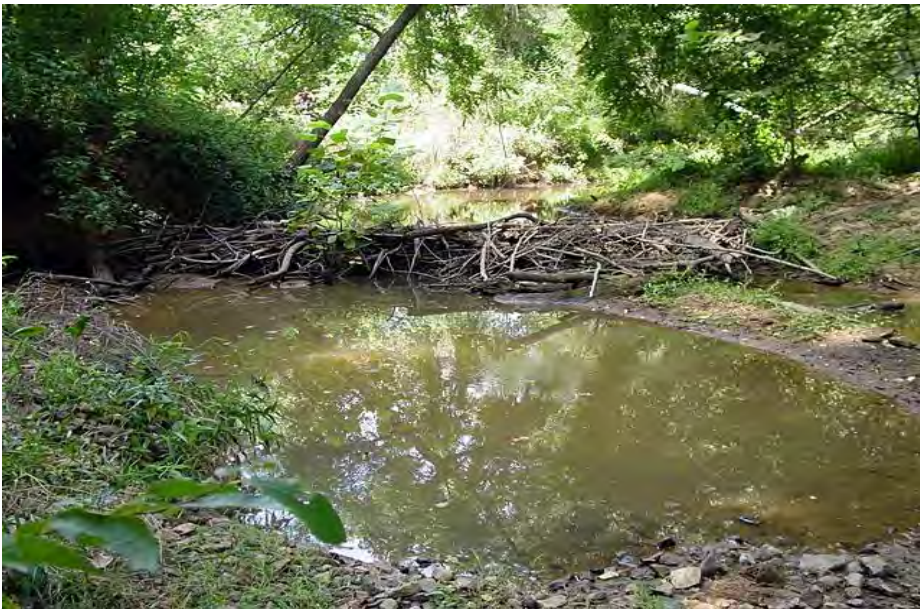
Beaver Dam: Trbutary Station 17+40, Sept 2016

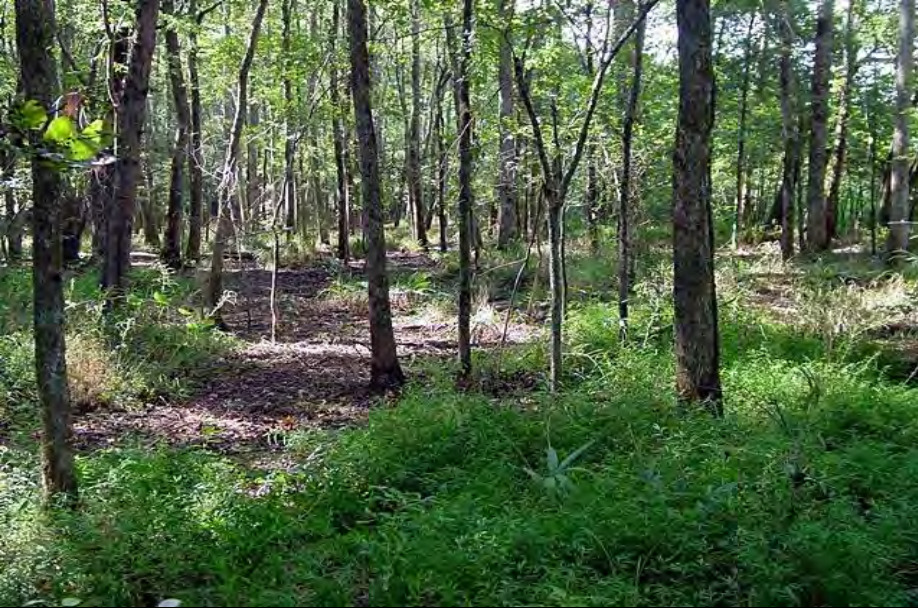
Dry wetland, W of Veg Plot 9, Sept 2016

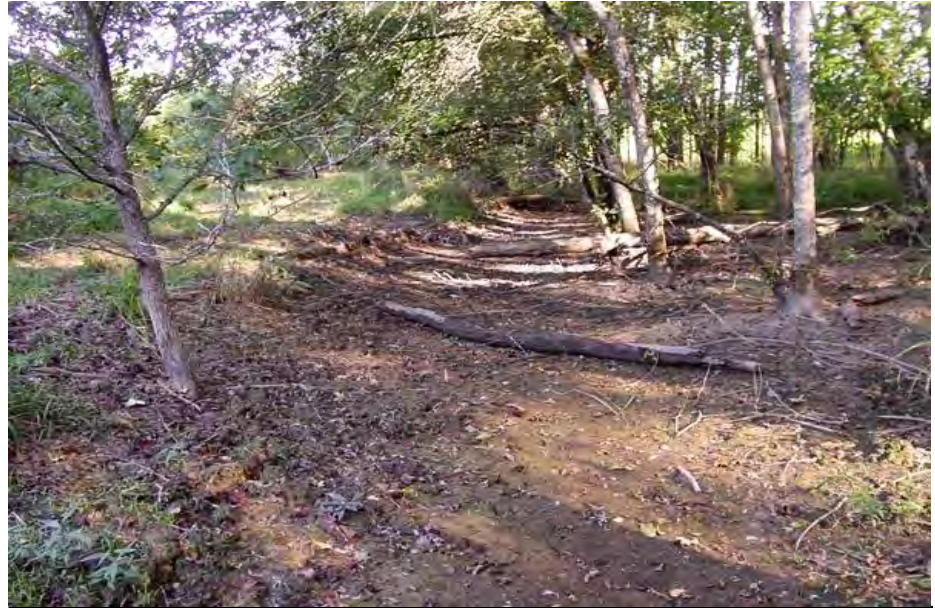
Ditch: SW of Veg Plot 1, Sept 2016

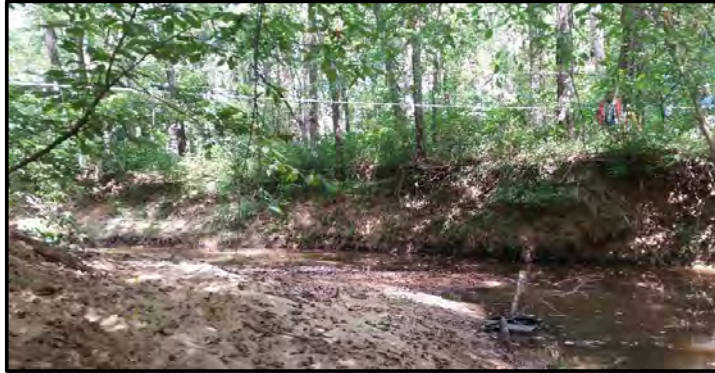
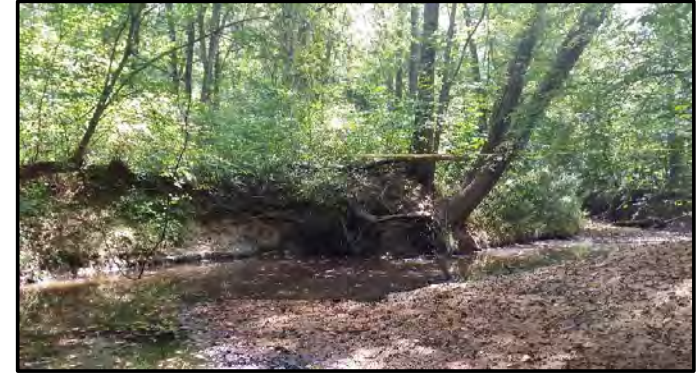
XS-2: Upstream

The six cross-sections on DBC (Figure 3) show negligible change from 2014 and 2015. Cross-section #2 deepened by about one foot at the toe of the steep left bank, on the outer bend of a pool. The scour pool observed in September 2015 at the confluence of Dutch Buffalo Cr and the restored tributary (DBC station 39+60), just below cross-section #6, has filled in during the past year.
