Tarlton Stream and Wetland Restoration Project

Contract #: D05013-1
County: Cumberland
Cataloging Unit: Cape Fear 03030004
Monitoring Firm POC: Mid-Atlantic Mitigation, LLC
Rich Mogensen (704) 782-4133
Kimley-Horn Associates, Inc.
Will Wilhelm (704) 333-5131
Prepared For: EEP Project Manager, Guy Pearce

Year 2 (2007) Monitoring Report

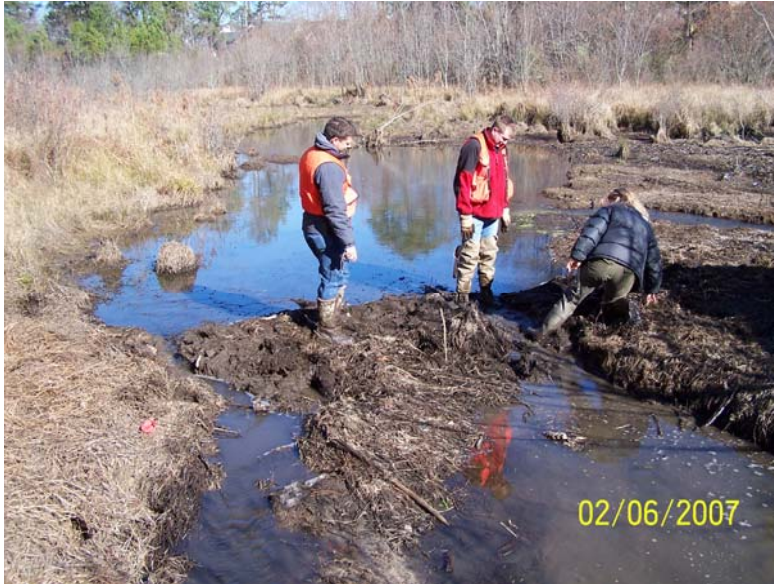
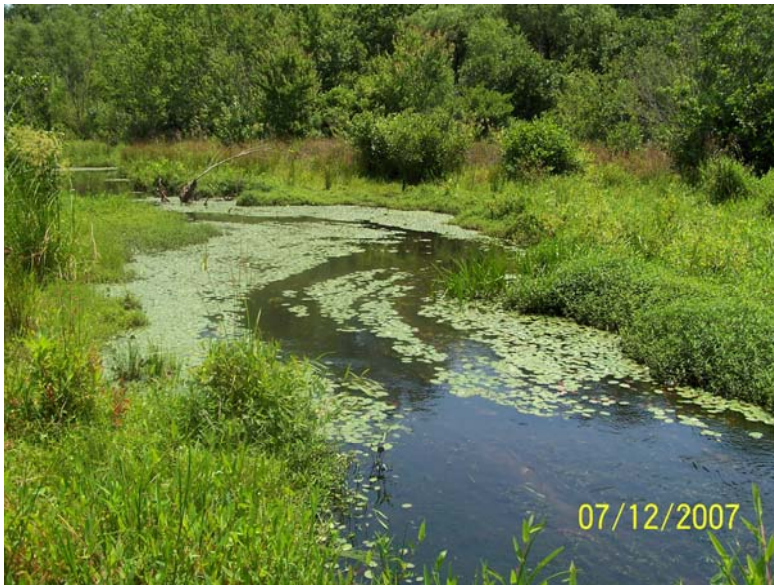
Problem area at end of project between Cross Sections 1 and 2.
This area was smoothed out and live staked.

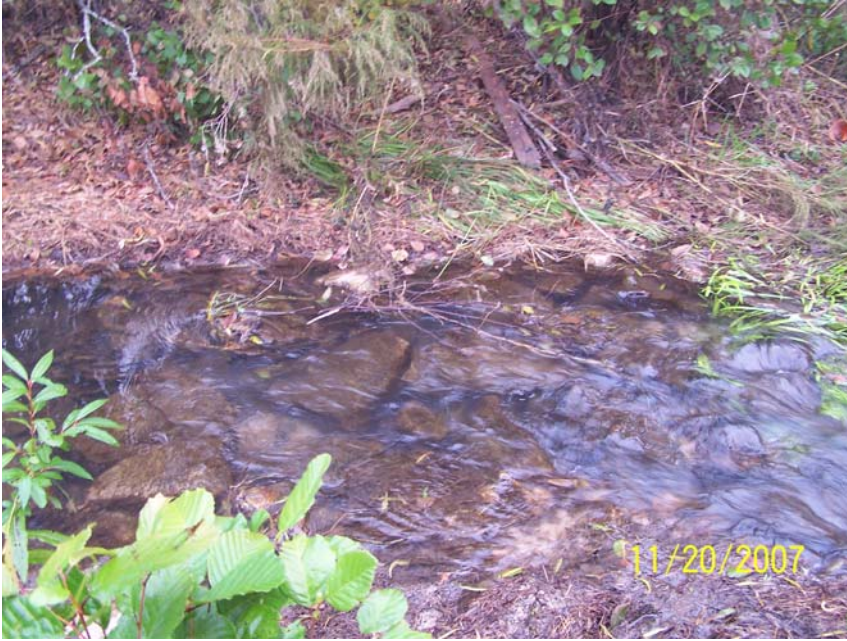
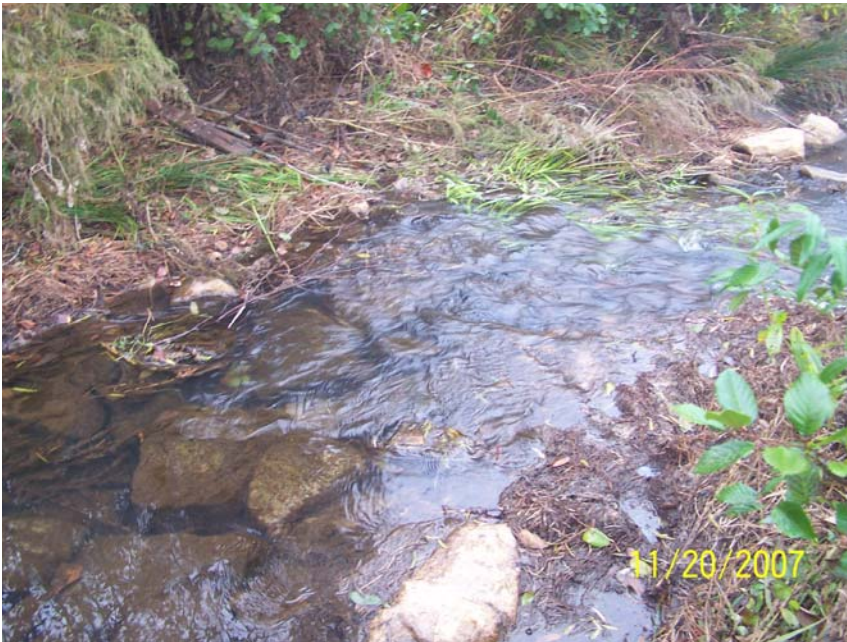
Riffle in Cross section 1 is stable.

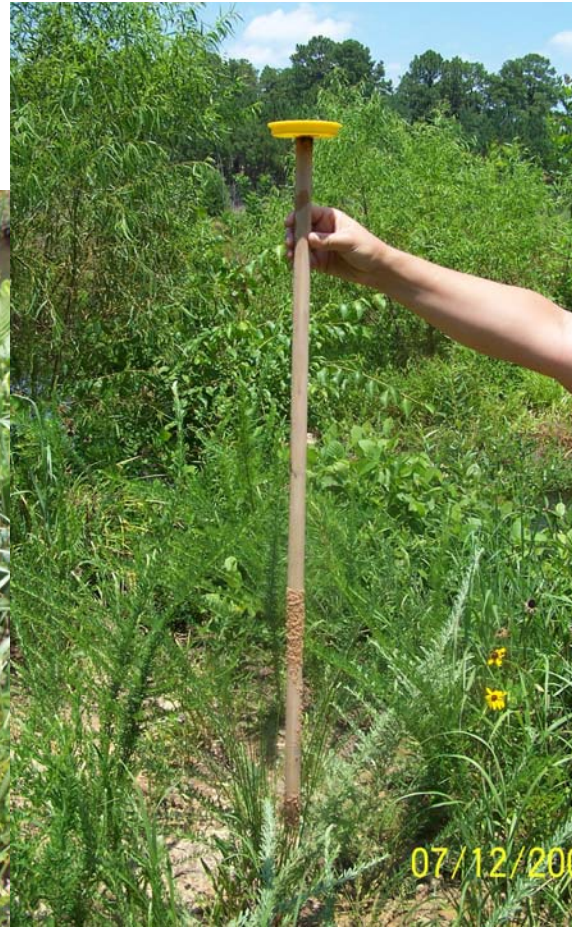
Crest stage gage was checked 7/12/2007 and showed indications of a bank full event. Several rainfall events of greater than an inch in 24 hours were recorded in June in the Fayetteville area and by the onsite rain gage.
