Thomas Creek Restoration Project Year 7 Monitoring/Closeout Report

Wake County, North Carolina

DMS Project ID Number – 96074, DEQ Contract No. 5549

Report Prepared and Submitted by Michael Baker Engineering, Inc.

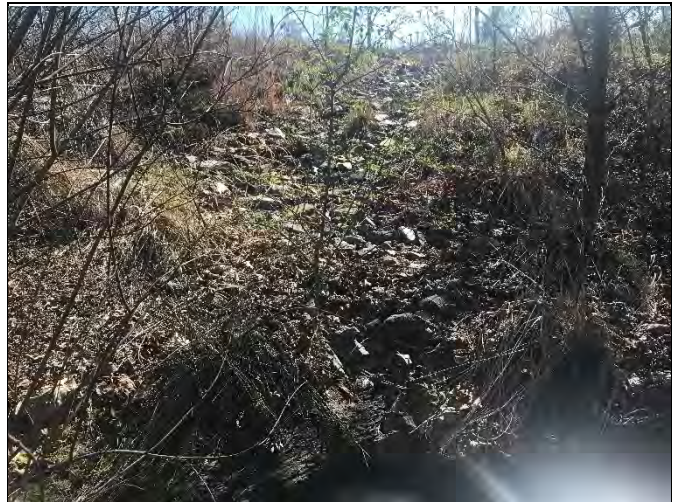
PP-18: Reach 2, view of stabilized drainage on left bank at Station 20+80

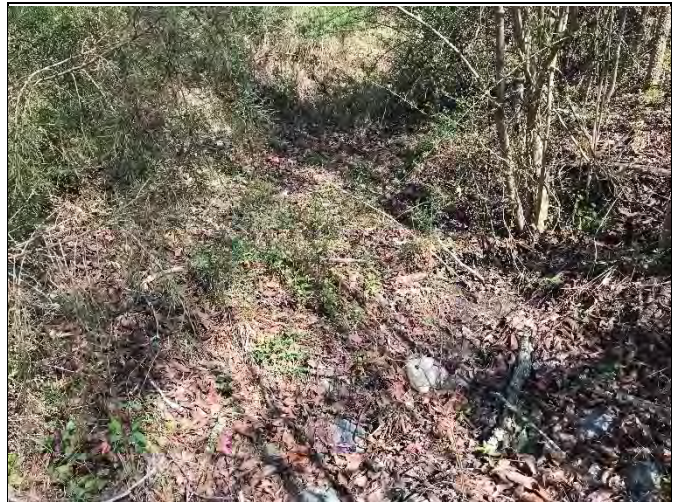
PP-36: Reach 1, view of drainage on left bank at Station 44+00

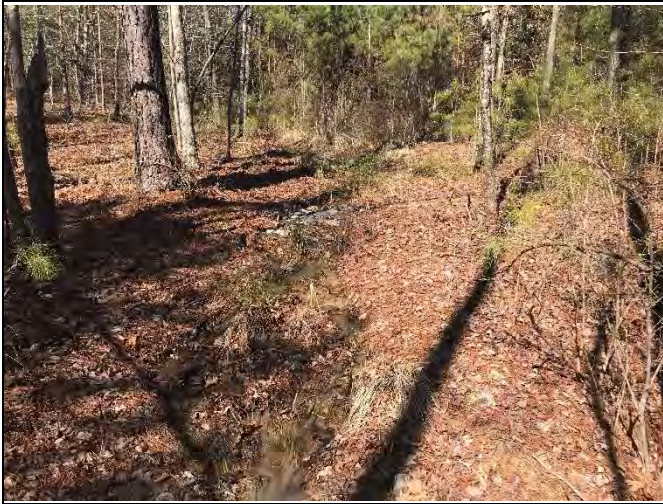
PP-43: Reach 7, view of stabilized drainage at Station 13+50

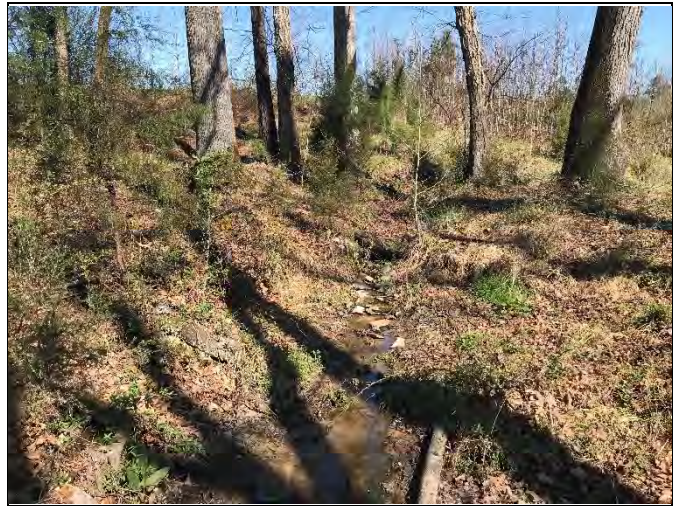
PP-58: Reach T2, view upstream at Station 10+80

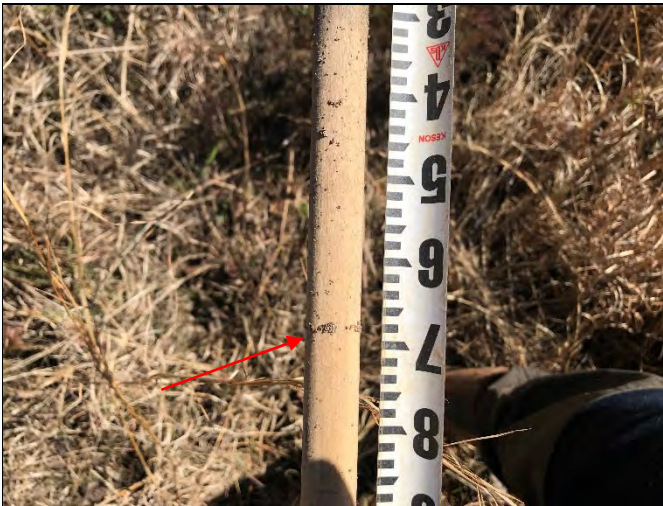
Overbank event of 0.67 ft on 1/3/22
(photo from 3/25/22)

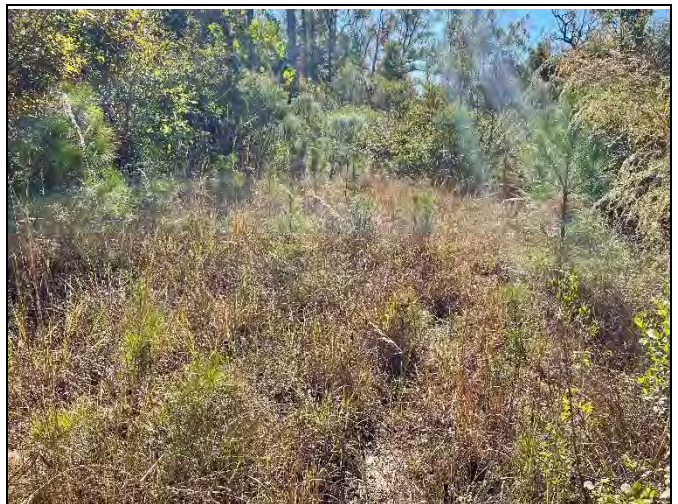
R3 soil amendments (photo: 10/19/2022)

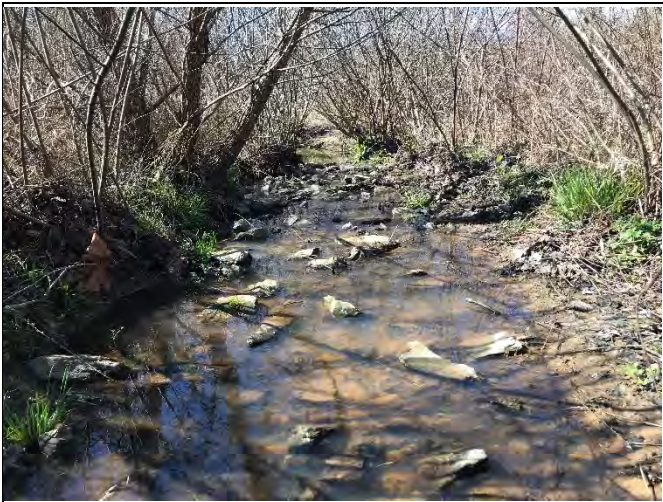
R2 station 37+50 MY7 photo of riffle (photo: 3/25/22)
